JLRTB02052NAS1
TECHNICAL BULLETIN
16 SEP 2020

501-03

Rear Doors Difficult To Open

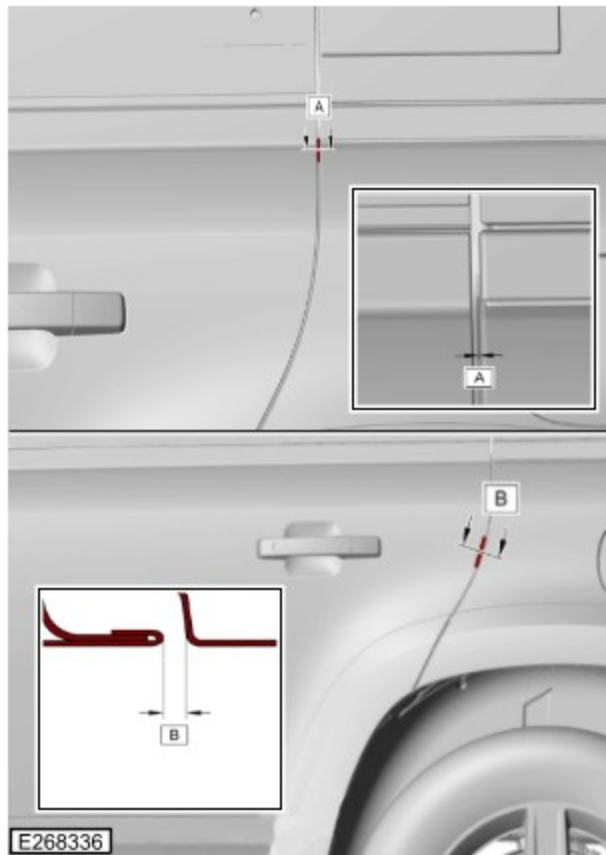
Check the alignment of the rear door(s) in the areas shown in the illustration.

SECTION	DESCRIPTION	GAP	PROFILE
A	Rear door to rear quarter	N/A	0.0 ± 0.5 mm
B	Rear door to rear quarter	3.5 ± 0.7 mm	0.0 ± 0.7 mm

Adjust the rear door(s) to be within tolerance (see TOPIx Workshop Manual section 501-26: Body Repairs: Vehicle Specific Information and Tolerance Checks - General Procedures - Rear Door Alignment).

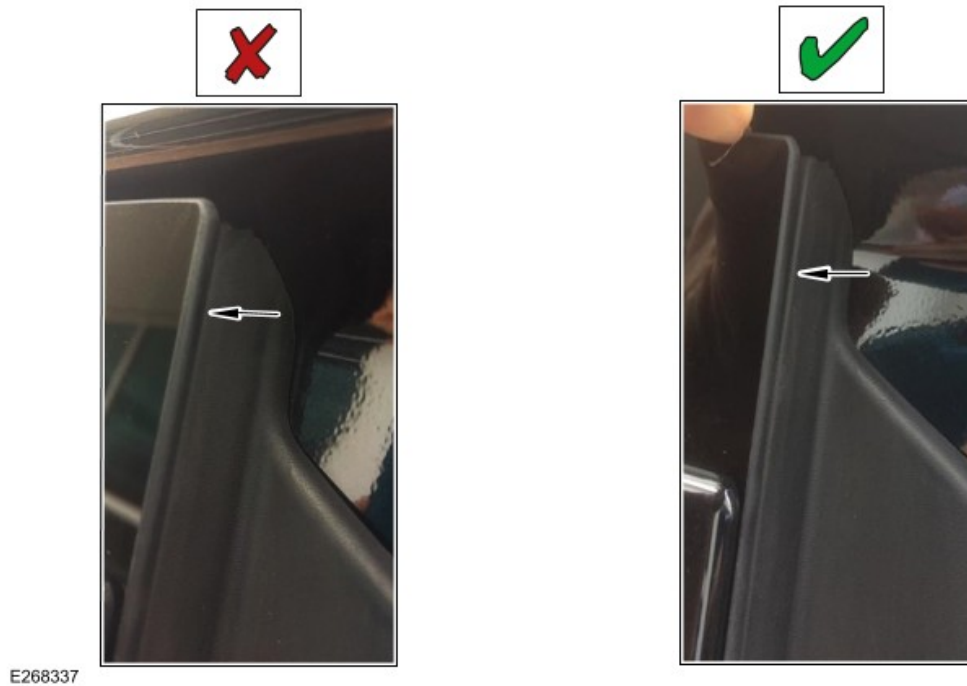
- ■ Remove the adhesive tape backing.
 - ■ **Make sure the C-pillar exterior finisher trim protrudes 1-1.5 mm away from the rear quarter window, as shown in the illustration, before fully securing.** The image with the **RED 'X'** shows the C-pillar exterior finisher trim installed incorrectly behind the rear quarter window. The image with the **GREEN '✓'** shows the C-pillar exterior finisher trim installed correctly with a 1-1.5 mm protrusion from the rear quarter window.
-

Install the new C-pillar exterior finisher trim.
