SI B51 19 19
Body Equipment

SQUEAKING NOISE WHEN OPERATING THE SIDE WINDOWS

I01 (I3)			
----------	--	--	--

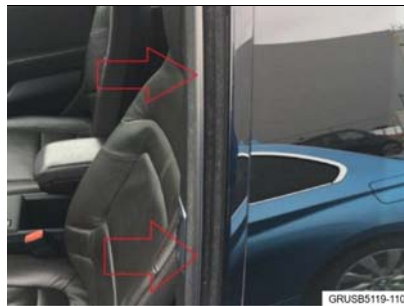
A squeaking noise is heard when operating either side window.

Interference between the side window glass and the B-Pillar seal.

1. Clean both B-pillar seals using warm water and a clean cloth.

2. Apply Gummi-Pflege rubber care fluid, PN 83 19 2 449 390, to the edge of both B-pillar seals where the window slides (arrows).
