N576NAS1

TECHNICAL BULLETIN

Service Action - Coolant Level Sensor Loose

MODEL:	MODEL YEAR:	VIN:
Defender (LE)	2020-2021	000001-025820

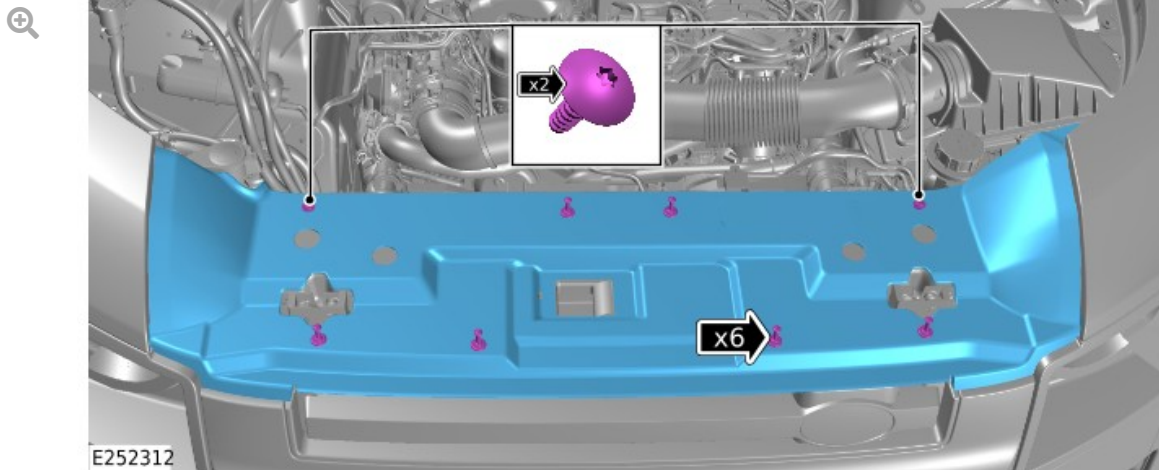
1.

Remove the upper radiator grille panel.

- Remove the 2 bolts.
 - Torque: **5 Nm**
- Remove the 6 clips.

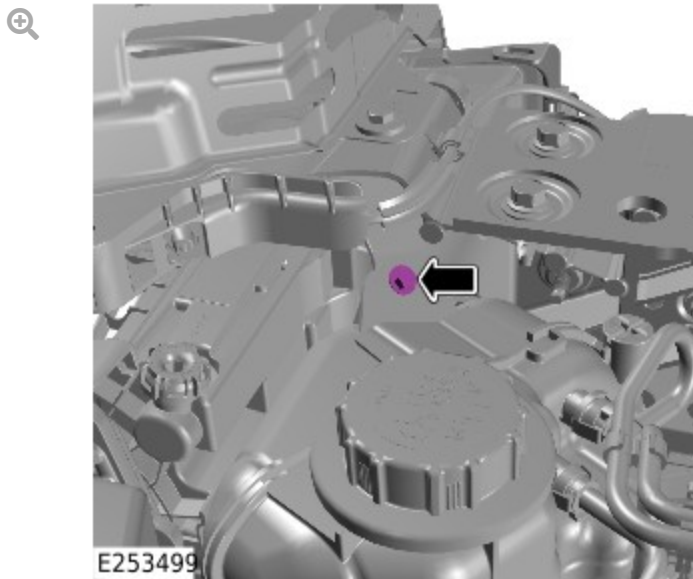
2.

Remove the bolt from the coolant expansion tank bracket.

- Torque: **2.8 Nm**

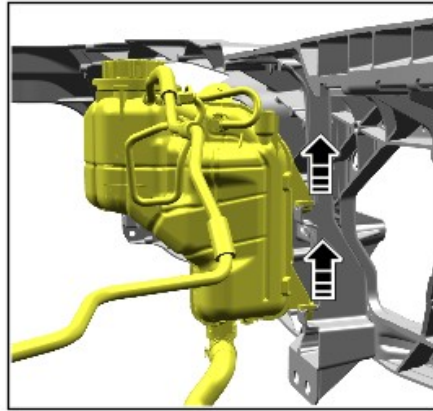
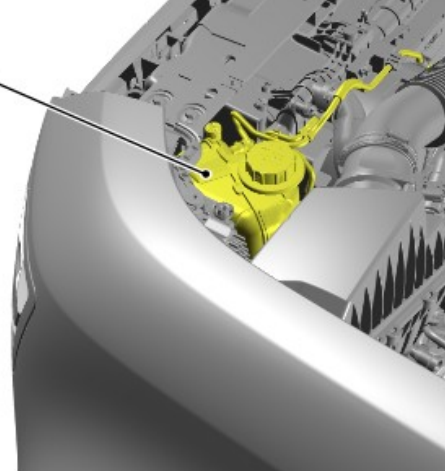
3.

The coolant expansion tank part number is located on the opposite side of the expansion tank to the Min/Max markings.

Release the coolant expansion tank and reposition upwards so the part number is visible.

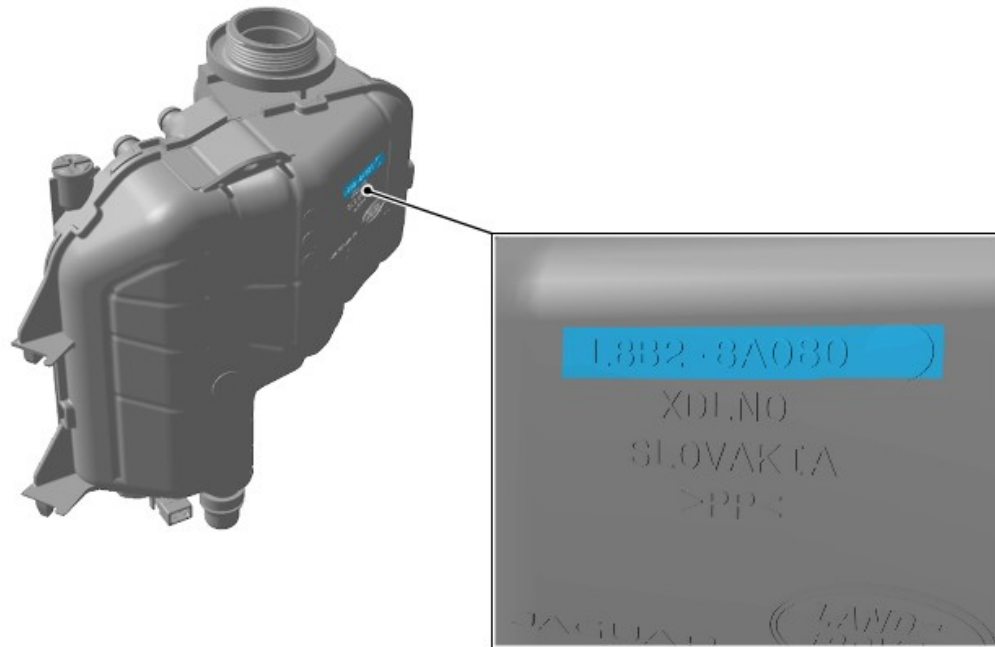
4.

Inspect the coolant expansion tank part number.

- If the coolant expansion tank part number is **L8B2-8A080-AF** or **L8B2-8A080-AG**, reverse steps 1 to 3 and release the vehicle.
- If the coolant expansion tank part number is not **L8B2-8A080-AF** or **L8B2-8A080-AG**, continue to the Service Instruction.

1. Renew the coolant expansion tank (see TOPIx Workshop Manual section 303-03: Engine Cooling - Removal and Installation - Coolant Expansion Tank - **Complete removal steps 4 to 7, followed by all installation steps**).
