JLRTB02058NAS1
TECHNICAL BULLETIN
19 AUG 2021

501-08

Tapping Noise From A-Pillar Area

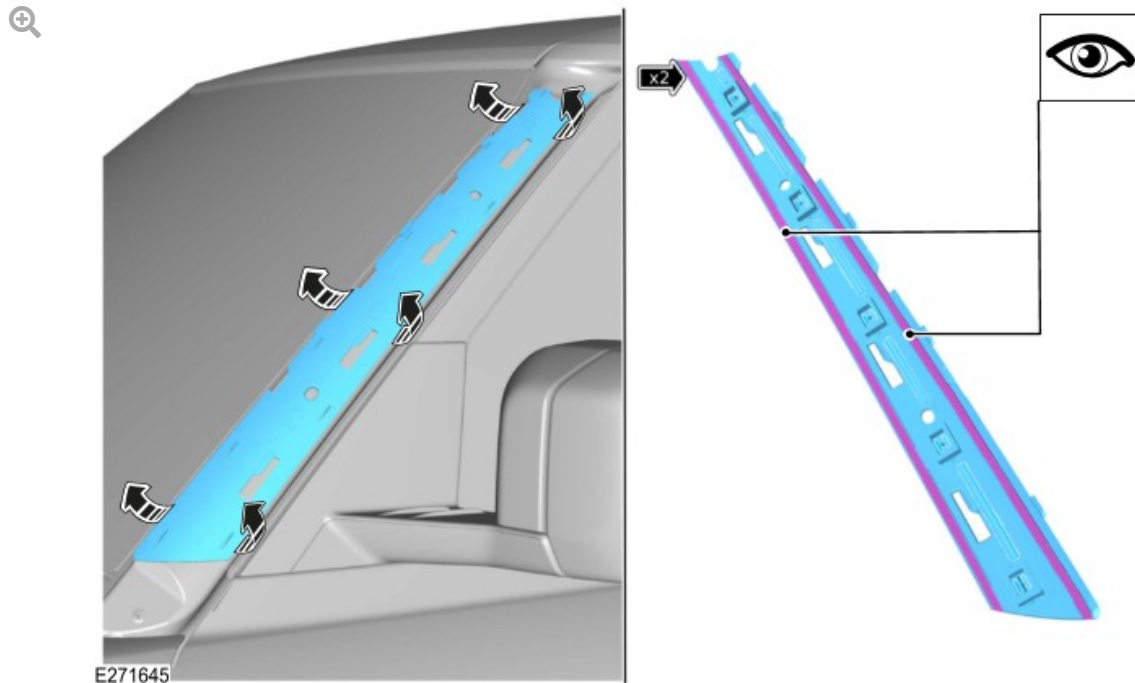
Check that the 2 strips of double sided tape are fully adhered to the body.

- By hand, pull along both edges of the windshield molding carrier while visually inspecting the tape for adhesion.
 - If both strips of double sided tape **are** fully adhered to the body, **continue to step 14.**
 - If any of the strips of double sided tape **are not** fully adhered to the body, **renew the windshield molding carrier as part of a separate warranty claim (see TOPIx Workshop Manual section 501-11: Glass, Frames and Mechanisms - Removal and Installation - Windshield Molding Carrier).**

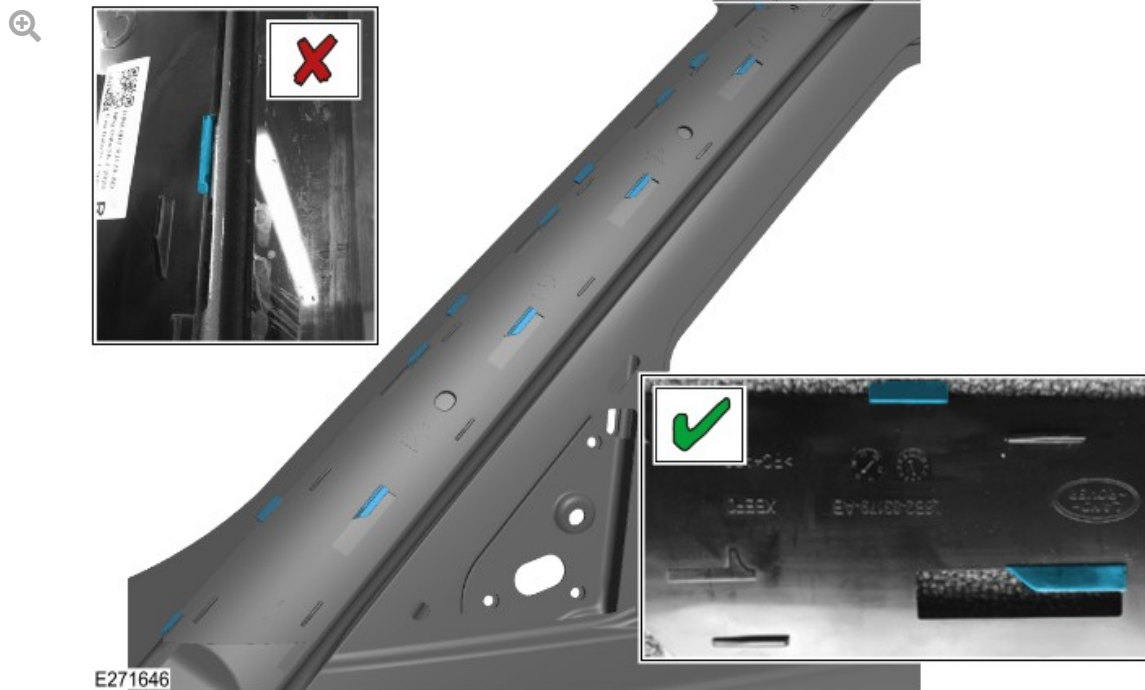
Visually inspect the windshield molding carrier for damage to the clipping features shown in the illustration.

- If the clipping features **are not** damaged, as shown in the image with a **GREEN '√'**, **continue to step 15.**
- If any of the clipping features **are** damaged, as shown in the image with a **RED 'X'**, **renew the windshield molding carrier as part of a separate warranty claim (see TOPIx Workshop Manual section 501-11: Glass, Frames and Mechanisms - Removal and Installation - Windshield Molding Carrier).**

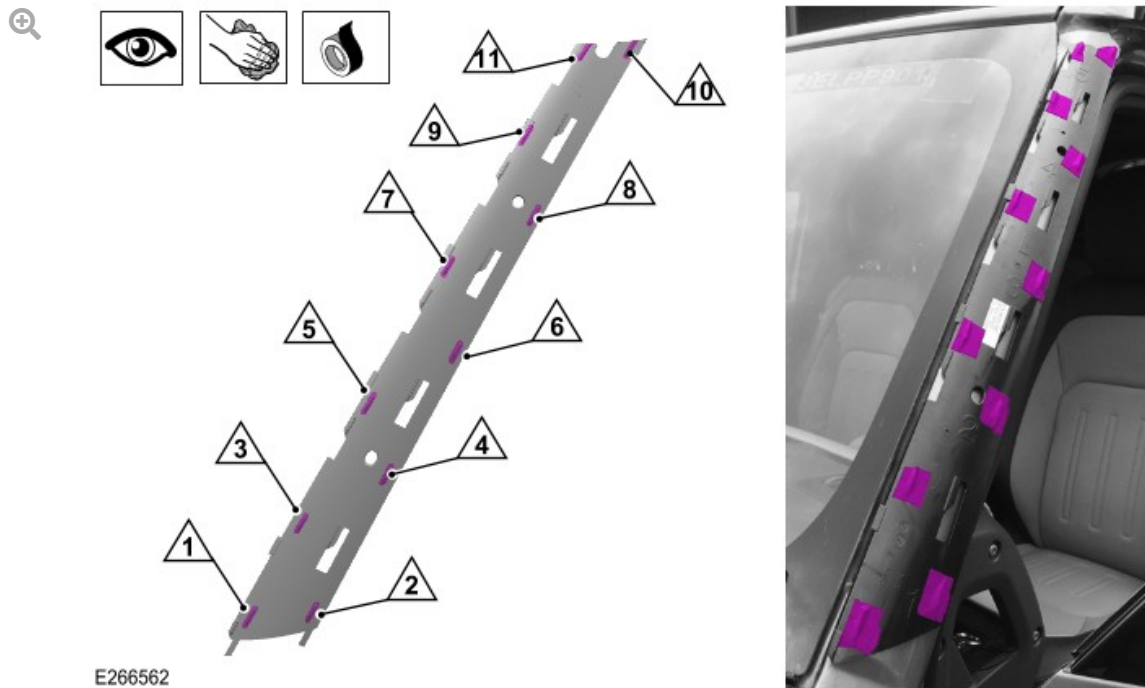
Locate the 11 windshield molding retaining ribs, as shown highlighted in the illustration.

- Clean the area around each windshield molding retaining rib.
- Apply felt tape to cover each of the 11 windshield molding retaining ribs, as shown in the illustration.

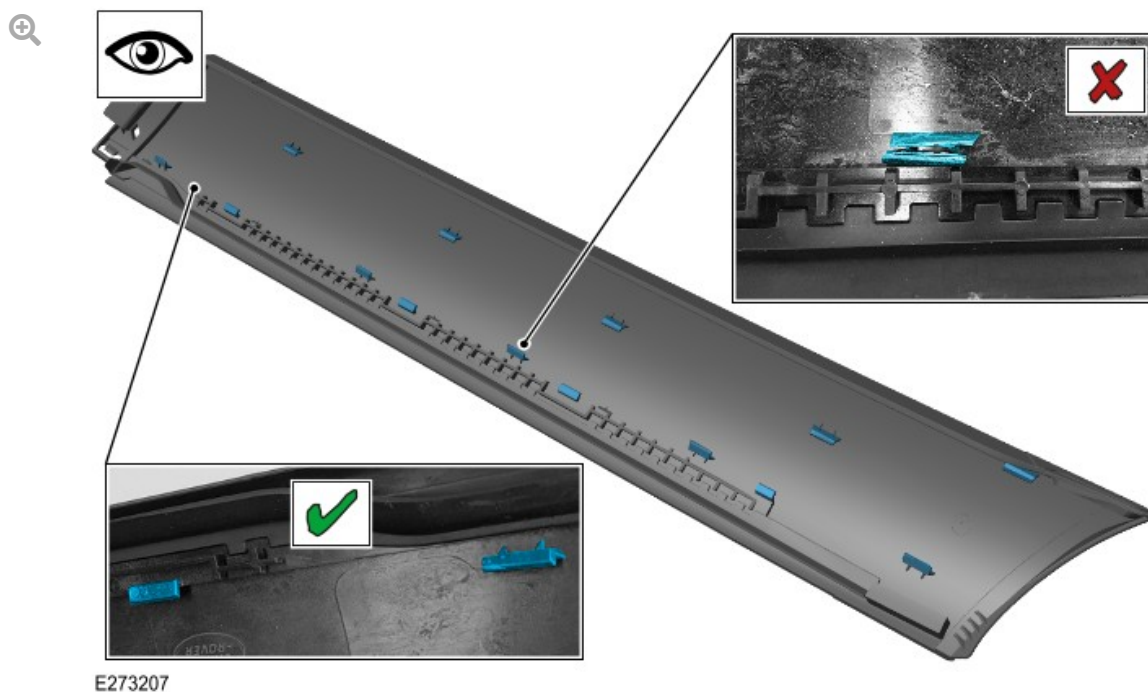
Inspect the windshield molding for damaged clipping features.

- If the clipping features **are not** damaged, as shown in the image with a **GREEN '✓'**, **continue to step 24.**
- If any of the clipping features **are** damaged, as shown in the image with a **RED 'X'**, **a new windshield molding must be ordered and claimed as part of a separate warranty claim before continuing to step 24.**

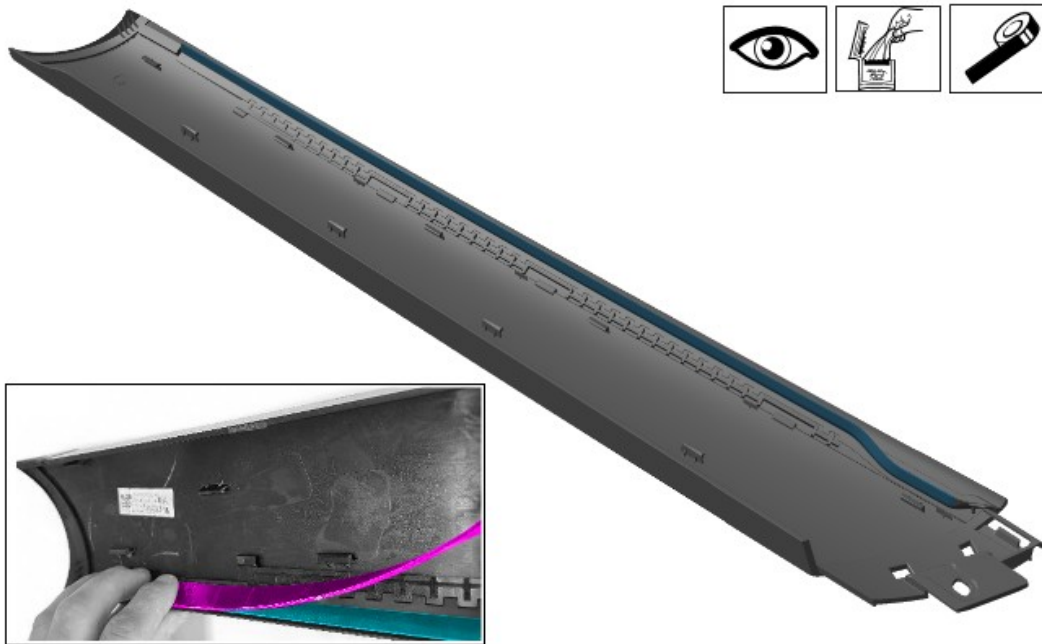
E271647

Inspect the rubber seal on the windshield molding for damage. If the seal is damaged a new windshield molding is required before continuing with this step, this must be claimed as a separate warranty claim.

Using 3M™ surface cleaner, clean the inside edge of the rubber seal, as shown highlighted in the illustration.

Following the manufacturer's specifications, apply the 3M™ adhesion promoter to the inside edge rubber seal, as shown highlighted in the illustration.

- Cut a length of 3M adhesive tape - ST 1200 to the following dimensions:
 - **10 mm x 620 mm**

Gradually remove the adhesive backing and install the 3M adhesive tape - ST 1200 (or equivalent) in small sections at a time. Apply firm pressure along the entire length of the rubber seal to make sure the adhesive is bonded.

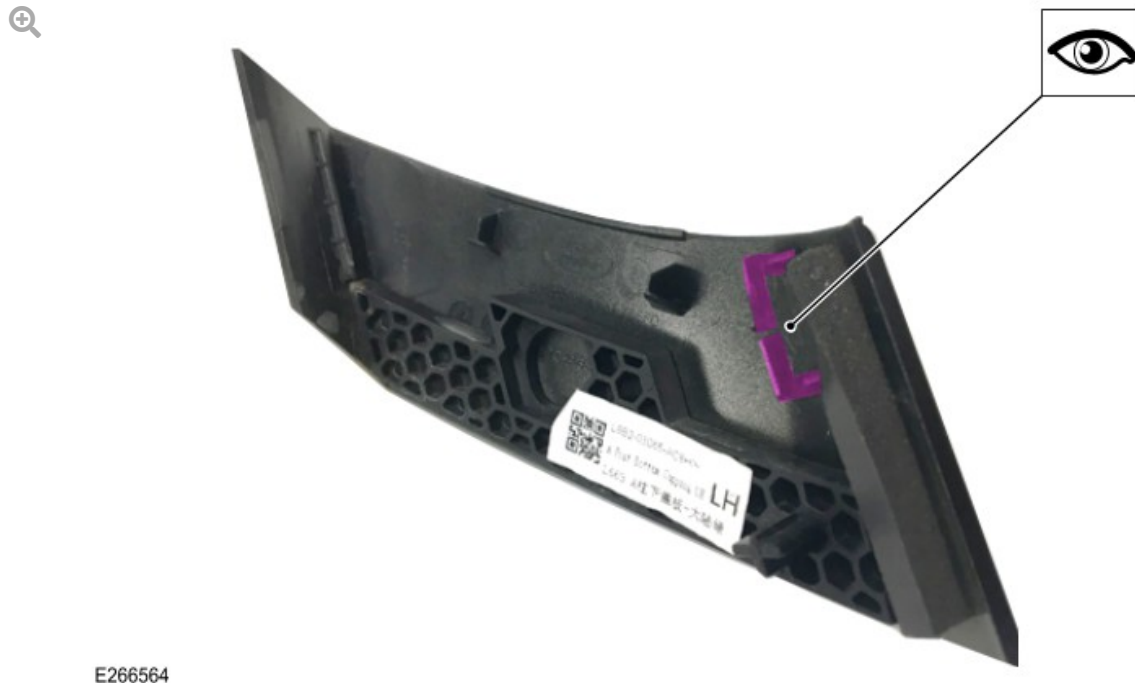
E266564

Inspect the retaining clip on the windshield molding bolt cover.

- If the retaining clip is broken, as shown highlighted in the illustration, **install a new windshield molding bolt cover during the next step and claim it as part of a separate warranty claim.**
- If the retaining clip is **not** broken, **install the original windshield molding bolt cover during the next step.**
