EXHAUST TAILPIPE CORROSION – 5.0L AJ133-8 CYLINDER ONLY

Defender

- 20–24MY Defender

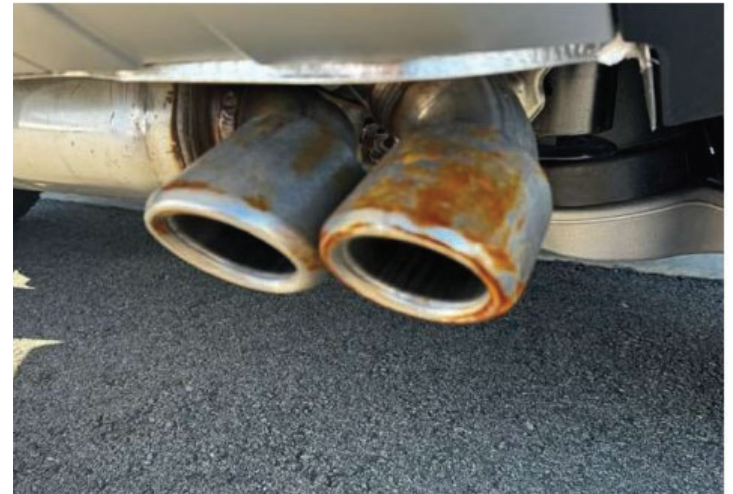
- JLR Retailers have reported visible corrosion around the outlet of the exhaust tailpipe prior to PDI

- Please find attached an example image showing light corrosion.
- Where mild corrosion is visible on the exhaust tail pipe, clear away the corrosion using a non metallic scouring pad or suitable mild cutting paste.
