JLRTB02052NAS3
TECHNICAL BULLETIN
07 AUG 2023

501-03

Rear Doors Difficult To Open

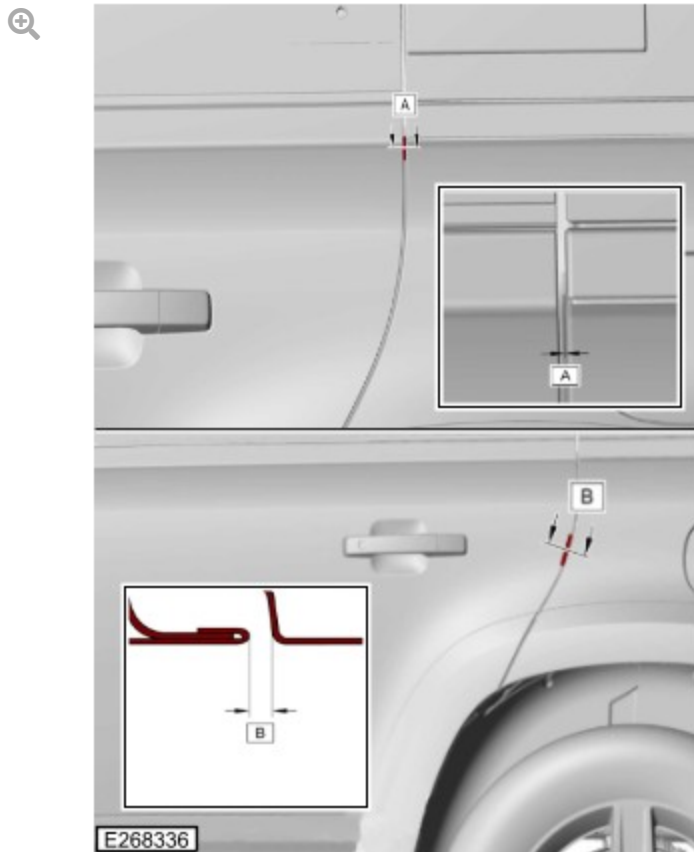
When opening either of the rear doors, the door seal contacts the rear quarter window and makes opening the doors more difficult and sometimes noisy.

C-pillar exterior finisher trim to rear quarter window alignment incorrect.

Check the alignment of the rear door(s) in the areas shown in the illustration.

SECTION	DESCRIPTION	GAP	PROFILE
A	Rear door to rear quarter	N/A	0.0 ± 0.5 mm
B	Rear door to rear quarter	3.5 ± 0.7 mm	0.0 ± 0.7 mm

Only adjust the rear doors that are either out of alignment tolerance or do not have a gap of 2.8 mm.

Adjust the rear door(s) to be as far rearward as possible while still being within tolerance, the gap must be 2.8 mm (see TOPIx Workshop Manual section 501-26: Body Repairs: Vehicle Specific Information and Tolerance Checks - General Procedures - Rear Door Alignment).
