1996-97 Discovery VSS Repair/Refurbish.

Version 1: 1/27/2013

Applies to:

Discovery series I, 1996 and 1997.

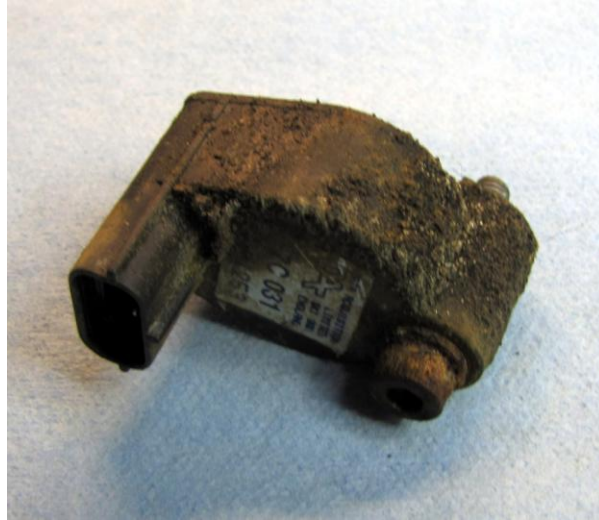
Figure 1: VSS from my truck – yuck!

The first thing you notice is that these things get dirty. The position of the VSS on the transfer casing seems to trap dirt on it.

The first thing to do is to clean the outside thoroughly. You don't want any of this stuff inside your expensive sensor. Then just grab the input shaft with a pair of pliers and pull it out. Yeah, I know, "why would you think that would work?". The answer is that for the first one, I didn't. I just wanted to get it apart to satisfy my curiosity. Now I know. The shaft is held to the internal working with silicone gasket adhesive. It comes apart and can be put back together.

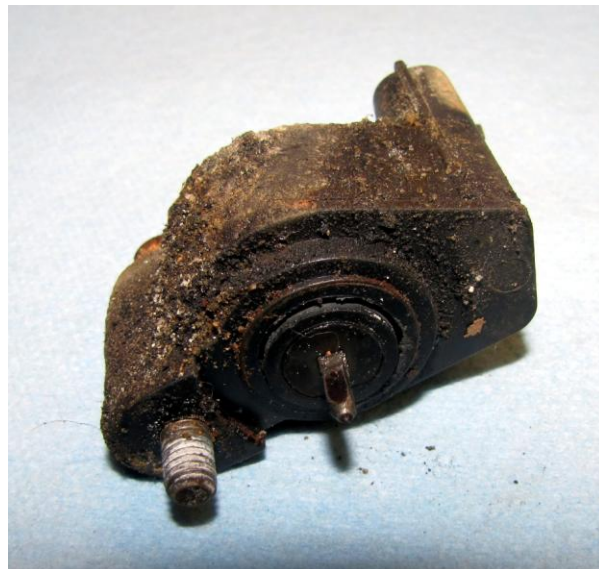
Figure 2: Other side is worse

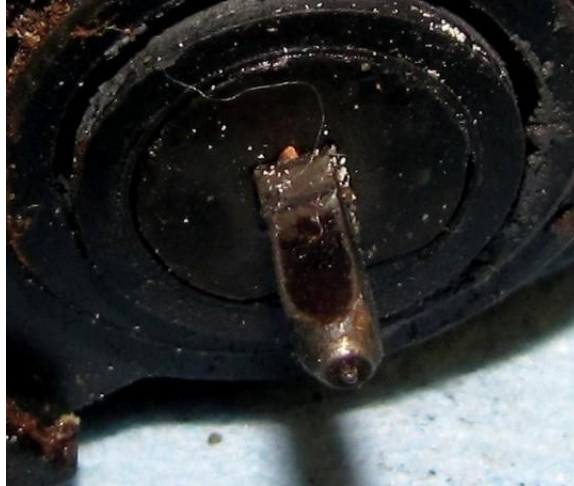
Figure 3: Input shaft

Wear on the input shaft is not unexpected on something that's gone 132000 miles. However, if you look at the shaft, it's got notching far back on it. This indicated that the shaft has been tilting, and has had some force applied to it. It's probably been binding.

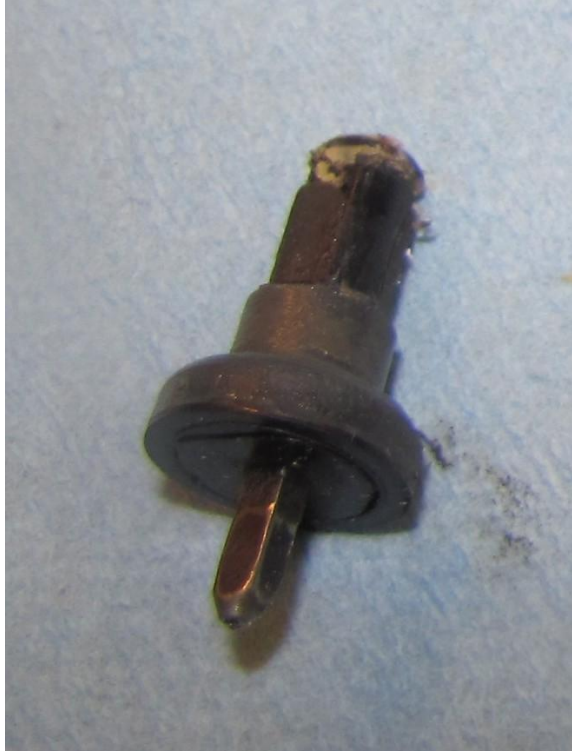
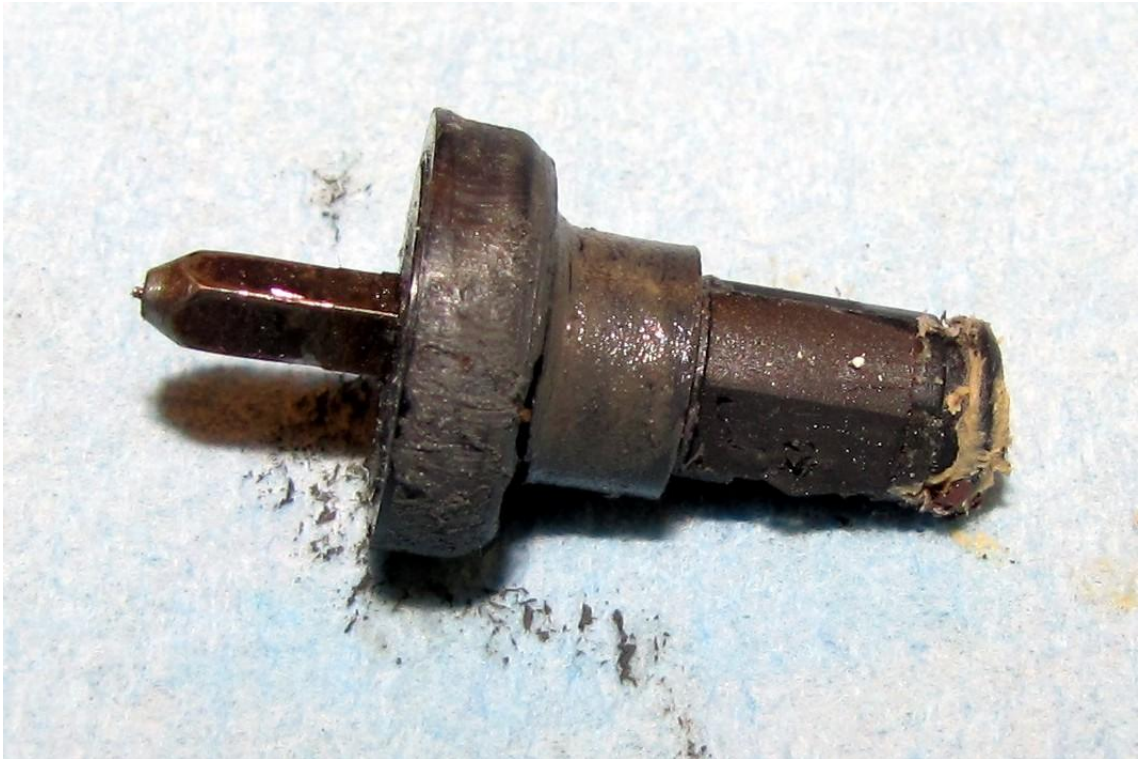
Figure 4: Input shaft

Here we see the shaft with the grease and silicone seal on it. You need to clean all of this thoroughly.

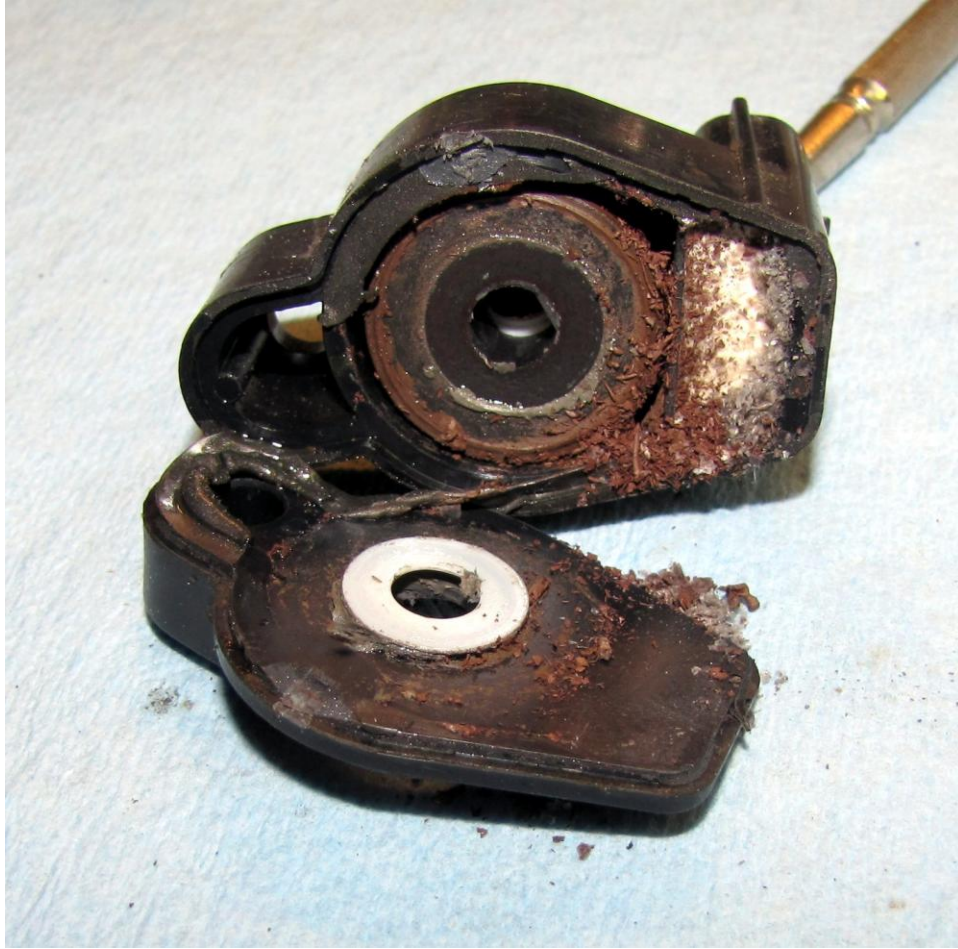
Figure 7: Bigger yuck!

Now you get to see the inside of the housing. There's a 0.016 inch thick plastic shim, the round magnet driven by the input shaft, and a whole bunch of stuff that at first glance looks like rust. It's not.

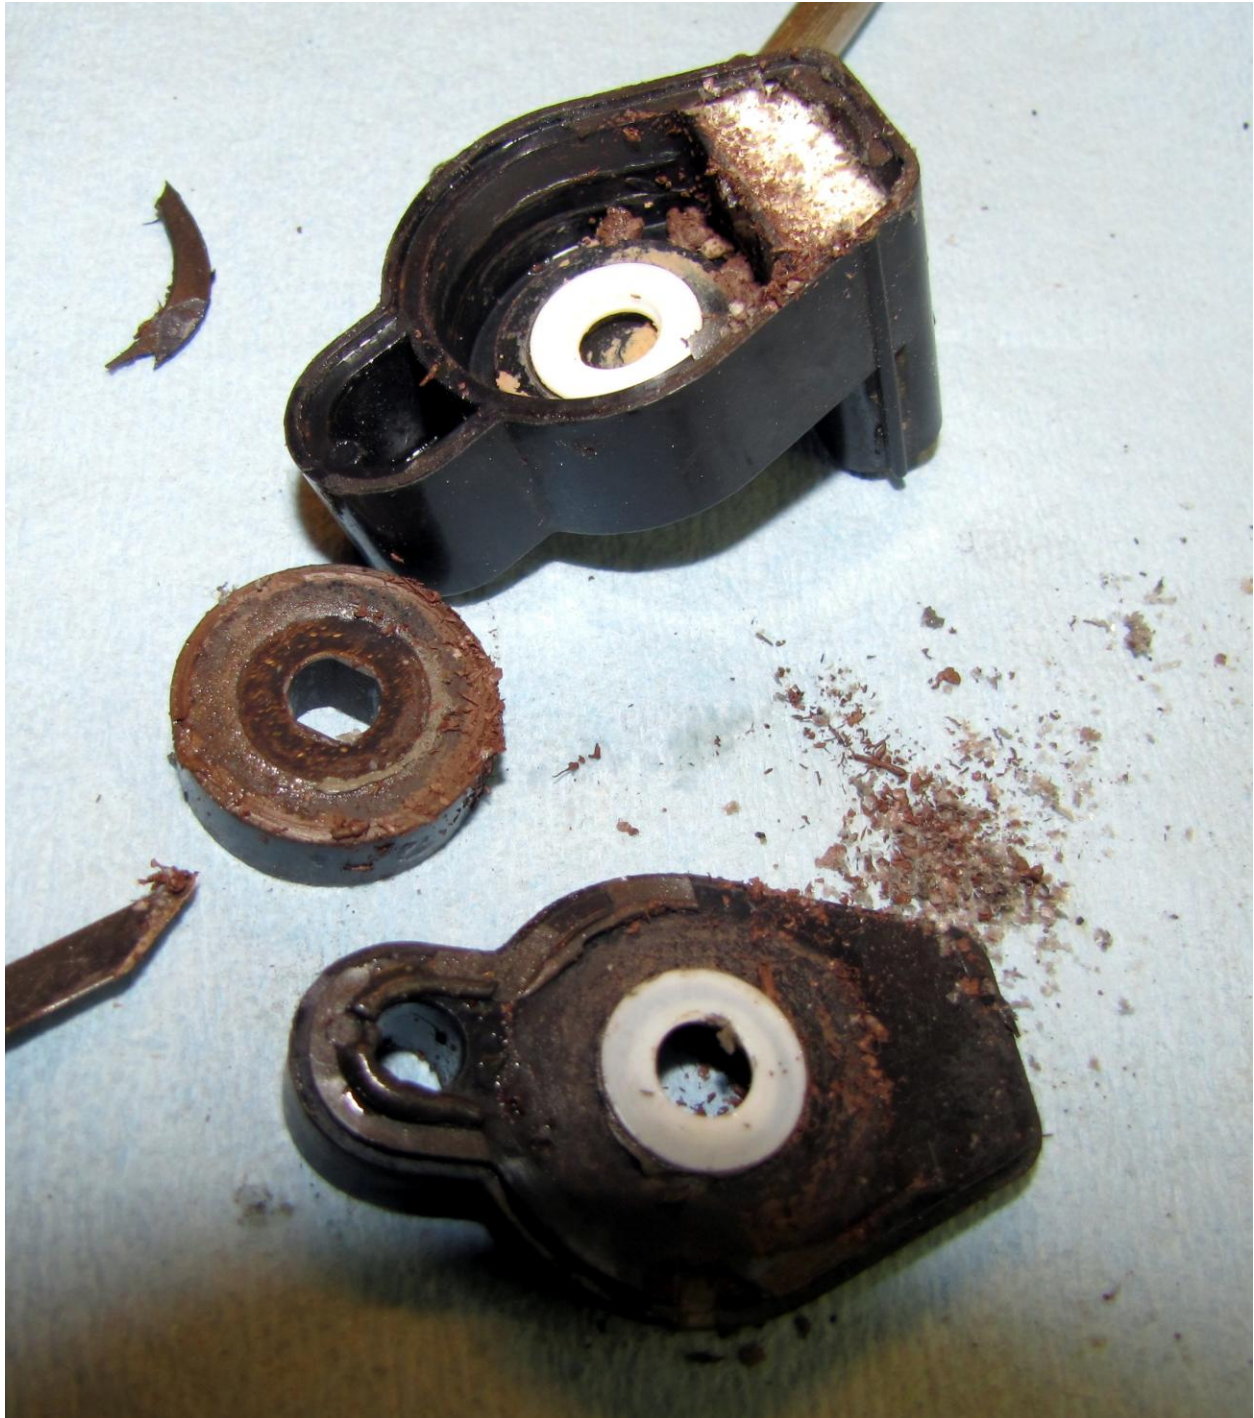
Figure 8: Housing with magnet removed

After pulling out the magnet, you can see more debris, along with the rear plastic bearing/thrust washer. The brown stuff turns out to be plastic shavings coated with brown grease.

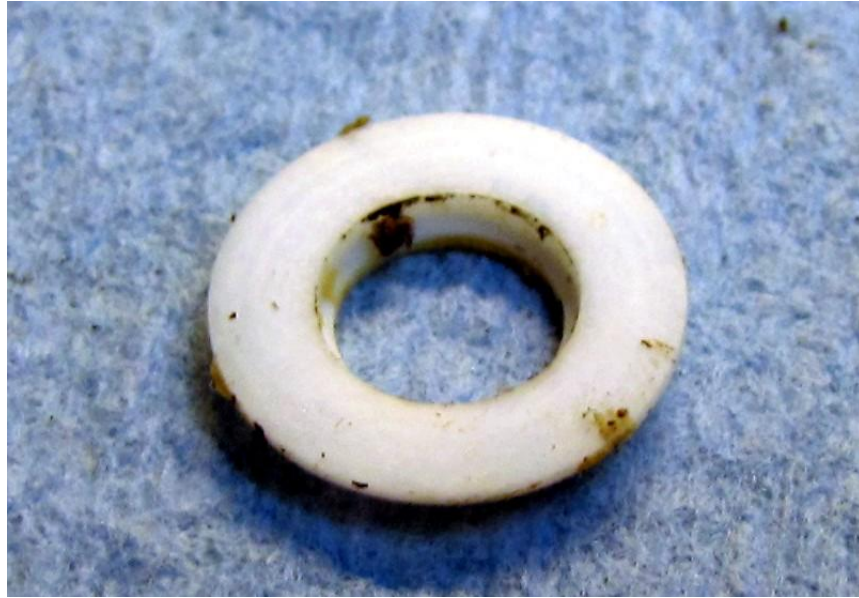
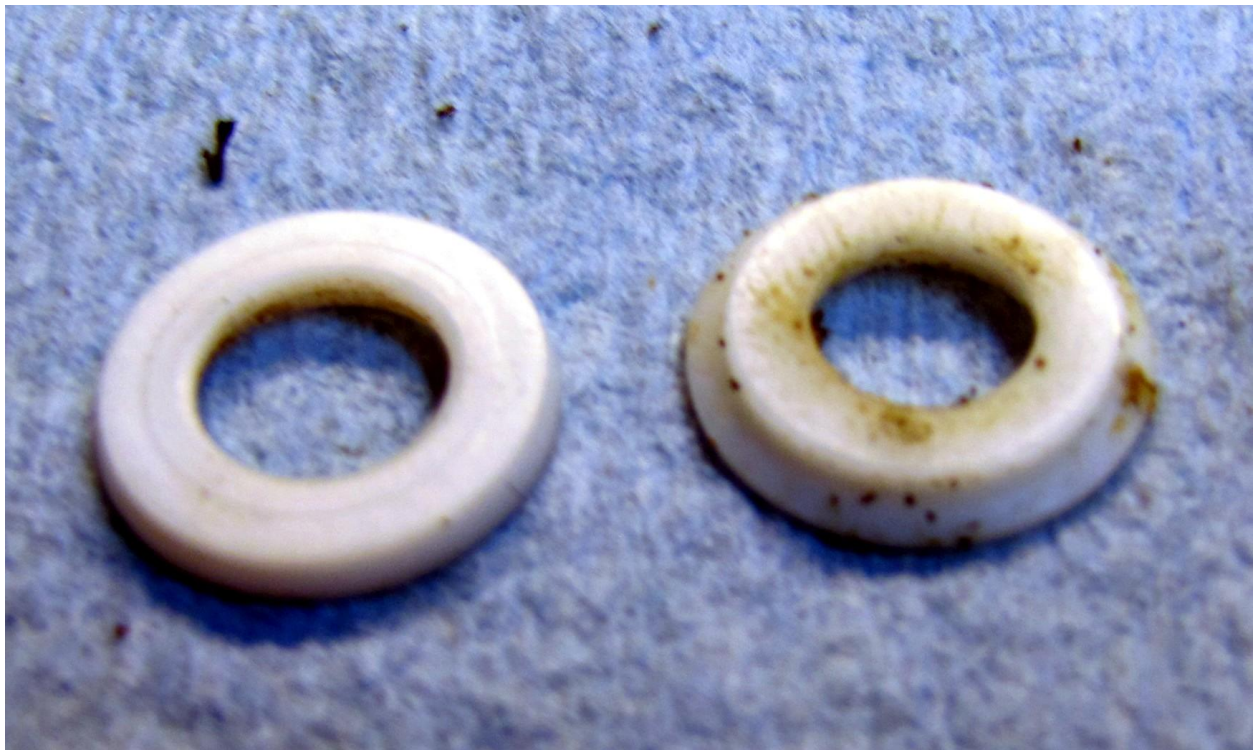
Figure 9: Rear bearing/thrust washer

Figure 10: Two different VSS bushings

The plastic shavings come mostly from the rear bearing. Originally a flat washer with an inside diameter of .257 inches, the inside diameter now is .3 inches. This allows the shaft with the magnet on it to move around so much that you get this:

So, it looks like what happens is the bushing/bearing/thrust washer that is supposed to hold the magnet in position as it spins wears down. This is not surprising as the shaft that sits in it is hard material, and has flat sides that can gouge the bushing. As the material wears, the shaft wobbles more, and wears faster. Eventually the bushing has worn so much that the magnet starts to hit the sides of the housing. At this point, it bounces and binds, causing an unpredictable response from the magnetic reed switch, and as a result, from the ECU.

I was unable to find anything off the shelf to do this locally, but I've order some things that might work. I'll update this when I get something that fits without modification, but for now, I'll explain how you can make something.

I started by finding the closest thing I could to what's needed. I got these washers at Home Depot. They've got the correct center dimension, but are too wide and a little bit less thick than the correct ones.

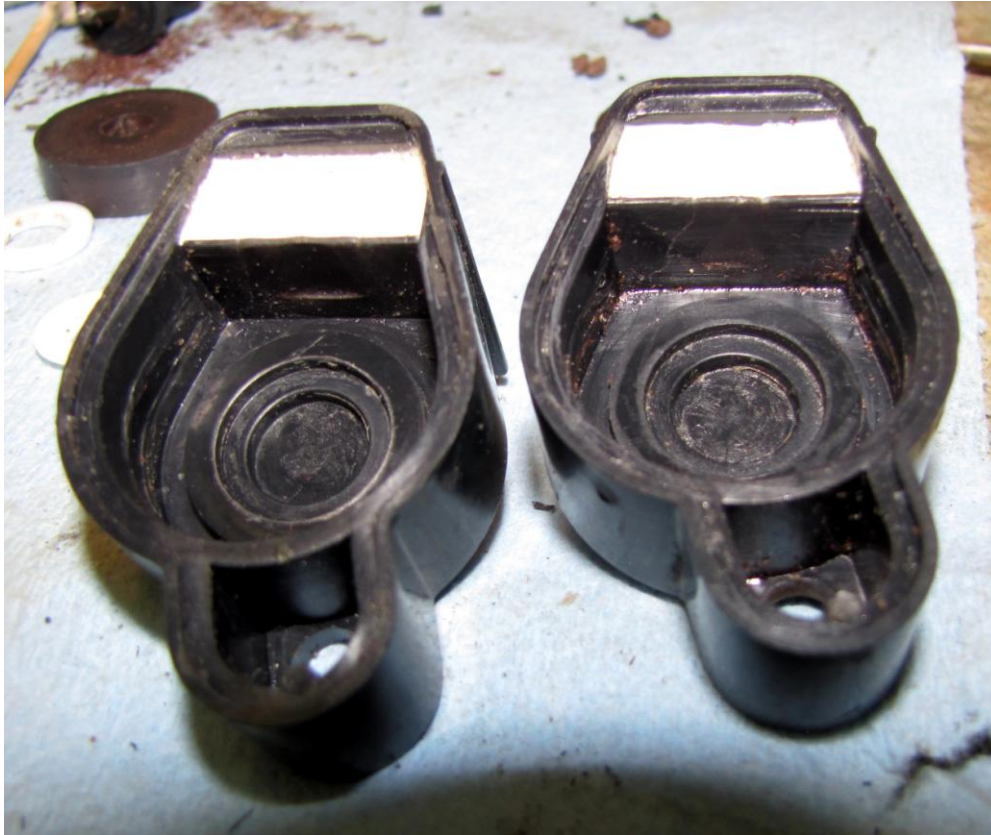
Figure 11: Two VSS housings showing wear from magnet rubbing.

The magnet moves around so much it causes wear in the sides of the case.

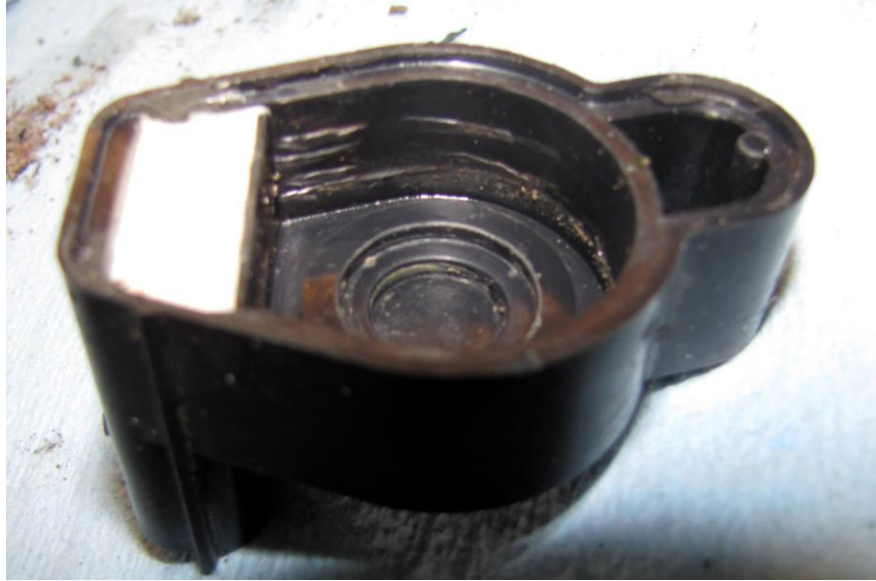
Figure 12: Side wear as well

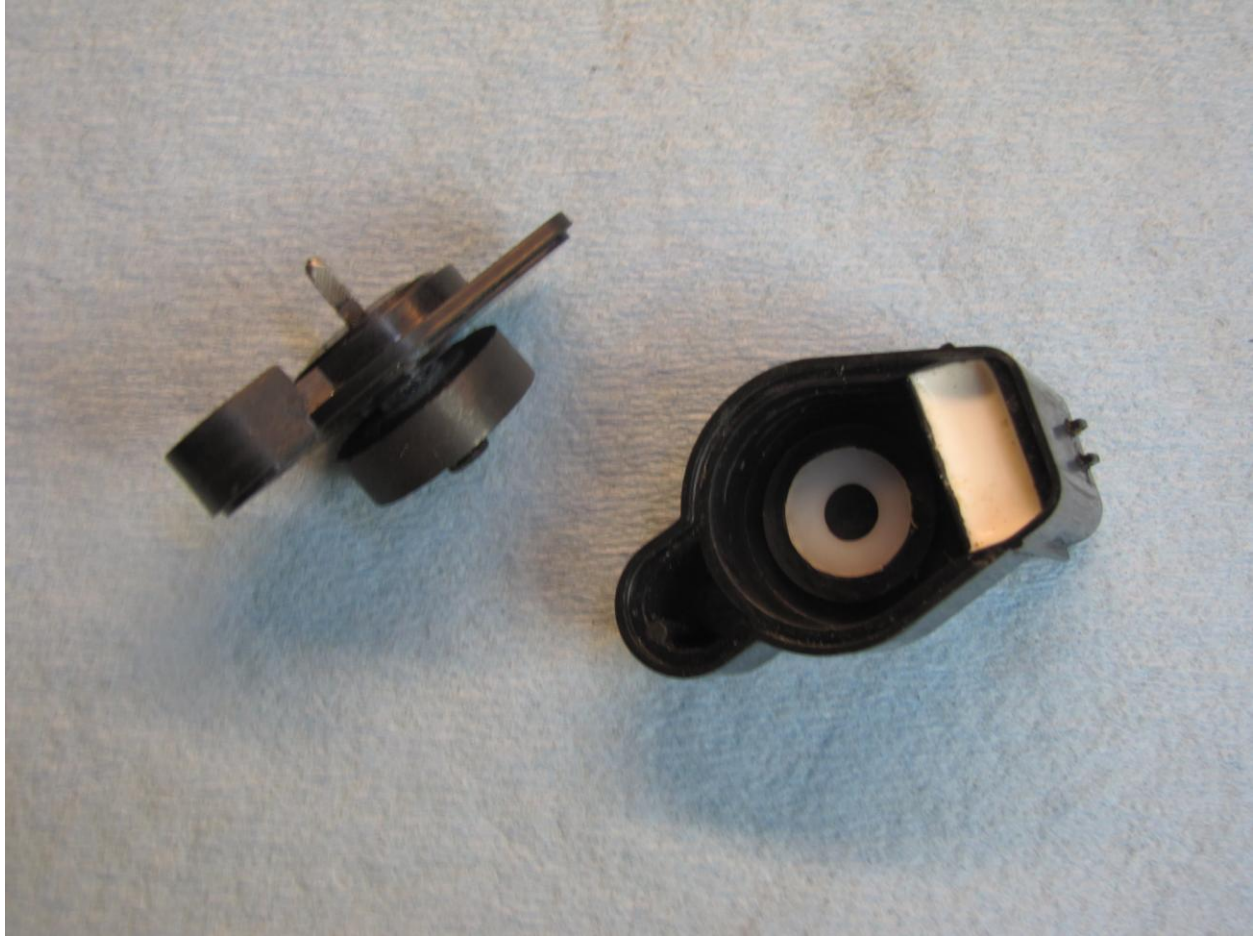
Figure 15: two parts of housing read to go together

Here you can see the main housing with the washer installed, and the upper housing with the shaft, shim and magnet installed. I use a small bit of white lithium grease on the shaft, and smeared a bit of silicone gasket sealer on the flat sides of the shaft before pushing the magnet all the way up the shaft.

I then put a small amount of lithium grease behind the thrust washer and sealed the two parts of the housing together with silicone gasket adhesive.

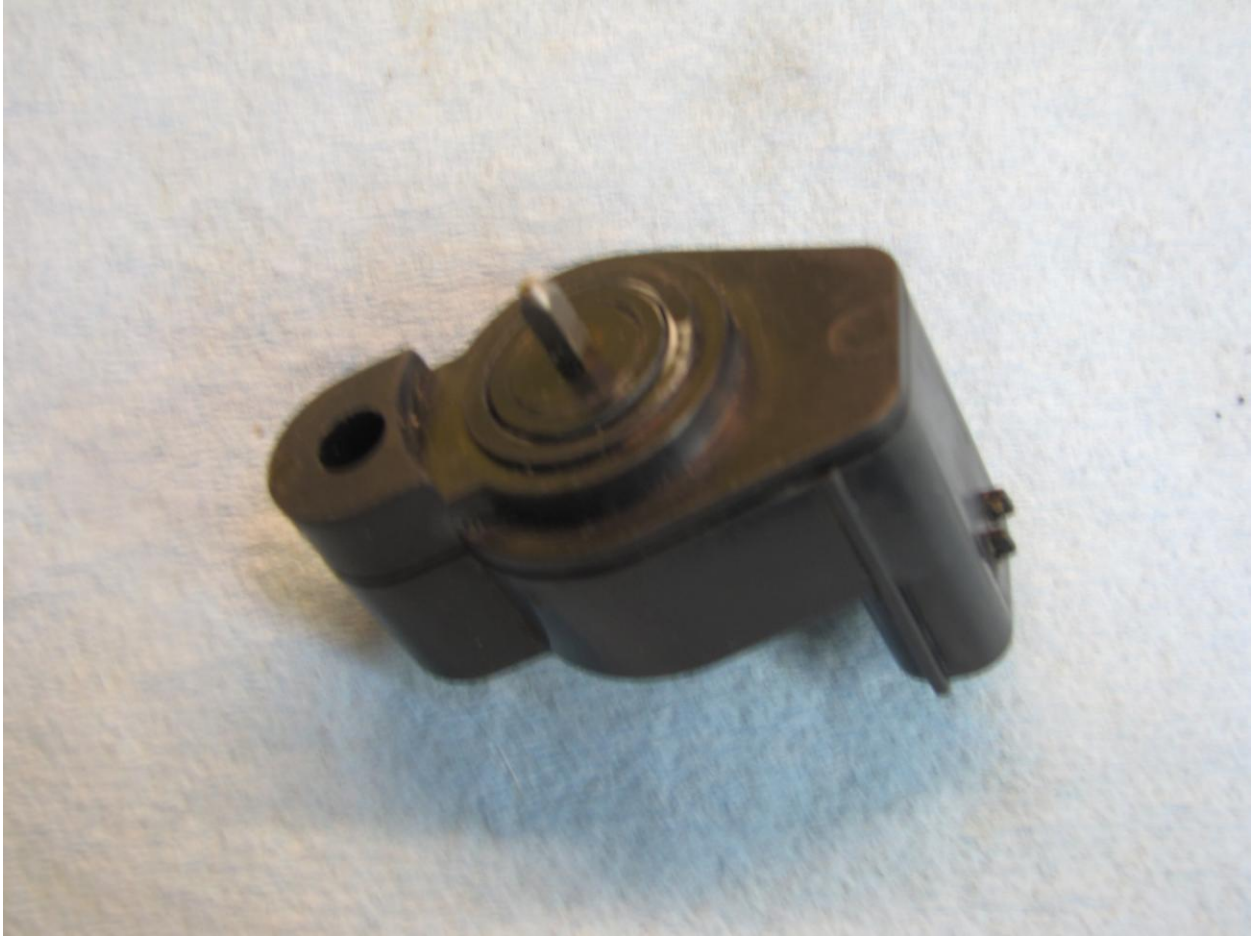
Figure 16: Finished VSS

The rebuilt units spin much more smoothly than they did before, and the magnets don't wobble or hit the sides of the housings. These should be good for another 30,000 miles I'd guess, and then you get to do it again!
