TECHNICAL INFORMATION

SUBJECT	Inlet Manifold Valley Gasket- Leak	03/14/97 12/01/97/NAS
AFFECTED VEHICLES	LP up to 350645 LH up to 664120 LJ up to 709316 and 540078 LD up to 999463

**Revised Intake Manifold Gasket For
1989-97 Rover 4.0L Engines**

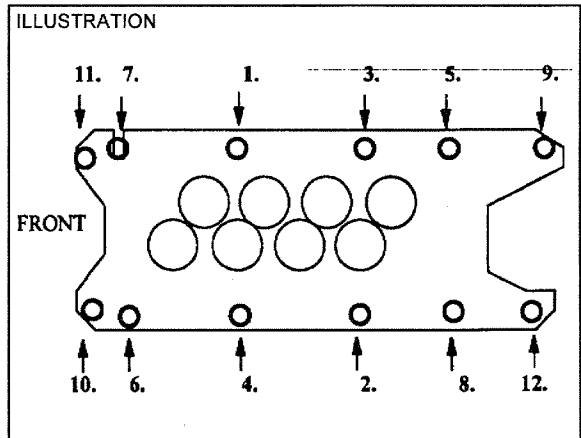
There has been a number of cases of inlet manifold valley gasket leaks. It has been found that the assembly line torque-down procedure does not fully compress the Wolverine gasket material. A two-stage torque-down procedure has been introduced to ensure that full compression is achieved. The new torque-down procedure should be used in addition to installing flat washers beneath the head of each inlet manifold bolt when replacing the inlet manifold gasket. Using the flat washers and the correct torque down procedure will ensure proper compression of the gasket material. Vehicles after the above VIN range have the washer fitted with the correct torque procedure.

The gasket design change can be easily identified as a change in the shape of the gasket around each inlet and coolant port opening. The installation of the new parts requires the correct torque procedure and must be followed with the new style gasket and flat washers. Refer to the numbered sequence in Figure 2 below to torque the mounting bolts.

When installing a new inlet manifold gasket, torque the manifold using the following procedures:

1. Tighten clamp bolts at front and rear of gasket to **5 Nm-10 Nm (4-7 lb.ft.)**.

CAUTION: A flat washer must be used beneath each bolt head to ensure correct pressure is being applied.

2. Tighten the 12 inlet manifold/cylinder head bolts to **30 Nm (21 lbf. ft.)**
3. Allow gasket to bed in for at least 5 minutes.
4. Refer to the illustration for correct bolt tightening sequence and tighten all inlet manifold/cylinder head bolts to **47-54 Nm (35-40 lbf.ft.)** using a standard torque wrench.
5. Tighten clamp bolts at front and rear of gasket to **14-20 Nm (10-15 lbf.ft.)**.
6. Remove any excess water from valley area.

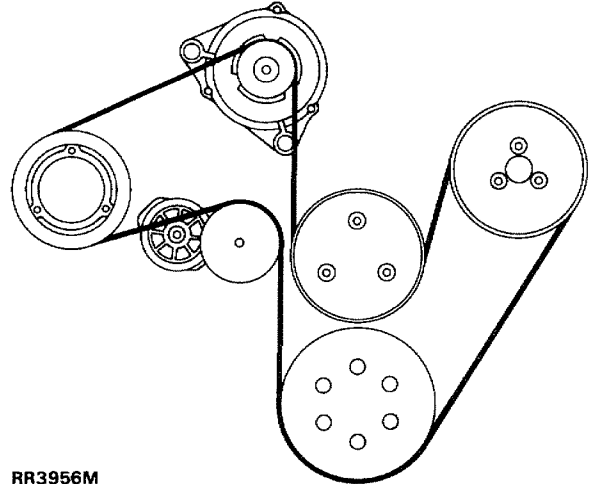
RR3956M

A single 'serpentine drive belt' is introduced for 1995 model year. This belt drives the water pump and all the ancillaries. It is essential that the belt is fitted exactly as shown in illustrations RR3956 and RR3957. It should also be noted that the water pump/viscous fan is driven in a counter clockwise direction.
