TECHNICAL INFORMATION

No: 76/04/04/NAS
Ref:
Issue: 1
Date: 30 April 2004

Water Ingress to Headliner

Discovery Series II (TL)

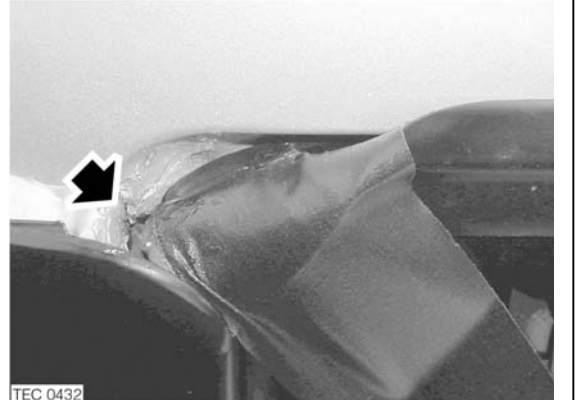
Figure 4

1. Carefully pull back the corner of the windscreen upper seal and use tape to secure the trim moulding to the windshield glass. (Figure 3).
2. Inspect for pin-holes or cracks around the 'A' post-to-roof joint, and the drip rail sealed joints (Arrowed in Figure 4).
3. Refer to RAVE/GTR section 76.64.15.21 and carefully remove interior A-post trim and sun visor assembly.
4. Spray soap water into the affected area outside and test the corner of the windscreen upper seal with low-pressure air nozzle directing the air stream through the sun visor and/or the A-post mounting hole.
5. If no pin-holes, cracks, or air bubbles are found, remove tape securing the windshield upper moulding to the windshield and push the trim moulding back into position.
