TECHNICAL INFORMATION

No: 76/13/03/NAS	
Ref:	
Issue: 1	
Date: 05/23/03

Front Frame Spacer Noise Correction

Discovery Series II (LT) **ALL**

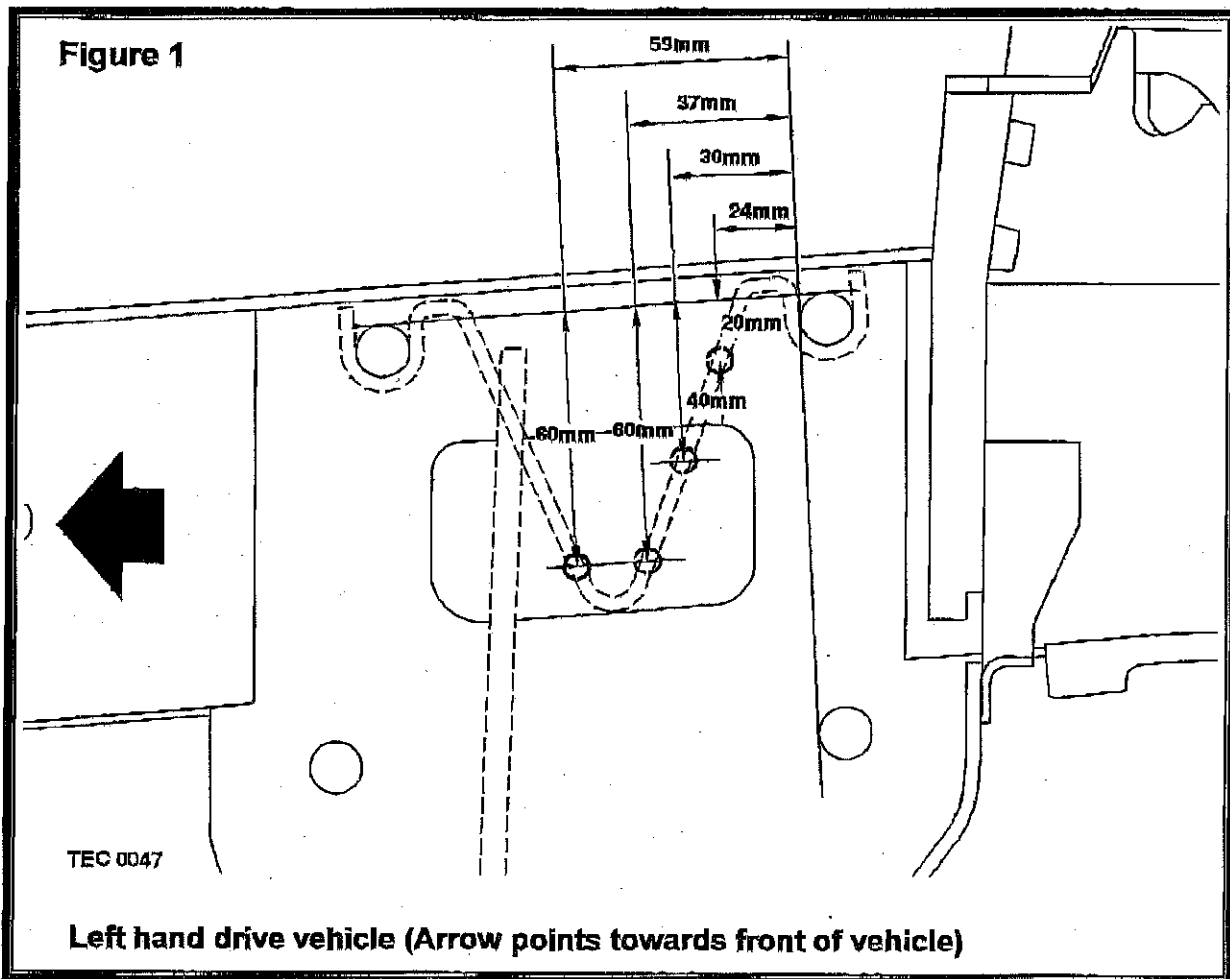
The customer may complain of a knocking or creaking noise from the front of the vehicle. The noise is frequently noticeable when making a turn. Movement of an internal spacer in the front longitudinal chassis member where the Power Assisted Steering (PAS) box is located is the cause of the noise.

**NOTE:** The dimensions shown on Figure 1 are approximate and are intended as a guide to the drilling position only.

7. Refer to Figure 1 for measurements to help locate the spacer.
8. Mark the "59 mm" hole position (front lower position) and center punch the 59 mm position for drilling.

9. Drill a 3 mm (0.315) diameter hole at the 59 mm position.
10. If the spacer is not exposed, drill a hole next to the first hole to establish the position of the internal spacer.
11. Mark the remaining four positions, adjusting the measurement for any variation required in step 10.
12. Punch and drill 8 mm (0.315) diameter holes at all positions including the correct 3 mm pilot hole at the 59 mm position.
