TECHNICAL INFORMATION

No: 76/13/03/NAS	
Ref:	
Issue: 1	
Date: 05/23/03

Front Frame Spacer Noise Correction

Discovery Series II (LT)

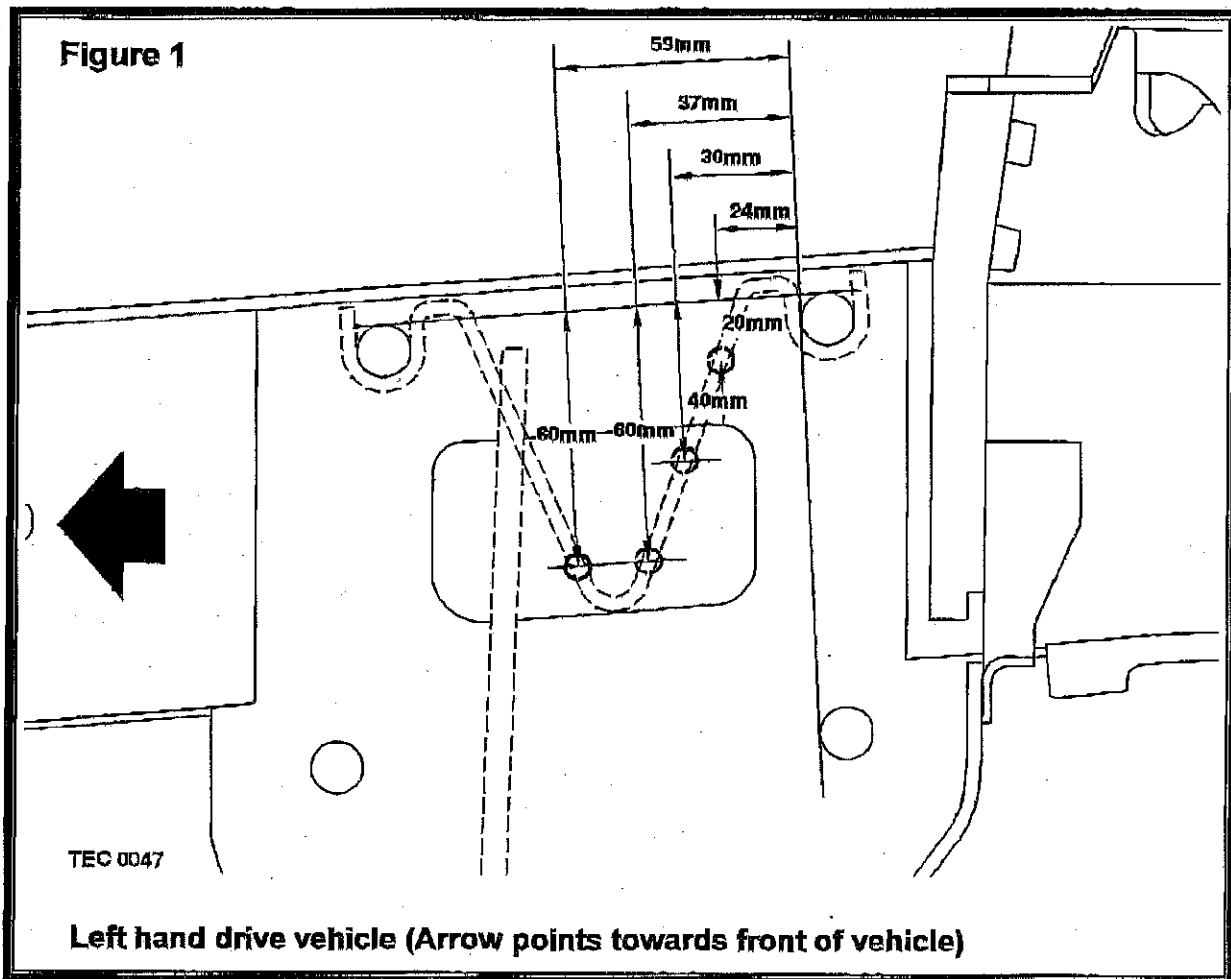
The customer may complain of a knocking or creaking noise from the front of the vehicle. The noise is frequently noticeable when making a turn. Movement of an internal spacer in the front longitudinal chassis member where the Power Assisted Steering (PAS) box is located is the cause of the noise.

**NOTE:** The dimensions shown on Figure 1 are approximate and are intended as a guide to the drilling position only.

7. Refer to Figure 1 for measurements to help locate the spacer.
8. Mark the "59 mm" hole position (front lower position) and center punch the 59 mm position for drilling.

9. Drill a 3 mm (0.315) diameter hole at the 59 mm position.
10. If the spacer is not exposed, drill a hole next to the first hole to establish the position of the internal spacer.
11. Mark the remaining four positions, adjusting the measurement for any variation required in step 10.
12. Punch and drill 8 mm (0.315) diameter holes at all positions including the correct 3 mm pilot hole at the 59 mm position.

1. Protect any nearby chassis fittings such as brake pipes from the welding process.
2. Grind chassis to expose bare metal around the drilled holes.
3. Apply Weld-thru coating.
4. Verify that the spacer is attached to the frame before proceeding.
5. MIG weld the edge of the internal spacer to the chassis and completely fill all holes with weld.
6. Grind excess weld material level with the chassis.
7. Etch prime bare metal, repair paint finish as required internally and externally using Rustoleum paints or Mar-hyde.
8. Install the removed steering box bolts and tighten to 90 Nm (67 lbf. ft.).
9. Install removed anti-roll bar link, washer and nuts and tighten to nuts to 100 Nm (74 lbf.ft.).
10. Install front wheel and tighten nuts to 140 Nm (105 lbf. ft.).
11. Lower the vehicle.
12. Connect the previously removed alternator and the battery leads.
