# TECHNICAL INFORMATION

No: 76/04/04/NAS  
Ref:  
Issue: 1  
Date: 30 April 2004

## Water Ingress to Headliner

Discovery Series II (TL)

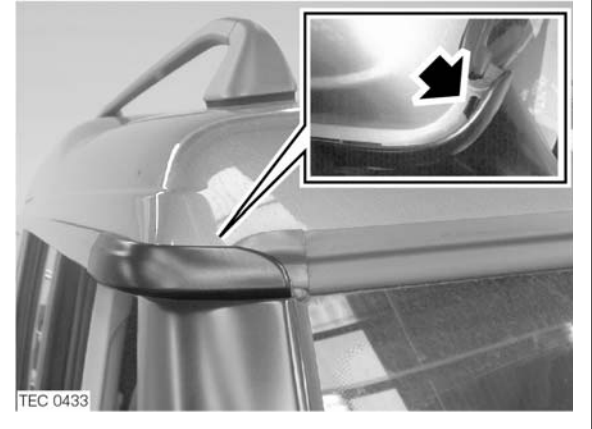
Figure 1

1. Carefully lift the clip securing the drip rail corner trim to the drip rail. (Arrowed in Figure 1)
2. Inspect the drip rail seam joint for a gap or void.

1. If a gap or void is present, perform the following drip rail rectification procedure:
  - Refer to RAVE section 76.43.39 and remove the windshield side trim moulding.
  - Release and remove the drip rail corner trim from the drip rail.
  - Clean the drip rail.
  - Fill the gap / void with sealant (see Figure 2).

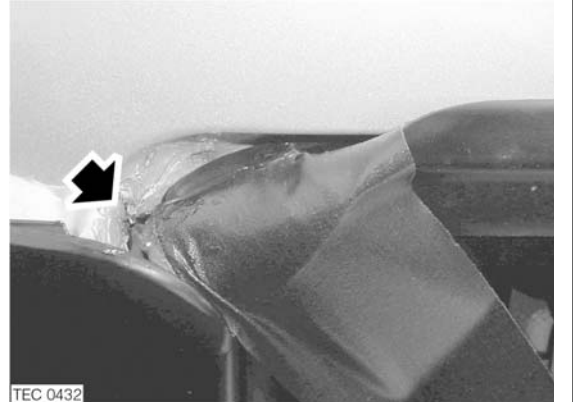
Figure 4

1. Carefully pull back the corner of the windscreen upper seal and use tape to secure the trim moulding to the windshield glass. (Figure 3).
2. Inspect for pin-holes or cracks around the 'A' post-to-roof joint, and the drip rail sealed joints (Arrowed in Figure 4).
3. Refer to RAVE/GTR section 76.64.15.21 and carefully remove interior A-post trim and sun visor assembly.
4. Spray soap water into the affected area outside and test the corner of the windscreen upper seal with low-pressure air nozzle directing the air stream through the sun visor and/or the A-post mounting hole.
5. If no pin-holes, cracks, or air bubbles are found, remove tape securing the windshield upper moulding to the windshield and push the trim moulding back into position.
