# TECHNICAL BULLETIN

No: LTB00060  
Issue: 1  
Date: 22 Jun 2007

## Shuttle Valve Switch Related ABS/TC/HDC Warning Lamp Illumination Troubleshooting

Discovery Series II (LT)

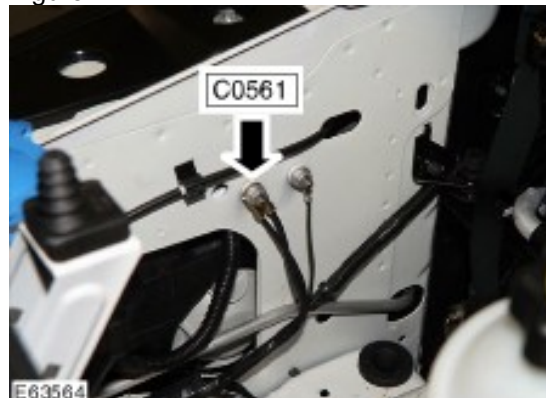
Figure 1

- Inspect the ground stud connection C0561 for damage and corrosion. (Figure 1)
- If the ground stud is damaged or corroded clean the eyelet and stud and tighten the nut to 10 Nm (7.5 lbf-ft).
- Check for continuity between the ground stud C0561 and the black wire on the ABS modulator body connector C0500. (Figure 2)

- If there is no continuity, or intermittent continuity when the wire is flexed, repair the damaged wire and ensure the splice is correctly crimped and sealed.

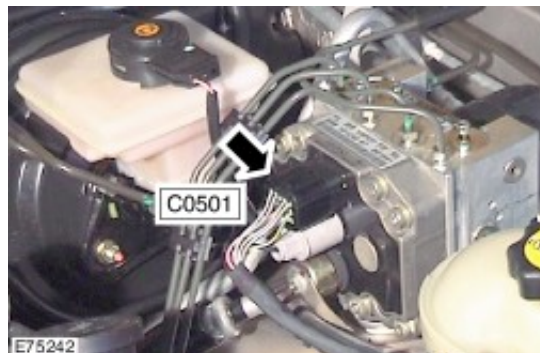
Figure 3

2. Disconnect and check the 13-pin connector at the ABS modulator (C0501). (Figure 3)
3. Disconnect the 15-pin connector C0506 at the Self Leveling and Anti-lock Braking (SLABS) ECU. (Figure 4)

4. Inspect both connectors for moisture ingress or corrosion and correct as follows:
  - If moisture or corrosion is present, dry and clean the connectors.

- Repair corroded connectors as necessary.
5. With connectors C0501 and C0506 disconnected perform the following:
  - Check for continuity between pin 6 of the 15-pin SLABS ECU connector (C0506) and pin 9 of the 13-pin ABS modulator connector (C0501) yellow/green wire.

- If there is no continuity (or intermittent continuity when the wire is flexed), repair as necessary and ensure the wire is correctly crimped and soldered.

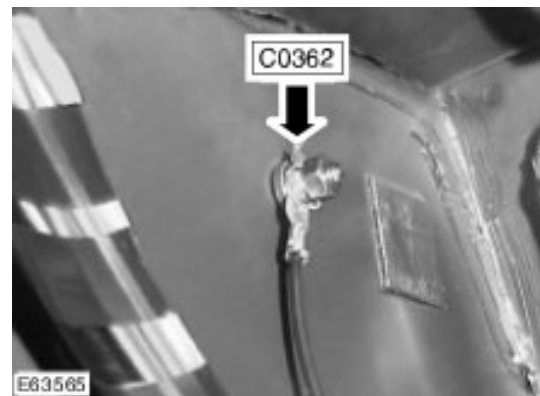
Figure 5

6. Disconnect the 18-pin SLABS ECU connector (C0504).
7. Check for continuity between pin-12 of C0504 and the ground connection located under the left-hand side of the fascia (C0362 – black wire). (Figure 5)

8. If there is no continuity (or intermittent continuity when the wire is flexed), repair as necessary and ensure the wire is correctly crimped and soldered.
