# TECHNICAL INFORMATION

## Water Ingress to Headliner

No: 76/04/04/NAS  
Ref:  
Issue: 1  
Date: 30 April 2004

Discovery Series II (TL)

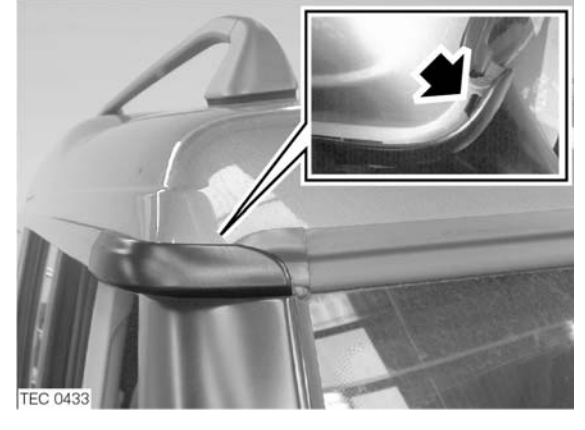
Figure 1

1. Carefully lift the clip securing the drip rail corner trim to the drip rail. (Arrowed in Figure 1)
2. Inspect the drip rail seam joint for a gap or void.

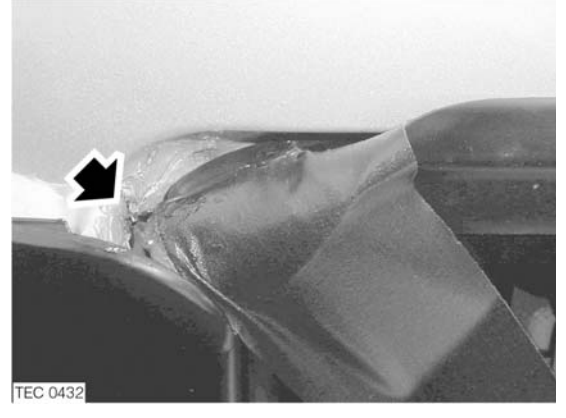
Figure 4

1. Carefully pull back the corner of the windscreen upper seal and use tape to secure the trim moulding to the windshield glass. (Figure 3).
2. Inspect for pin-holes or cracks around the 'A' post-to-roof joint, and the drip rail sealed joints (Arrowed in Figure 4).
3. Refer to RAVE/GTR section 76.64.15.21 and carefully remove interior A-post trim and sun visor assembly.
4. Spray soap water into the affected area outside and test the corner of the windscreen upper seal with low-pressure air nozzle directing the air stream through the sun visor and/or the A-post mounting hole.
5. If no pin-holes, cracks, or air bubbles are found, remove tape securing the windshield upper moulding to the windshield and push the trim moulding back into position.
