TECHNICAL INFORMATION

No: 76/01/03/NAS
Ref:
Issue: 1
Date: 01/17/03

Water Ingress at Rear of Vehicle

Discovery Series II (LT)

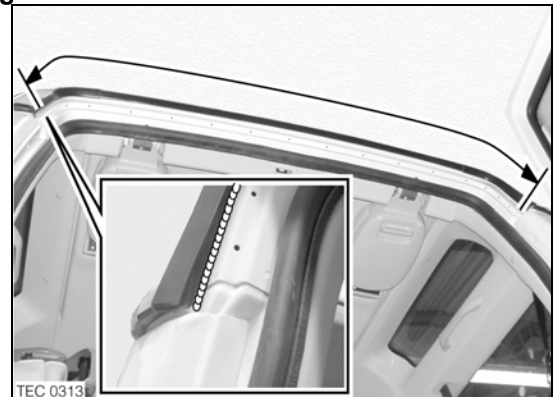
Figure 1

A sealing operation between the roof and the rear header outer joint may have been inadvertently omitted during production. The lack of sealant in the joint can permit water ingress.

1. Open the tail door.
2. Release 17 clips securing the tail door opening secondary seal to the body.
3. Remove the seal.
4. Clean between the roof and the rear header outer joint (Figure 1).
5. Apply a continuous bead of sealant between the roof and the rear header outer joint (Inset in Figure 1).
6. Wipe off any excess sealant.
7. Fit and secure the tail door opening secondary seal to the body.
8. Close the tail door.
