# TECHNICAL INFORMATION

## Front Frame Spacer Noise Correction

No: 76/13/03/NAS  
 Ref:  
 Issue: 1  
 Date: 05/23/03

Discovery Series II (LT)

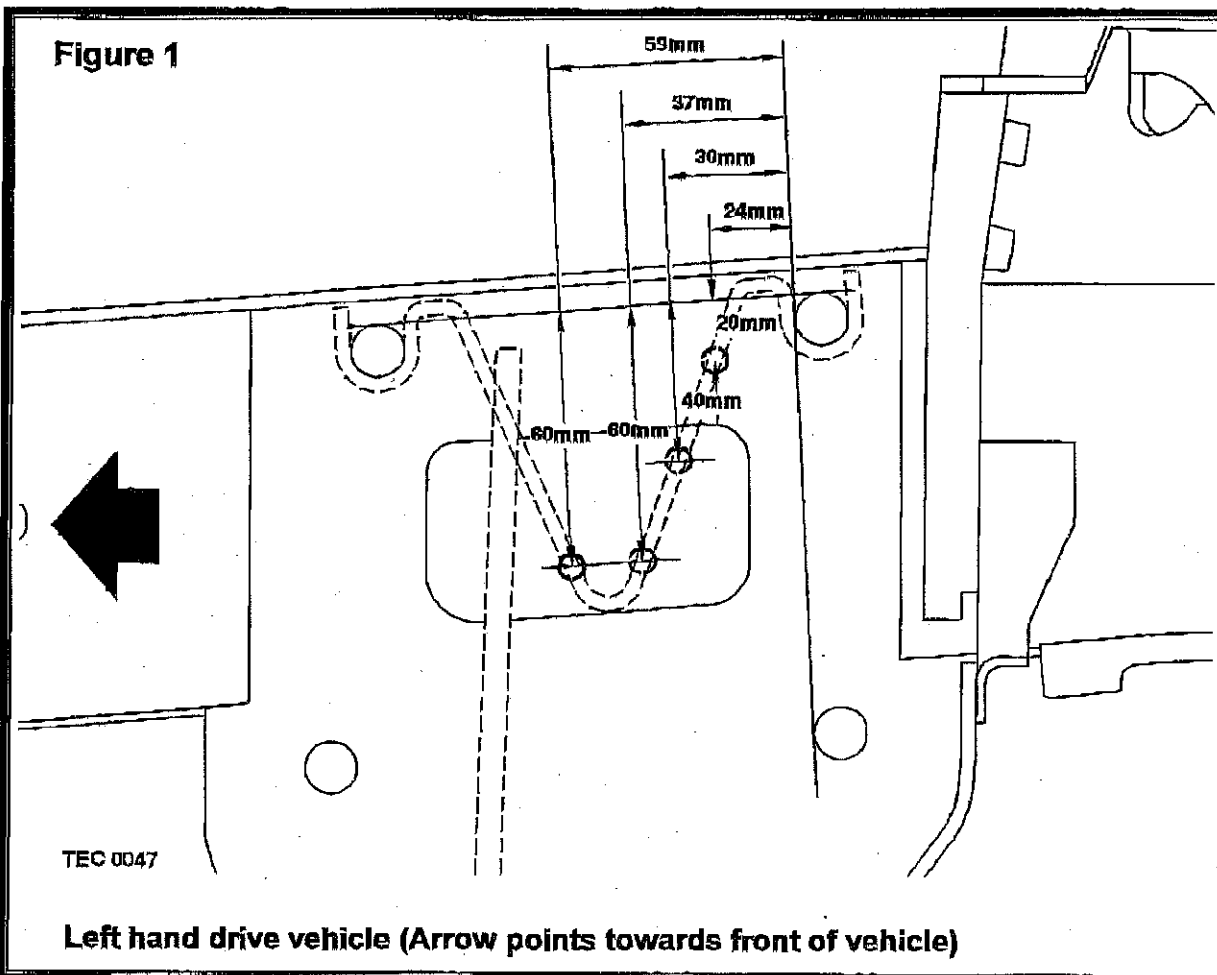
**Figure 1**

**NOTE:** The dimensions shown on Figure 1 are approximate and are intended as a guide to the drilling position only.

7. Refer to Figure 1 for measurements to help locate the spacer.
8. Mark the "59 mm" hole position (front lower position) and center punch the 59 mm position for drilling.

9. Drill a 3 mm (0.315) diameter hole at the 59 mm position.
10. If the spacer is not exposed, drill a hole next to the first hole to establish the position of the internal spacer.
11. Mark the remaining four positions, adjusting the measurement for any variation required in step 10.
12. Punch and drill 8 mm (0.315) diameter holes at all positions including the correct 3 mm pilot hole at the 59 mm position.
