Land Rover North America, Inc. Land Rover Canada

Bulletin:	STE05-04
Section:	<b>Tools &amp; Equipment</b>
Date:	26 January 2005
Model:	ALL

### Subject: New LR3 and Range Rover Navigation System Disc for "Bootloader" Fault

## HLDF CAN BOOTLOADER RECOVERY PROCEDURE

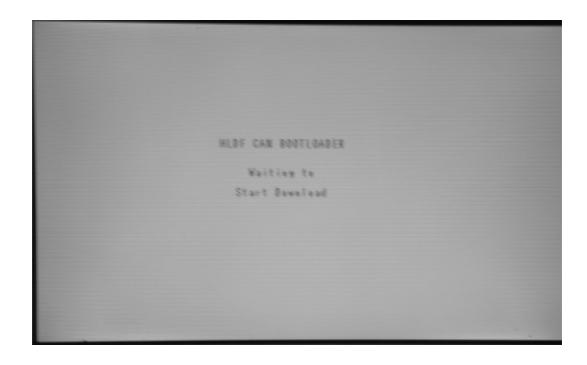
1 Please be absolutely sure that the screen is displaying "HLDF CAN BOOTLOADER Waiting to Start Download" as shown below. The text on the screen may appear faint.

Text and screen colour can vary somewhat to that shown.

If it is does NOT display this message you must not continue.
