TECHNICAL BULLETIN

No: LA-501-006

A-pillar Water Leak

Land Rover LR3 (LA)

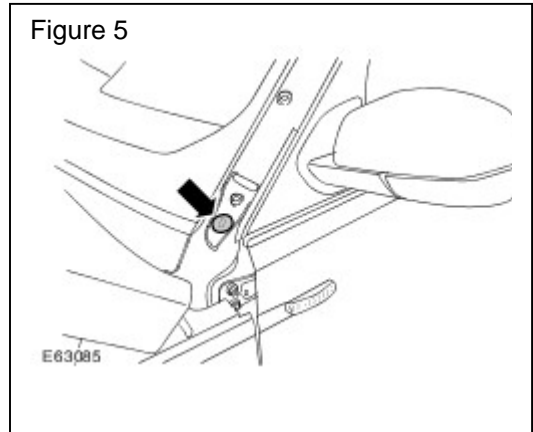
Figure 5

Situation: A customer may report water in the footwell of the vehicle. Water ingress through the lower slot in the A-pillar structure, where the exterior trim lower location peg slots into the body, may be the cause. The customer may also report unexplained illumination of warning lights such as the oil pressure warning lamp.

⚠ CAUTION: The area to which the adhesive patch is applied must be clean and dry before patch installation. The patch must completely adhere to the body surface to ensure a proper seal.

6. Clean area surrounding the lower elongated slot in A-pillar structure
7. Apply adhesive patch, supplied in kit DHB500400, to body covering lower elongated slot. (Figure 5)
8. Attach clip IPN500050 to the lowermost A-pillar exterior trim mounting location. (Figure 6)
9. Install 4 clips (DZM000070) to the remaining A-Post exterior trim mounting locations. (Figure 7)
