# TECHNICAL BULLETIN

No: LTB00103  
Issue: 3  
Date: 20 NOV 2009

### 'Squeak' / 'Squeal' Noise After Selecting Recirculation

### GREASE RECIRCULATION FLAP LINKAGES - LR3

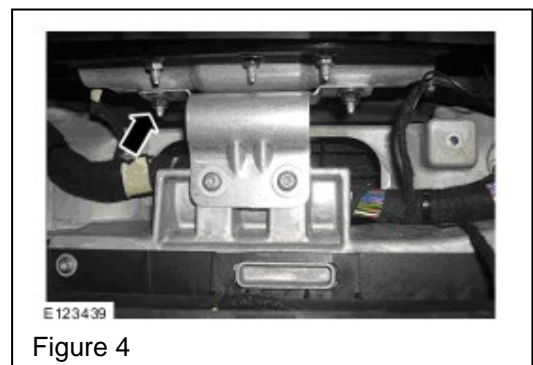
Figure 4

**NOTE:** Instrument panel cover removed for clarity.

5. Set climate control to 'Fresh Air' mode.
  - Once 'Fresh Air' mode is activated, the recirculation flap lever will be visible. (Figure 4)
6. Turn ignition 'OFF'.

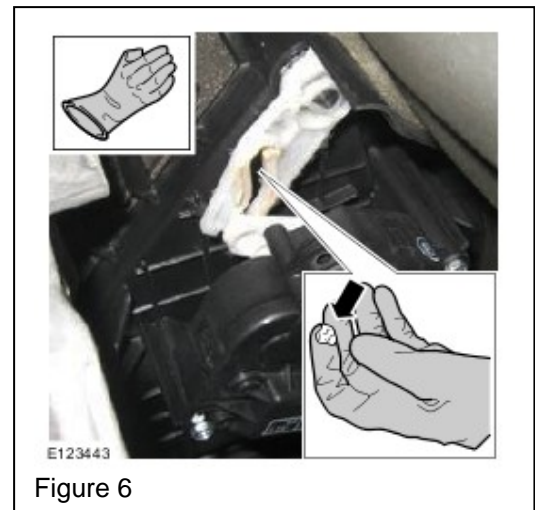
Figure 6

**Situation:** After selecting 'Recirculation' on the climate control panel, a 'squeak' or 'squeal' noise is heard. The noise is generated by the movement between the two resin linkages due to dust contamination of the lubricating grease.

8. Apply grease to the lever slide: (Figure 6)
  - Approximate quantity as shown in Figure 6.
9. Turn ignition 'ON'.
10. Alternately select 'Recirculation' and 'Fresh Air' mode on the climate control panel to open / close the recirculation flap, distributing the grease on the lever.
  - It may be necessary to repeat the open / close cycle 10 times.
11. Verify noise has been eliminated.
12. Turn ignition 'OFF'.
13. If squeak / squeal noise is still evident, repeat steps 8 - 12.
14. Install stowage compartment tray.
15. Install the passenger side register trim panel.
16. Install the instrument panel console.

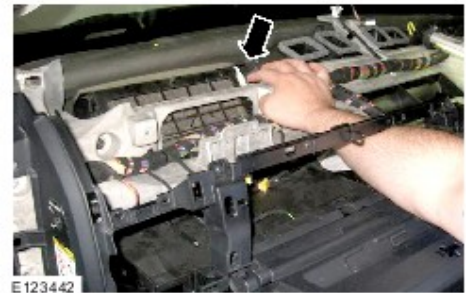
Figure 13

**NOTE: Instrument panel cover removed for clarity.**

8. Locate recirculation flap lever. (Figure13)
