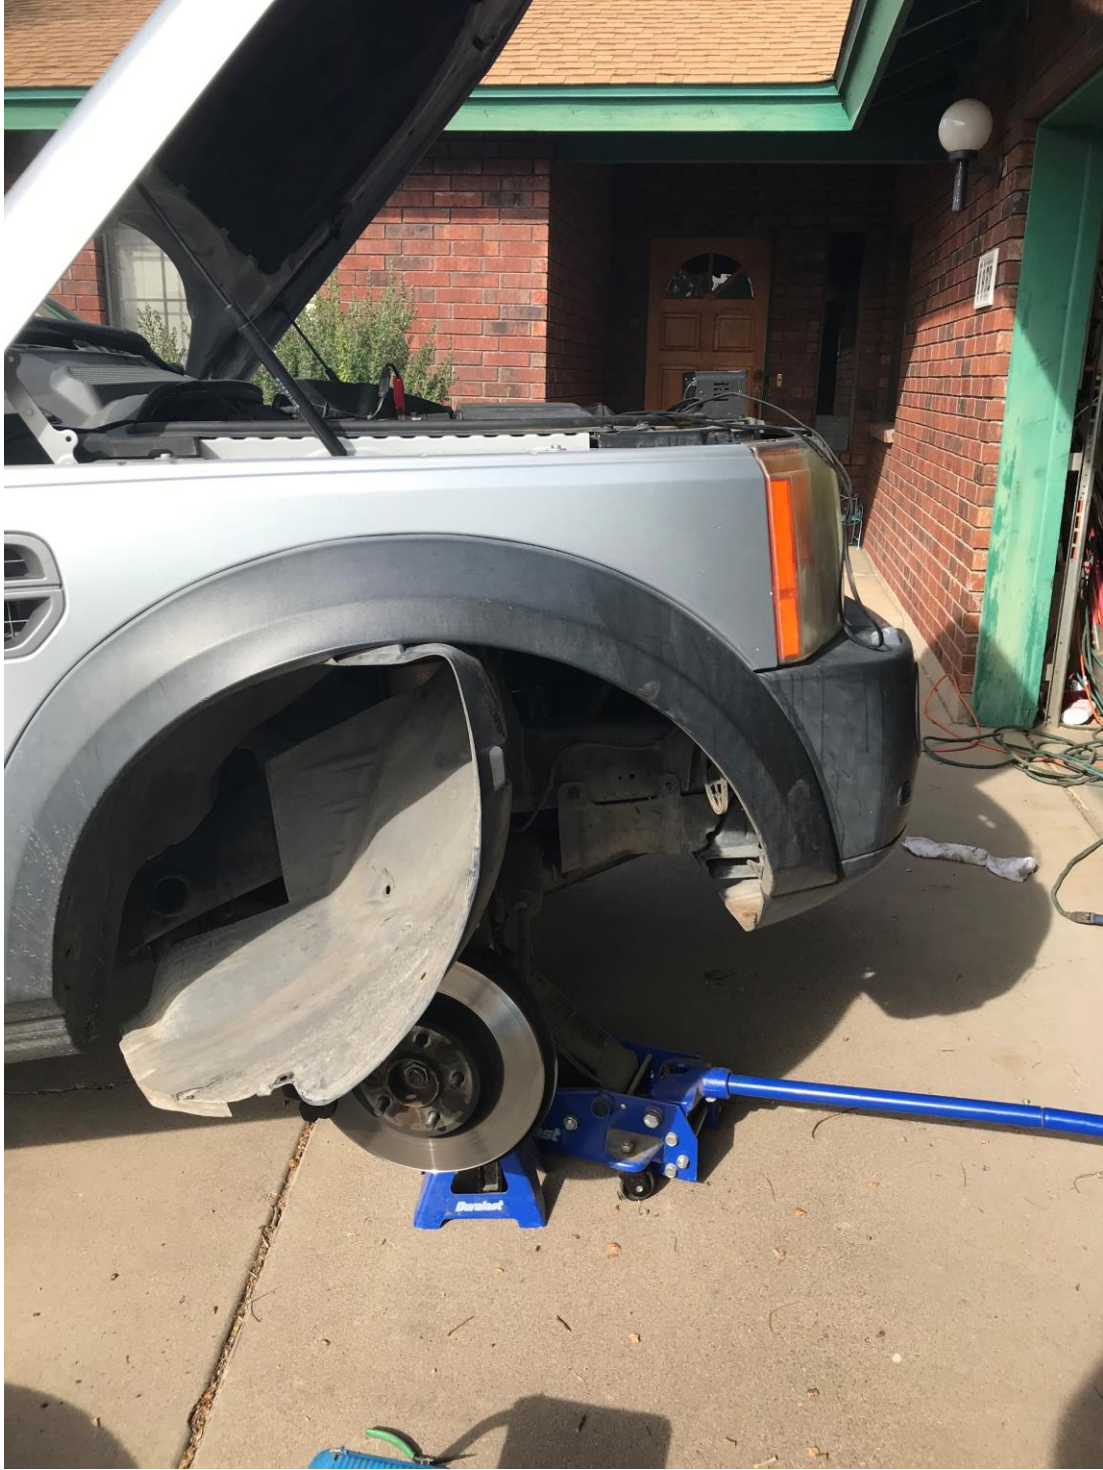
Jacked up the right front, peeled back the interior of the fender, to find the ground cable. From the battery ground, to ground the battery.

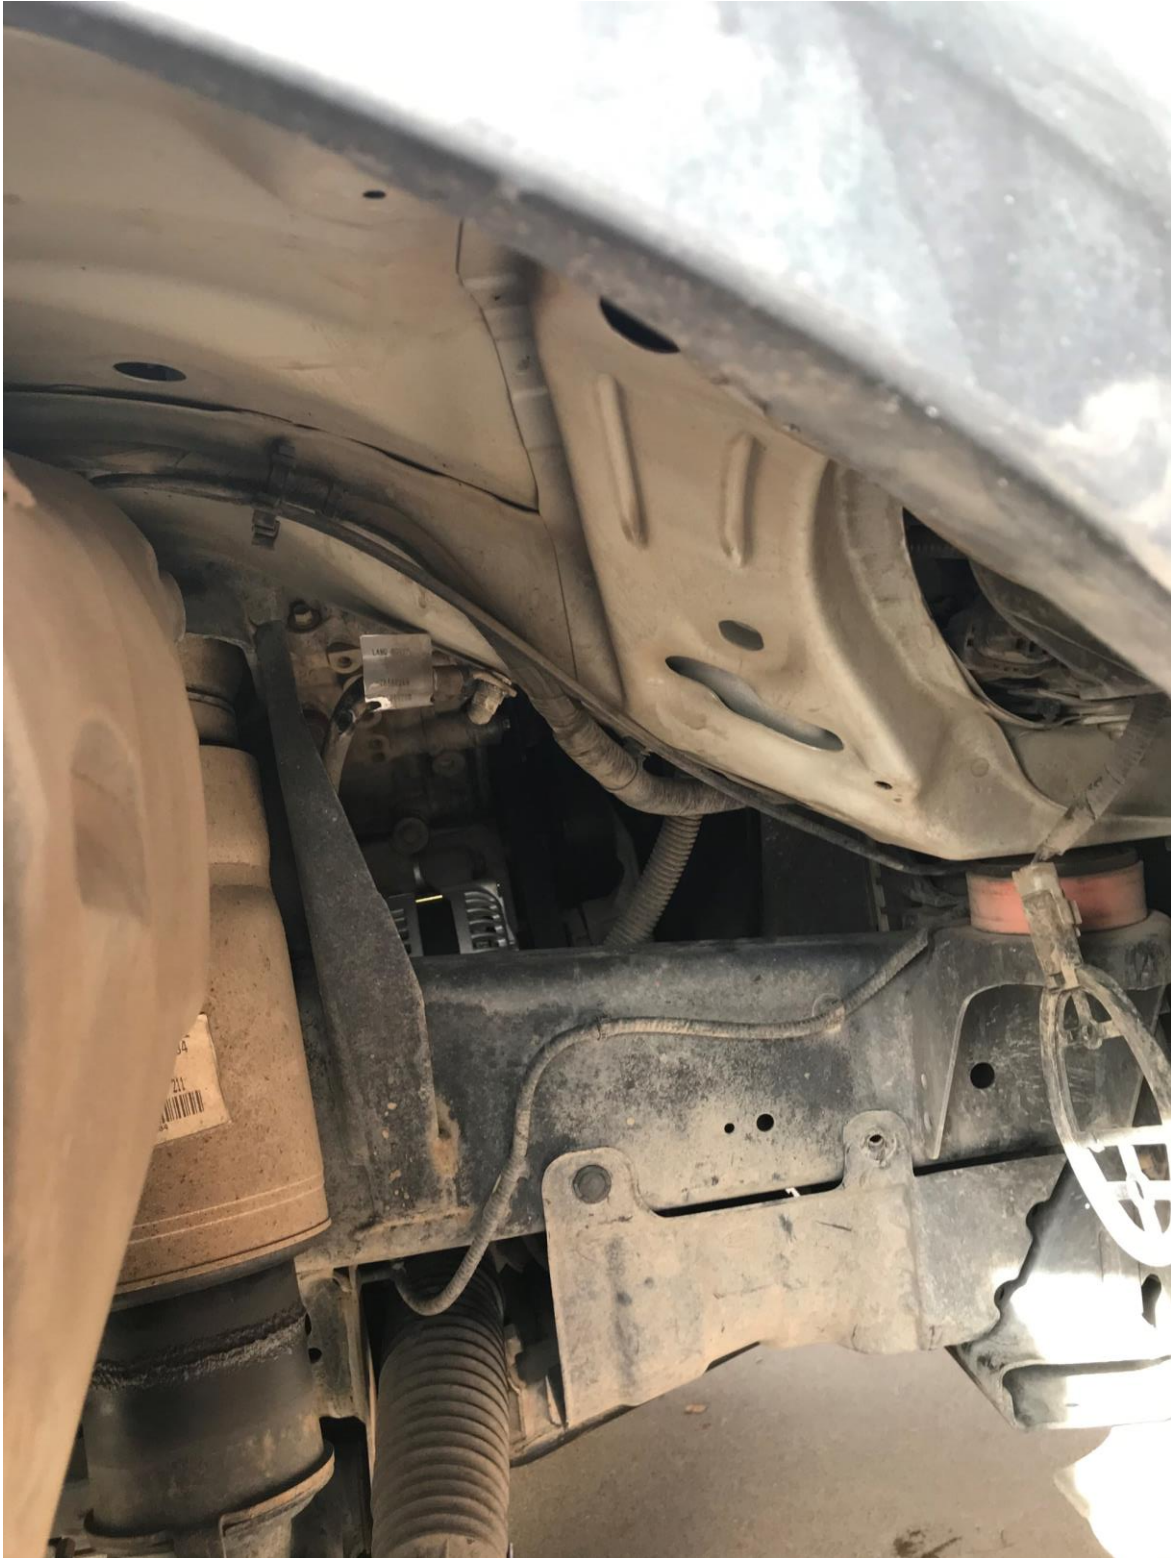
Found the ground cable on the body of the vehicle, inside the right front fender

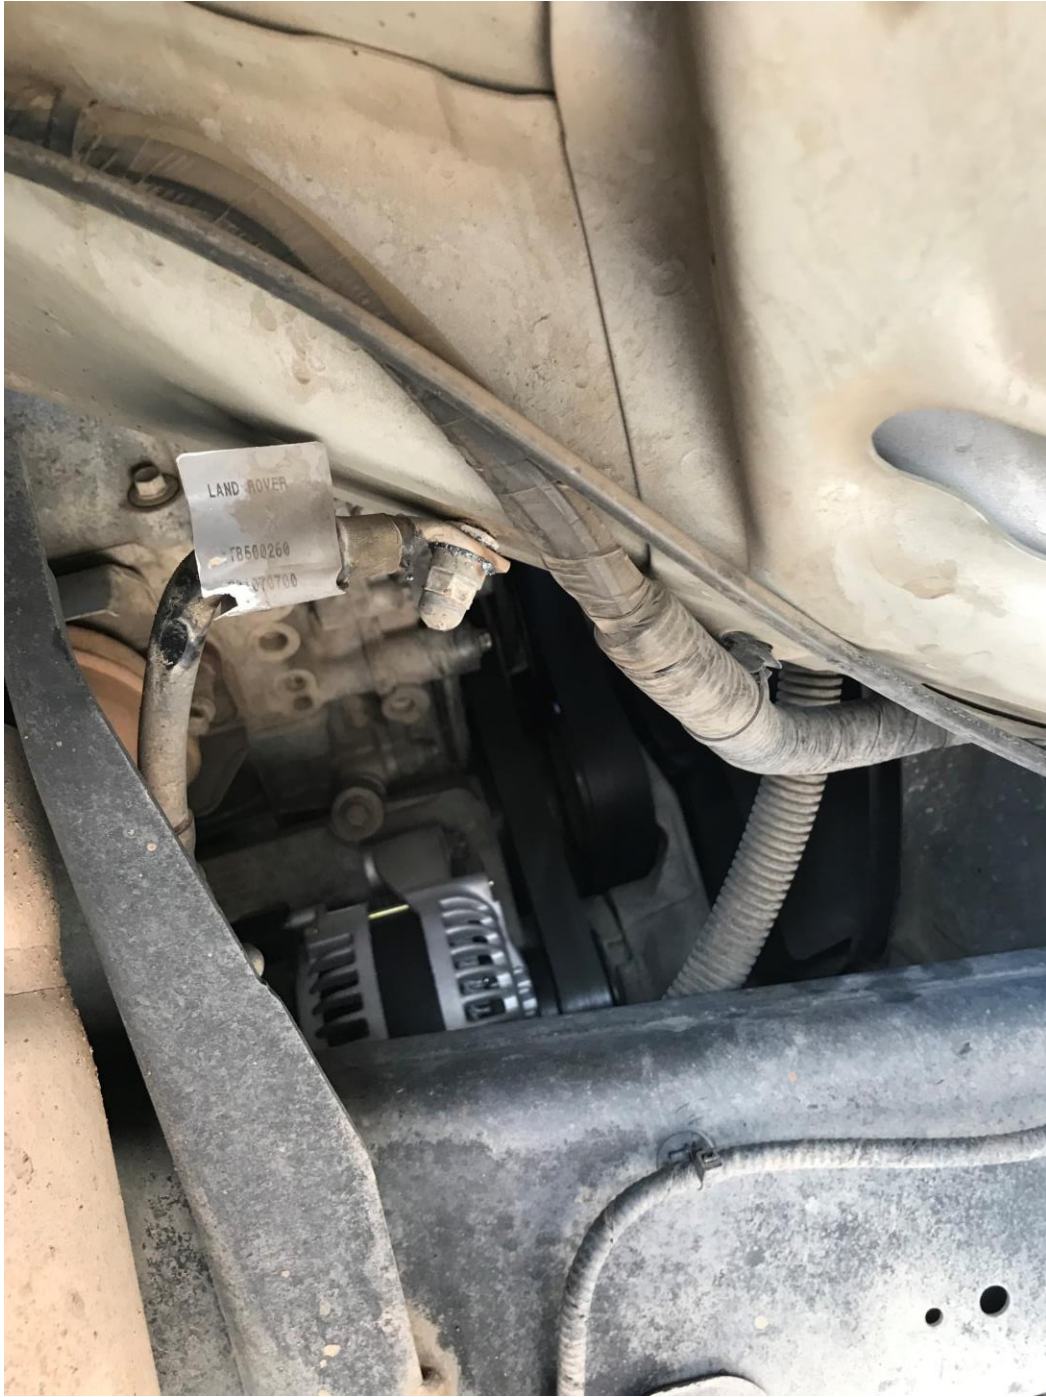
Inspecting the cable closely, you can see where it had been melting.

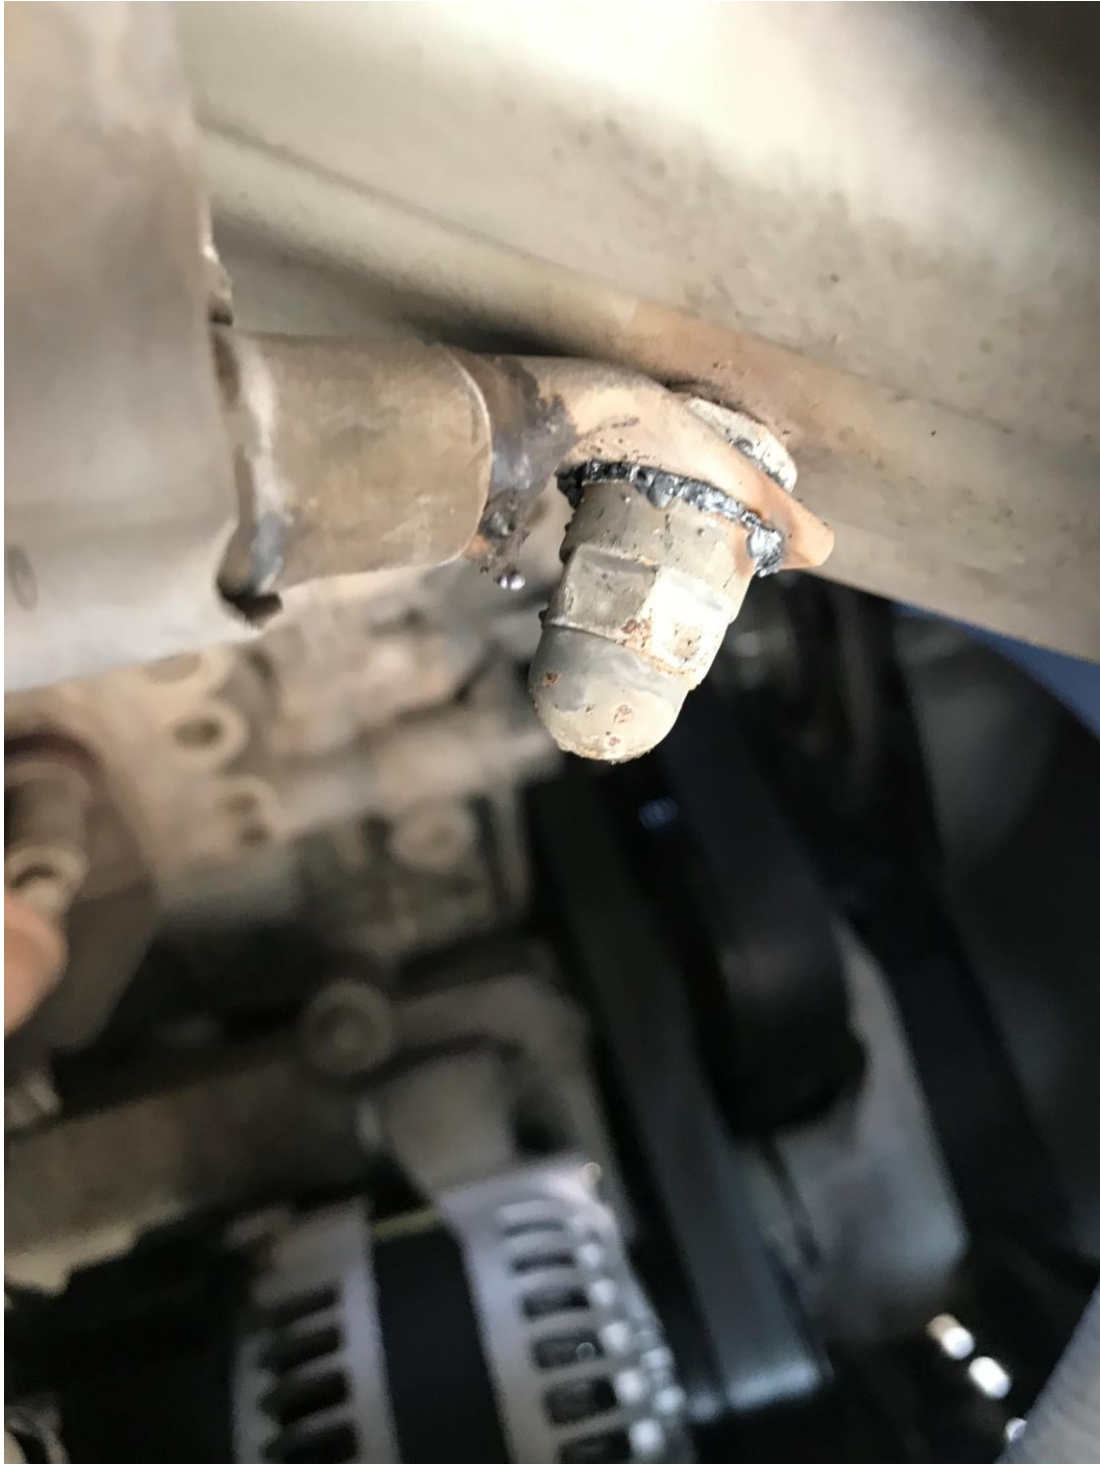
Close up of the battery ground cable, where it terminates on the body.

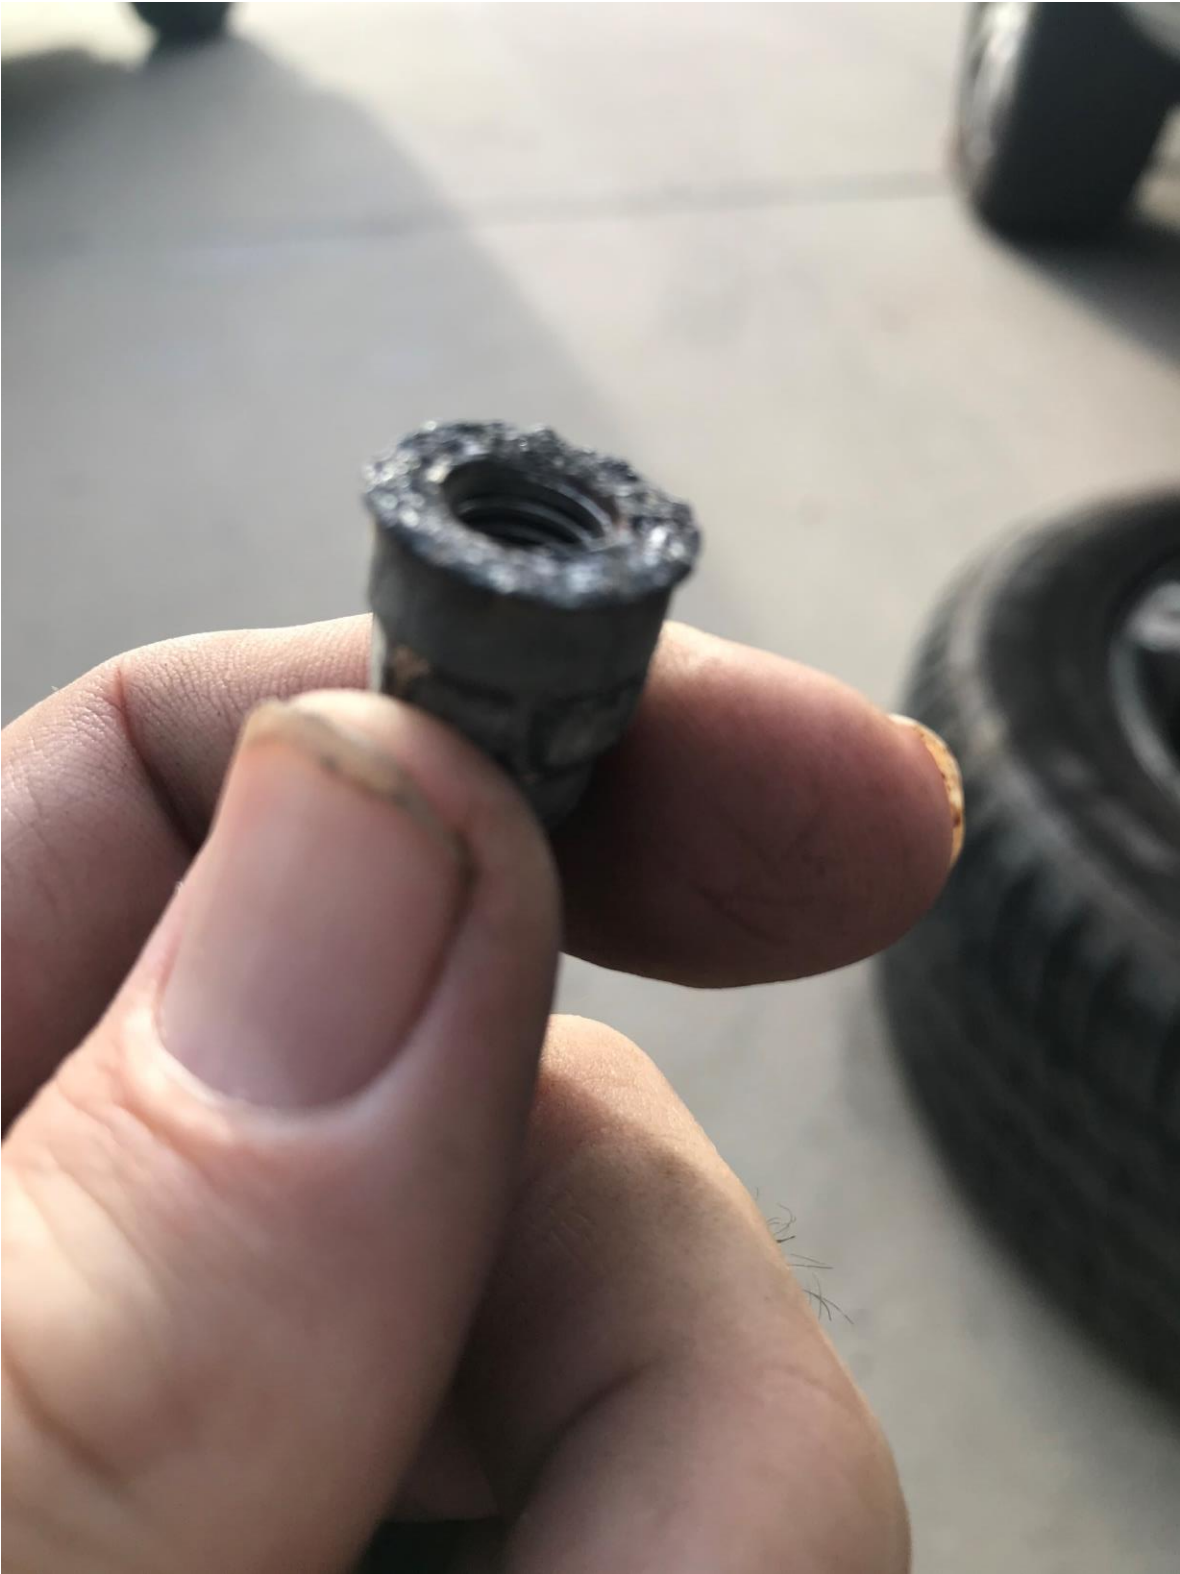
Removed the nut that holds the ground cable to the body. Obvious carbon build up and melting.
