Models : LA - Discovery 3
LM - New Range Rover
LS - Range Rover
Sport
Title : (42264) - AJV8 Cold Start Rattle - Variable Valve Timing (VVT) Variants

AJV8 4.2/4.4 Petrol Cold Start Rattle - Variable Valve Timing (VVT) Vehicles Only

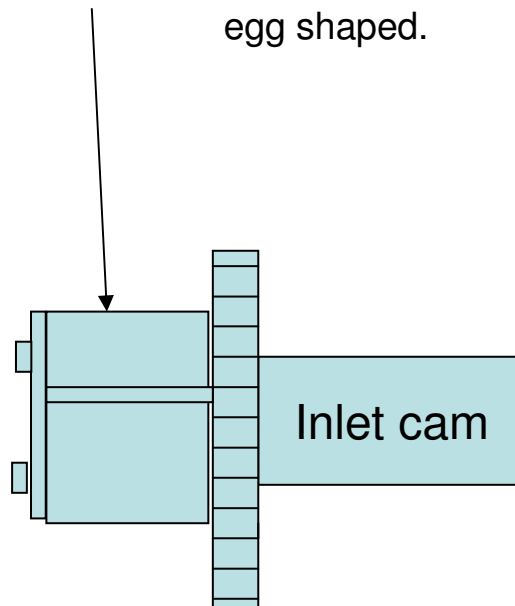
This can be further confirmed by a dial gauge applied as shown in the picture below, this will show excess run out on the VVT housing that is restraining the locking pin from engaging, allowing the unit to move between end stops creating the hammering noise.

This is the area to check for run out normal will be around 150/200 microns/ .006 inch a faulty unit will be double this and it can be noted that all the run out is in a concentrated area as the housing is egg shaped.

The only part that requires renewal is the VVT assembly this will eliminate the noise.

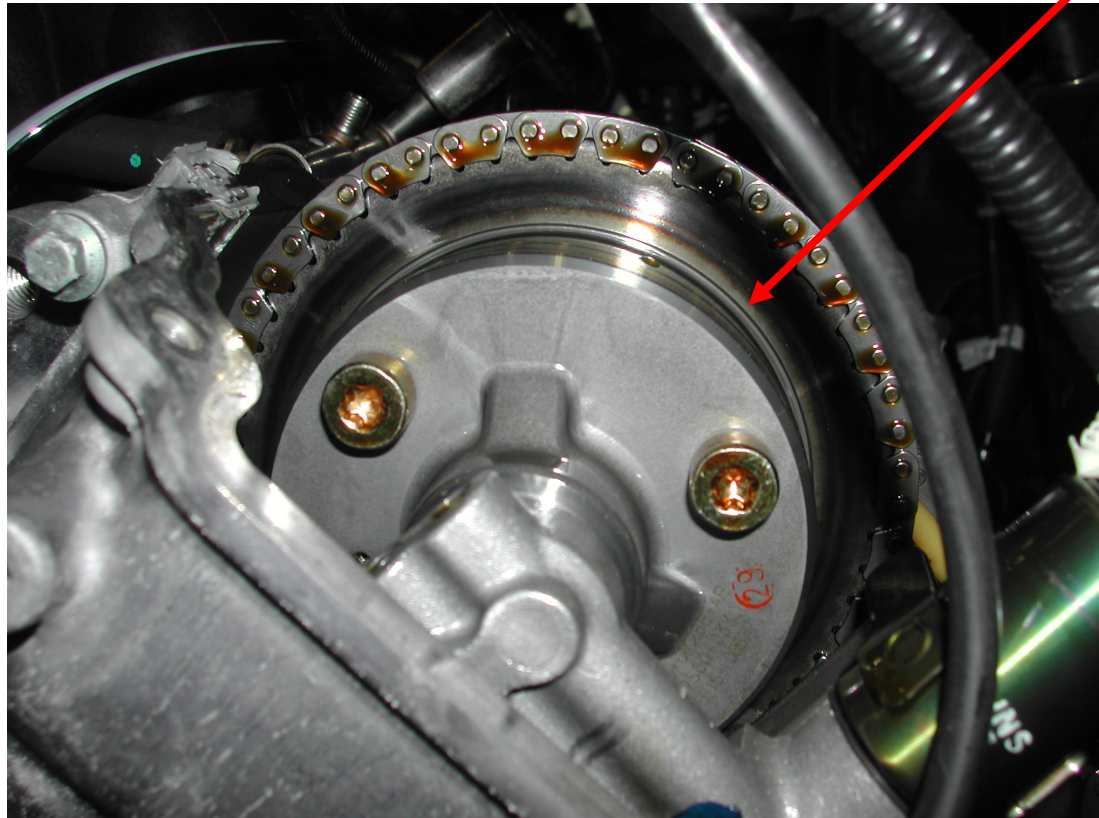
Look for an even gap here of 2mm all the way round if the unit has failed it will vary distinctly.
