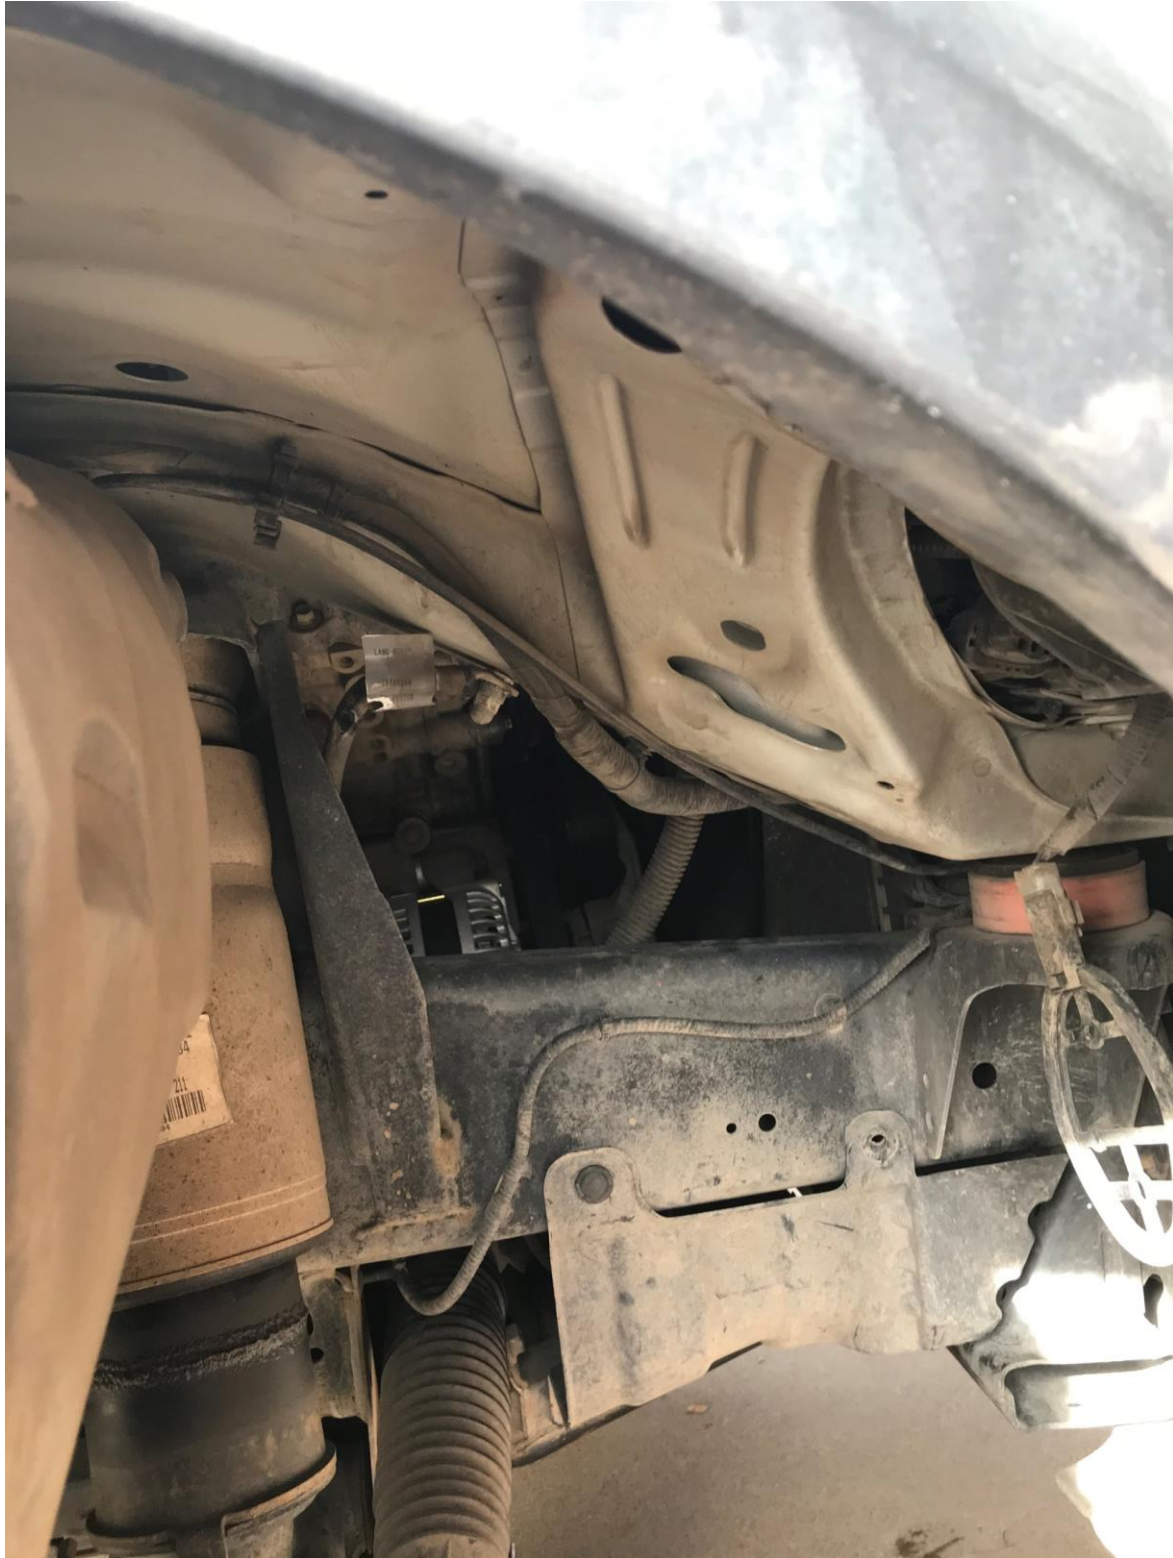
Found the ground cable on the body of the vehicle, inside the right front fender

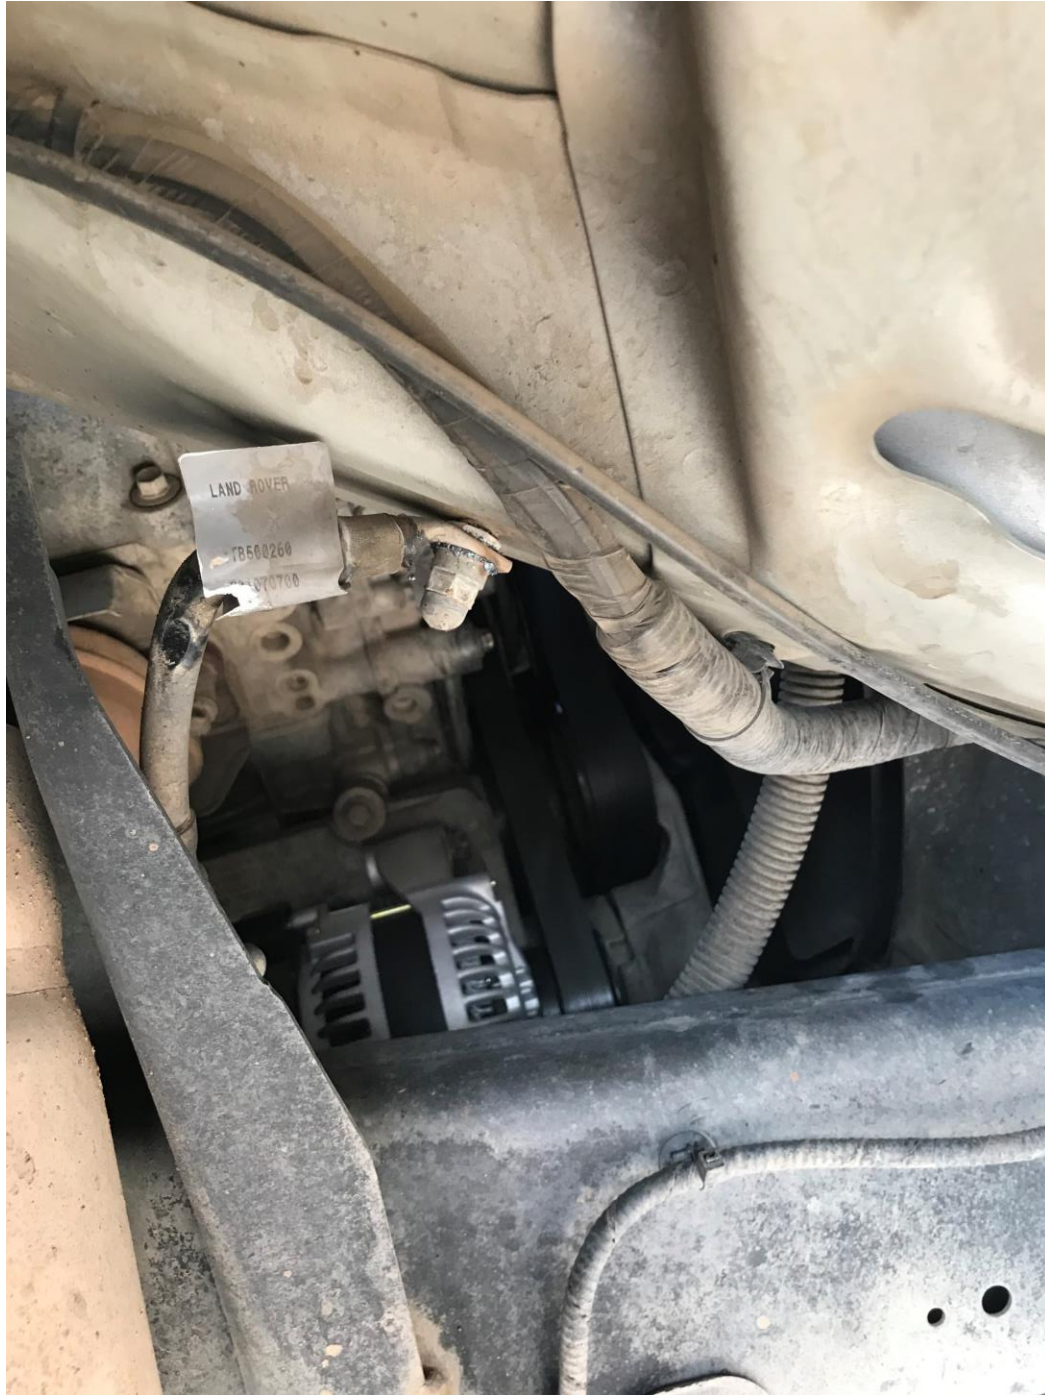
Inspecting the cable closely, you can see where it had been melting.

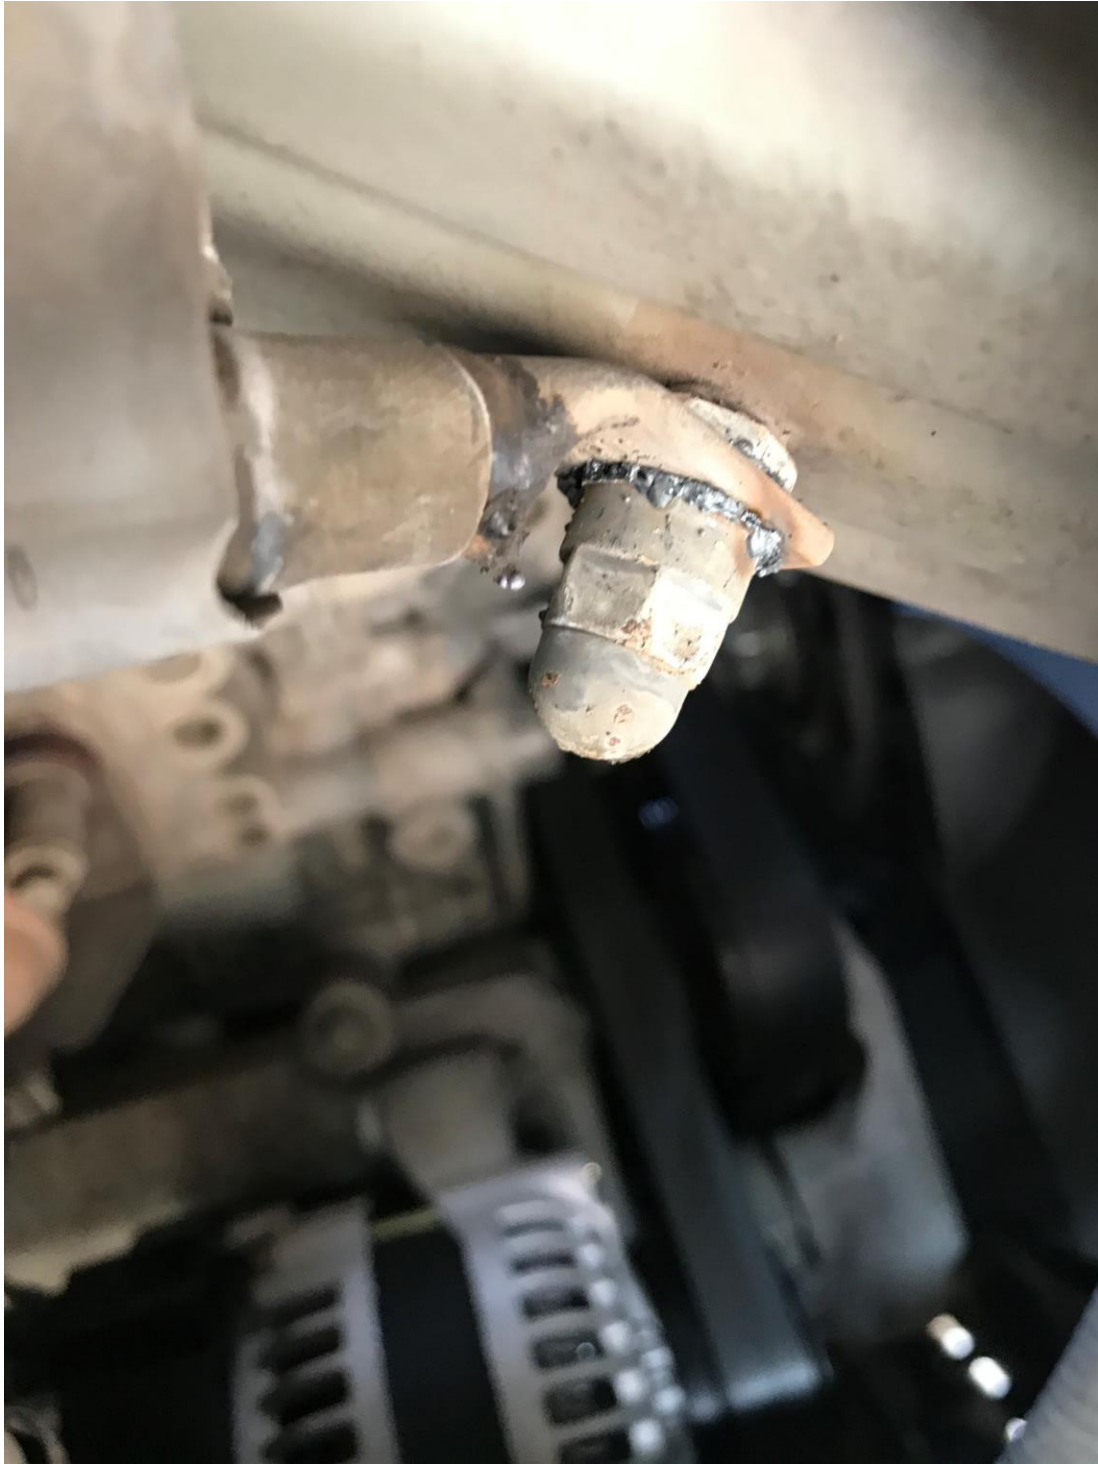
Close up of the battery ground cable, where it terminates on the body.

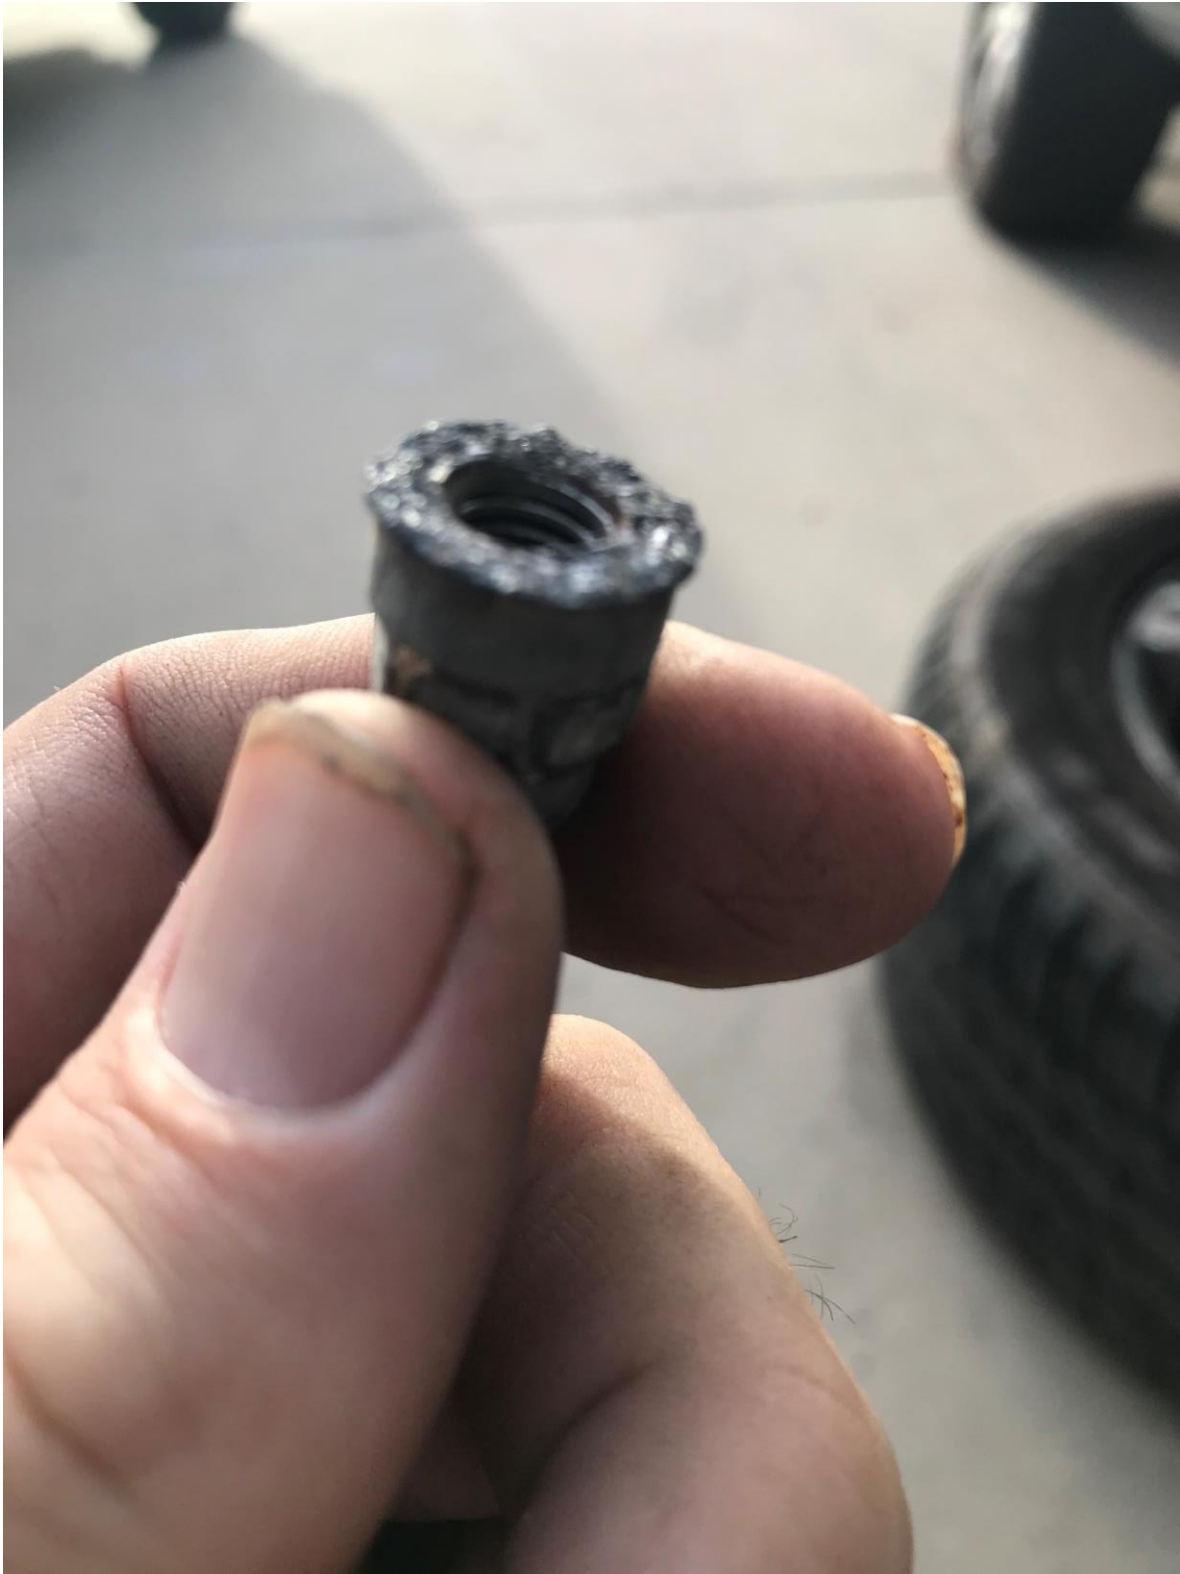
Removed the nut that holds the ground cable to the body. Obvious carbon build up and melting.
