# TECHNICAL BULLETIN

No: LA-501-006

## A-pillar Water Leak

Land Rover LR3 (LA)

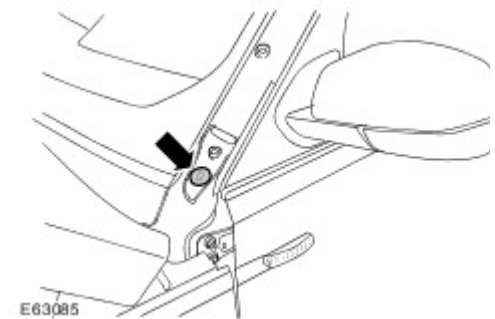
Figure 5

**Situation:** A customer may report water in the footwell of the vehicle. Water ingress through the lower slot in the A-pillar structure, where the exterior trim lower location peg slots into the body, may be the cause. The customer may also report unexplained illumination of warning lights such as the oil pressure warning lamp.

**⚠ CAUTION:** The area to which the adhesive patch is applied must be clean and dry before patch installation. The patch must completely adhere to the body surface to ensure a proper seal.

6. Clean area surrounding the lower elongated slot in A-pillar structure
7. Apply adhesive patch, supplied in kit DHB500400, to body covering lower elongated slot. (Figure 5)
8. Attach clip IPN500050 to the lowermost A-pillar exterior trim mounting location. (Figure 6)
9. Install 4 clips (DZM000070) to the remaining A-Post exterior trim mounting locations. (Figure 7)
