## 6 Speed Transmission mechatronic sleeve replacement

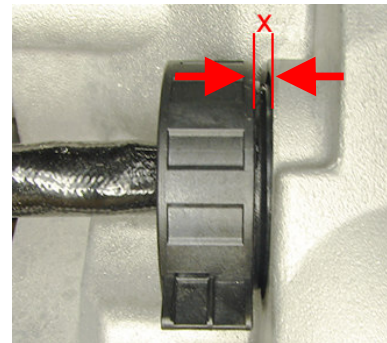
6. Push the sealing sleeve locking mechanism up into the locked position. Do not force the locking mechanism, if hard to lock, check that the sleeve is pushed in far enough with gap x smaller 3.0mm.
