Oil Dilution on Jaguar Land Rover D8 diesel SUVs

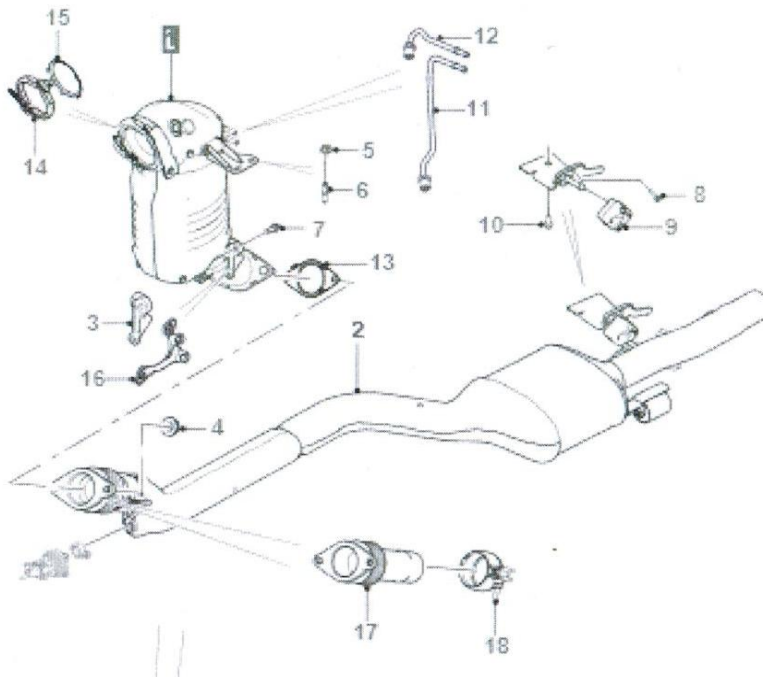
Fig 1 – Jaguar XE Exhaust

In the Jaguar XE parts schematic below the combined DOC-DPF is the vertical canister (1) which attaches to the Ingenium turbo outlet by clamp (14) and seal (15). DEF injection is made at bottom left under clamp (18) and the SCR consists of the horizontal pipe and canister (2).

The Jaguar XE X760 went on sale with this exhaust hardware and architecture in early 2015: the first sales recorded for the Jaguar XE were March 2015 (2), April 2015 (20) and May 2015 (624). The next vehicles scheduled to receive the Ingenium engine with EU6-compliant exhaust emissions after-treatment (mandatory for all new vehicles sold from 1st September 2015) would be the Discovery Sport L550 and Range Rover Evoque L538. Until August 2015 these cars were still being sold with a transversely-mounted EU5-compliant PSA/Ford Duratorq 2.2L diesel engine.

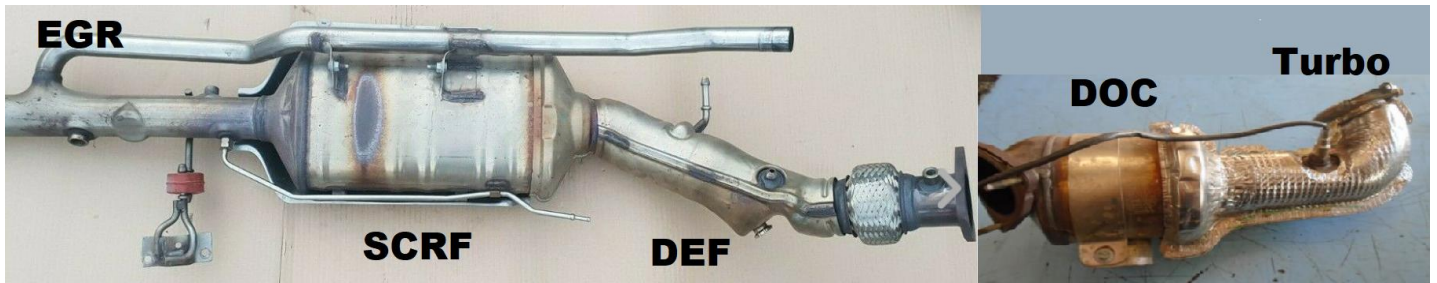
Fig 2 Discovery Sport / Range Rover Evoque Exhaust

The D8 chassis forward bulkhead prevented JLR from fitting a “close-coupled” exhaust like the schematic shown above in Fig 1 for the Jaguar XE X760. In the [letter to sales staff](#) JLR admitted that there were “*some engineering challenges with the current layout of the architecture, affecting the proximity of the heat source (engine) to the filter and so its ability to complete the burn off of the soot in the particulate filter*”. This refers to cooling effects caused by the additional pipework between the turbo outlet, DOC and SCR.

On the Discovery Sport L550 and Range Rover Evoque L538 the SCR is too far back from the engine for passive regeneration to occur during normal driving. According to Johnson Matthey an SCR-based filter performs less passive regeneration than a catalyzed soot filter (CSF) at a given temperature while an active regeneration of SCR takes 50% longer to complete ([Scientific paper 2016 / Presentation](#)). The performance of this after-treatment system is impaired by a number of operational constraints and consequences which can be summarised as follows:

As shown above (Fig 2) on the Discovery Sport L550 the DPF is separated from the turbo outlet by two lengths of pipework (total distance 70 cm), creating an effective heat sink. The SCR operates at much cooler temperatures than a close-coupled CSF-type DPF attached to the turbo outlet, e.g. the one fitted to the Jaguar XE. This effectively disables passive regeneration using oxygen unless the engine can be made to work extremely hard (for long periods) to overcome the heat losses.

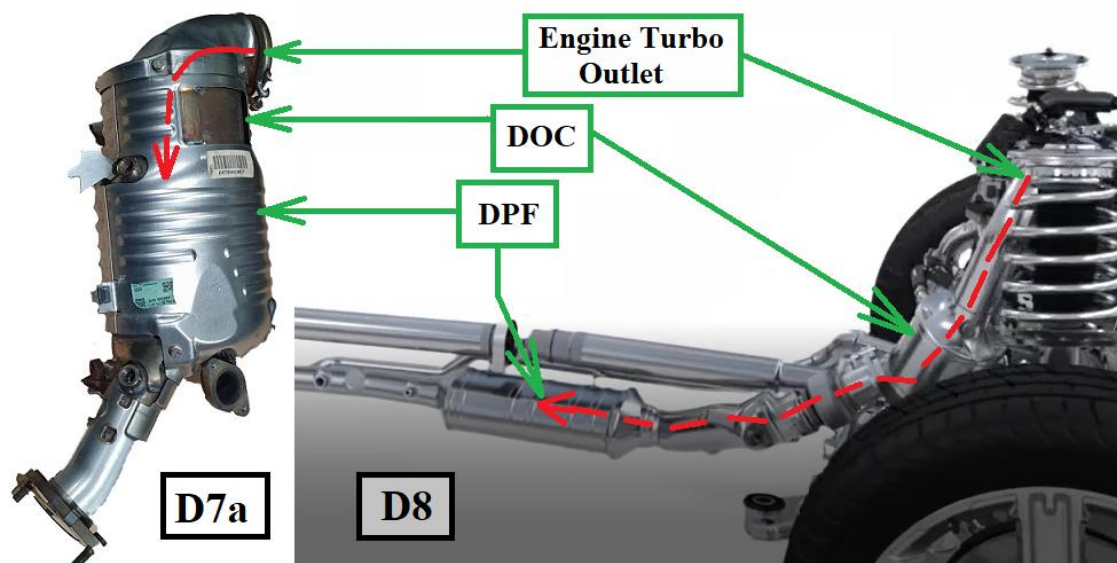
Fig 3. Jaguar Land Rover exhaust after-treatment architectures

The Jaguar XE oxidation catalyst and DPF are physically contained within a single canister so that virtually no heat loss occurs between the engine and the DPF. The DPF temperature remains high at all times and it requires very little additional heat to reach the temperature required for active regeneration to begin. On the D8 architecture there are two lengths of pipework separating the turbo outlet from the DOC and the DPF so heat losses are significant. The D8 vehicles require longer periods of active regeneration to heat up the DPF and maintain the temperatures required for active regeneration to continue. This is what is meant in JLRP00100 where it says that “*the duration / distance to complete a full regeneration on 2.0L diesel Evoque / Discovery Sport is longer than on 2.0L diesel Jaguar XE*”.

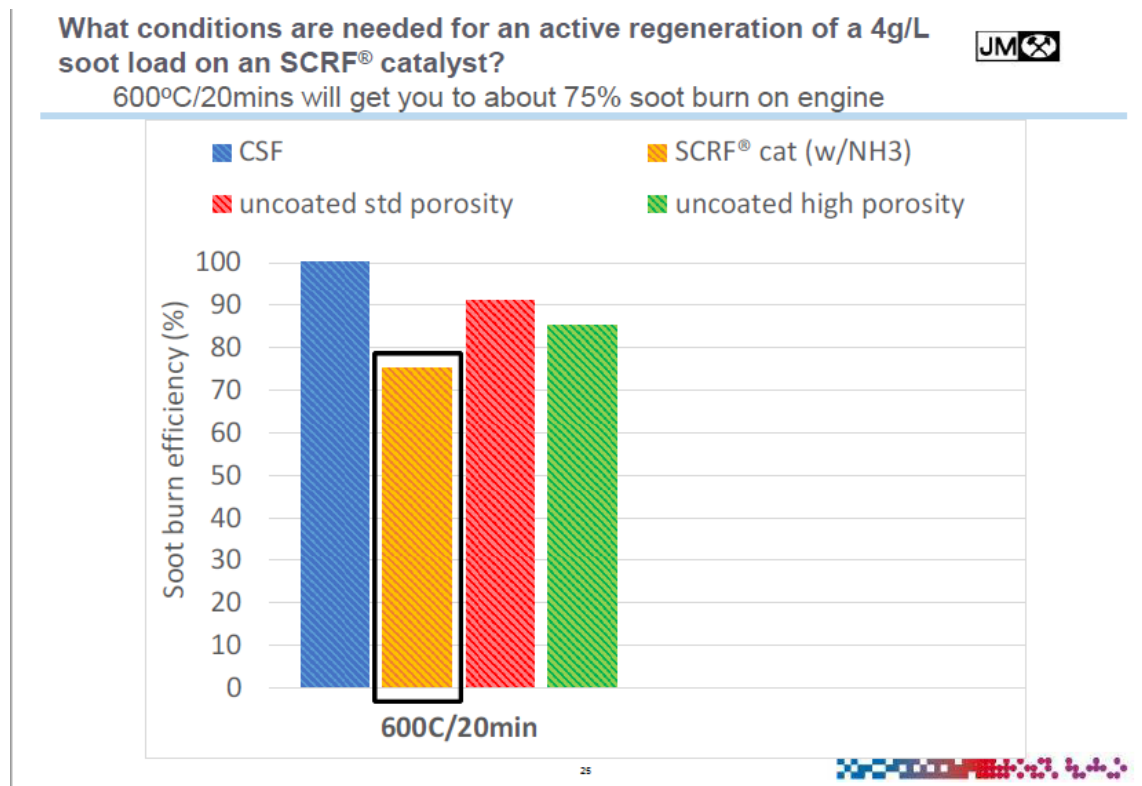
Fig 4. Comparison of active regeneration performance of SCR® vs CSF.

Active regeneration of a CSF (4g/L load) can complete within 20 minutes (as per JLR’s current video), but a similarly-loaded SCR regenerates only 75% in this time, *even with SCR operational*.

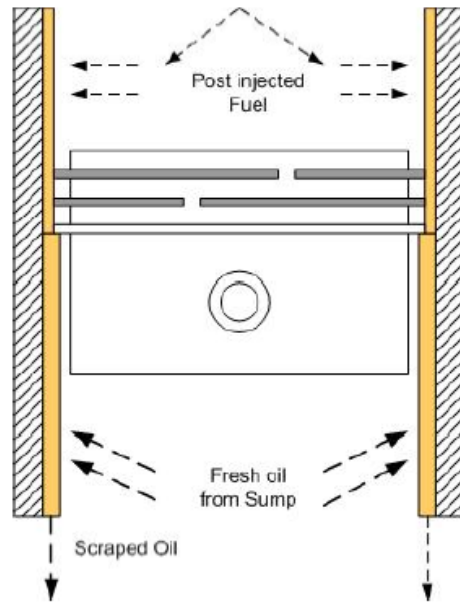
Fig 5. Diesel dilution occurs continuously during post-injection (active regeneration).

Engine oil dilution occurs due to small amounts of fuel entering the engine crankcase “during the post-injection phases” (JLR 2015) while the oxidation catalyst is being supplied with diesel via the engine’s diesel injectors. When an active regeneration completes, or the car engine is switched off before it has completed, post-injection and diesel dilution both stop. The mechanism by which post-injection causes diesel dilution has been described scientifically on several occasions, for example [Song and Choi \(2008\)](#), reproduced by the Journal of Mechanical Science and Technology.

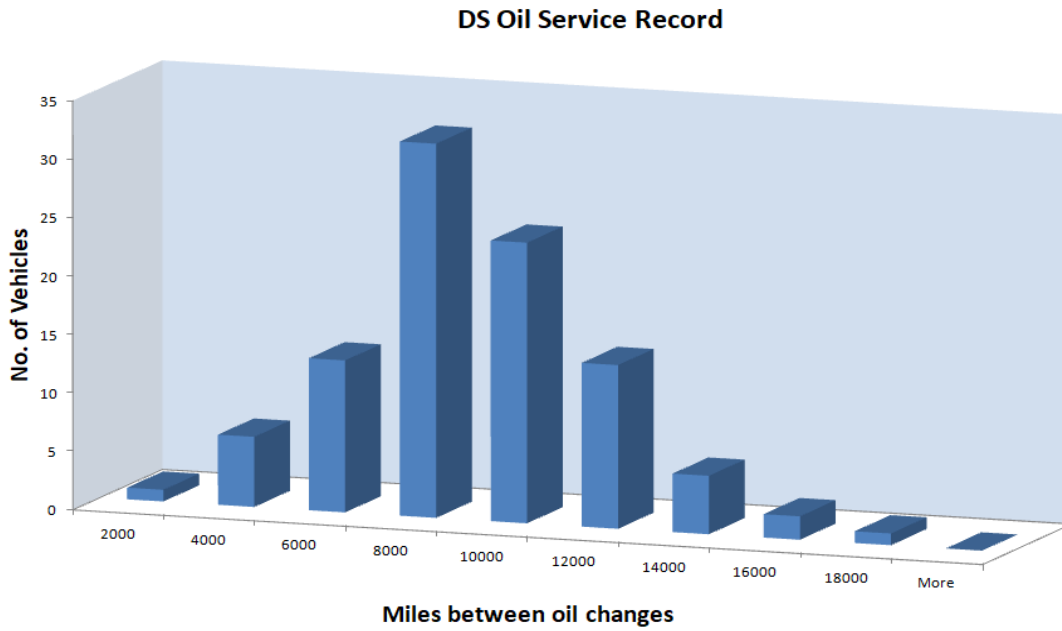
Fig 6. Engine oil change interval due to dilution – Discovery Sport L550.

Details of almost 100 early oil changes reported on the DS forum between July 2016 and January 2019 were collated and the data published on 12th March 2019. The average mileage before an oil change was required was [8,306](#), or 39.4% of the nominal service interval.
