TECHNICAL BULLETIN
LTB00563NAS1
22 JUL 2013

SECTION: 501-14

Smart Key Handset Lower Level Service Repair

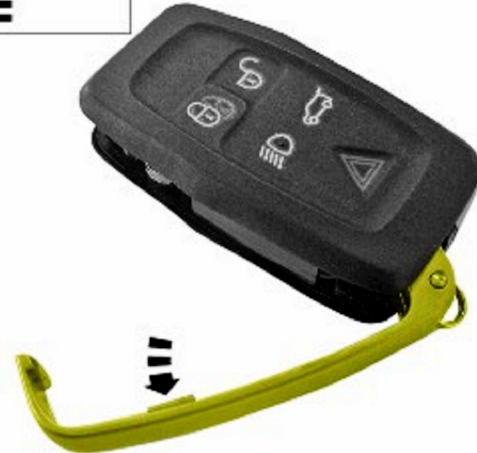
E158176

1. Press the release button and pull the battery cover frame open.

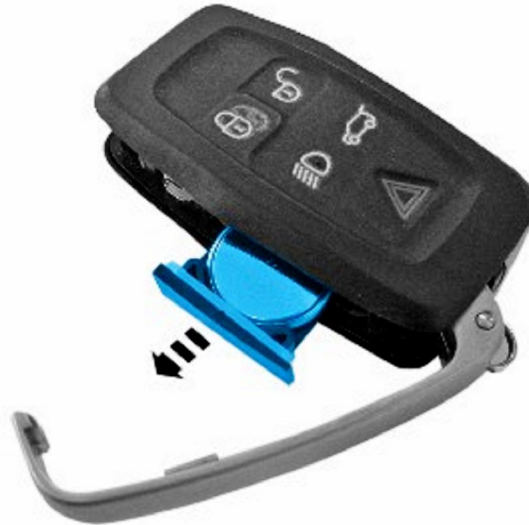
E158177

2. Remove the battery holder assembly; place to one side.

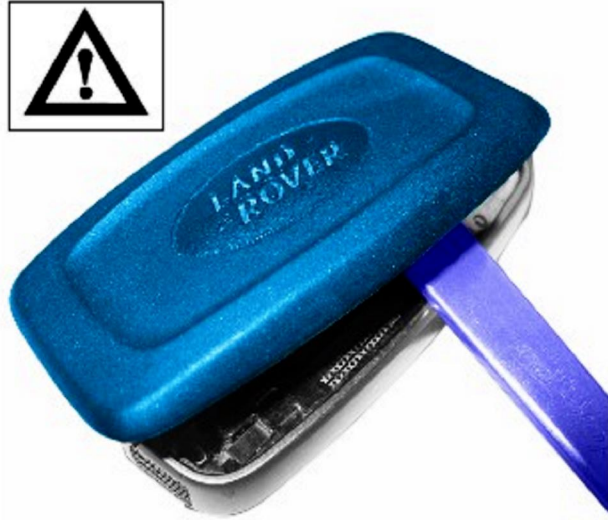
E158178

3. Using a suitable tool lever, open the body of the handset:

- Discard the handset upper case.

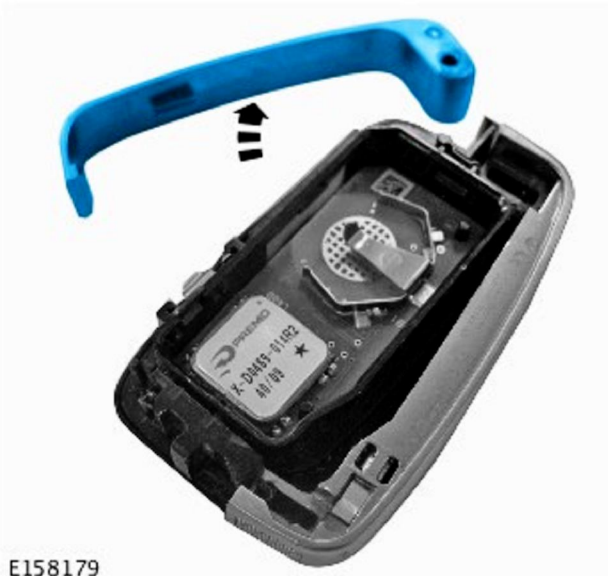
E158179

4. Remove the battery cover frame; place to one side.

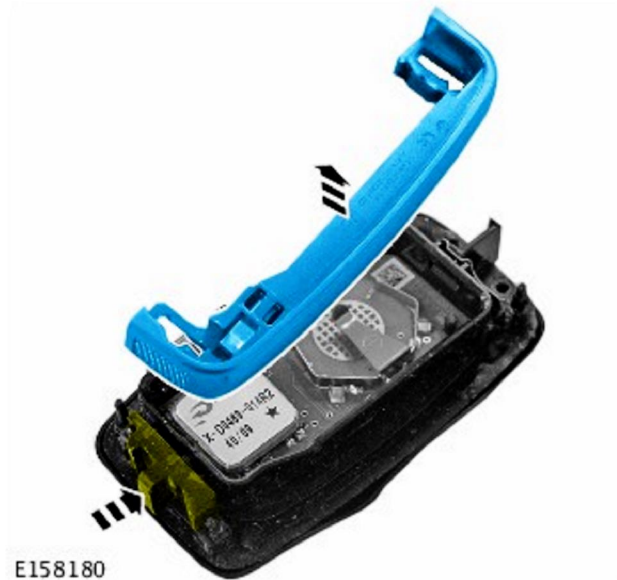
E158180

5. Remove the key frame holder; place to one side.

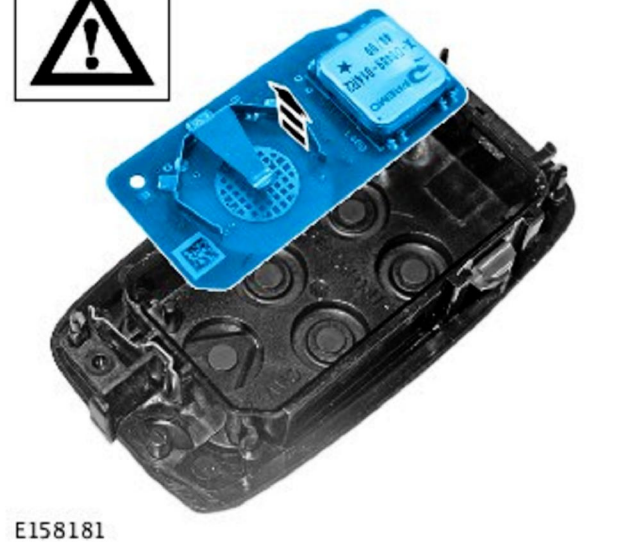
E158181

**CAUTION: When removing the Printed Circuit Board (PCB), only handle on the outer edges of the PCB.**

Remove the Printed Circuit Board (PCB); place to one side.

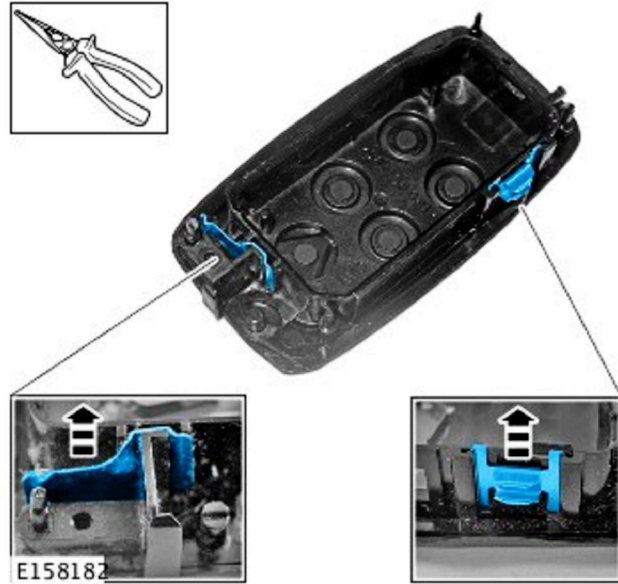
7. Remove retaining clip and leaf spring; place to one side.

- Discard the handset lower case.

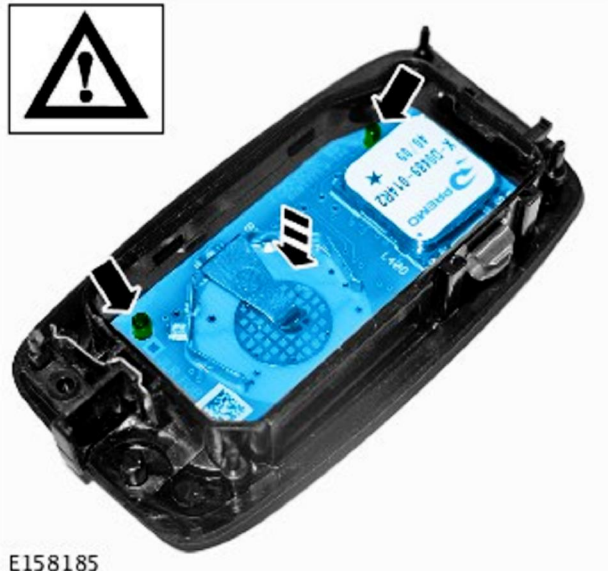
**CAUTION: When installing the Printed Circuit Board (PCB), only handle on the outer edges of the PCB.**

Install the Printed Circuit Board (PCB).
