JLRTB02070NAS1
TECHNICAL BULLETIN
22 JAN 2021

501-10

Cloth Seat Staining - Cleaning Procedure

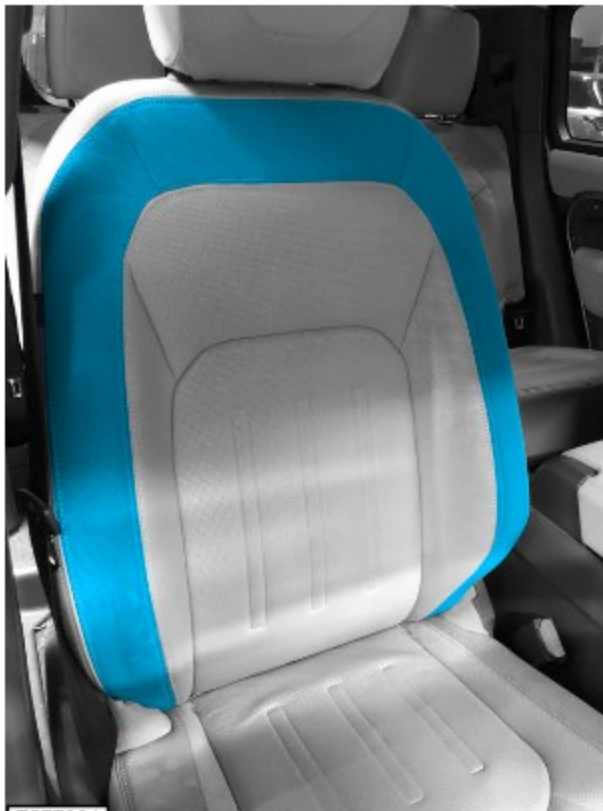
1.

This Service Information section shows the area of the front and second row seat covers that need to be cleaned using a wet vacuum cleaner.

Front backrest cover.

Only complete the Service Instruction on the area of the seats highlighted blue in the Service Information illustrations.

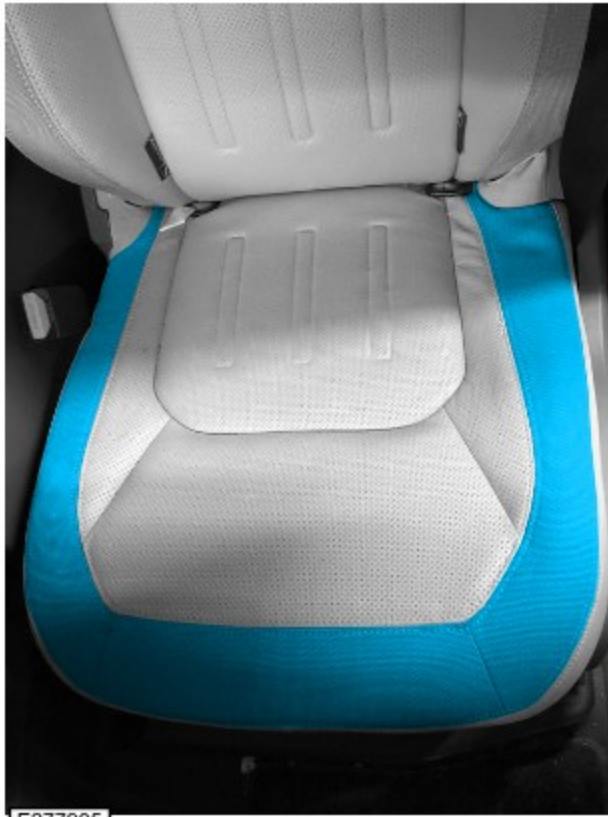
2.

Front cushion cover.

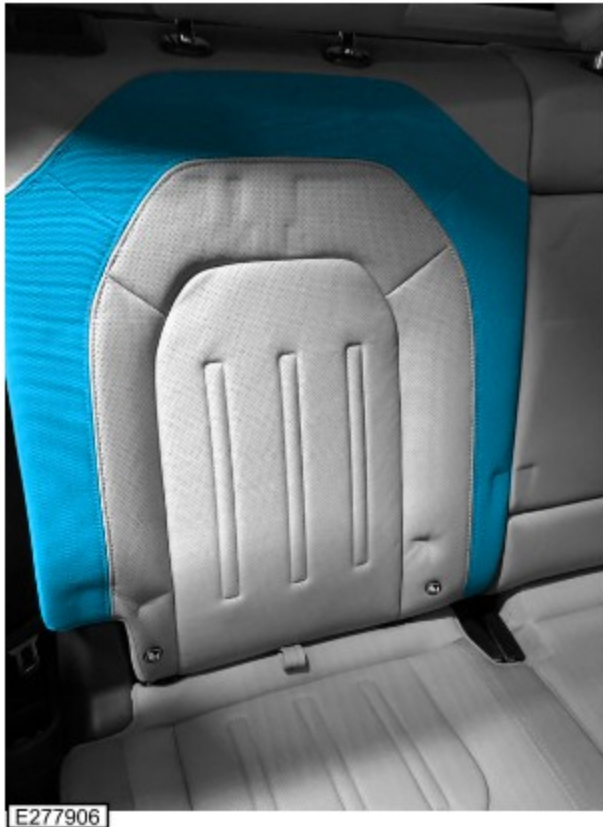
3.

Second row backrest cover.

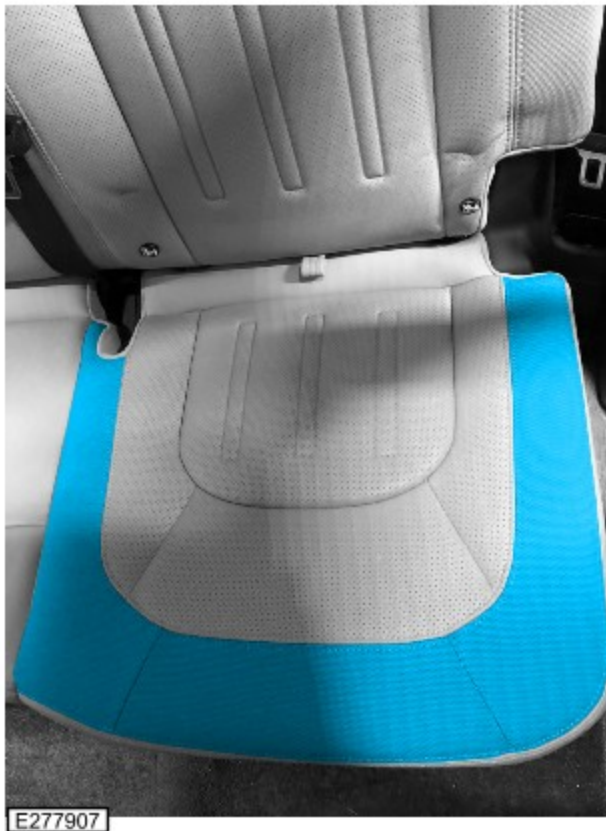
4.

Second row cushion cover.
