BRAKE AND CLUTCH PEDAL SWITCHES/VENT VALVES

Service repair no - 19.75.34 - Clutch Switch Service repair no - 19.75.35 - Brake Switch

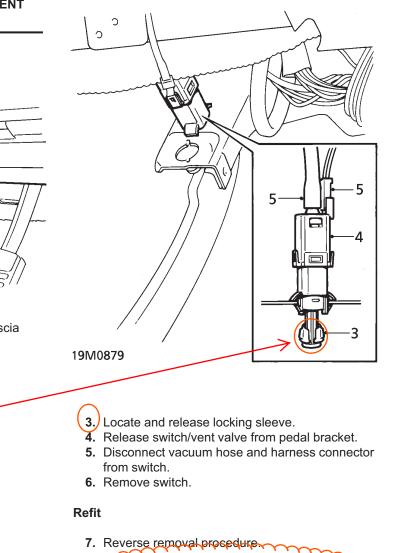
19M0878

- 1. Remove 3 studs securing driver's side fascia closing panel.
- 2. Release and move closing panel aside.

NOTE: Ensure locking sleeve is correctly

positioned.
