CIRCULATE TO:-		[REDACTED]	SUBJECT		12/31/96	
SERVICE MGR.	X		<b>PRIDE - Rear Brake Light/Rear Defogger Short</b>		86/13/96/US	
RECEPTION	X				MODEL  <b>Discovery</b> <b>Discovery</b>	AFFECTED VEHICLES LP LH LJ Up to VA542261 LJ Up to VA711170
WORKSHOP	X					
PARTS	X

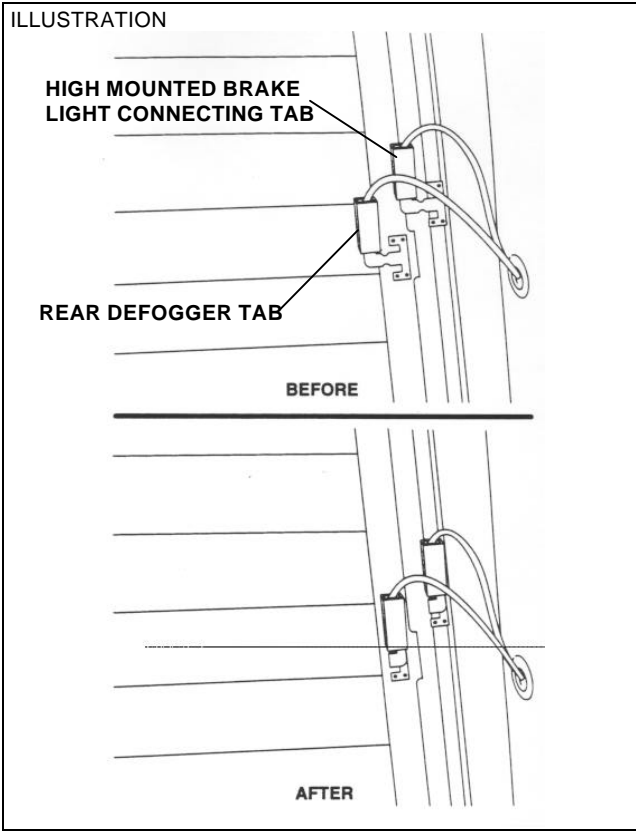
On some vehicles the rear defogger grid lead and the high mounted stop lamp lead may come in contact. This contact will blow fuse F1. If fuse F1 is blown, the shift interlock system locks the transmission when it is shifted into the Park position.

Bend the brake light lead tab and the defogger lead tab 180° to avoid electrical contact.

- PROCEDURE**
1. Locate the connector for the High Mounted Stop Light.
  2. Bend the vertical tab 180° to move it away from the rear defogger grid (see illustration opposite).
  3. In order to maintain a neat appearance, bend the rear defogger tab 180° also (see illustration).
