# LAND ROVER CLUB V.I.

## ABS MODULATOR ELECTRICAL FAULT REPAIR

11/2009

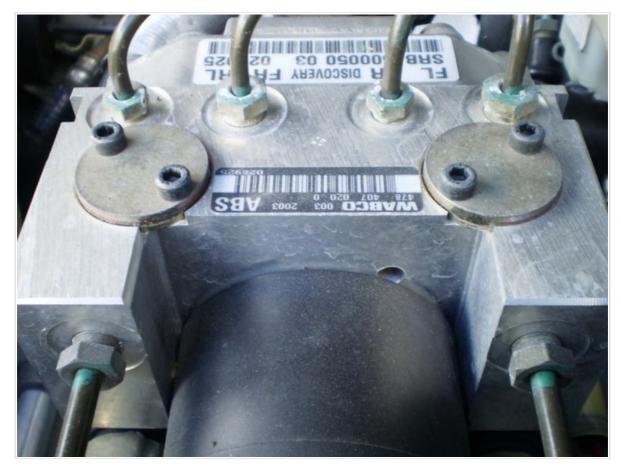
1. Spray Liquid Wrench on the 6 brake line nuts (4 on top and 2 on the side).

2. Also spray the four hex screws on the cover plates. Removal of the screws and plate will help remove the brake lines but it is not required.

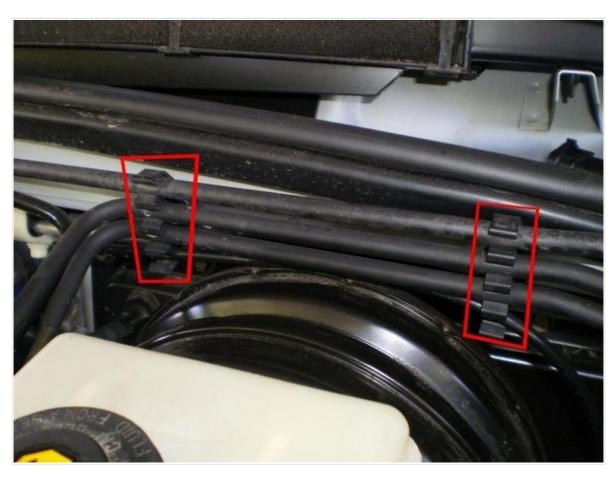
3A. While the Liquid Wrench is soaking the nuts and screws, remove the air intake arm and release the brake pipes from the clips on the bulkhead.

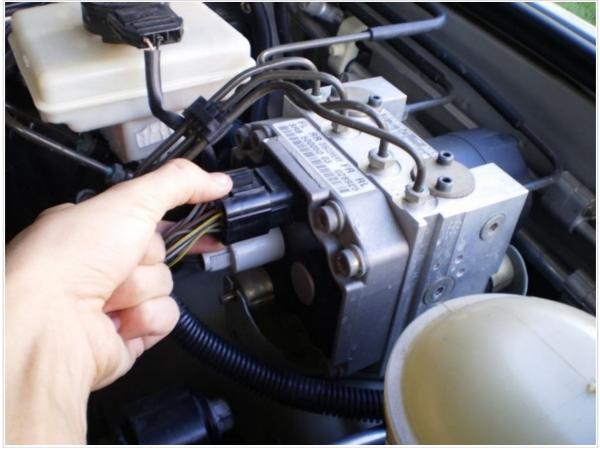
3B. Remove the 3 electrical connectors form the modulator. Two on the front and one on the side.

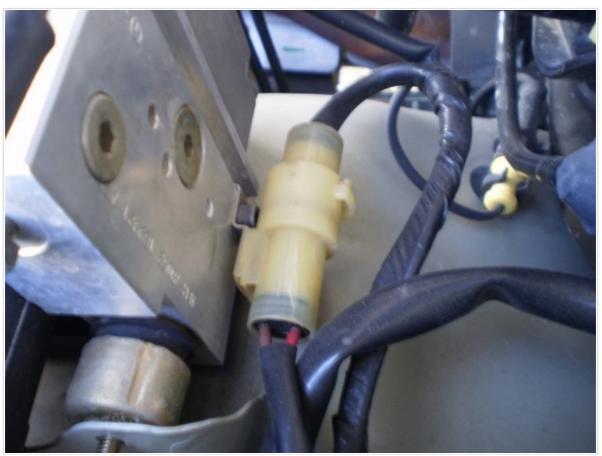
Removing black connector C0501 and grey connector C0500

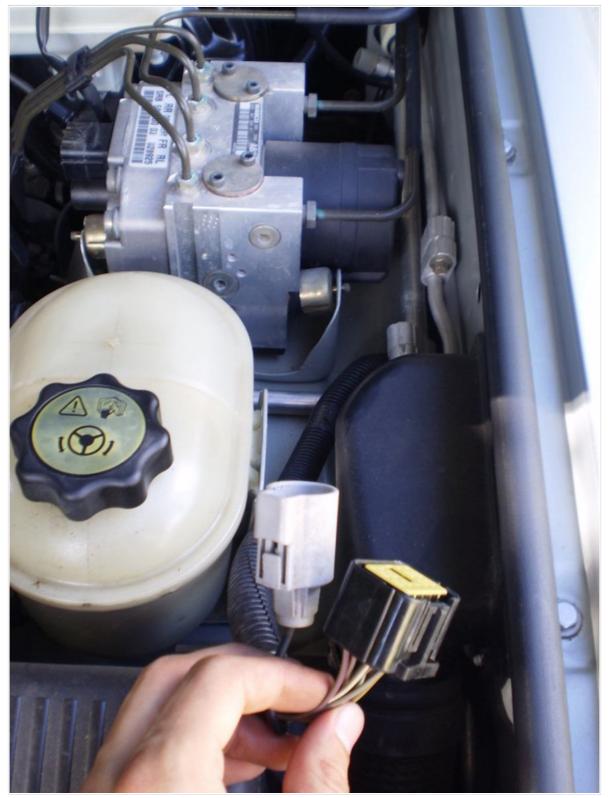
Side connector C0507

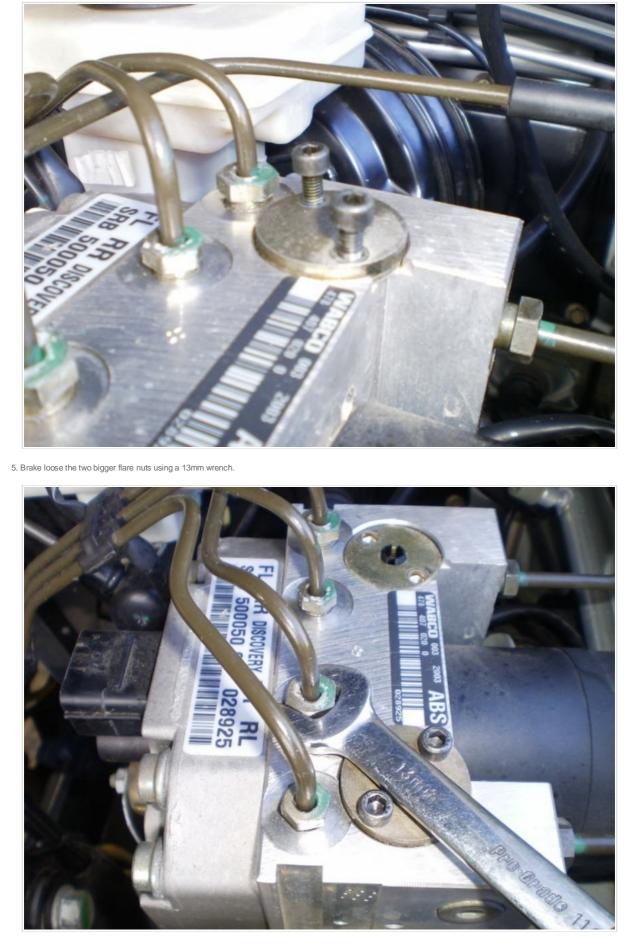
Place harness between intake and steering fluid reservoir

4. Using a 4mm hex bit, remove the two hex screws and cover plate.

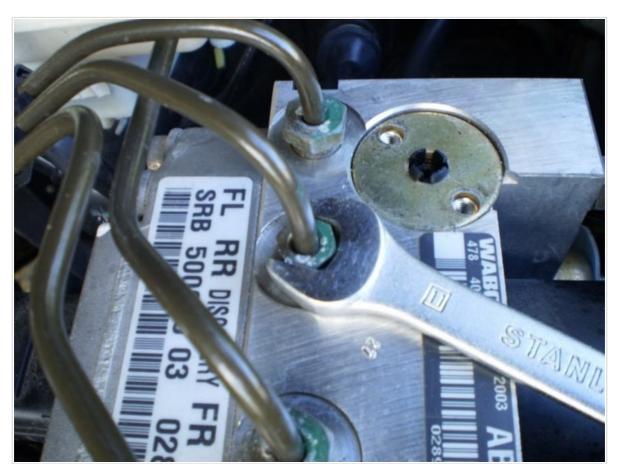
6. Brake loose the two smaller flare nuts using a 11mm wrench.

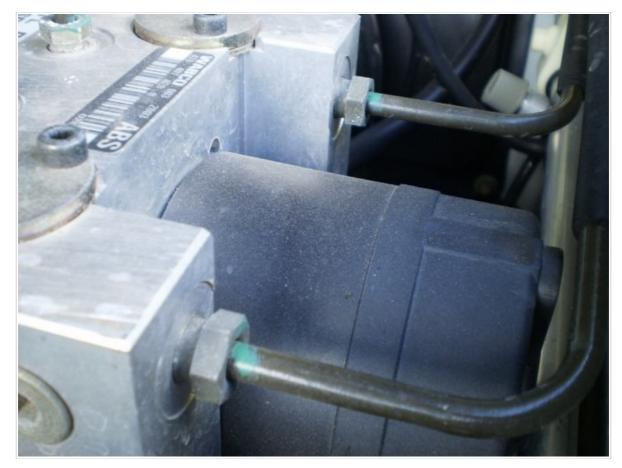
7. Brake loose the two side mounted brake line nuts using a 13mm wrench.

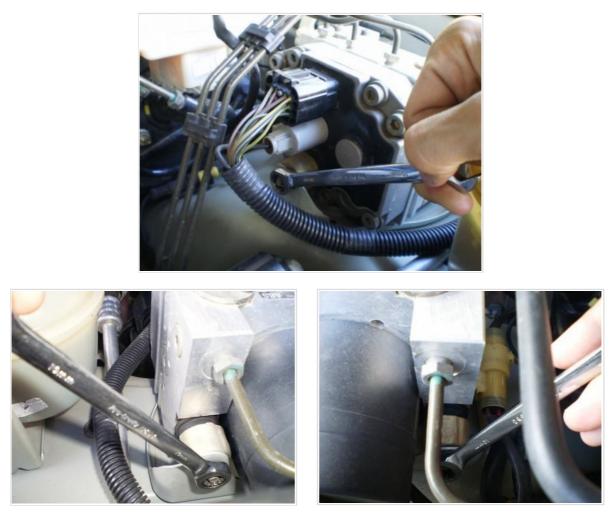
8. Once all 6 brake lines are broken loose, remove the 3 nuts securing the modulator on to its mounting bracket using a 10mm wrench.

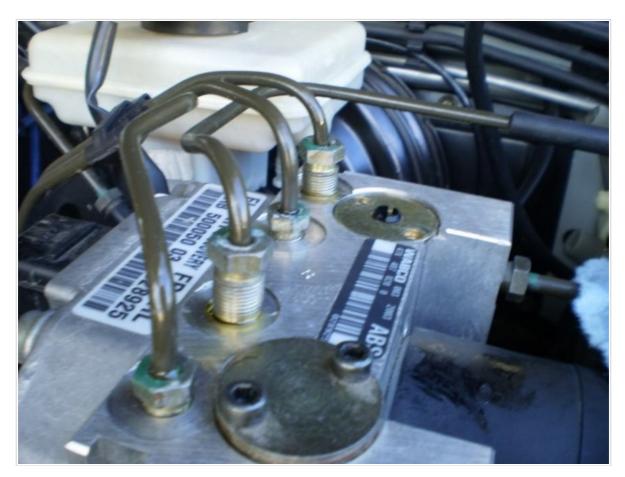
Note: Before fully disconnecting the brake lines from the modulator, clean up any excess Liquid Wrench so that it does not get inside.

9. Unscrew and disconnect the two bigger brake lines. Brake fluid will be dispensed from both the lines and pump side. Have a shop towel nearby.

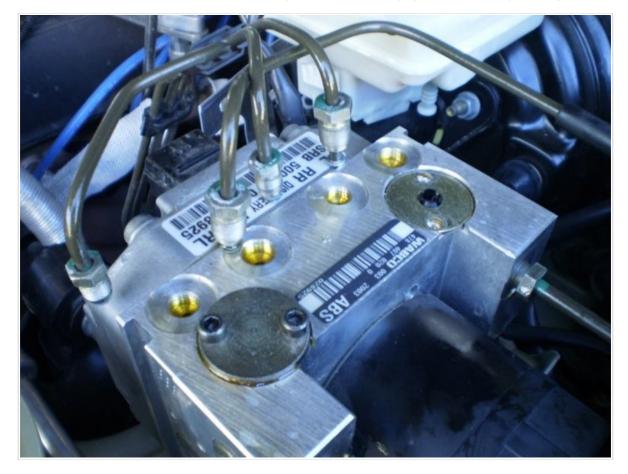
10. Unscrew and disconnect the two smaller brake lines. Brake fluid will be dispensed from both the lines and pump side. Have a second shop towel nearby.

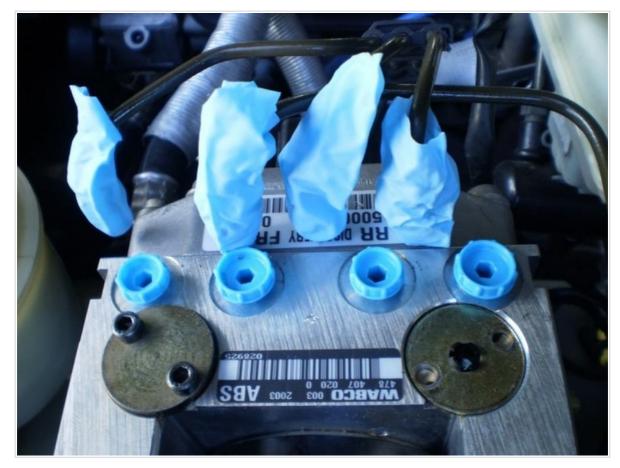
Luckily I had a second ABS modulator/pump that had plugs for all 6 brake line ports so I plugged them up. I also cut the fingers off a disposable rubber glove to keep the lines from dust contamination. It also helped catch some brake fluid. I recommend using a syringe or turkey baster to suck out the residual brake fluid from the modulator if you do not have brake plugs.

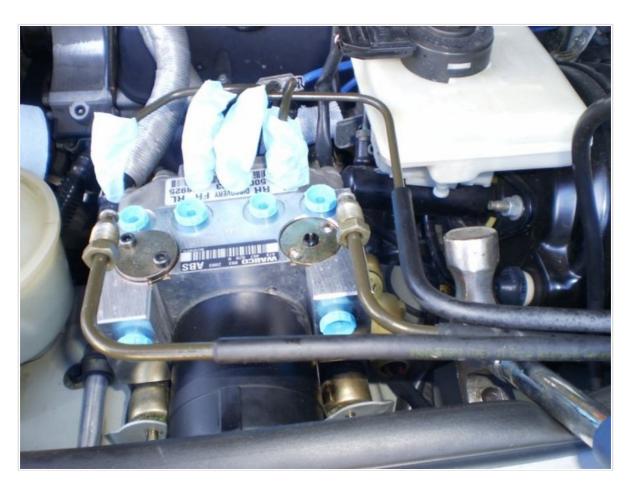
11. Disconnect the two side lines. Brake fluid will be dispensed from the lines and pump side. Have that third shop towel nearby.

Because of the slight incline on my drive way, it was necessary for me to elevate the two side brake lines coming from the master cylinder to prevent brake fluid from continuing to pour out. I used a hammer at first and wedged it between the inside of the quarter panel.

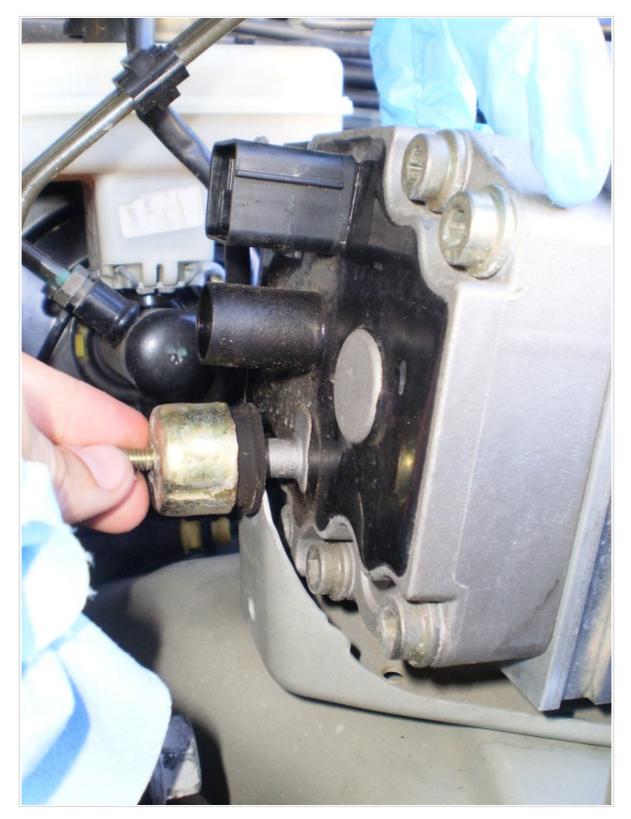
12. Lift the front of the modulator and remove the front rubber mount.

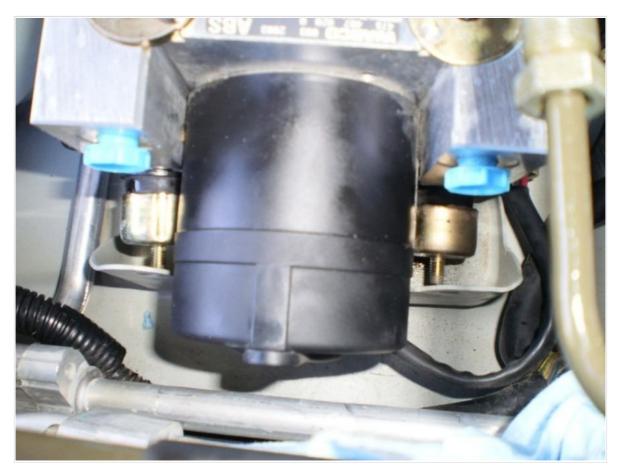
13. Carefully remove the ABS unit paying closing attention to the brake lines.

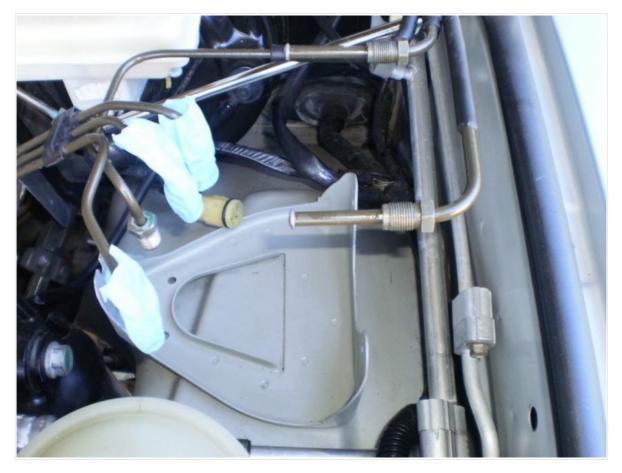
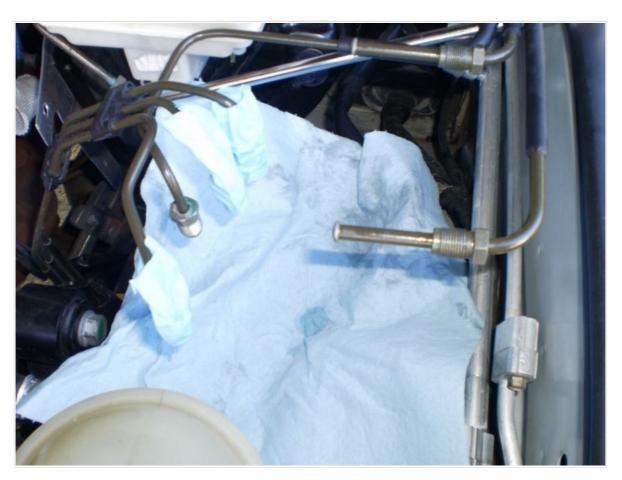
14A. Once removed, clean the area to prevent paint damage from spilled brake fluid. Place an absorbent shop towel or cloth to catch any brake fluid while you continue to work.

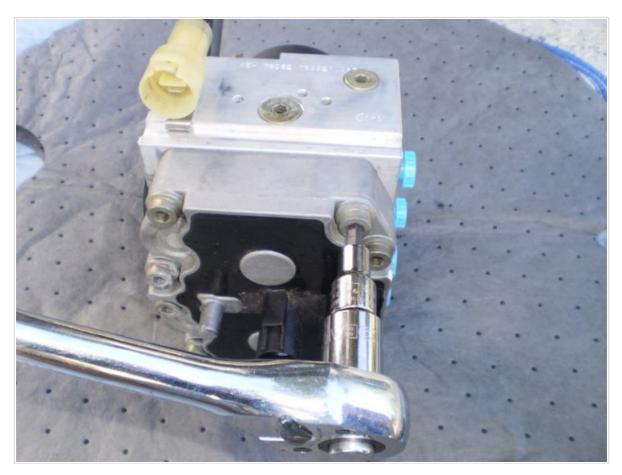
15. Clean off the modulator. Using a 6mm hex tool, remove 8 bolts on the modulator.

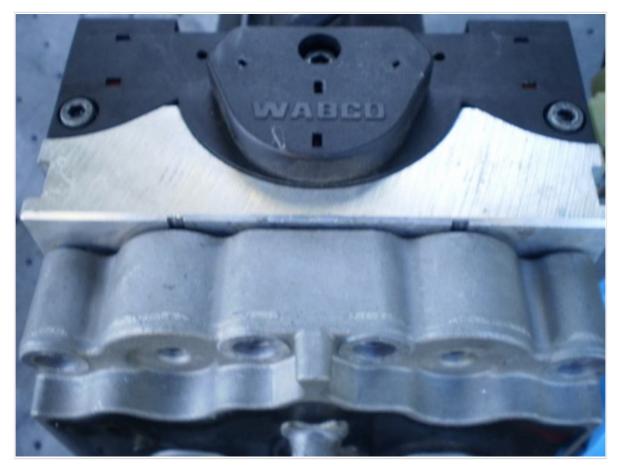
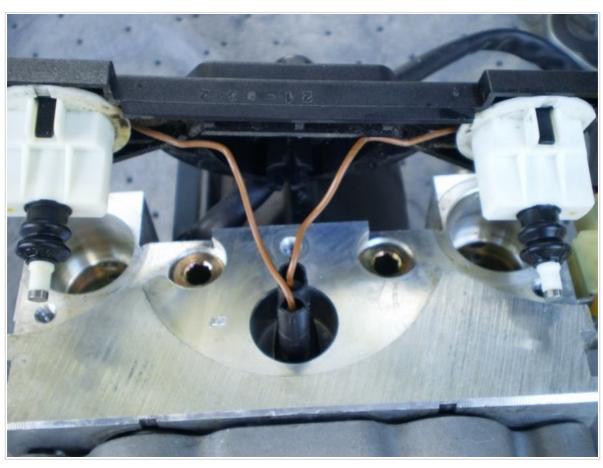
16. Turn the unit upside down. The SVS cover plate reading "WABCO" should now be on top. Using the 4mm hex bit, remove the 3 hex screws. They are installed with blue or red loctite, so let them soak in penetrating fluid to ease removal and prevent stripping.

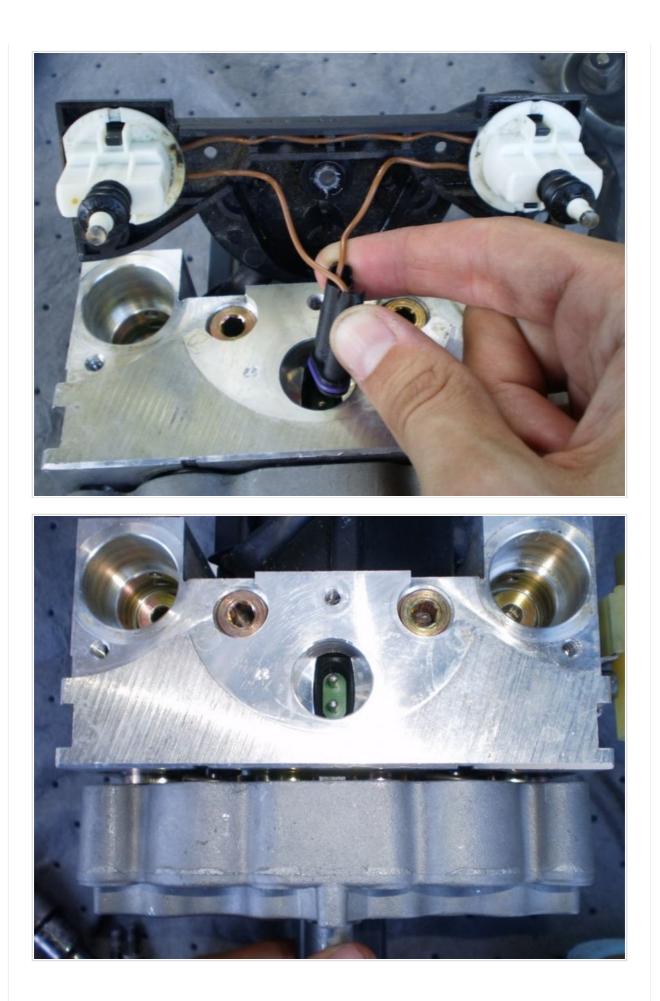
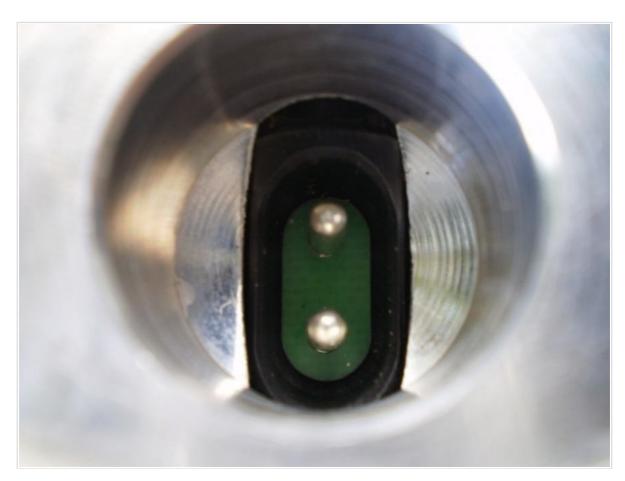
17. Carefully remove the SVS cover plate and disconnect the SVS plug. The plug should dislocate from the cover plate with minimal effort or hold it in place as you pry the cover out. If you find that a pin is lodged in the plug upon removal, and it did not remain in the SVS circuit board then you may have found your intermittent fault.

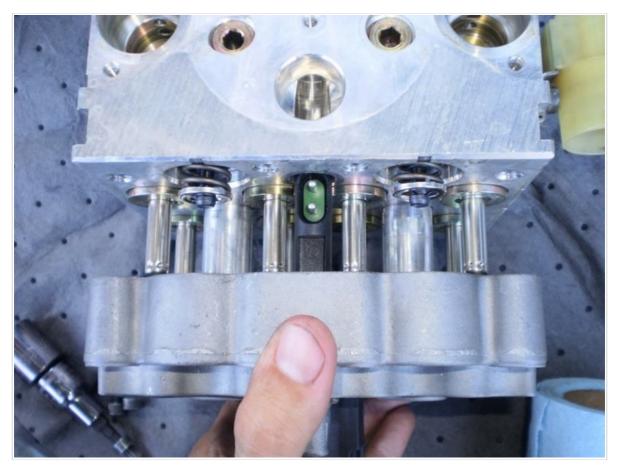
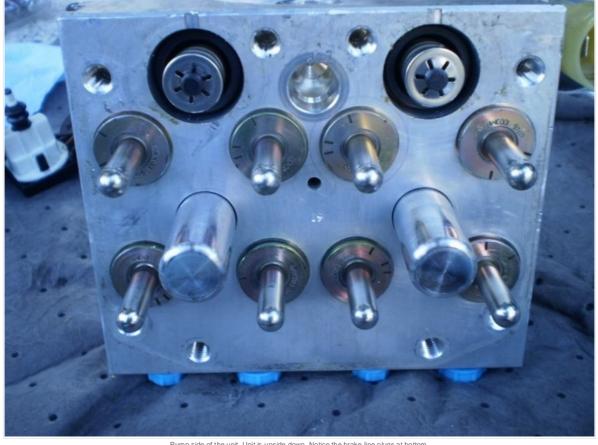
18. Continue to remove the two halves.
