Rover tech - repairs - Throttle BODy heater repair

Repairing the throttle body heater on a 2003 DII
December 2009

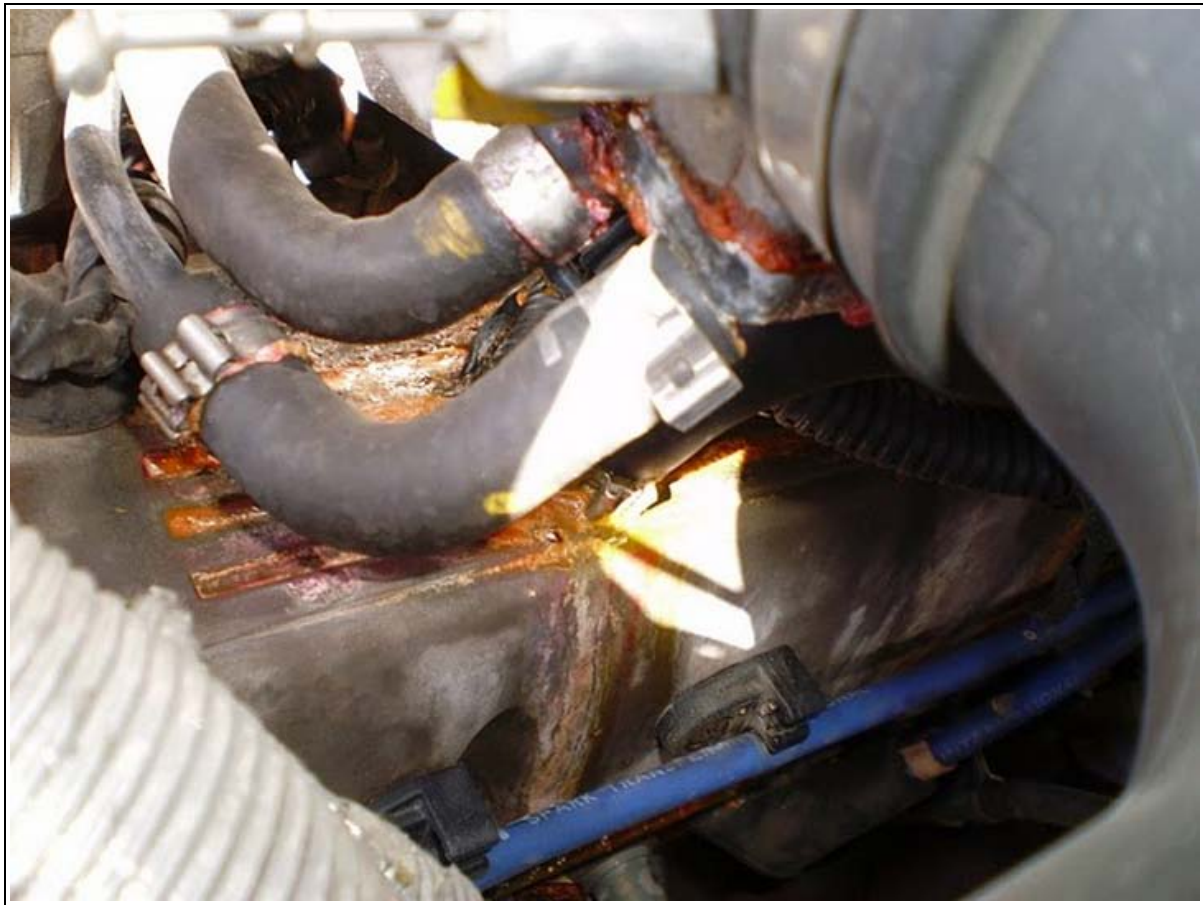
If your DII Throttle Body Heater plate is looking like this, it is time to replace it.

You may have noticed your coolant level dropping but no coolant on the ground. Depending on the severity, the coolant dries up before it makes it far enough.

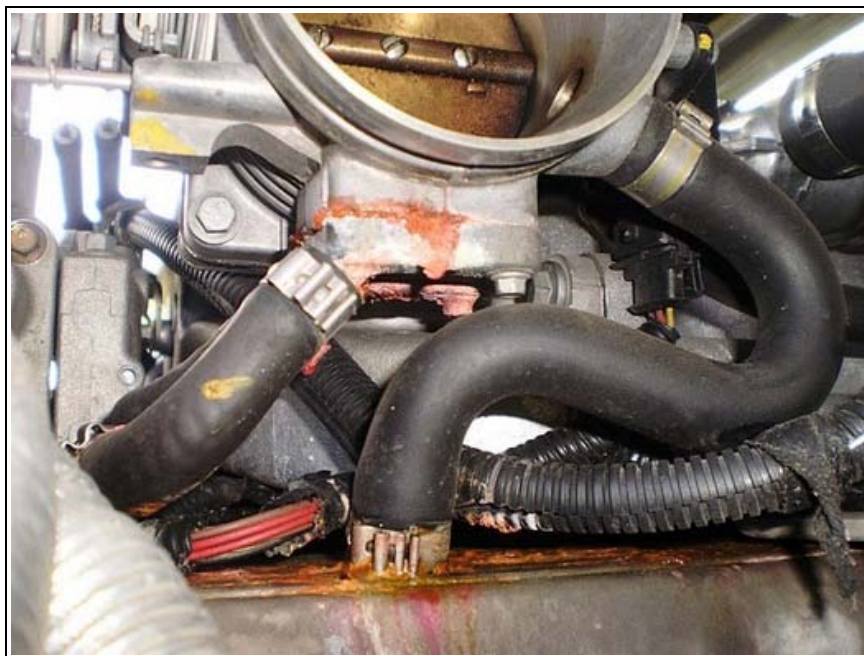
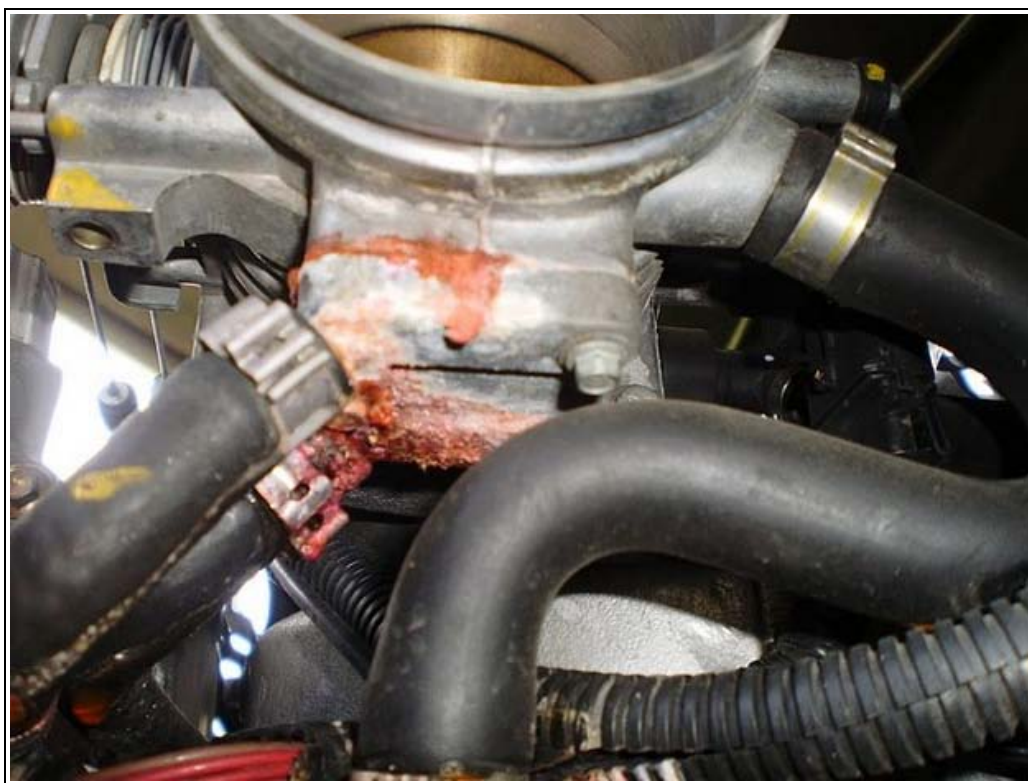
1. Remove throttle body air inlet arm. Take this opportunity to clean the butterfly valve.
2. Remove the PCV hose from the valve cover to throttle body.

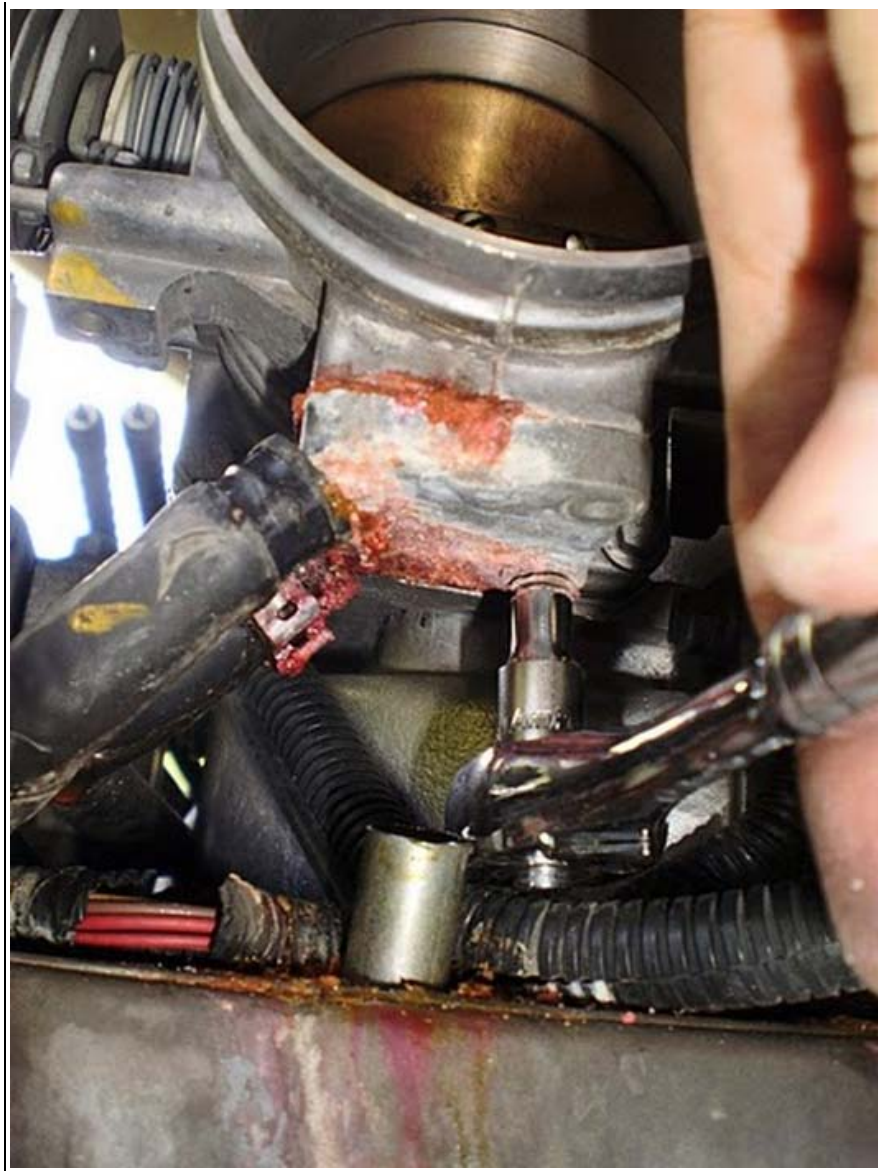
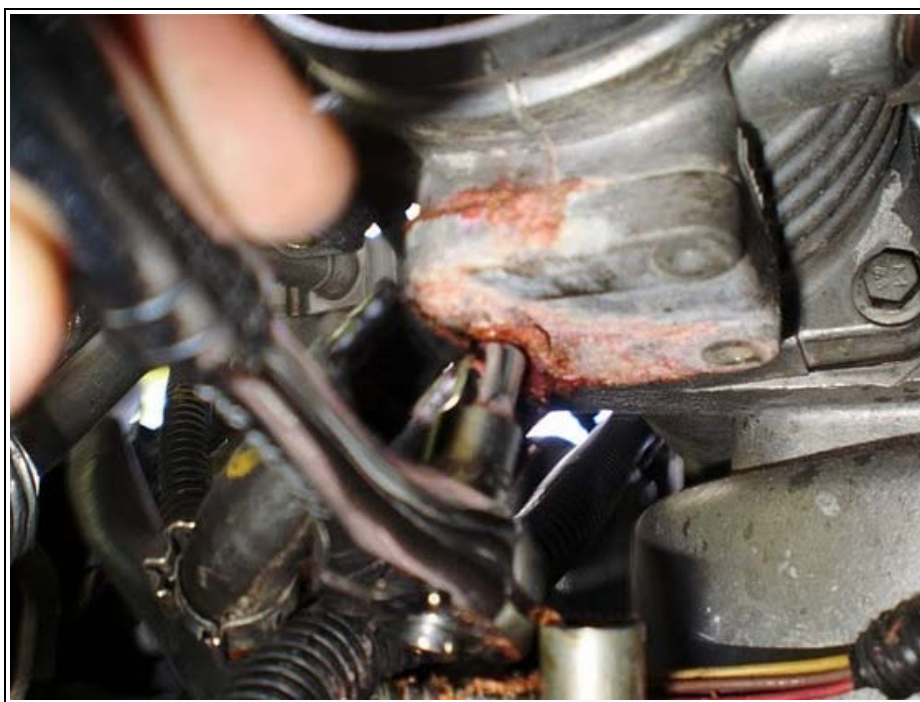
3. Remove three screws securing heater plate to throttle body.

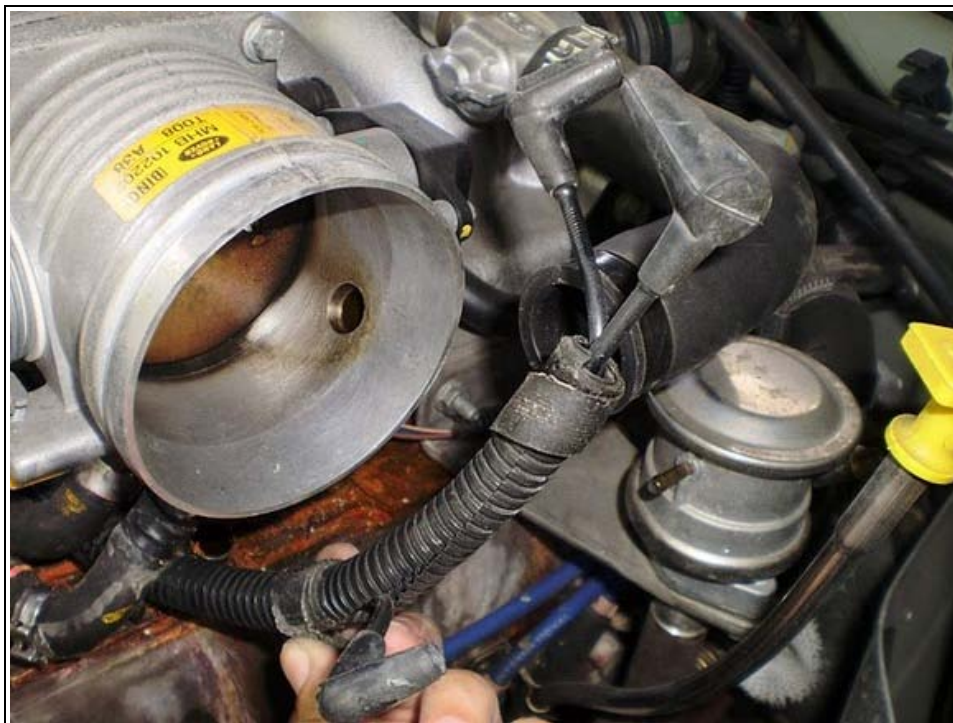
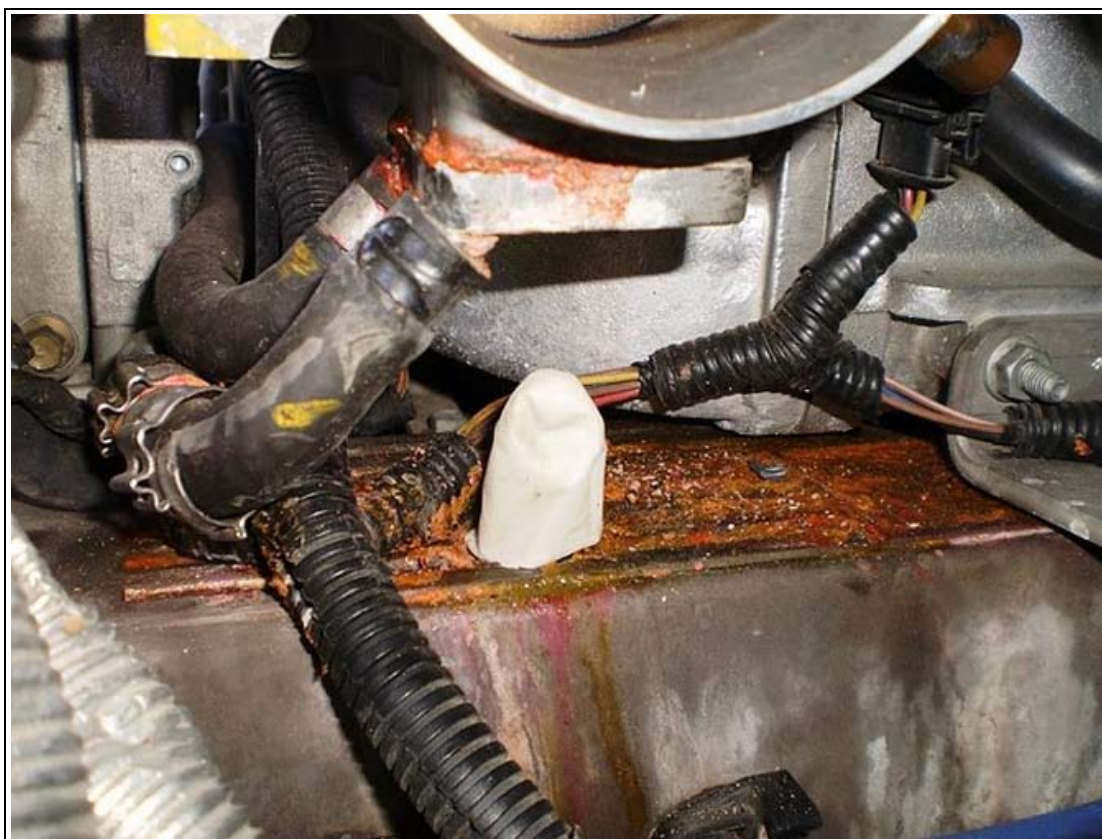
4. Remove the vacuum lines connected to the SAI Solenoid and SAI valve

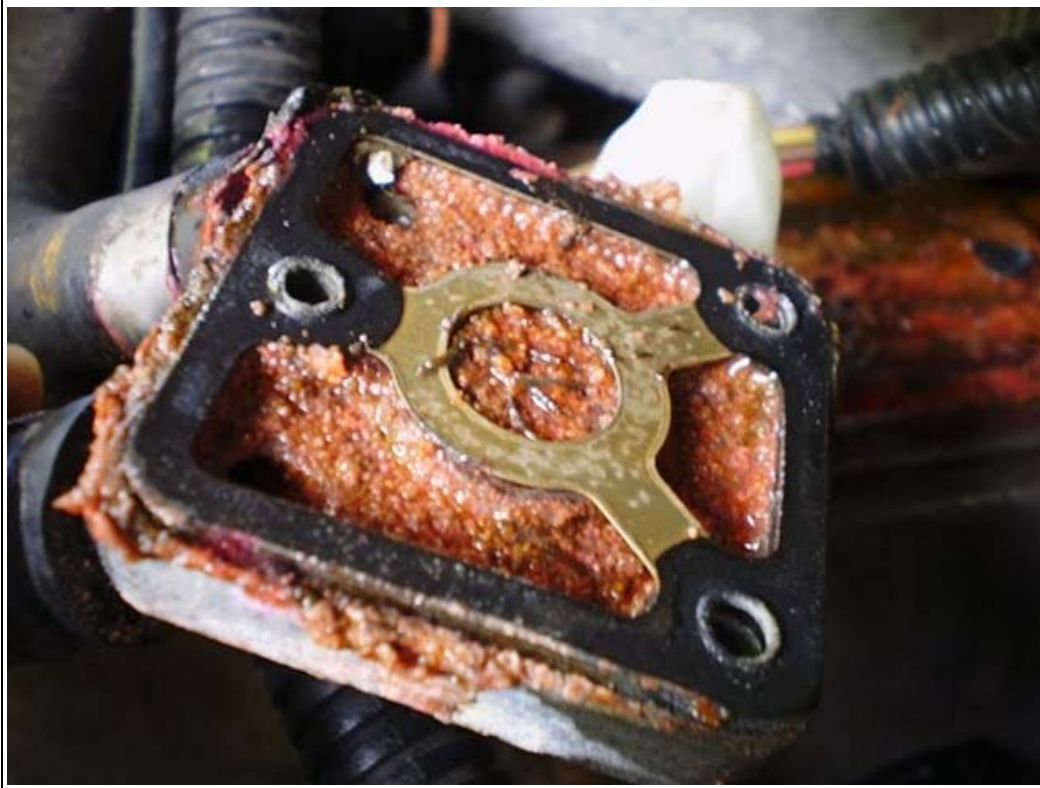
5. Remove heater plate

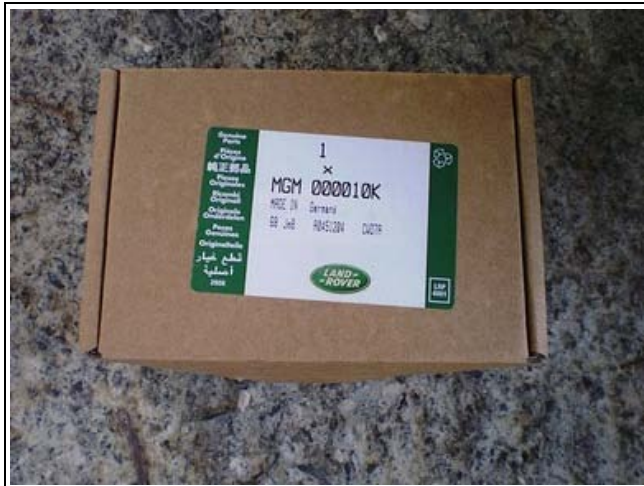
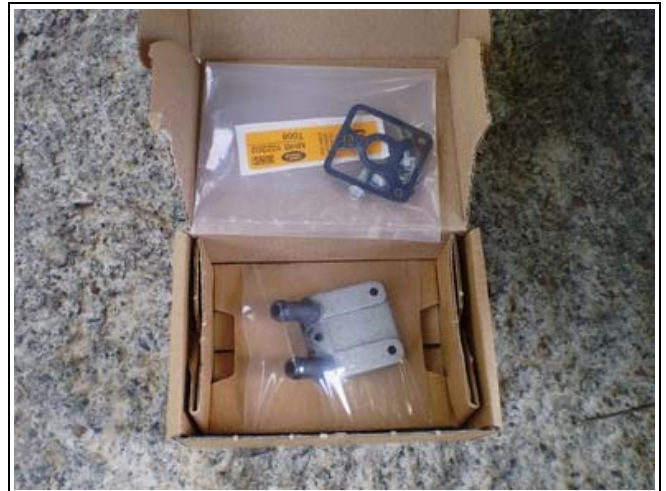
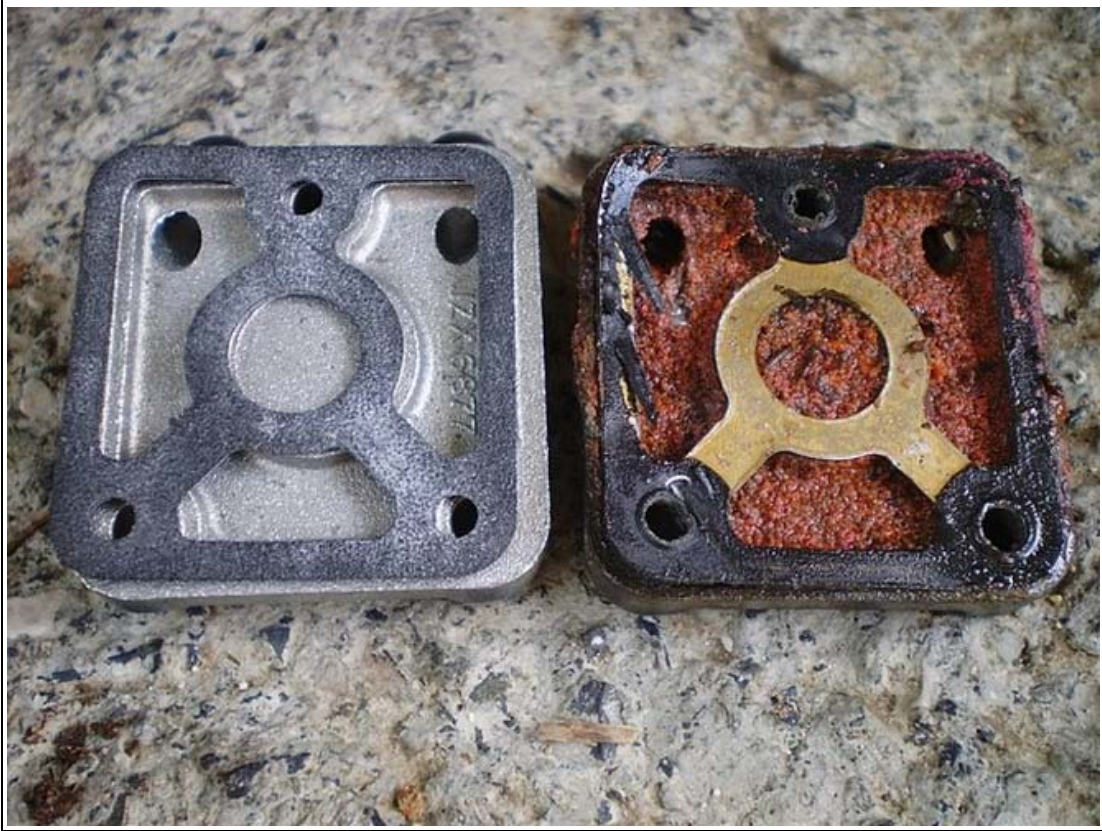
Dexcool isn't COOL

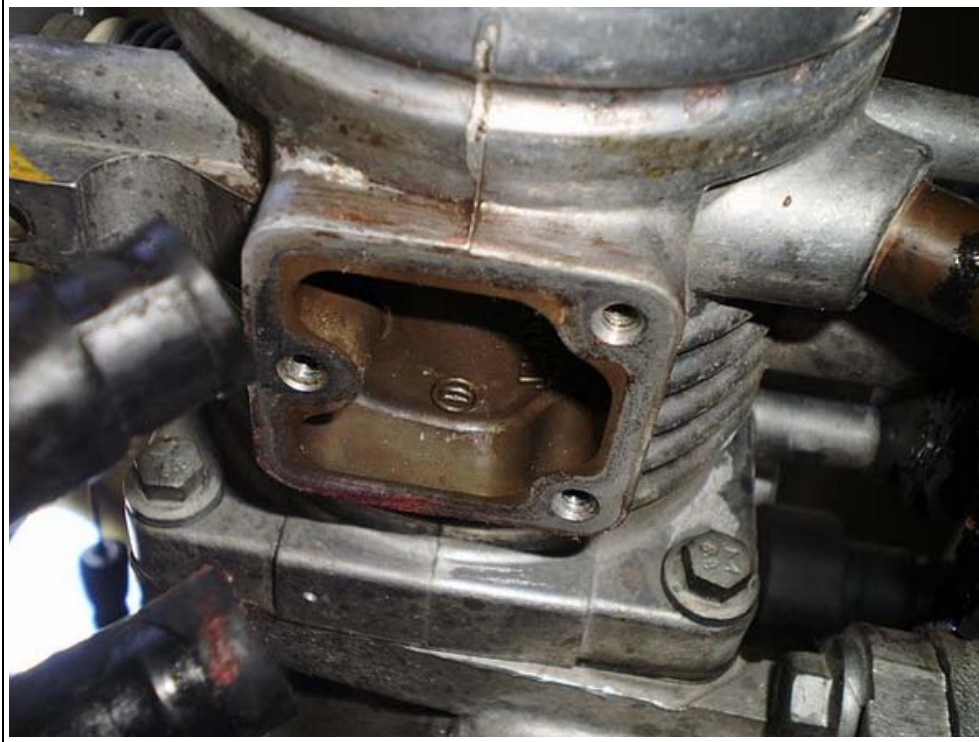
7. Clean bottom of throttle body

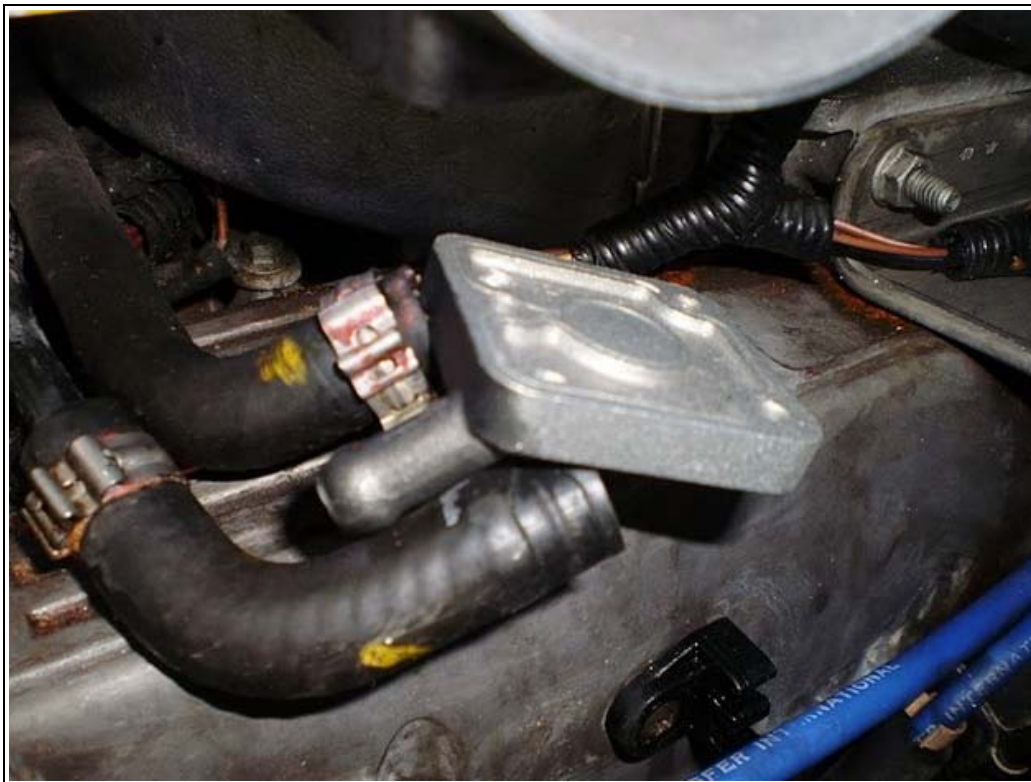
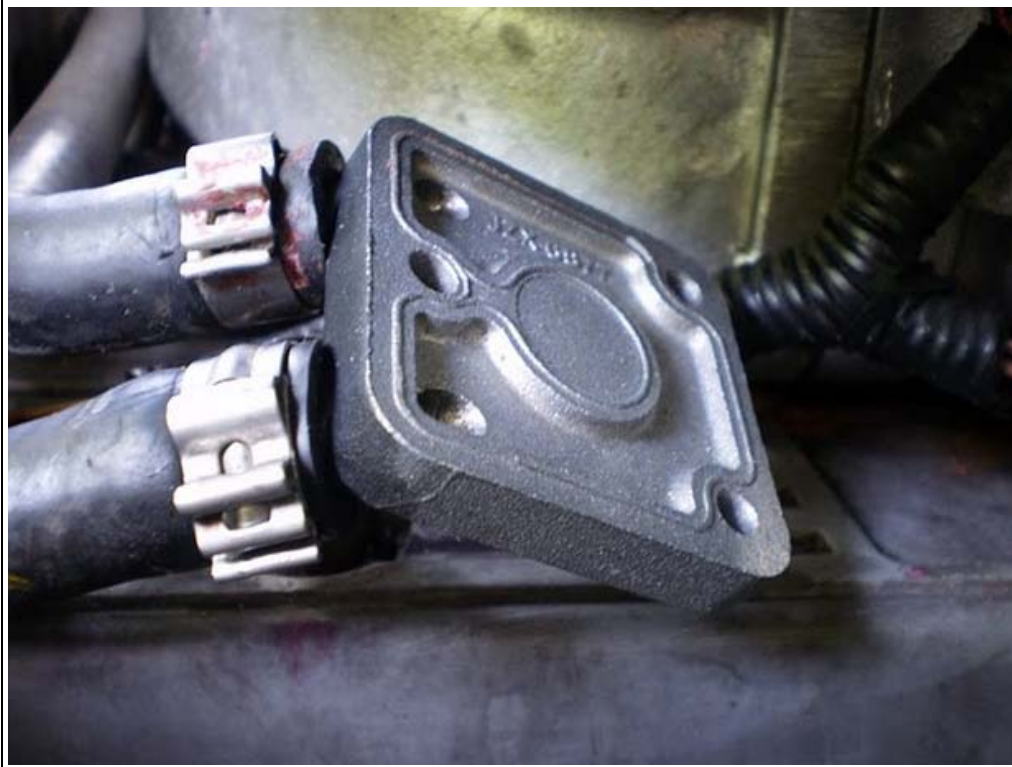
8. Attach new heater plate to coolant hoses

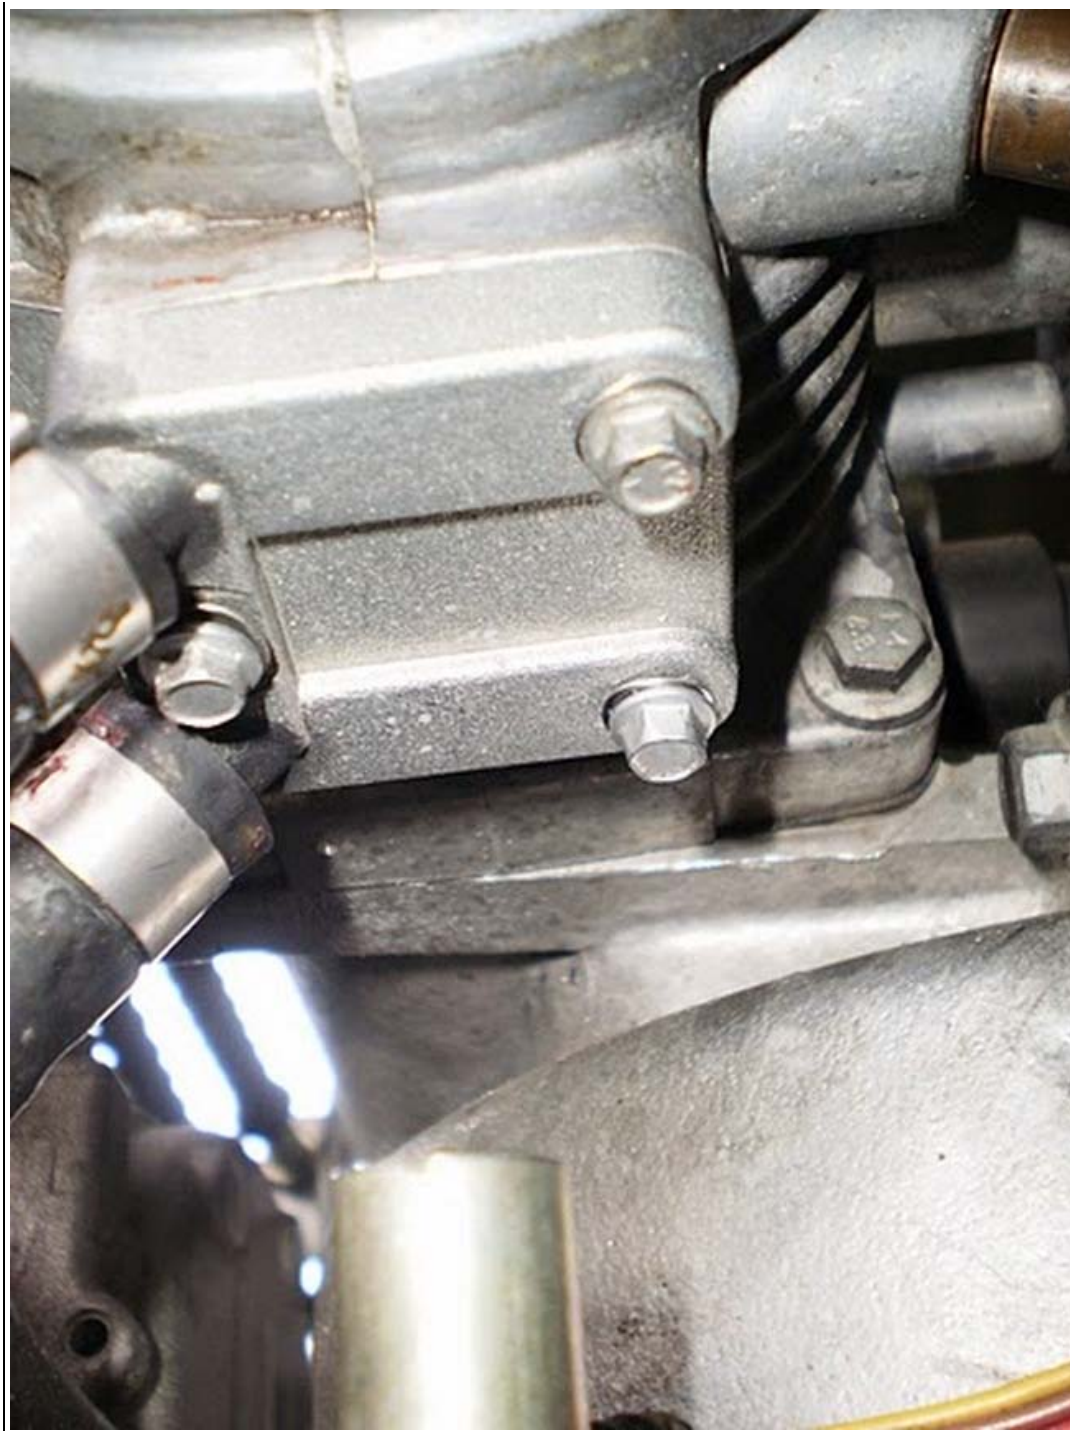
10. Install new heater plate to throttle body securing it with new screws provided with the new part.
