## ABS MODULATOR ELECTRICAL FAULT REPAIR

11/2009

### Introduction:

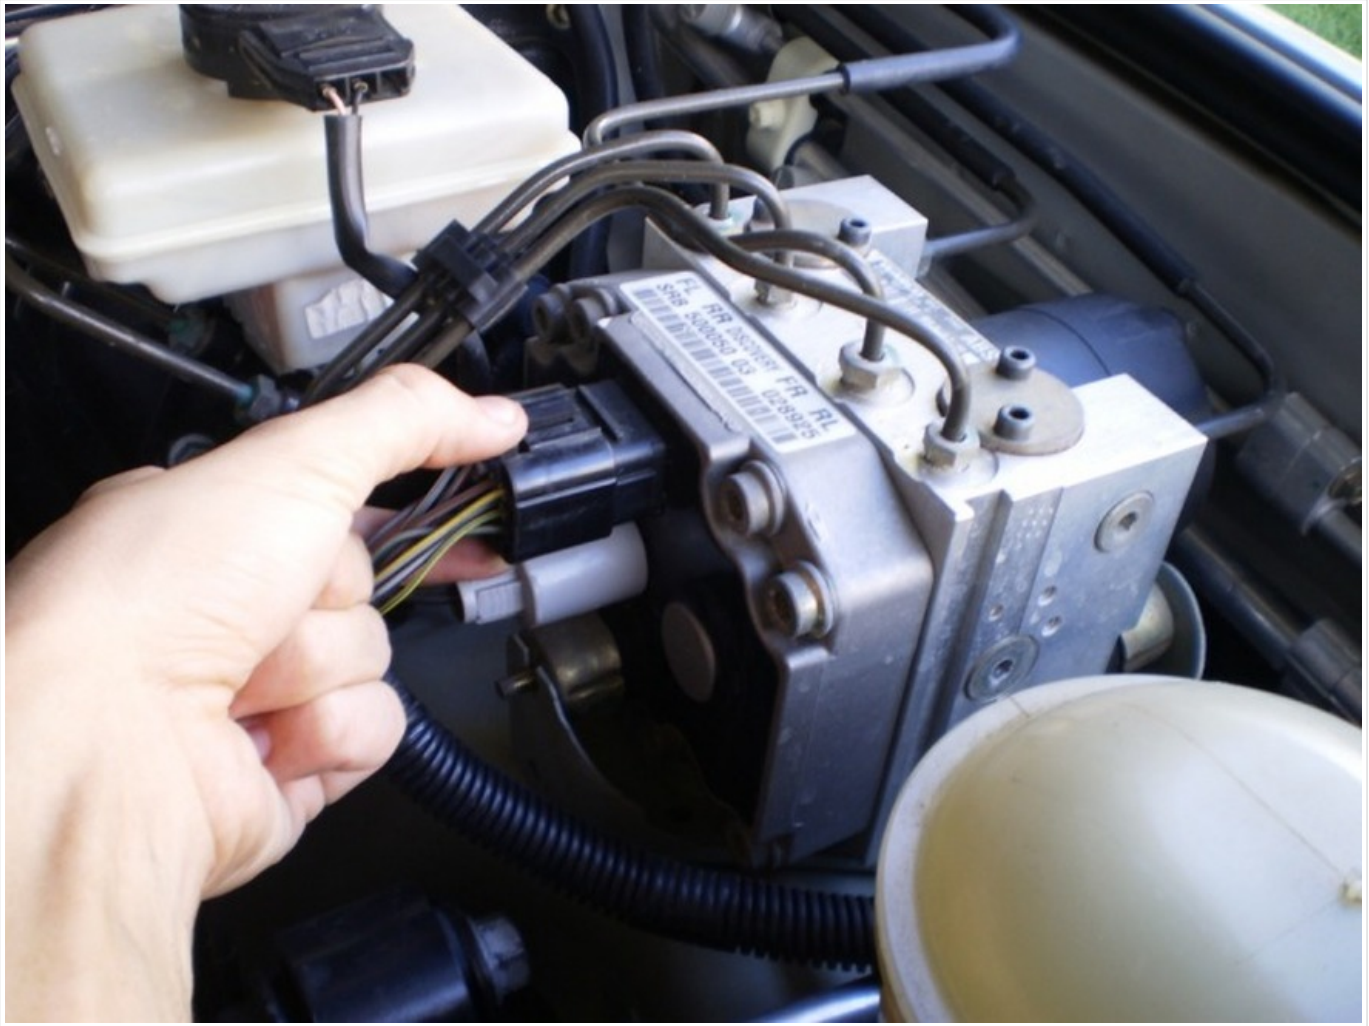
3B. Remove the 3 electrical connectors form the modulator. Two on the front and one on the side.

Removing black connector C0501 and grey connector C0500

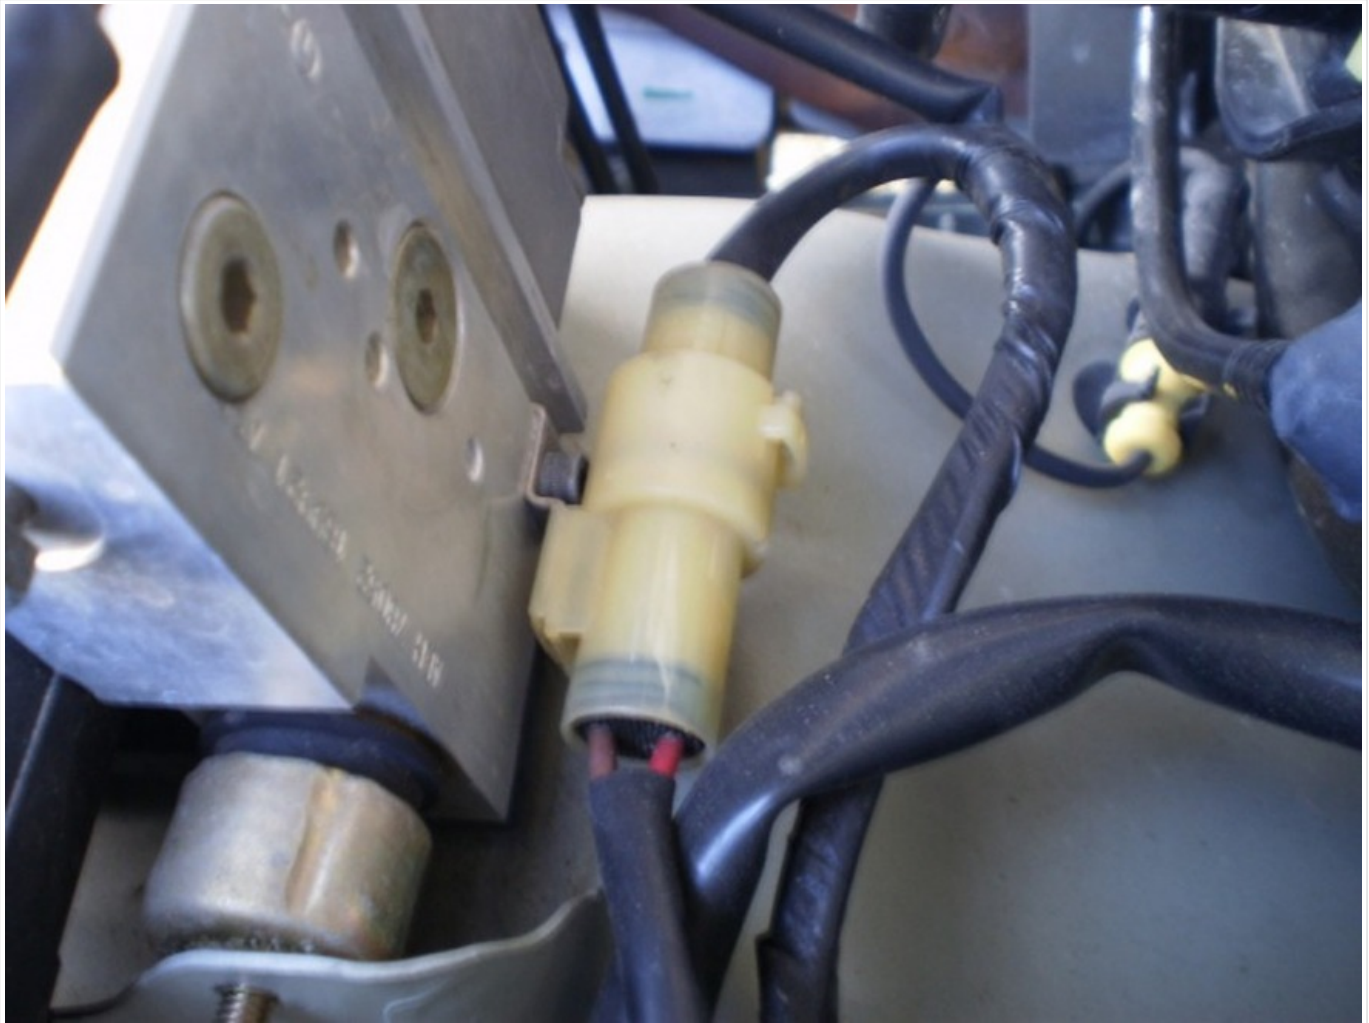
Side connector C0507

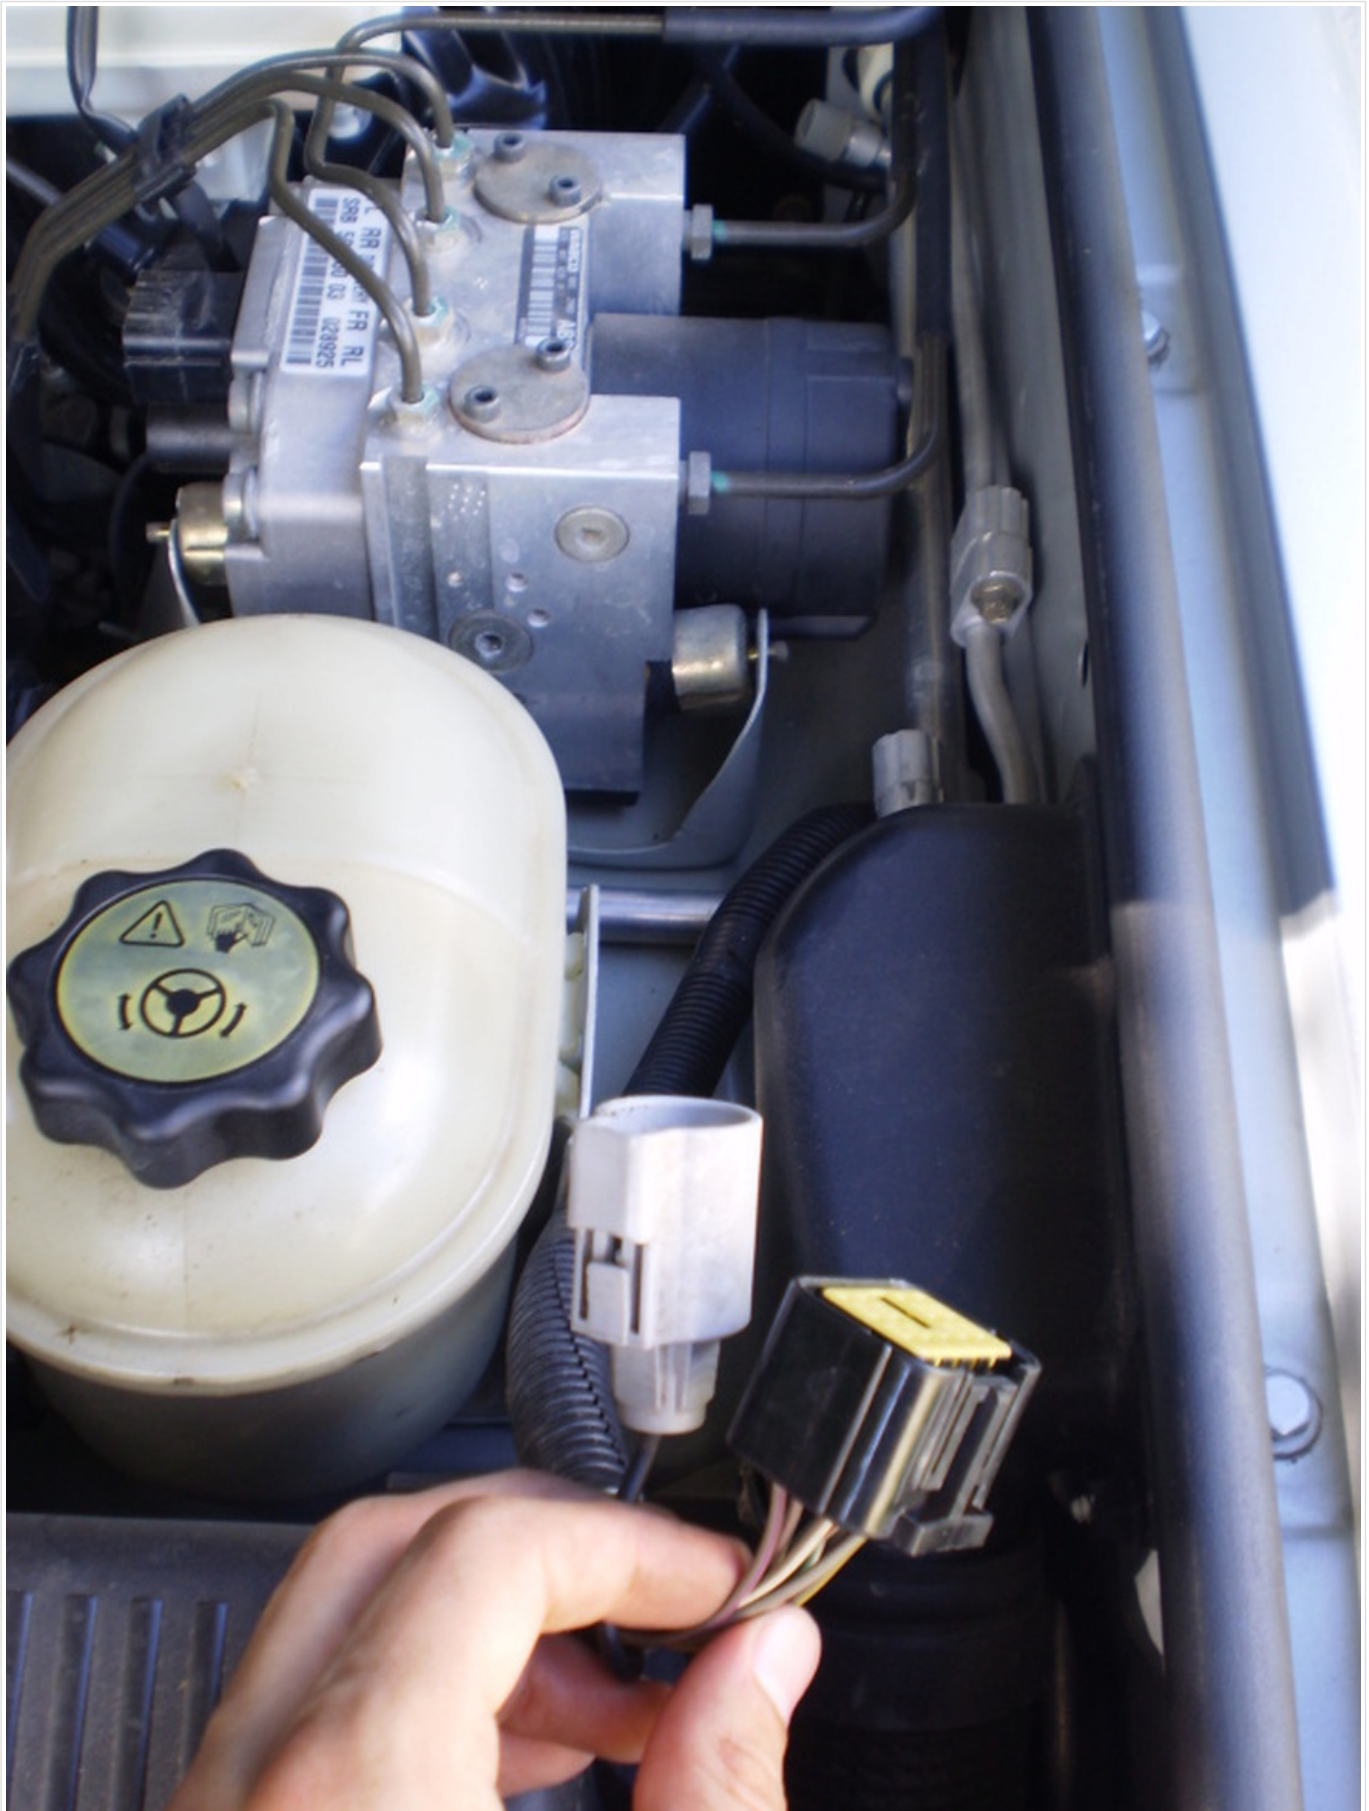
Place harness between intake and steering fluid reservoir

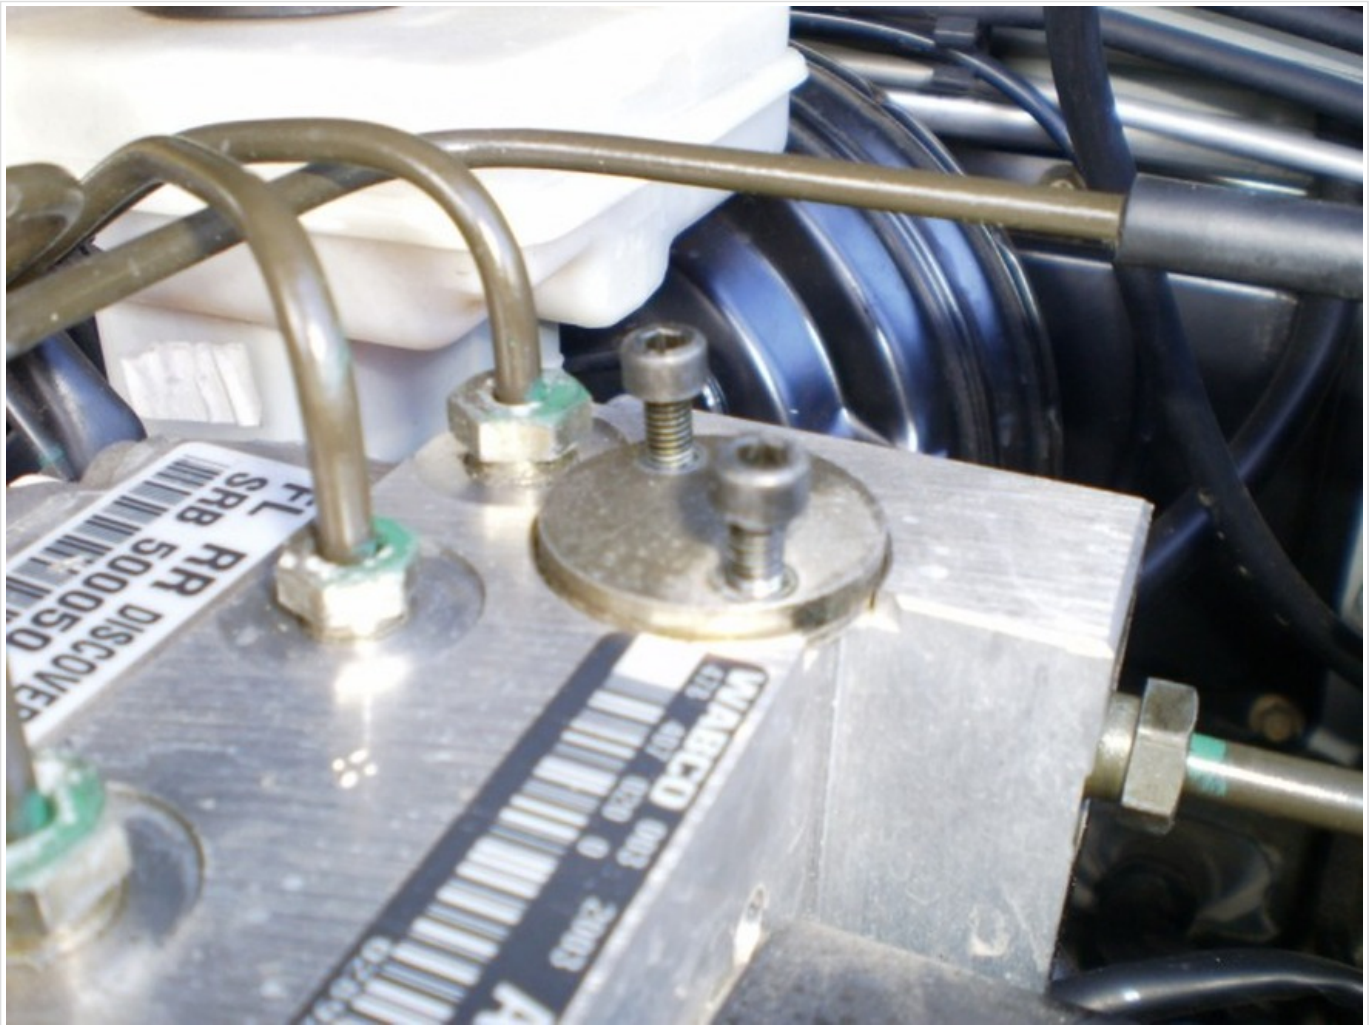
4. Using a 4mm hex bit, remove the two hex screws and cover plate.

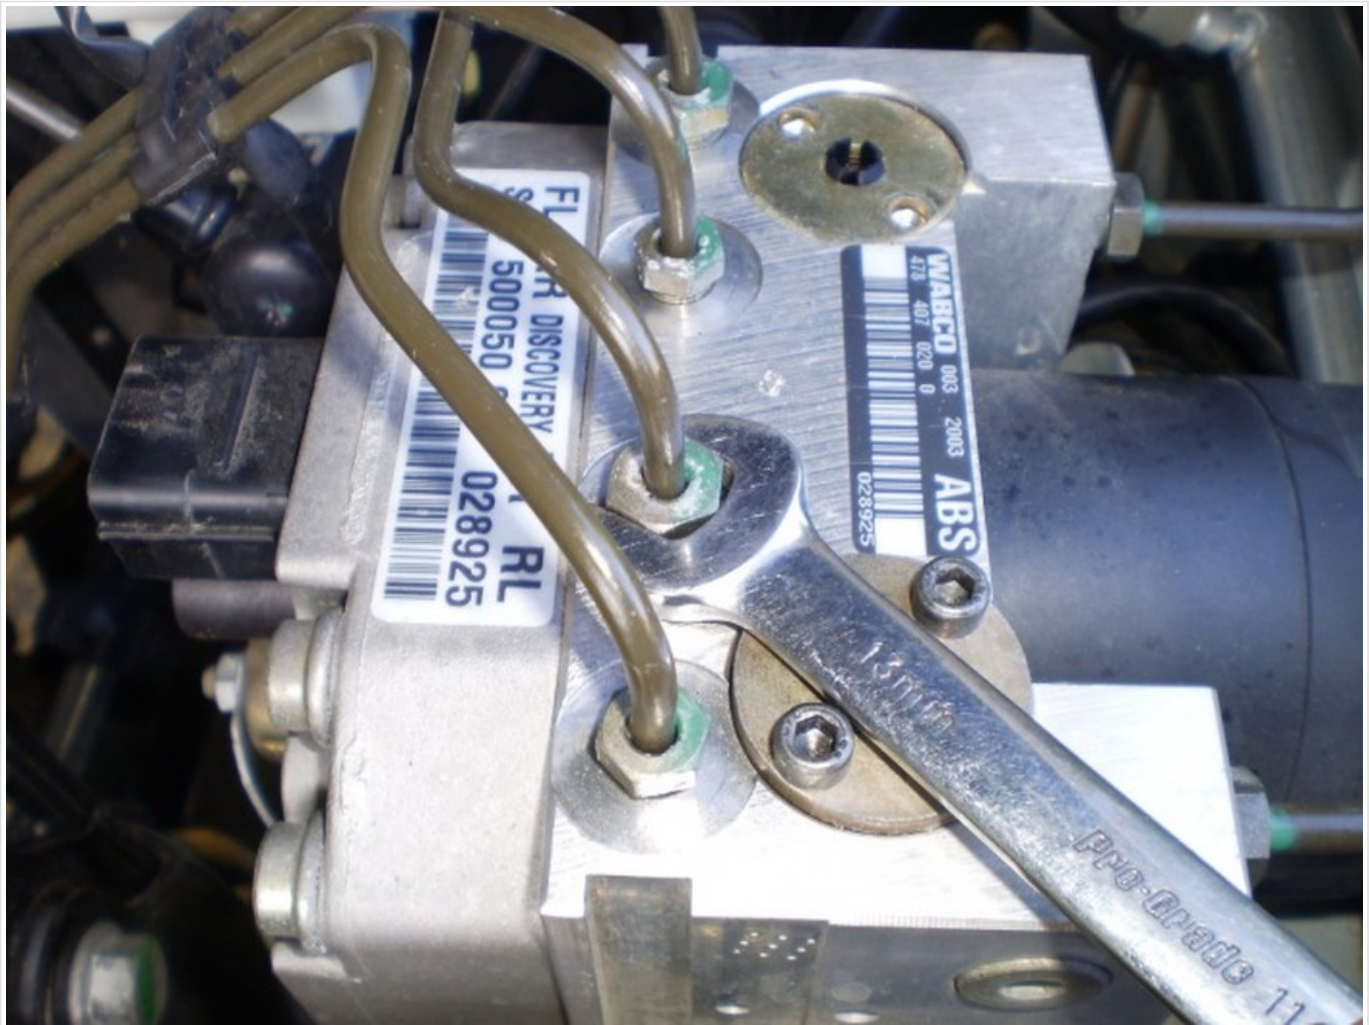
5. Brake loose the two bigger flare nuts using a 13mm wrench.

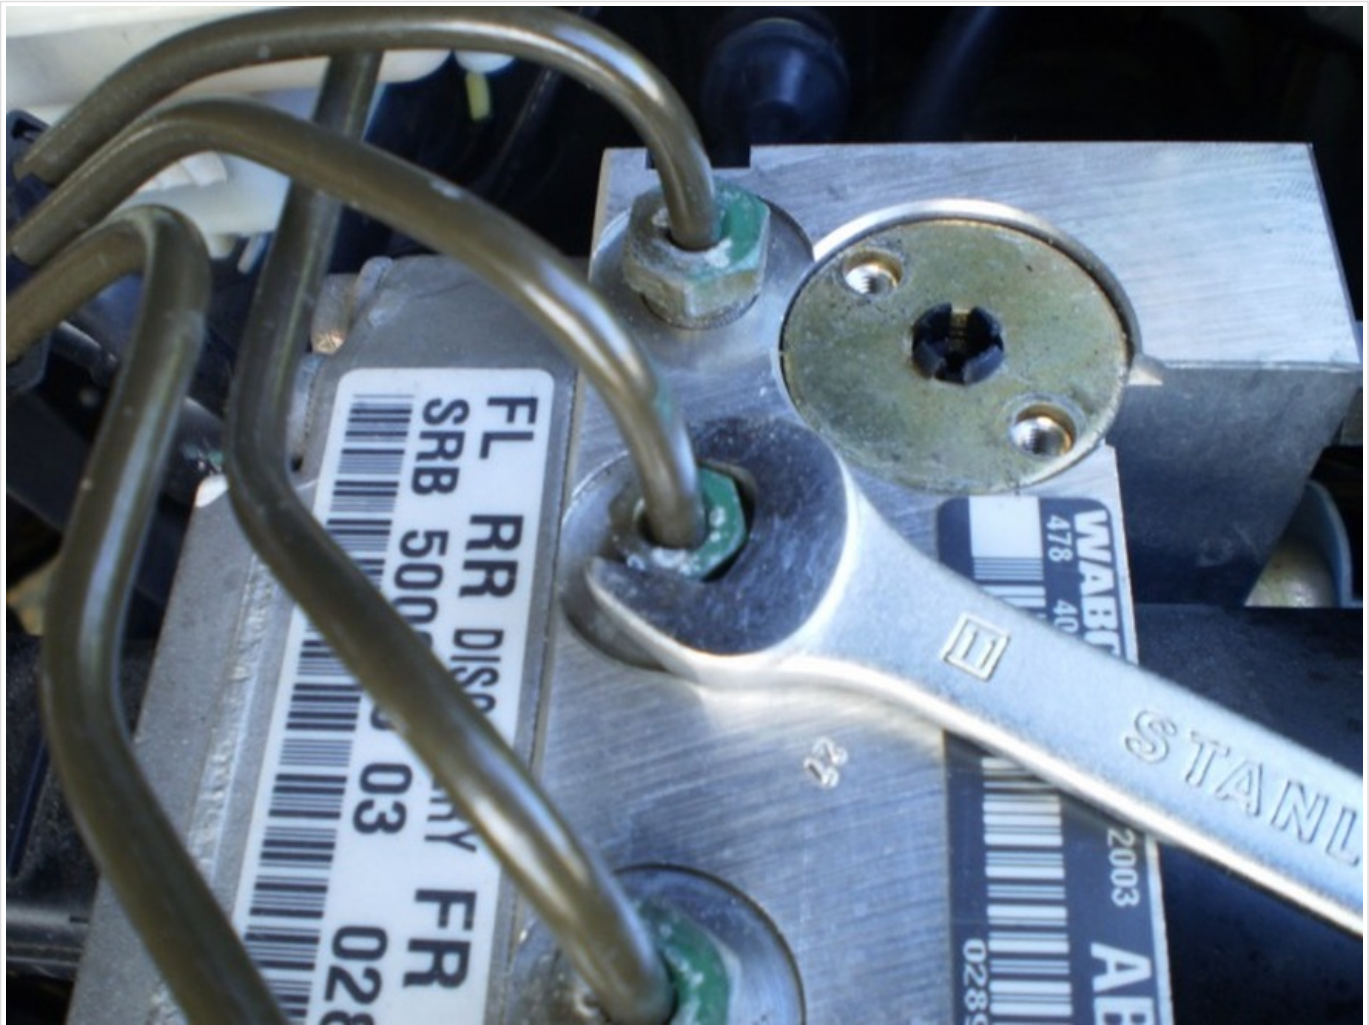
6. Brake loose the two smaller flare nuts using a 11mm wrench.

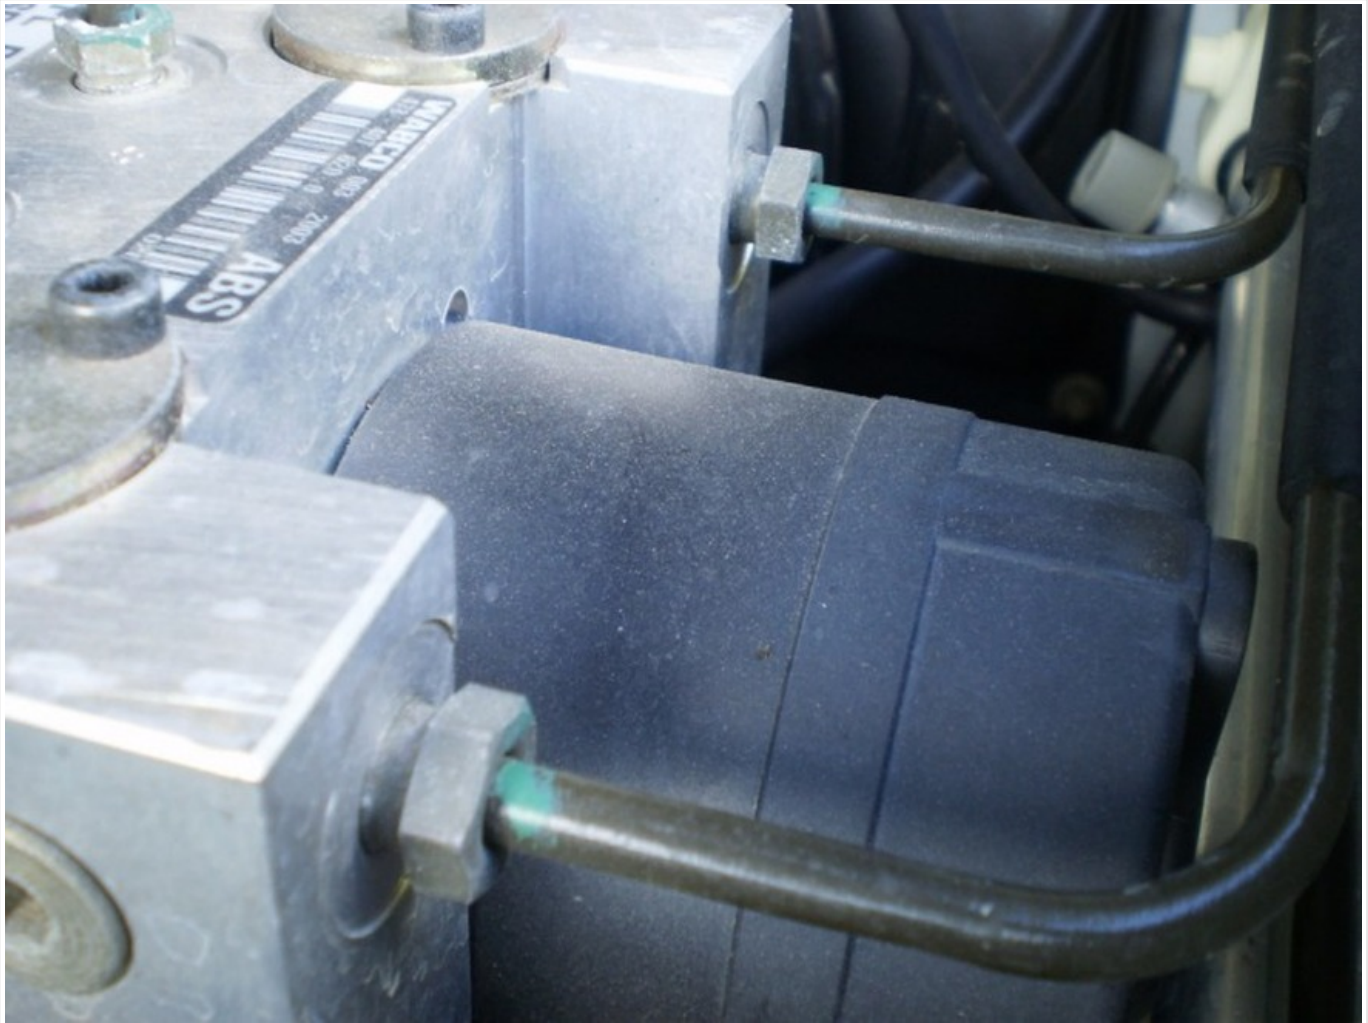
7. Brake loose the two side mounted brake line nuts using a 13mm wrench.

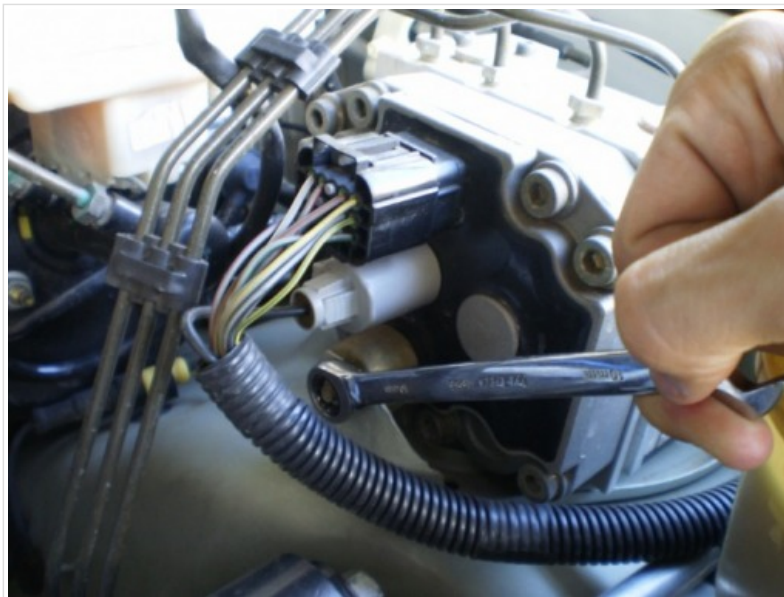
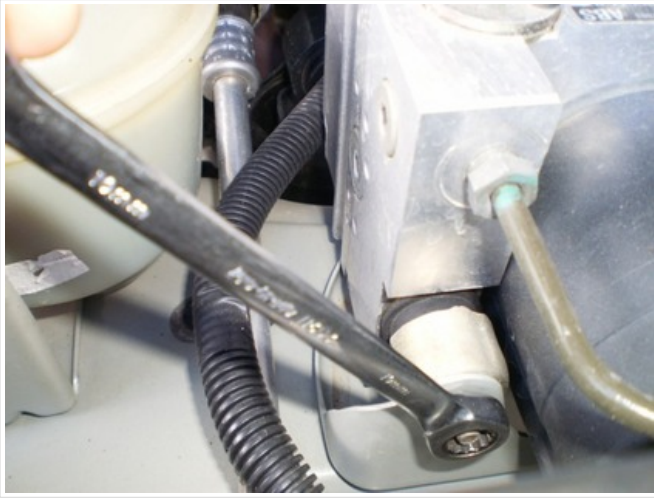
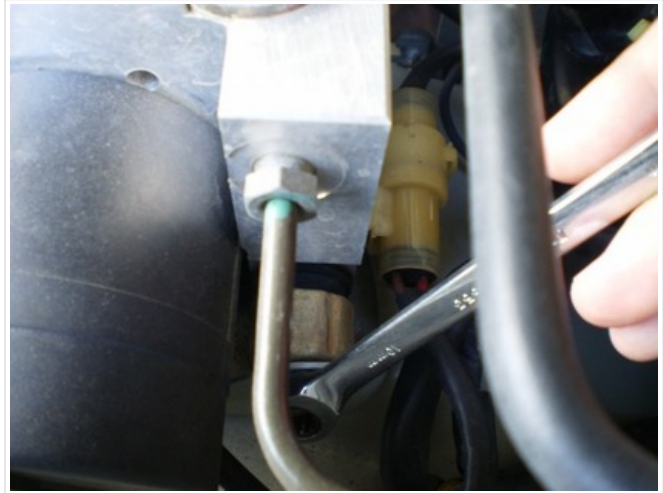
8. Once all 6 brake lines are broken loose, remove the 3 nuts securing the modulator on to its mounting bracket using a 10mm wrench.

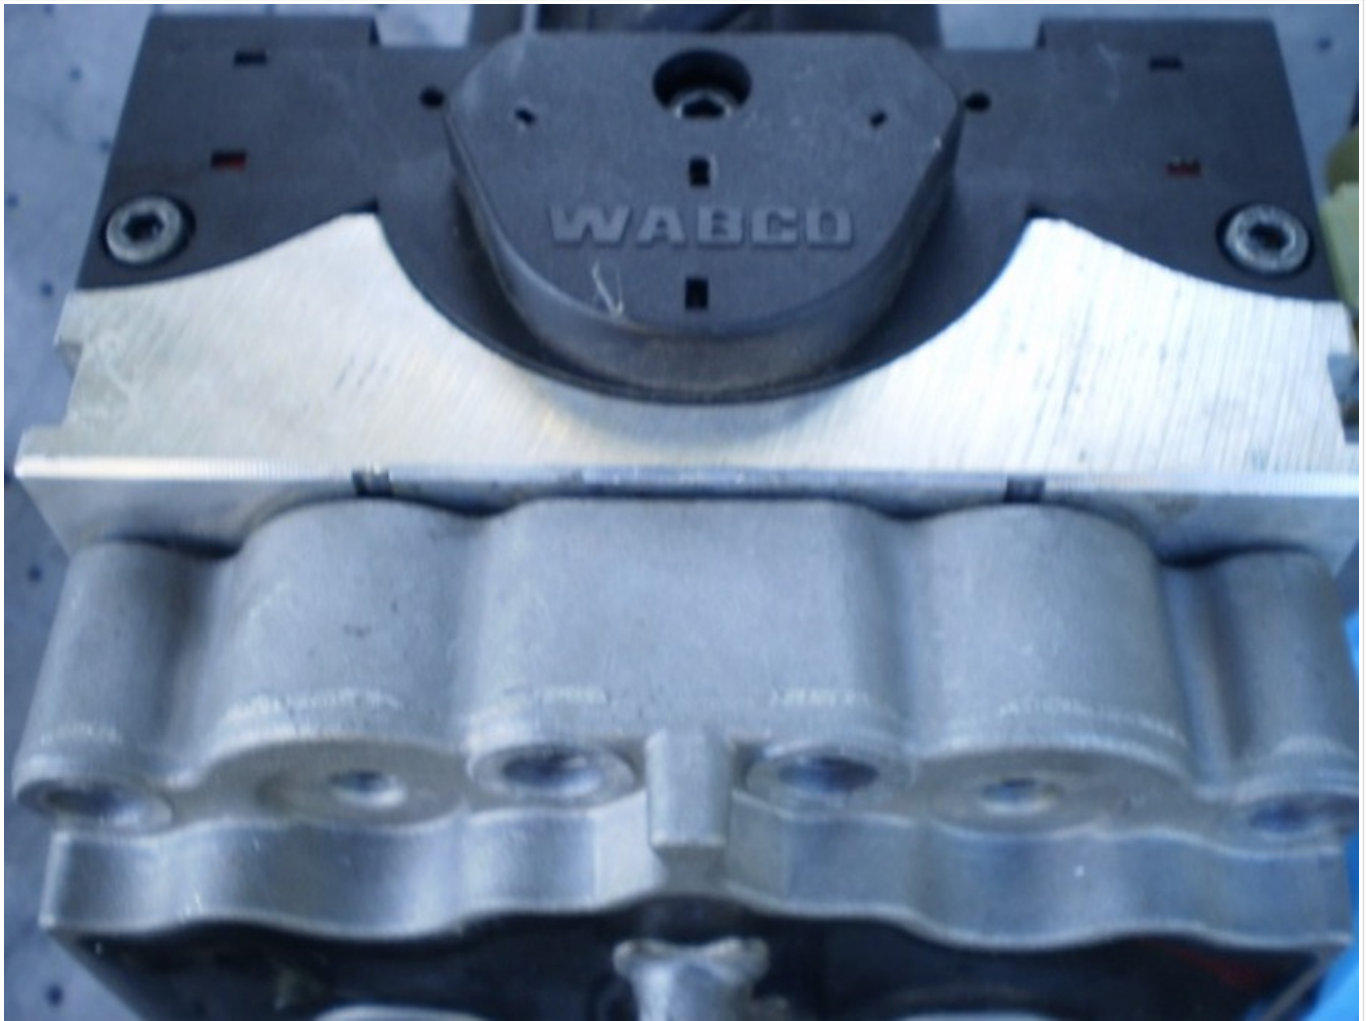
16. Turn the unit upside down. The SVS cover plate reading "WABCO" should now be on top. Using the 4mm hex bit, remove the 3 hex screws. They are installed with blue or red loctite, so let them soak in penetrating fluid to ease removal and prevent stripping.

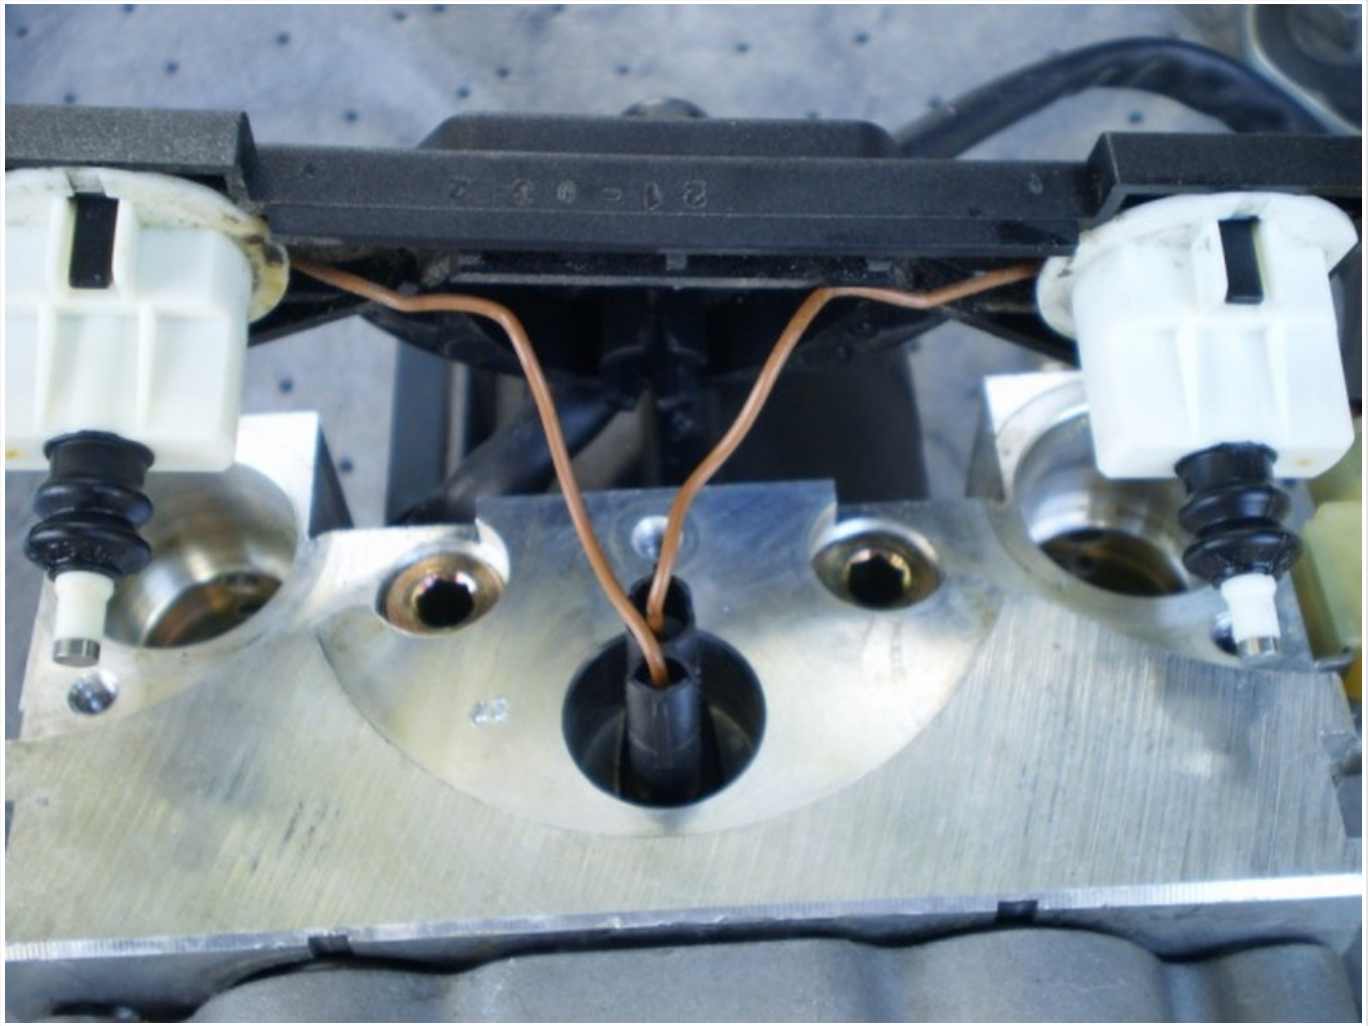
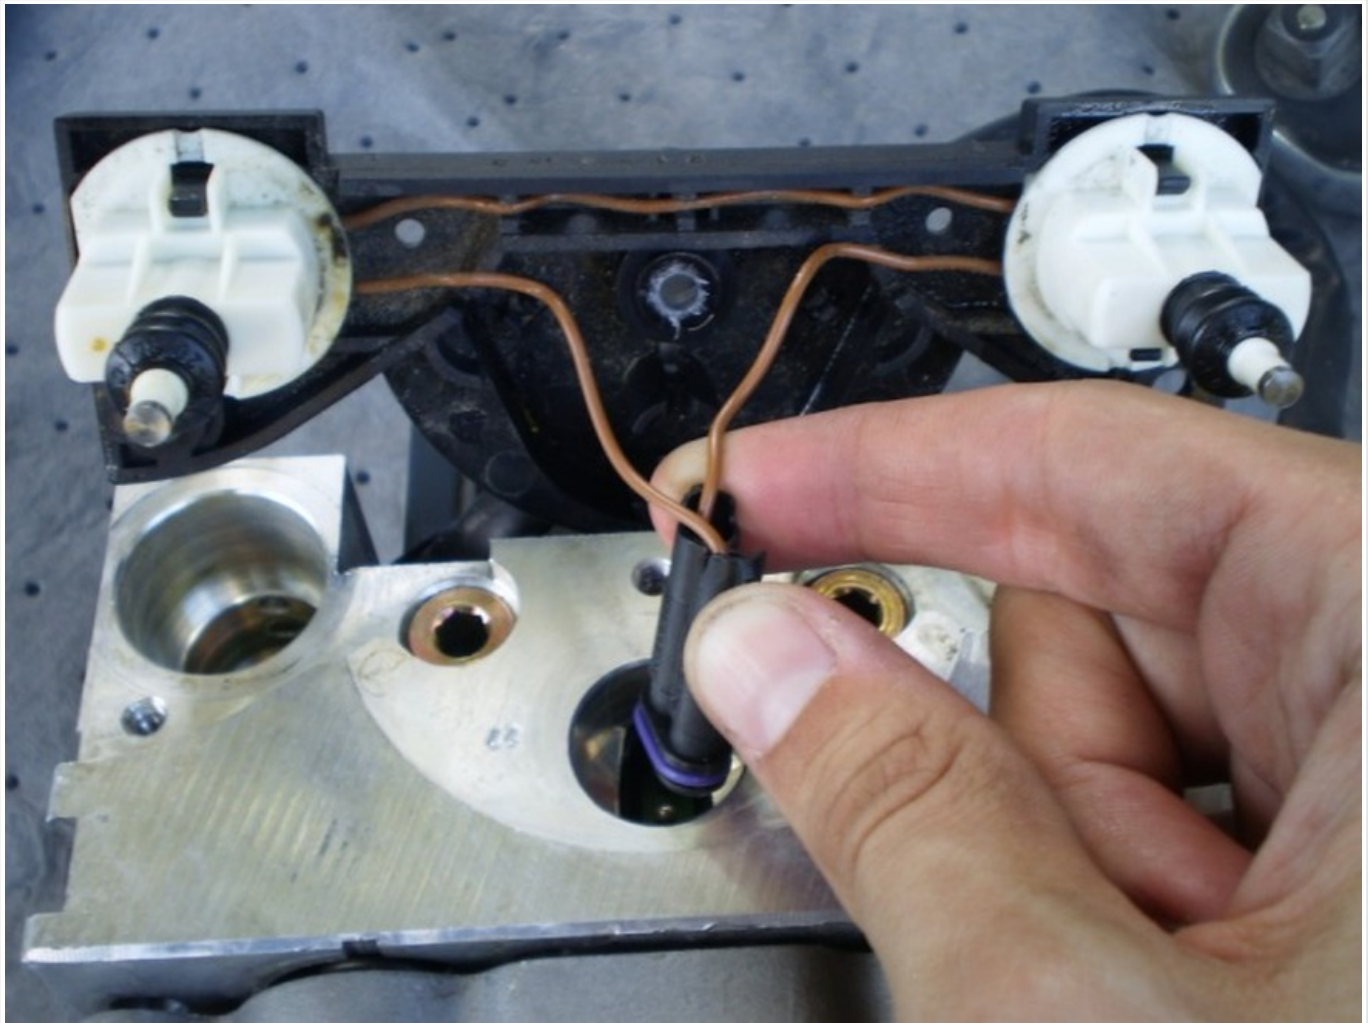
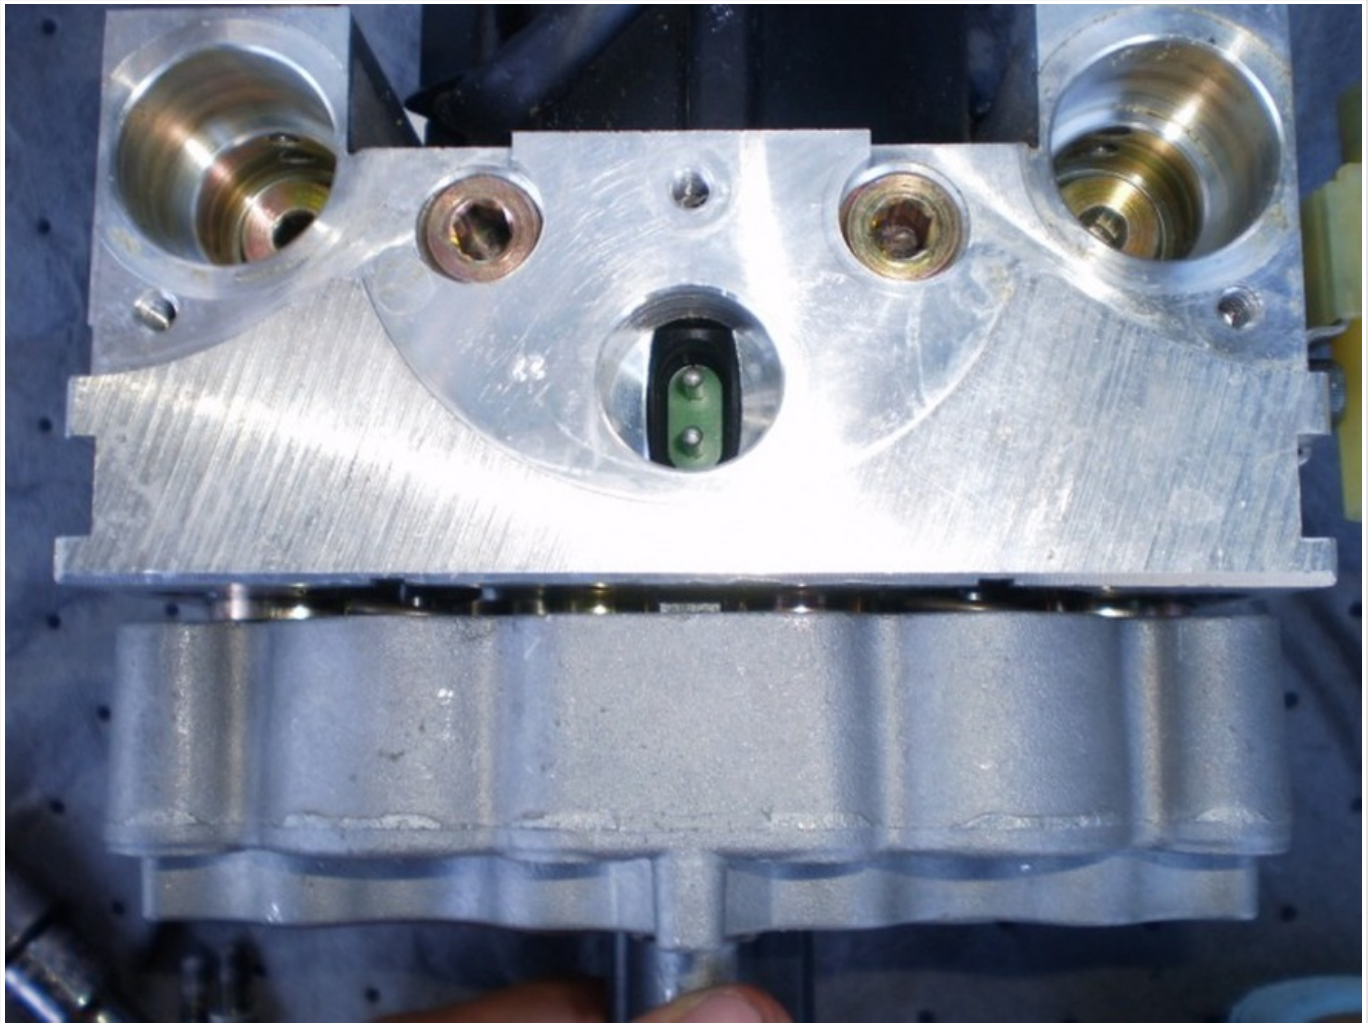
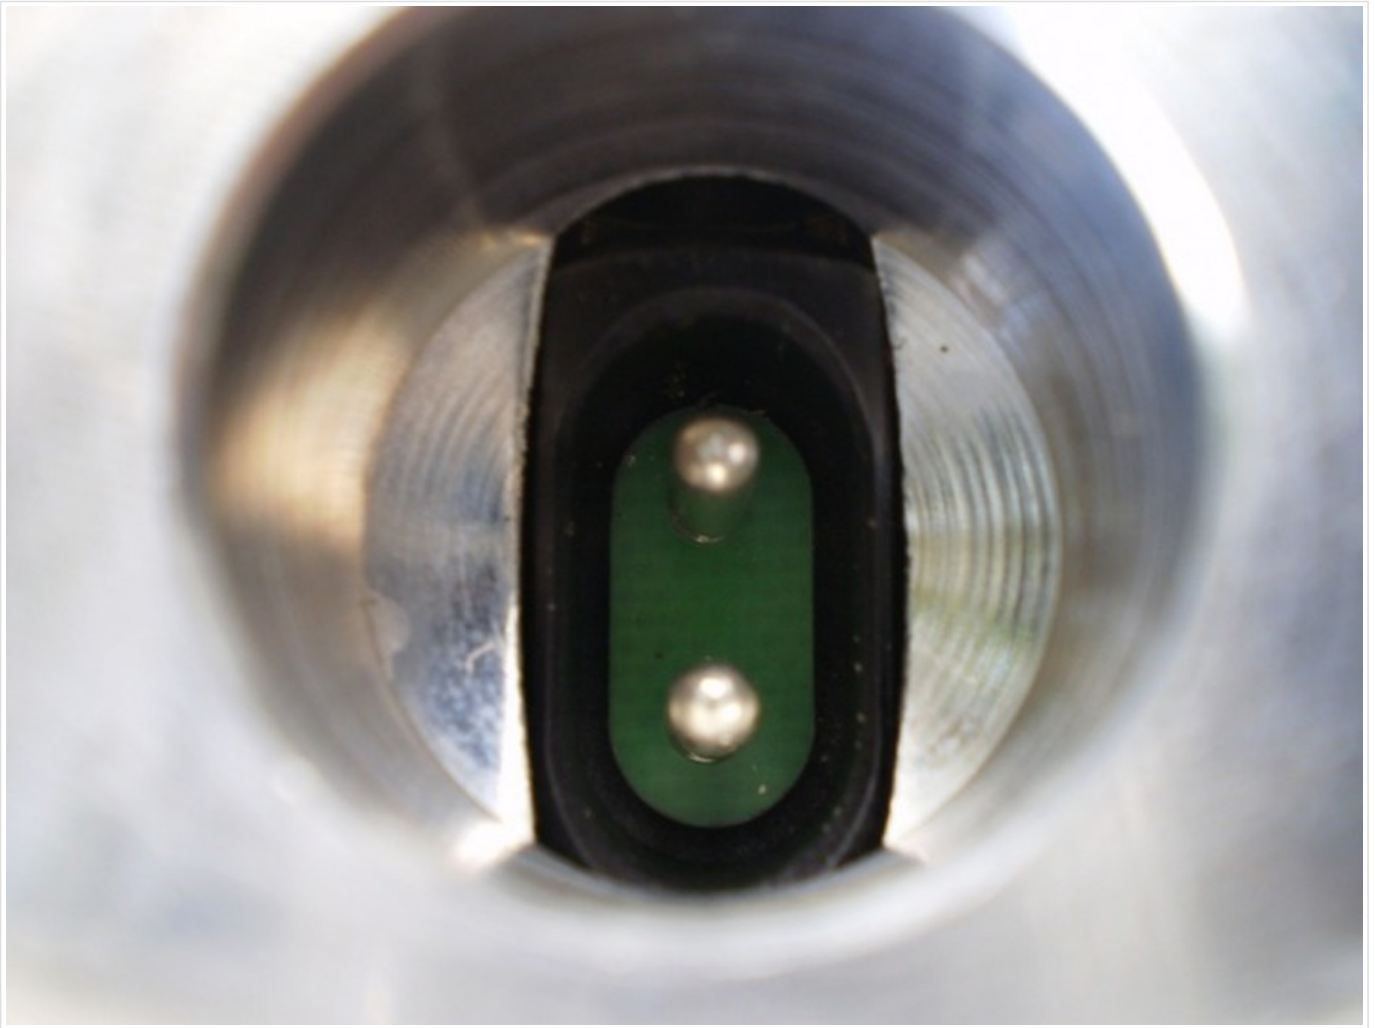
17. Carefully remove the SVS cover plate and disconnect the SVS plug. The plug should dislocate from the cover plate with minimal effort or hold it in place as you pry the cover out. If you find that a pin is lodged in the plug upon removal, and it did not remain in the SVS circuit board then you may have found your intermittent fault.

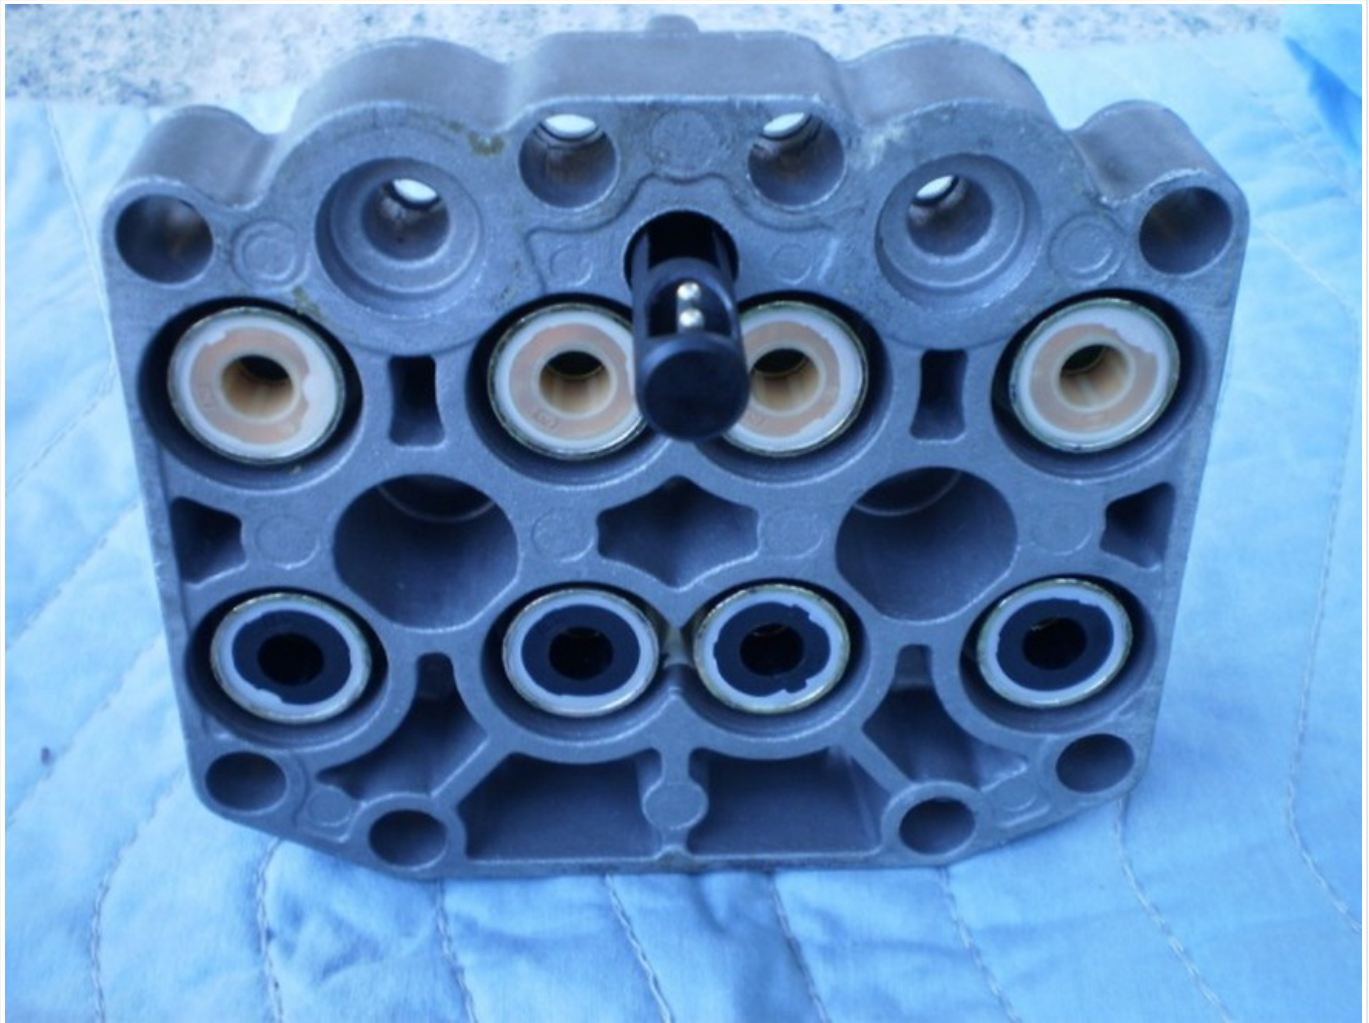
Pump side of the unit. Unit is upside down. Notice the brake line plugs at bottom.

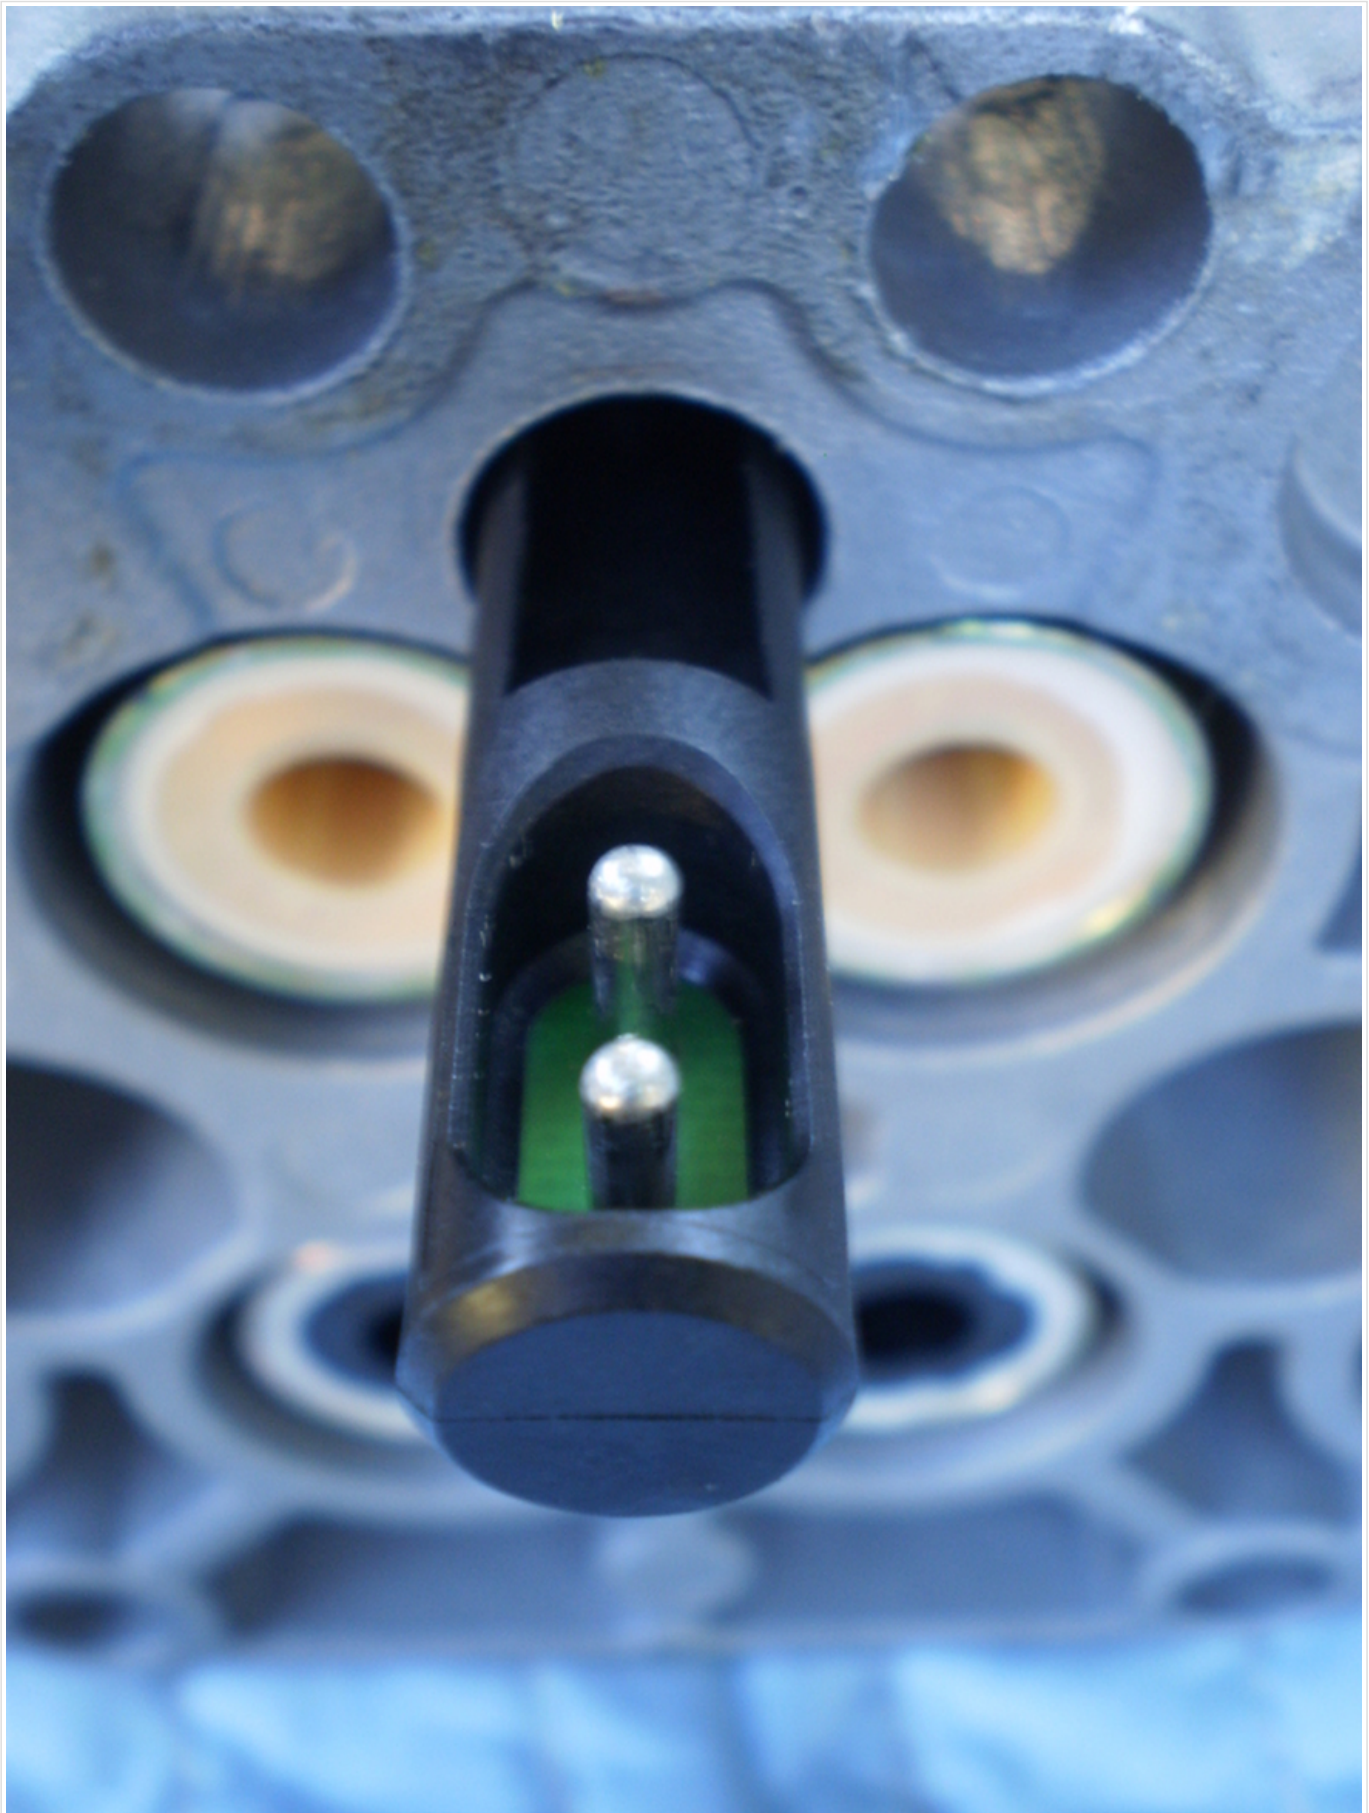
Modulator side of the unit
