## ABS MODULATOR ELECTRICAL FAULT REPAIR

11/2009

### Introduction:

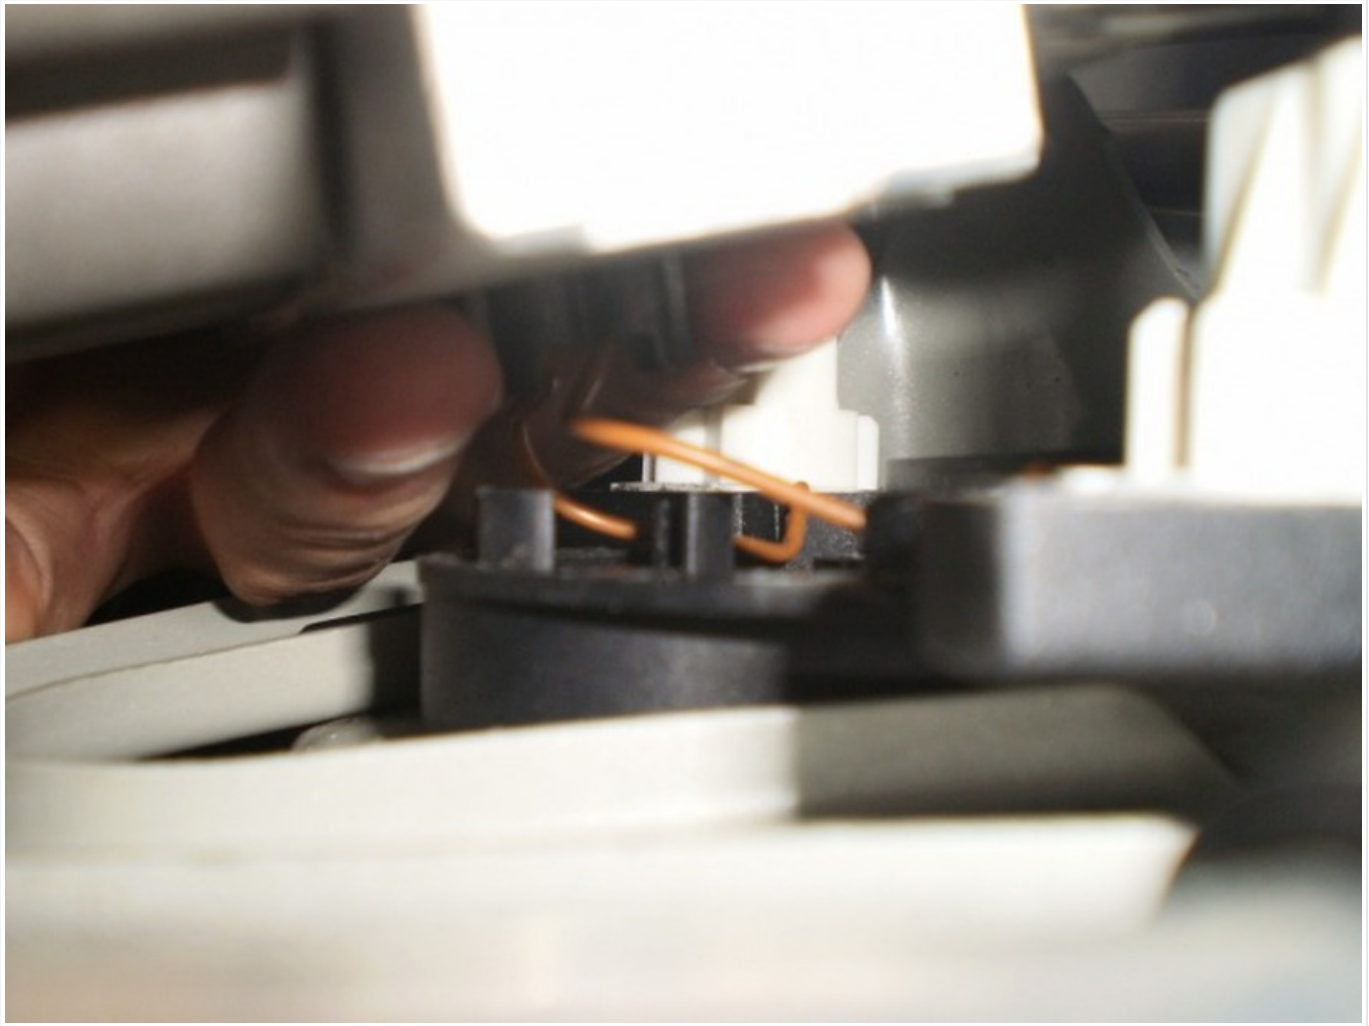
29. You should have enough room to get your fingers underneath and pull the SVS plug down. I needed my assistant to raise the ABS modulator/pump an inch or two so I could use my thumb to unplug it.

You can see the SVS plug between my fingers

*Once unplugged, carefully remove the SVS assembly out from under the unit.*

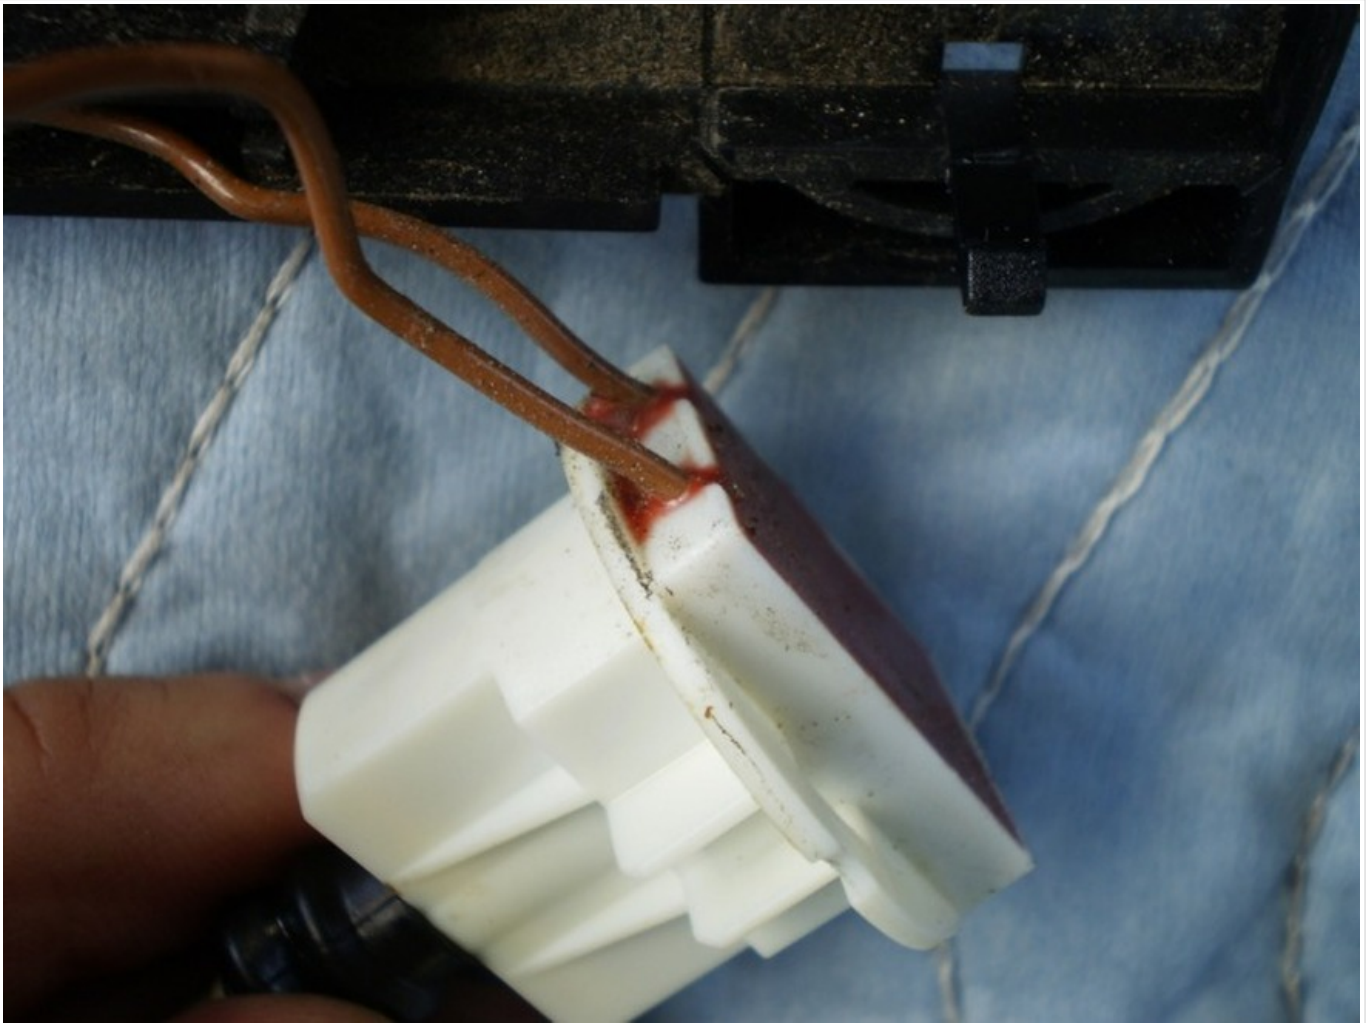
*The rubber boot is what prevents brake fluid from seeping out of the shuttle valves and getting inside fouling the switch. If the shuttle valves are leaking, they may be the cause of your THREE AMIGOS, you can replace the seals with this*

*Shuttle Valve seal KIT from Falconworks in Arizona ([http://www.jewellamberoil.com/sales/index.php?main\\_page=product\\_info&cPath=65\\_67&products\\_id=247](http://www.jewellamberoil.com/sales/index.php?main_page=product_info&cPath=65_67&products_id=247))*

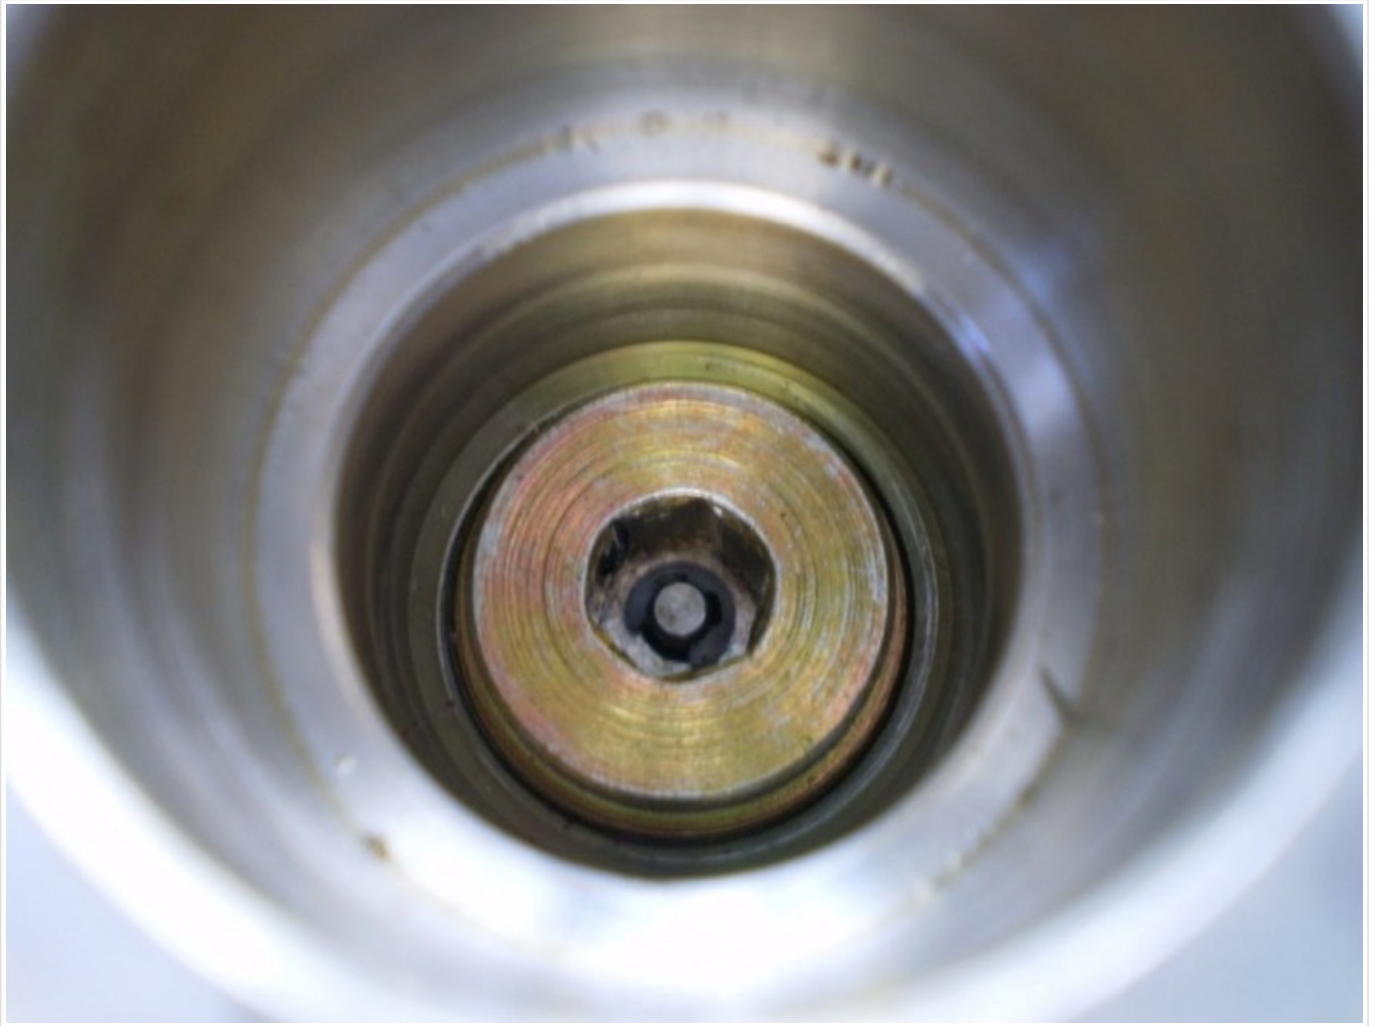
Shuttle Valve. You can see the SMALL circlip that comes in the kit mentioned above.

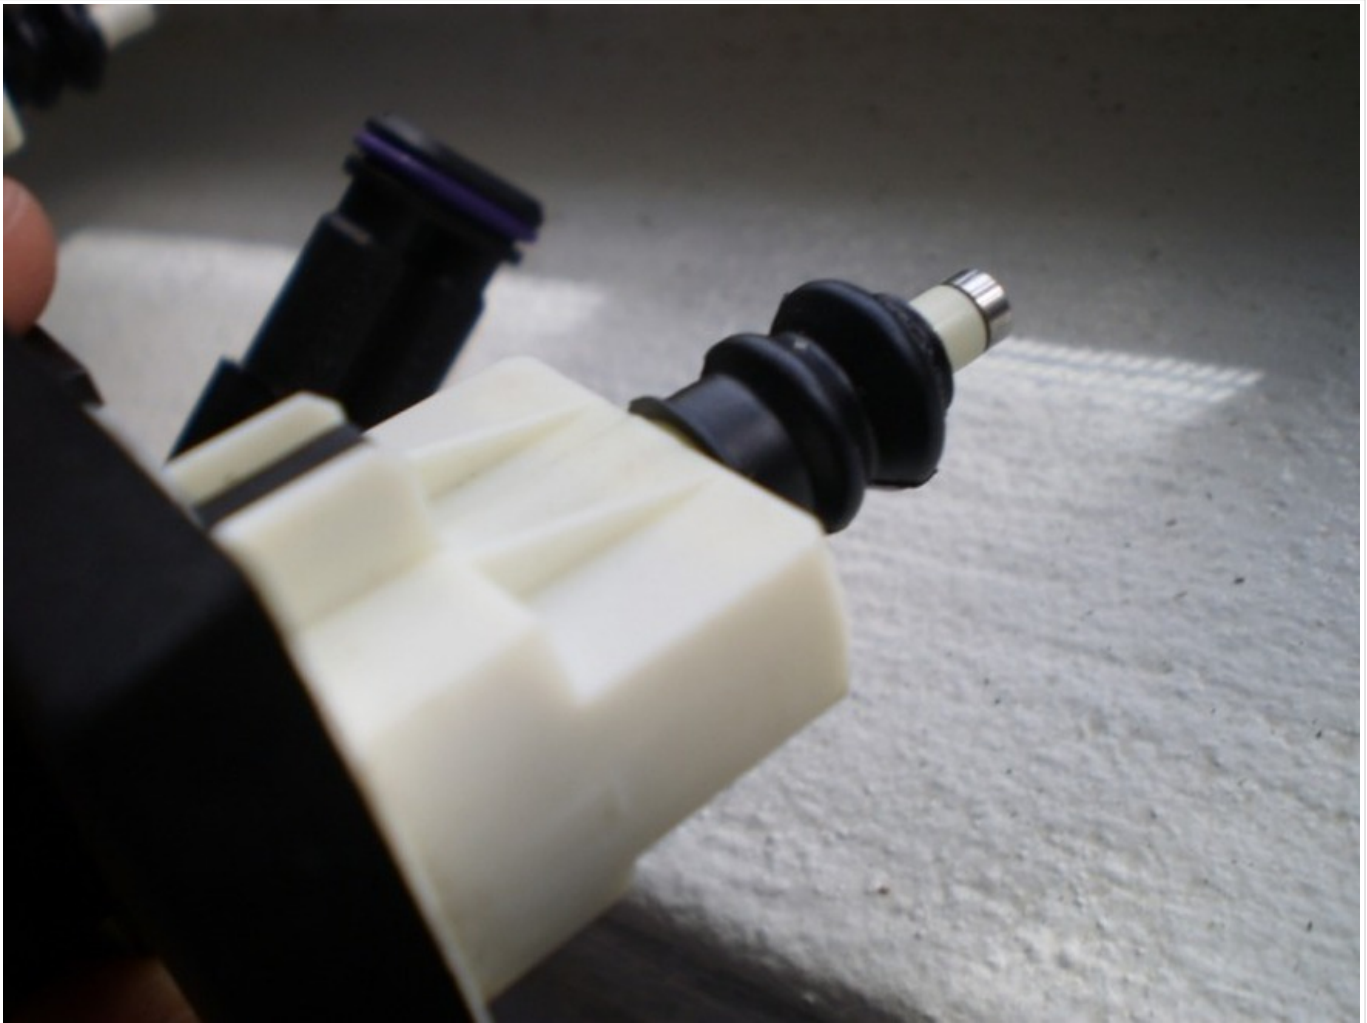
*Upon removing the boot I did find some fluid but not enough to cause any problems since they tested withing normal range.*

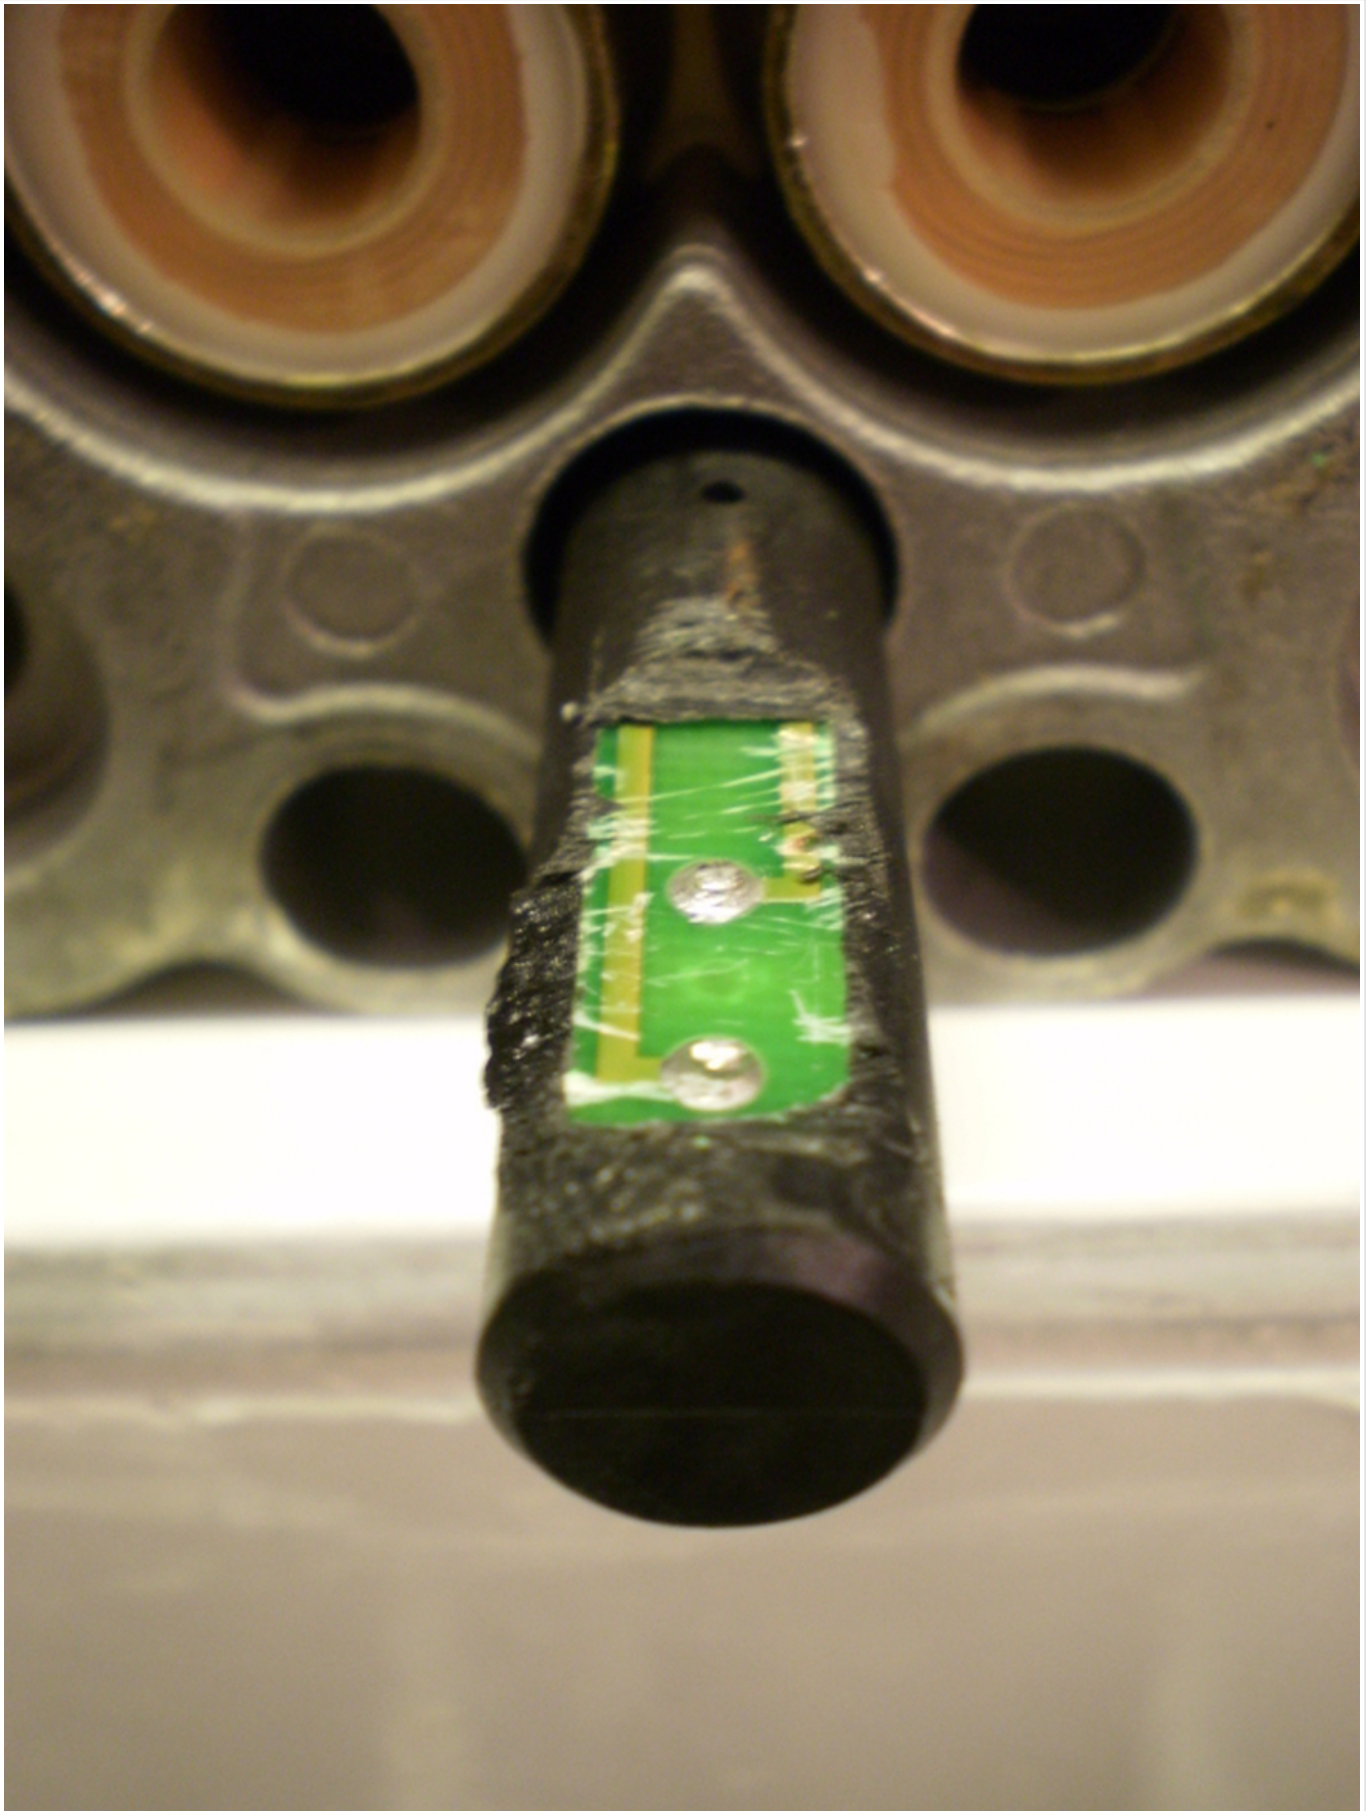
*My surgery worked SO well that I cut too deep into the circuit board lines which made this whole repair worthless. FAIL....*

*The new challenge I had was that I completely destroyed the circuit board and even straight wiring it (Option C) would not work.*

Since I severed the connections on the SVS circuit board, I created a permanent open scenario resulting in a permanent SVS Electrical Fault. The fix? Option B.

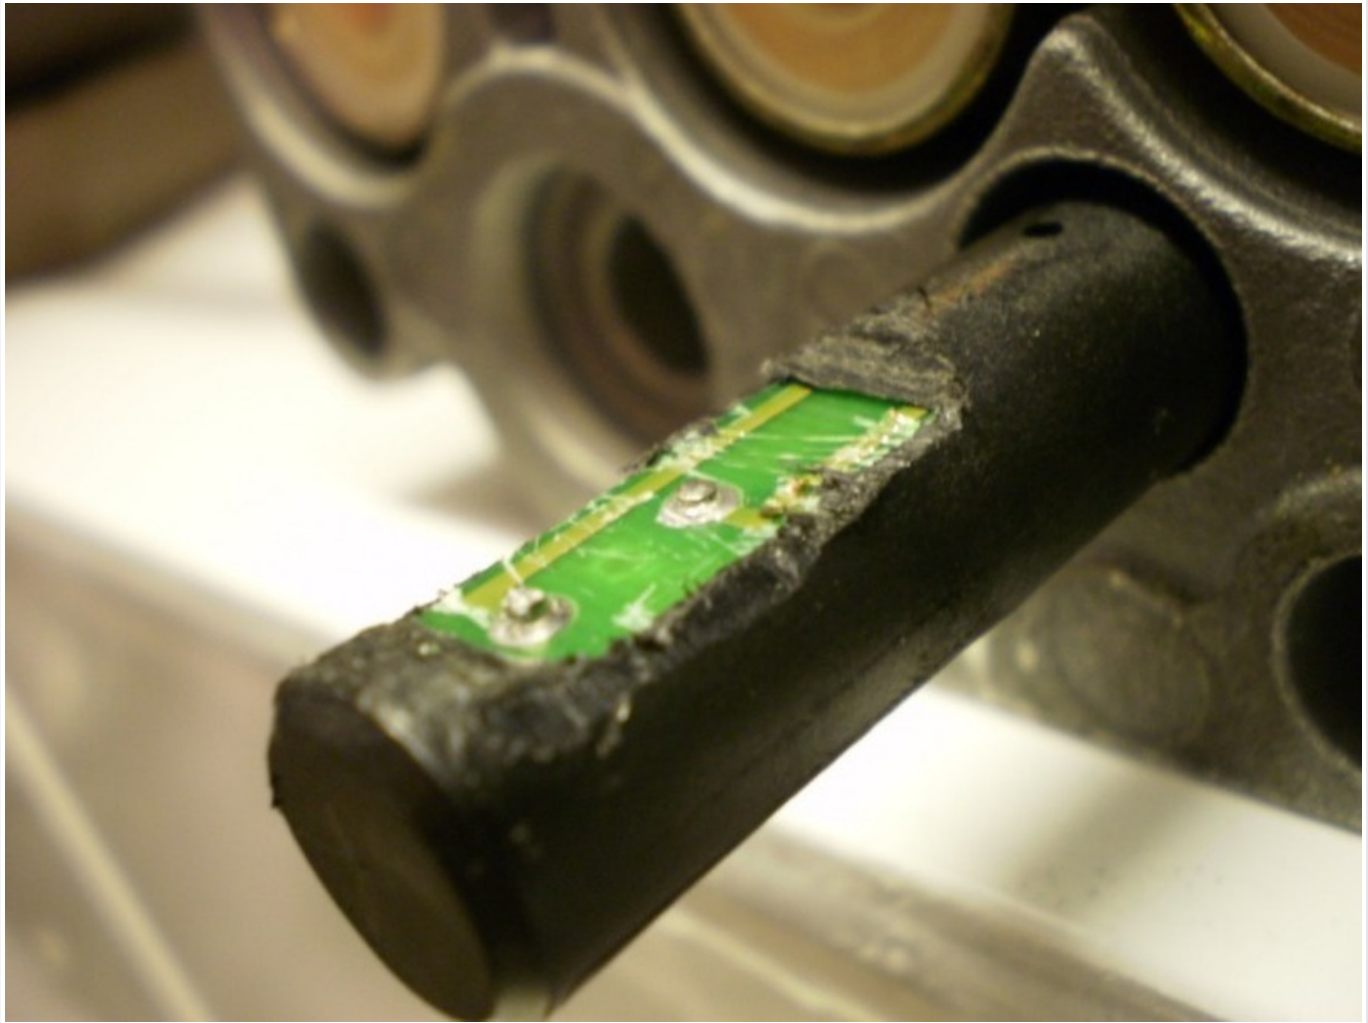
Re-doing the SVS ohm test after surgery is a good idea to make sure you didn't cut anything..... and of course I failed the test..

If you accidentally cut too much... go to Option B (# 37) If not, read on.

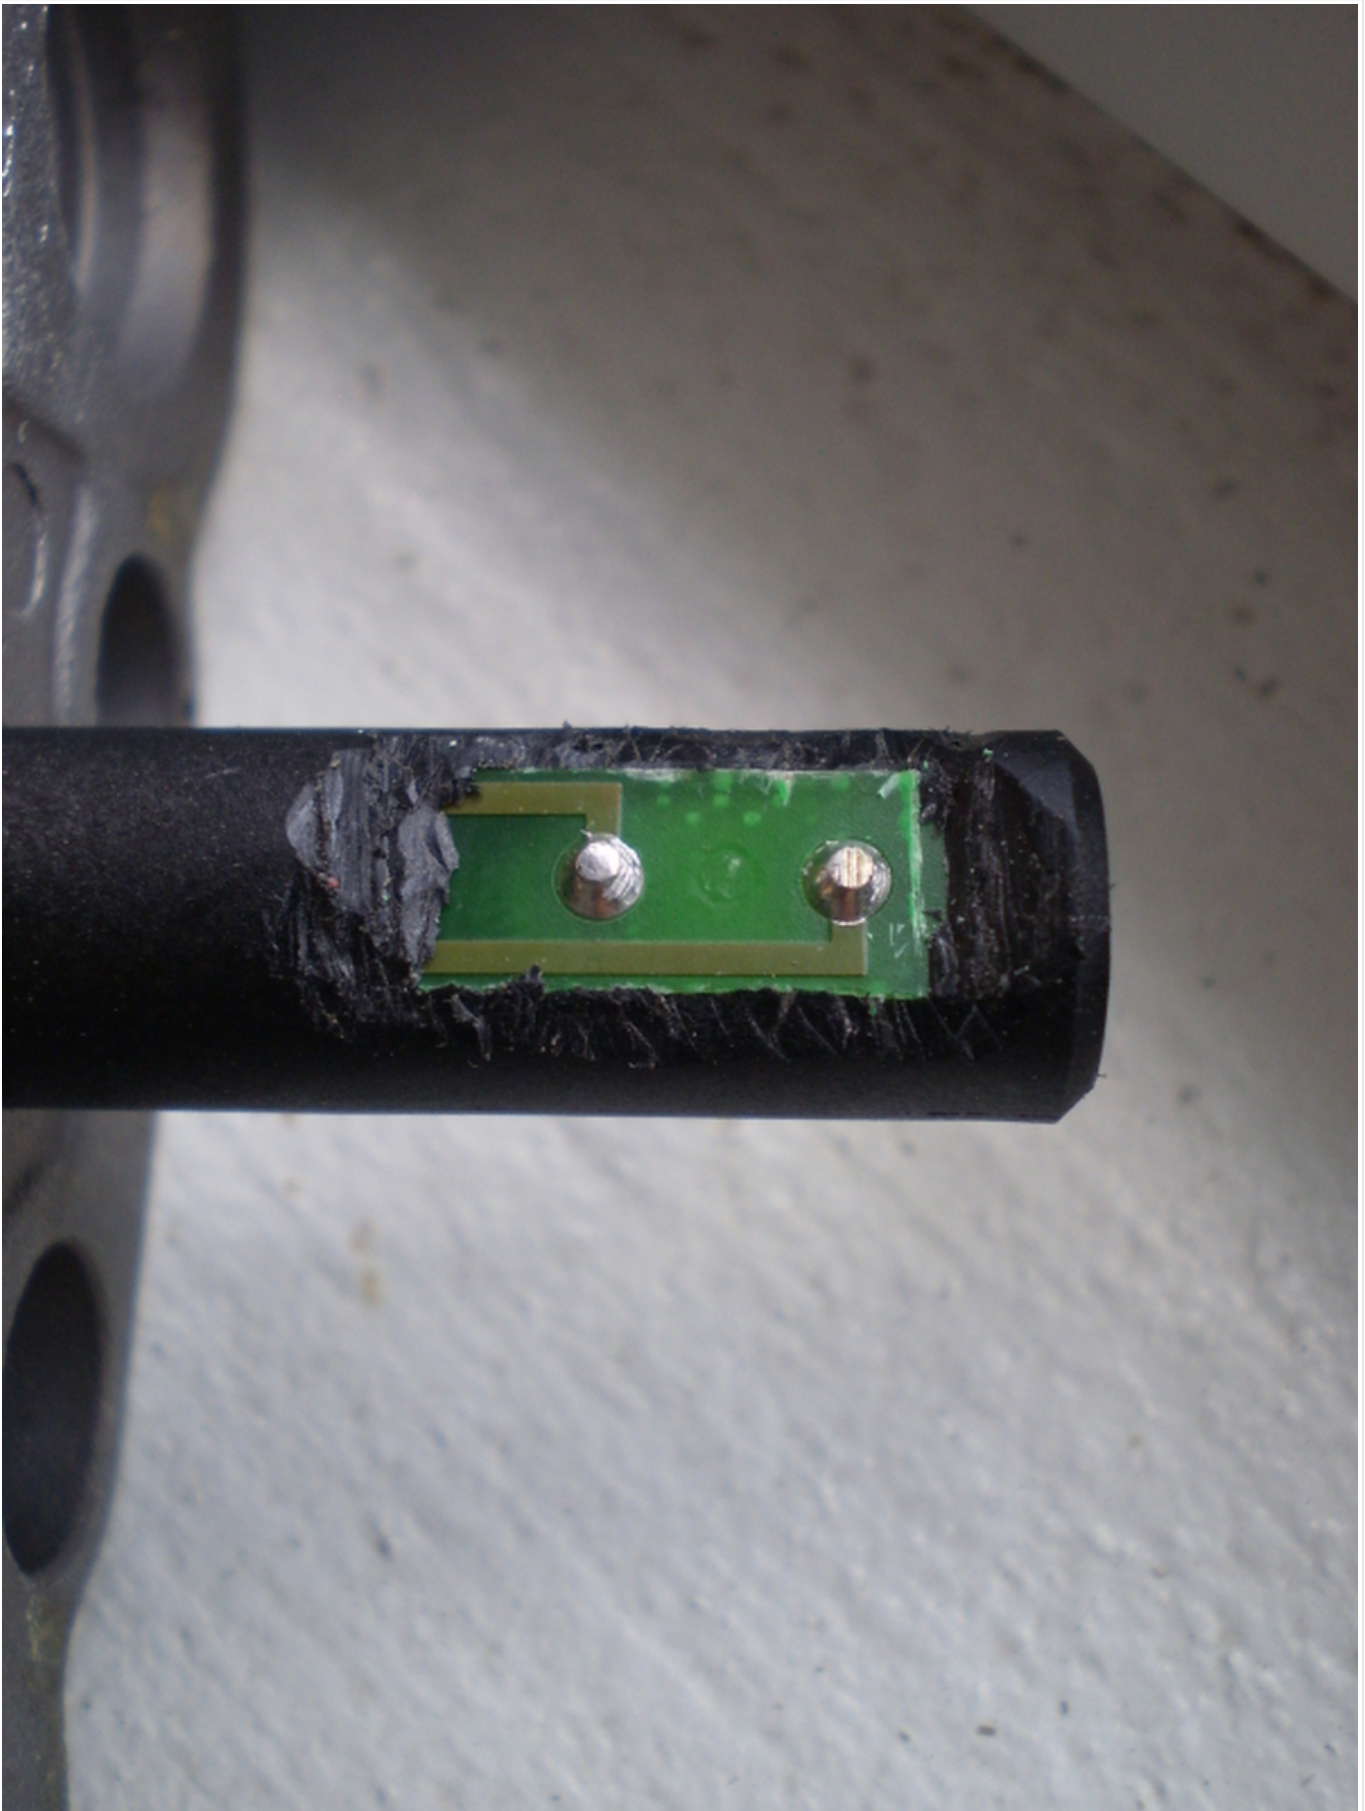
34. Luckily I had that spare modulator and I continued on with the repair. Except this time I used a very sharp serrated steak knife. **WHAT A DIFFERENCE!!!** I basically shaved it of little by little.

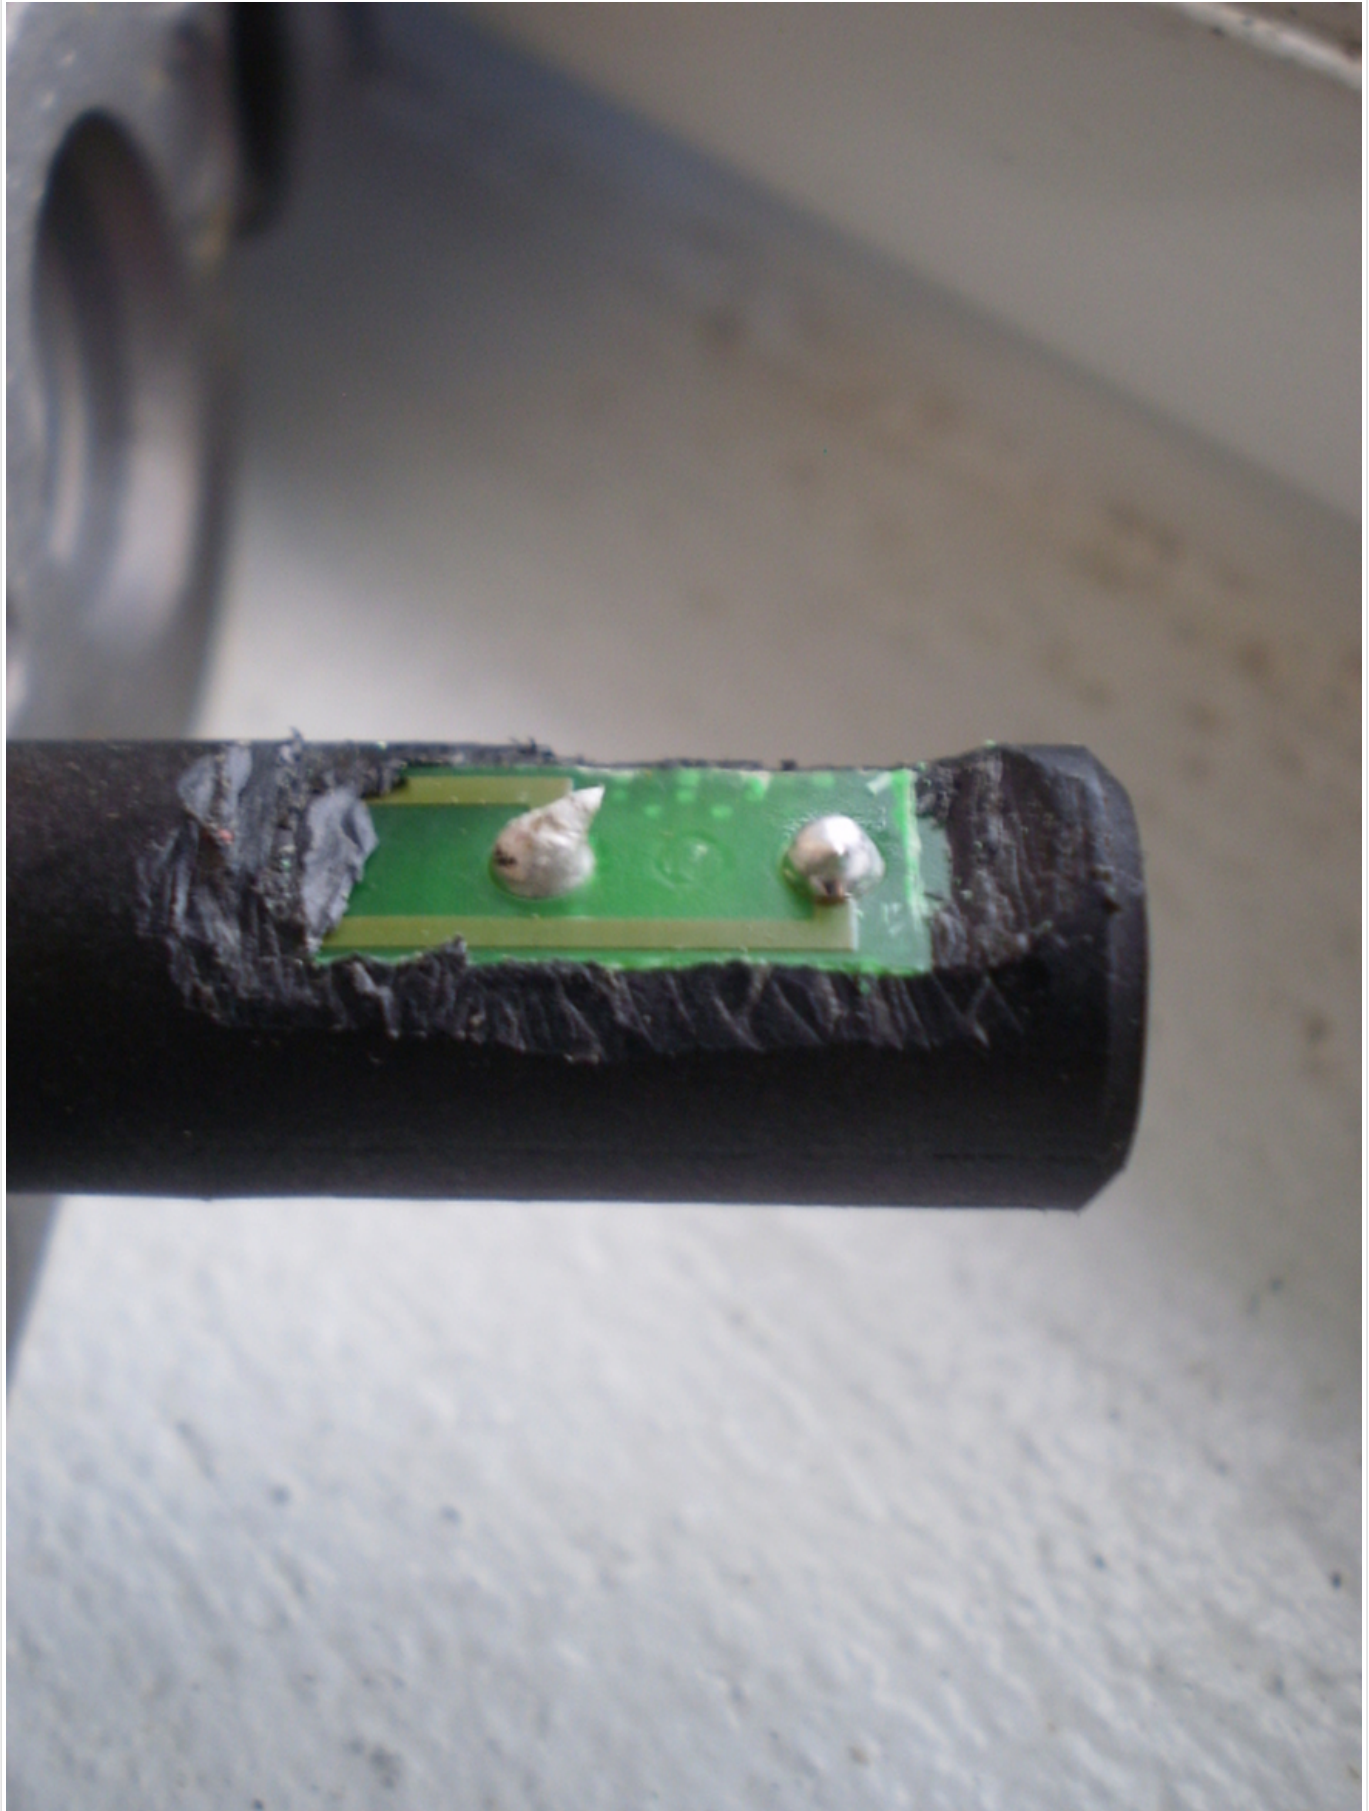
35. Upon inspection of my circuit board and that of the spare's, I found it very hard to tell if the soldered joints were bad. Both pins remained on the circuit board when I removed the SVS plug but I could tell they weren't 100% solid. I re-soldered the pins on the spare unit. Be careful as the pins may fall out, while soldering. One did fall out but I was able to reinsert it with pliers and re-soldered it. I re-tested the SVS on all three positions and passed.

*I was concerned that the fallen pin would not be soldered strong enough but surprisingly it held very well and it passed the ohm tests after about 10 tries plugging and unplugging the SVS plug just to make sure.*

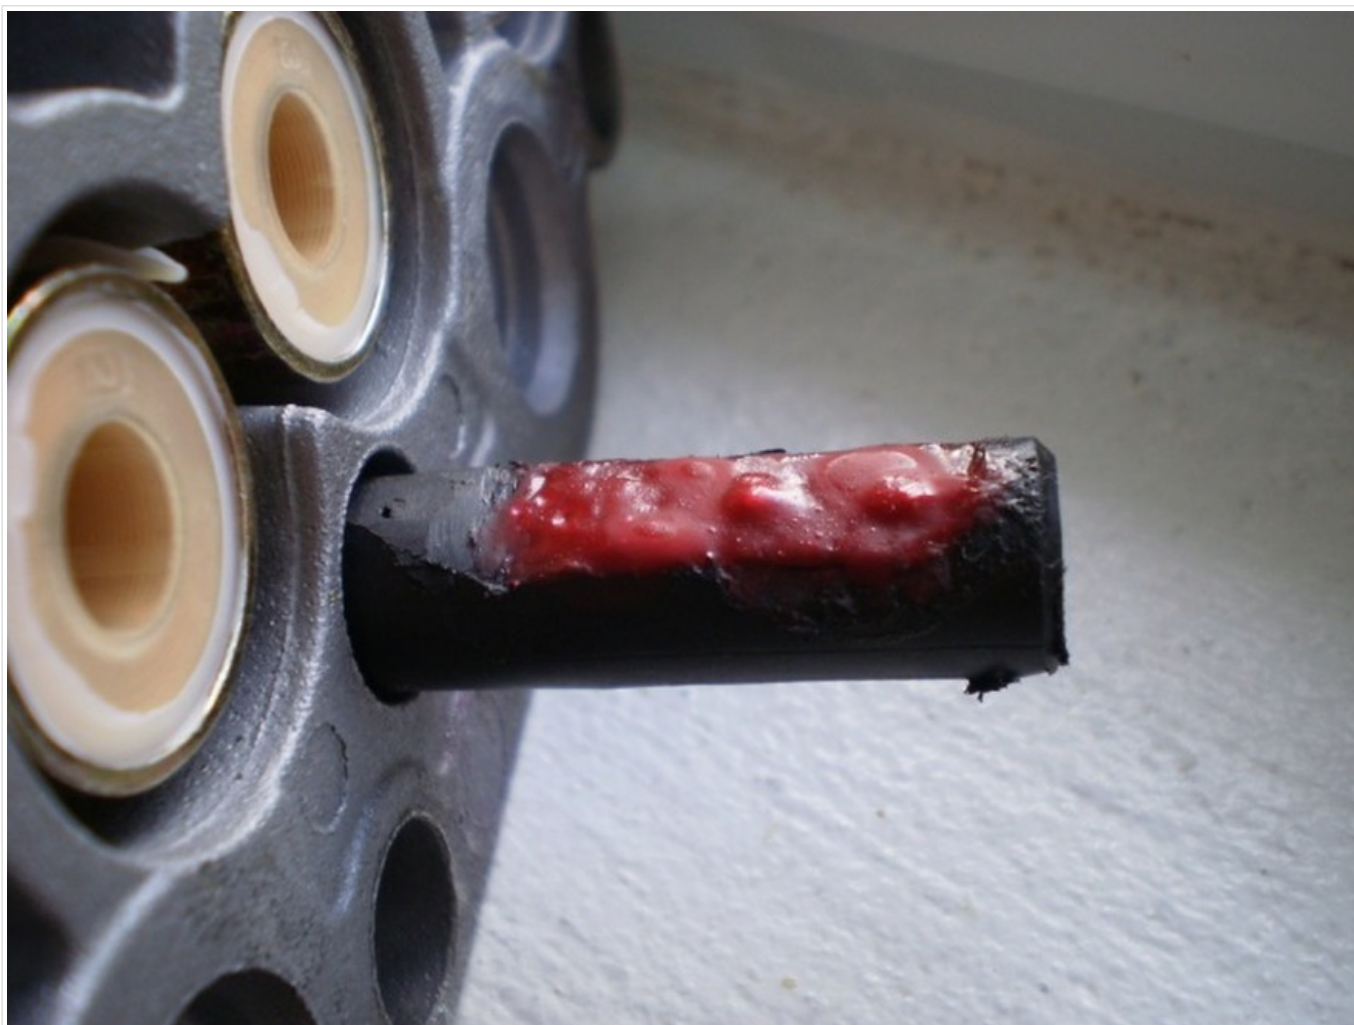
36. A few coats of liquid electric tape and done. The store only had red liquid electric tape.

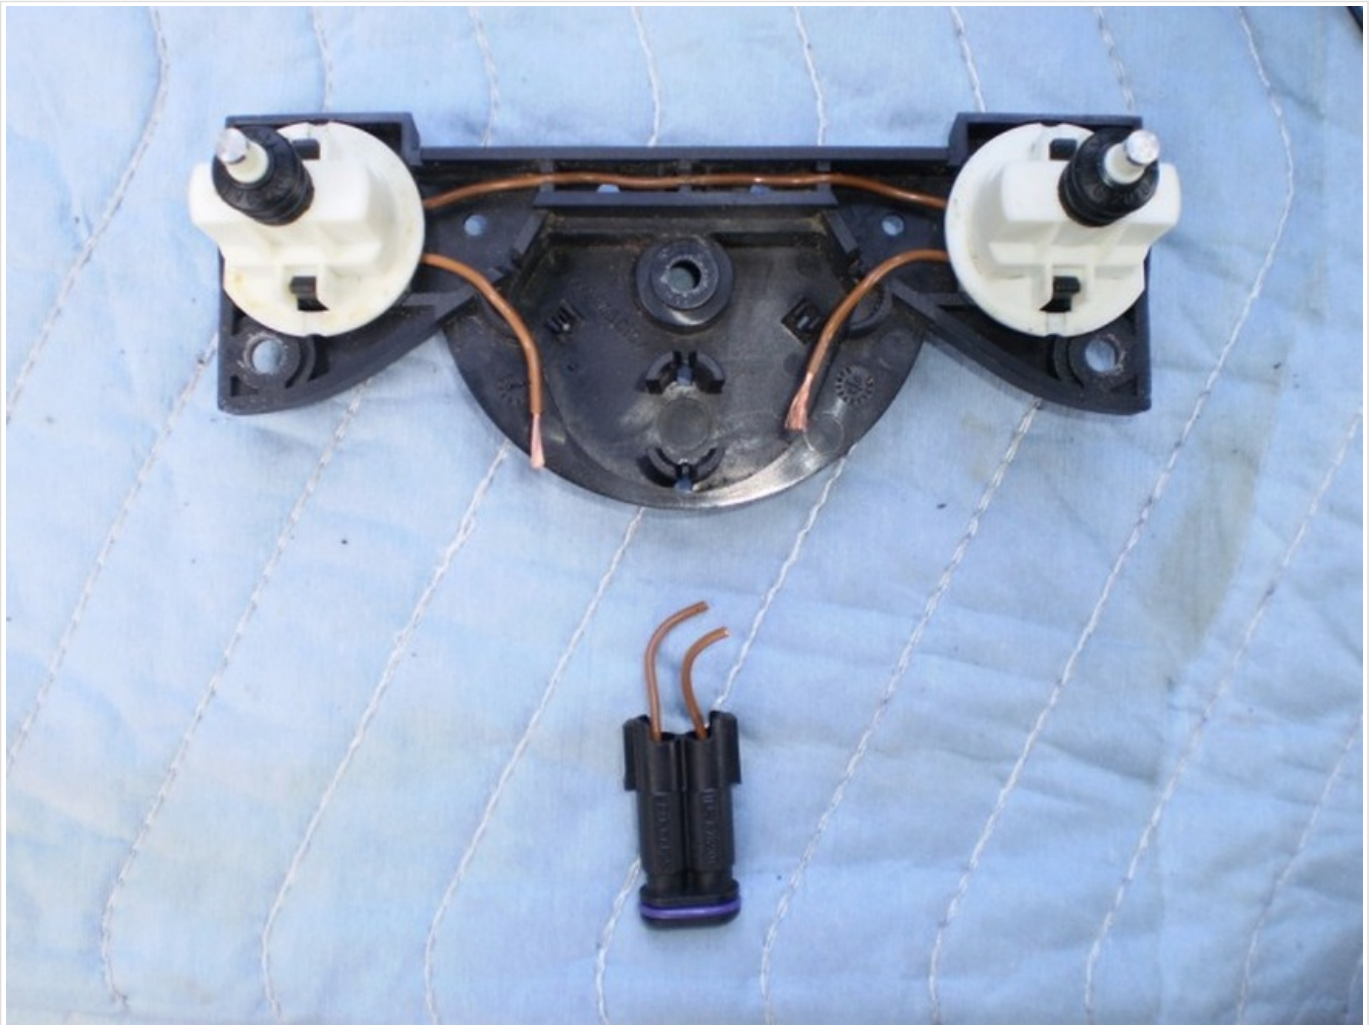
38. Remove your SVS any method you desire, Option A, or Option B without removing the modulator side (see steps # 25 through # 29) Cut SVS plug, but unlike my cut illustrated below, cut as close to the plug as possible.

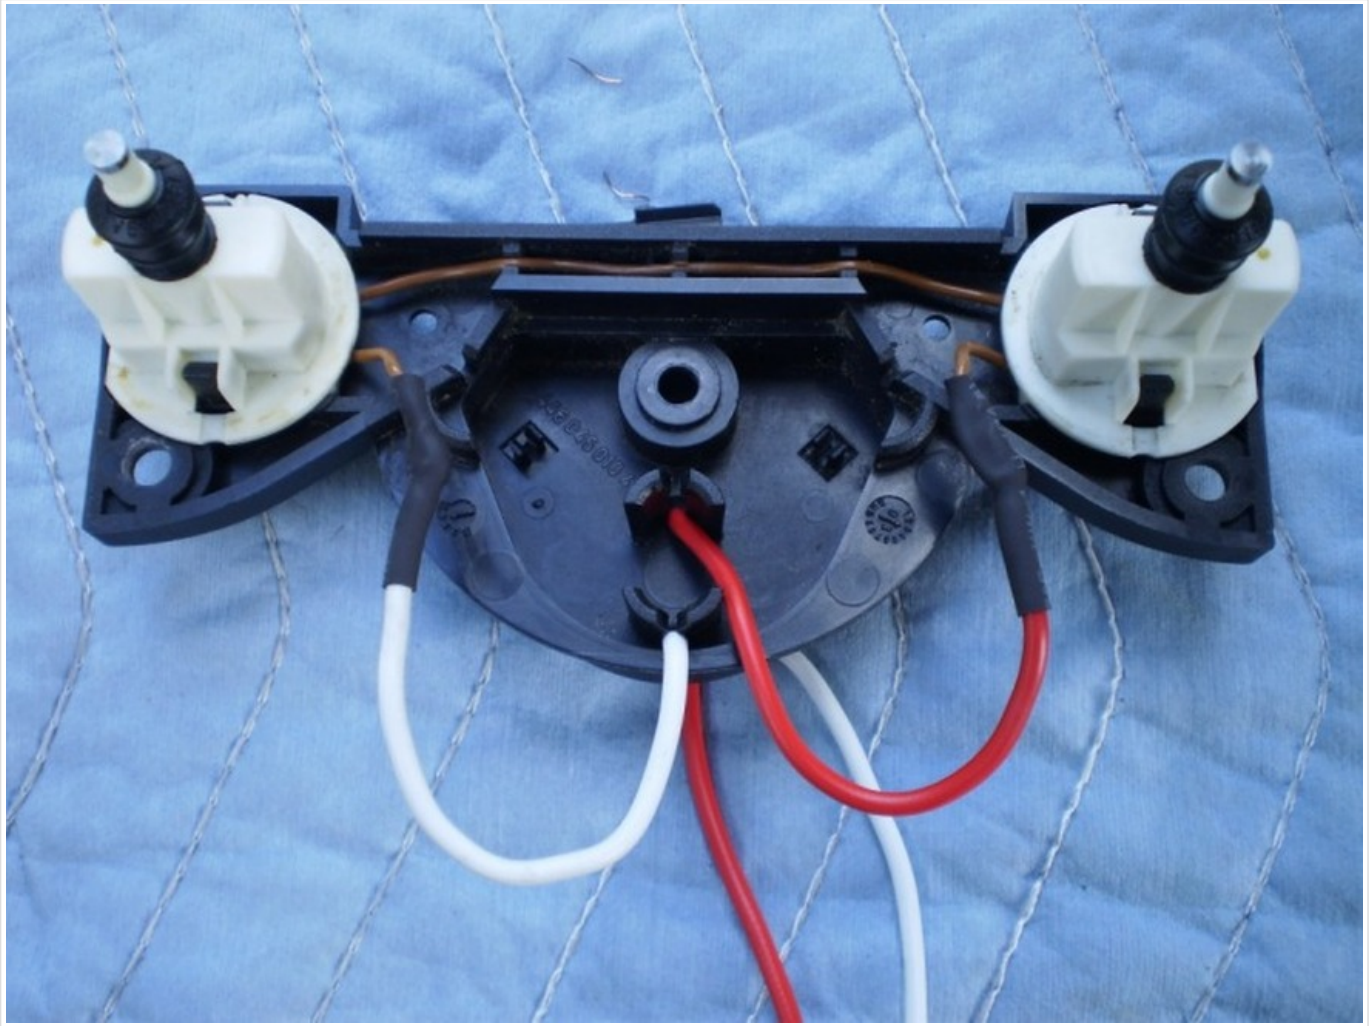
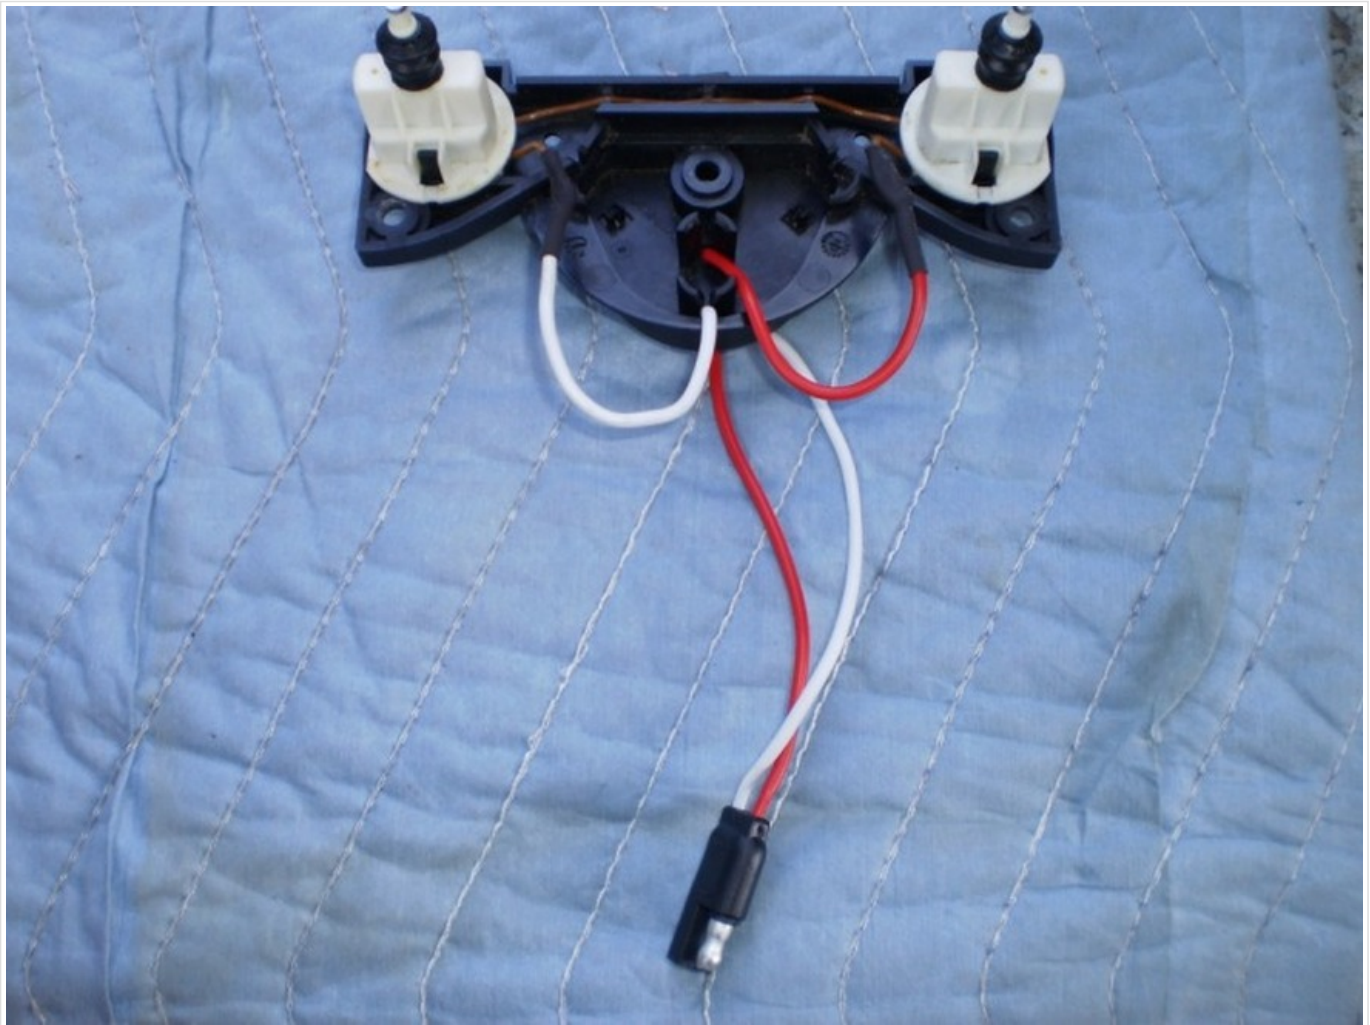
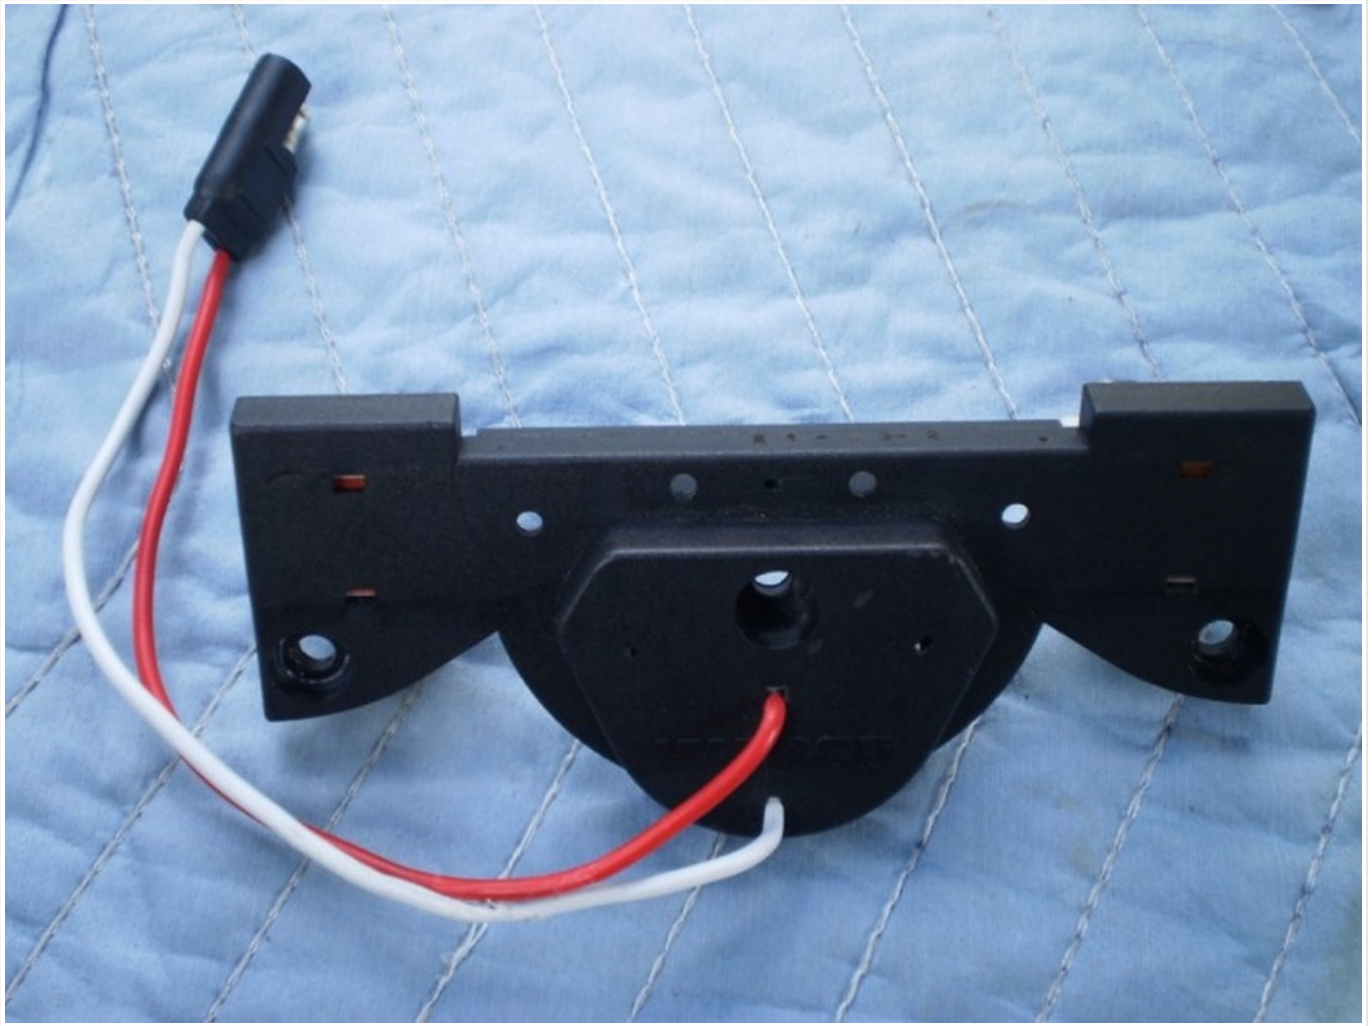
39. Splice, solder, and heat shrink the longer end of the trailer connector to the SVS wires and run them through the SVS cover plate.
