## ABS MODULATOR ELECTRICAL FAULT REPAIR

11/2009

### Introduction:

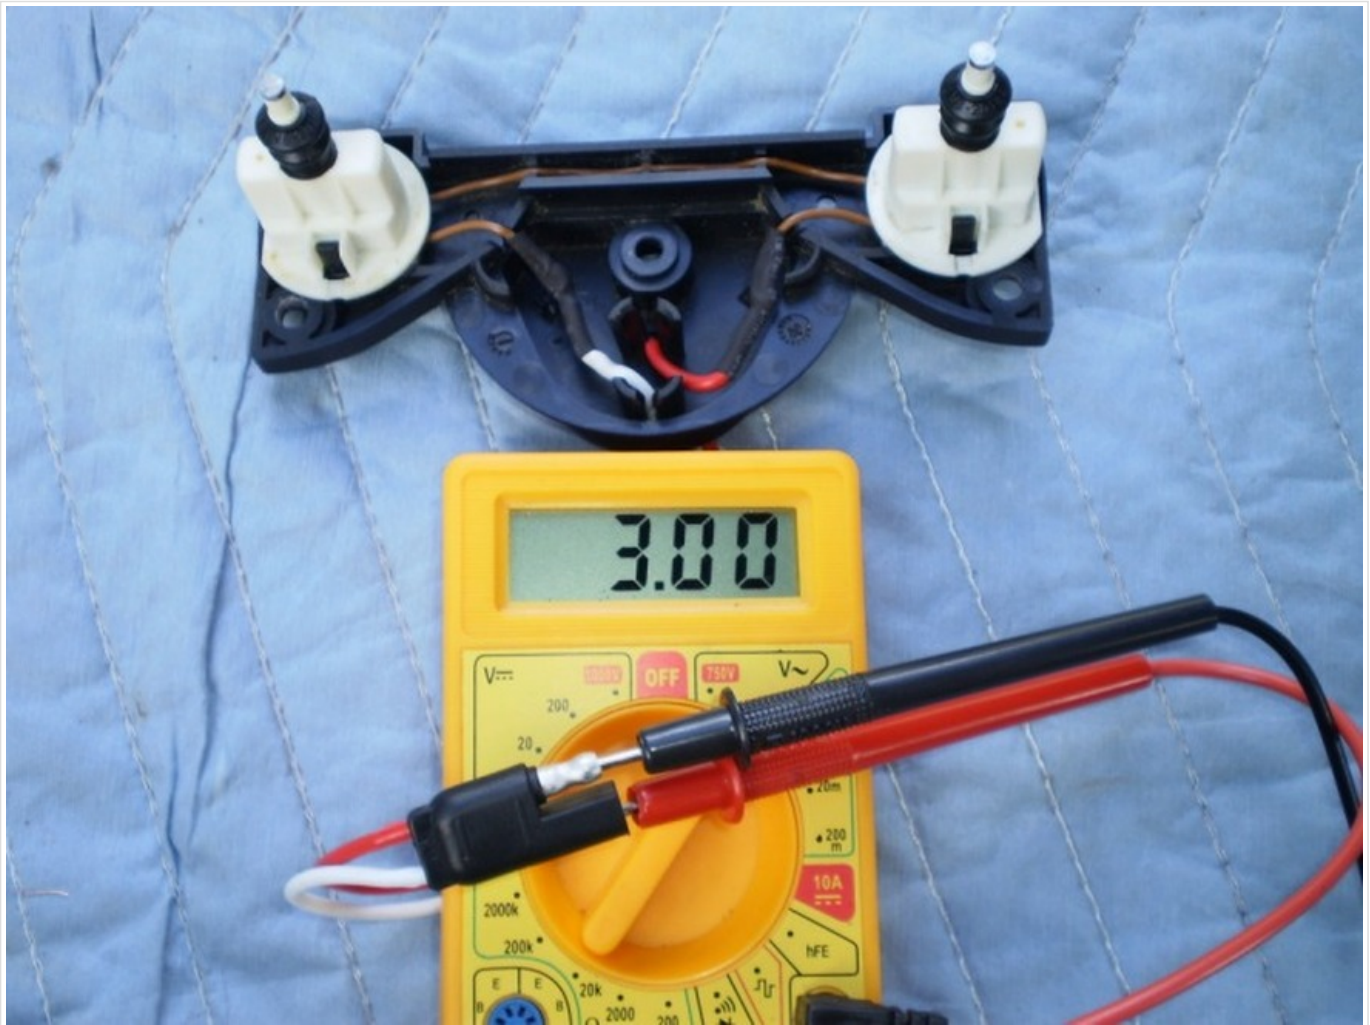
BOTH open, PASSED.

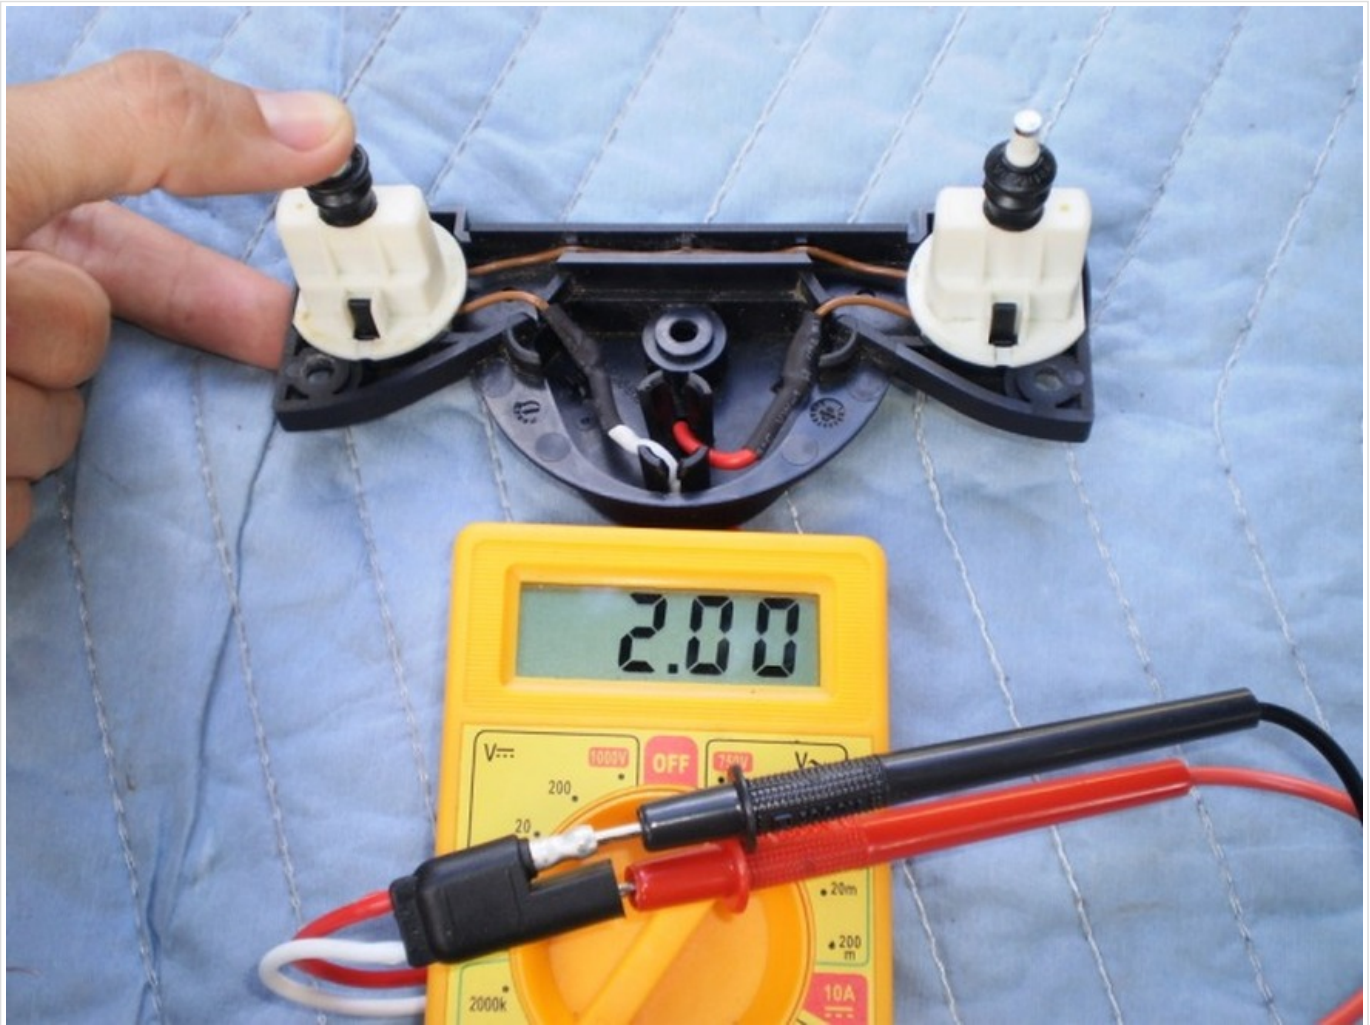
ONE Closed, PASSED.

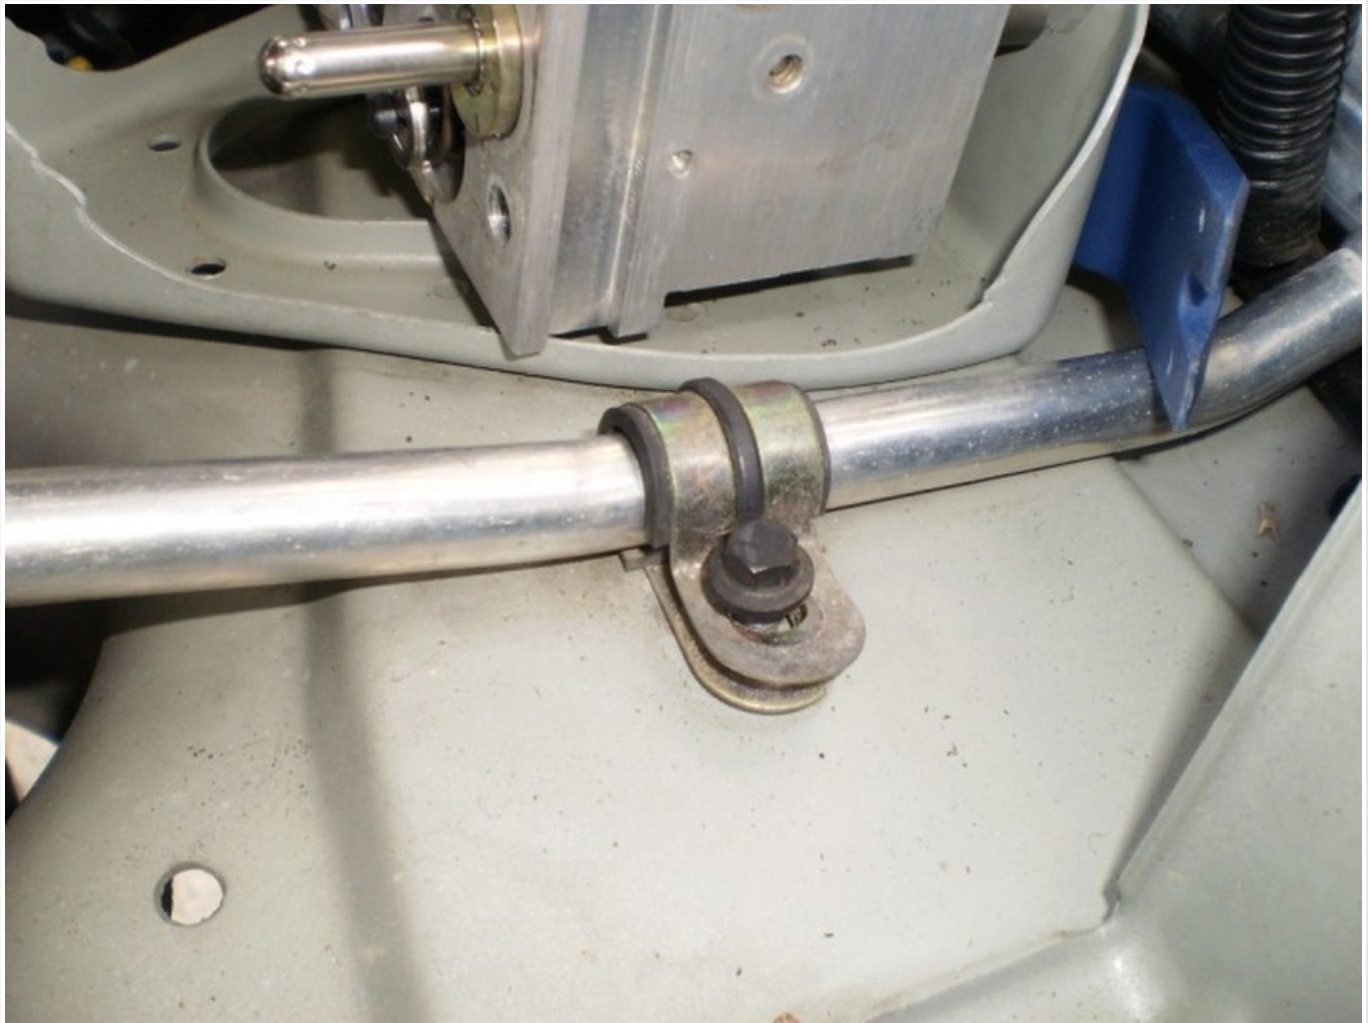
41. Now to find a close ground.... Since the YG wire we need to tap into runs along side the A/C line bracket retaining bolt.. Why not use it?

The Three Amigos returned in April 2010 as a result of this bolt coming loose. I may not have tightened it well when I did it the first time back in November 2009 so torque it good, and add loctite. I plan to check the bolt every oil change. In addition to using that bolt as a ground, ensure that it is free of dirt or rust or anything that would diminish a good electrical contact.

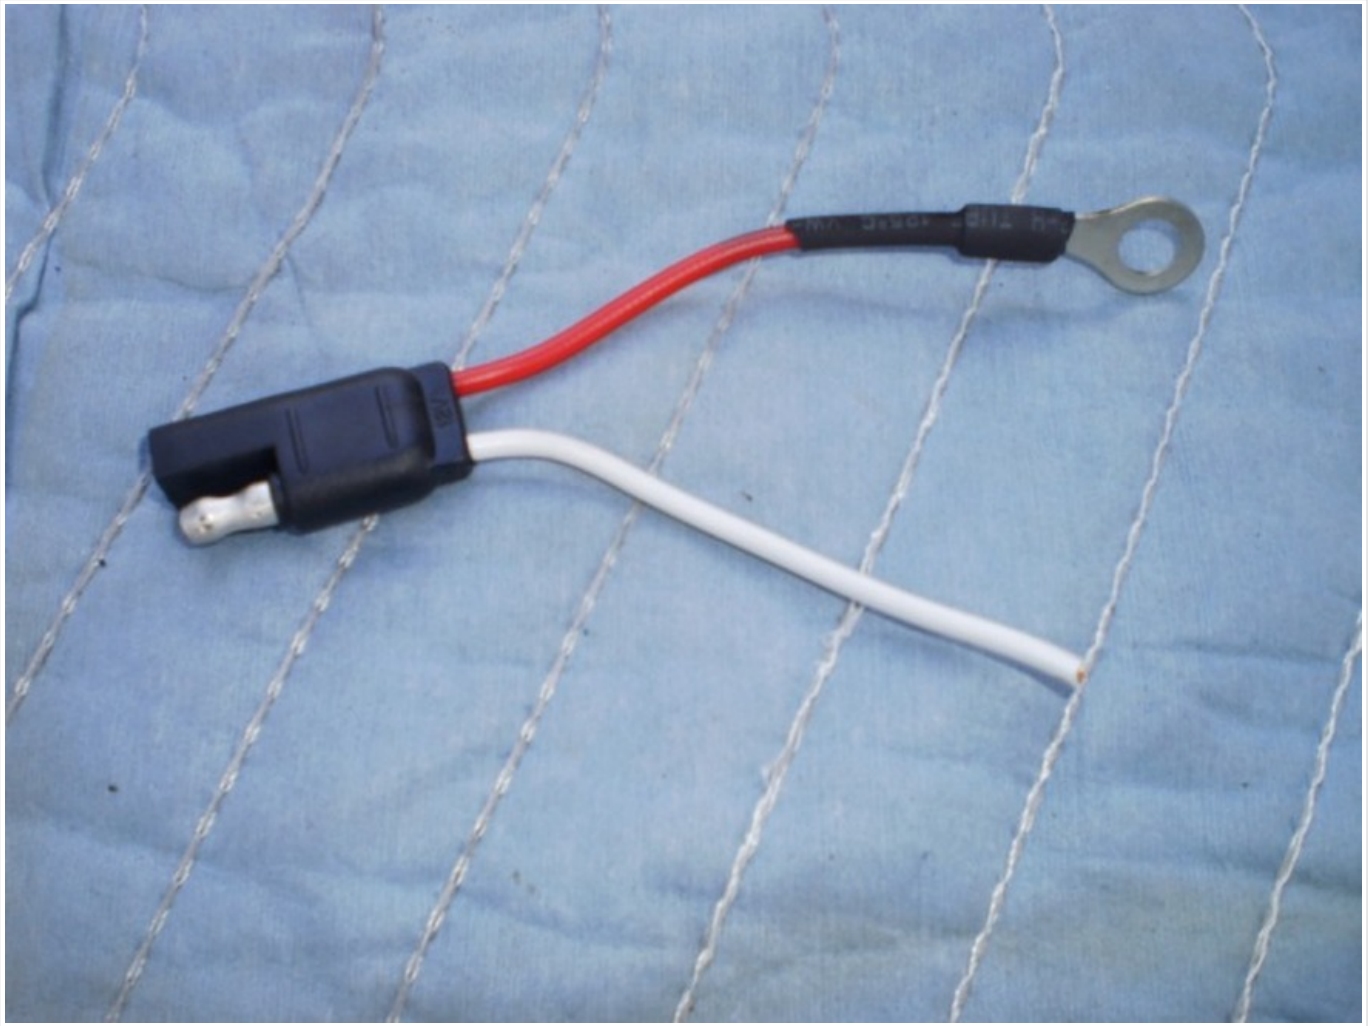
42. Take your other end of the harness and crimp a connector to secure to the ground bolt. Heat shrink it to provide better protection and it also just looks better.

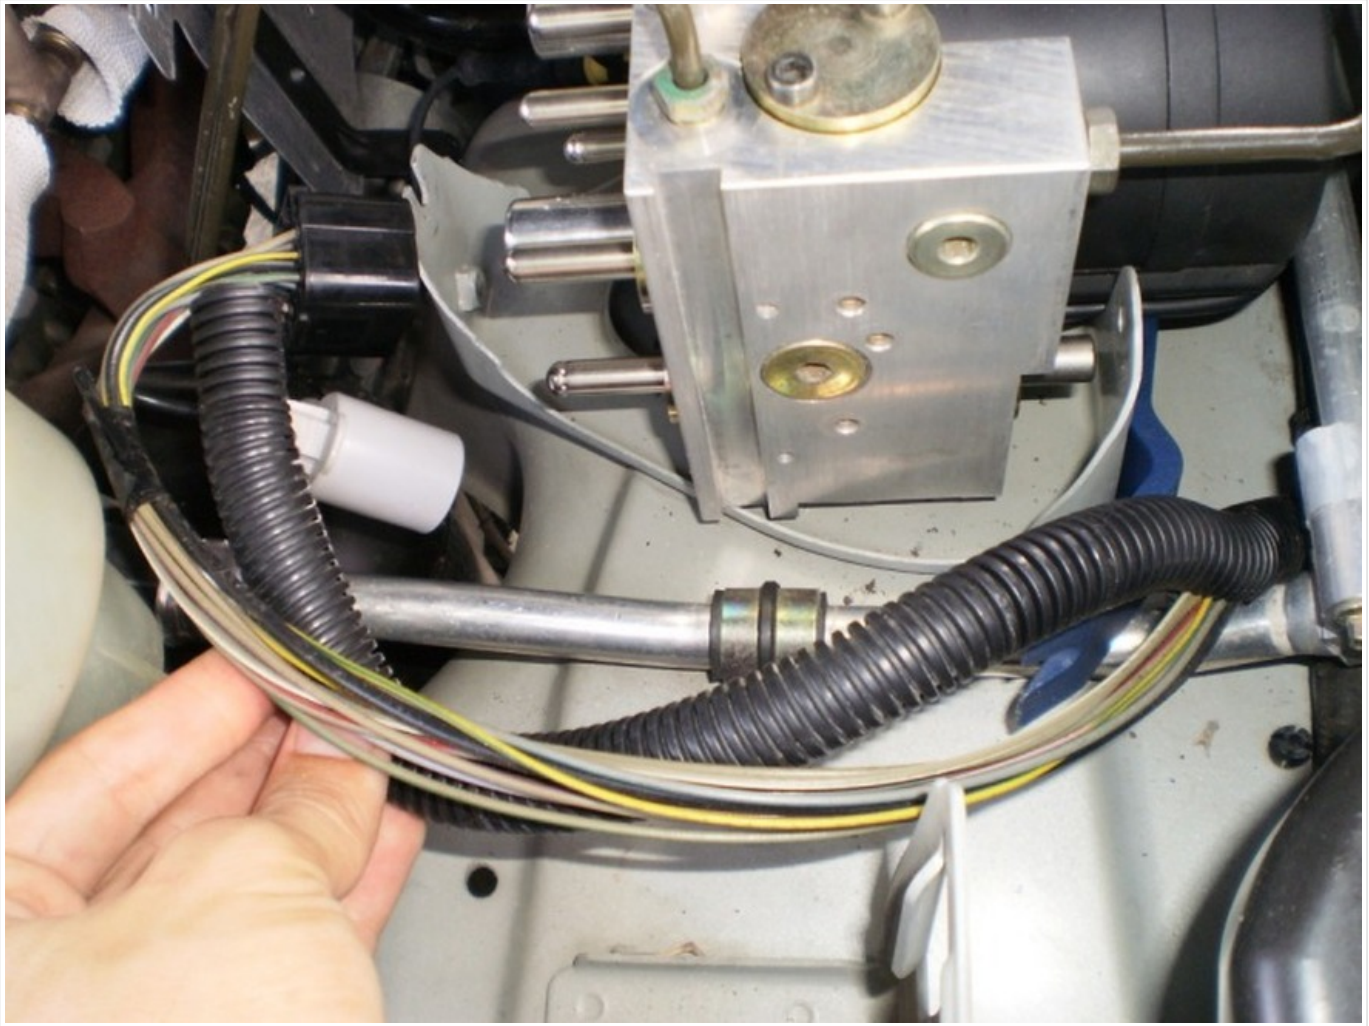
43. Peel off the wire loom shield off of the ABS Modulator wire harness. Locate the YG wire. Cut it in half but in such a way to leave enough length for your harness.

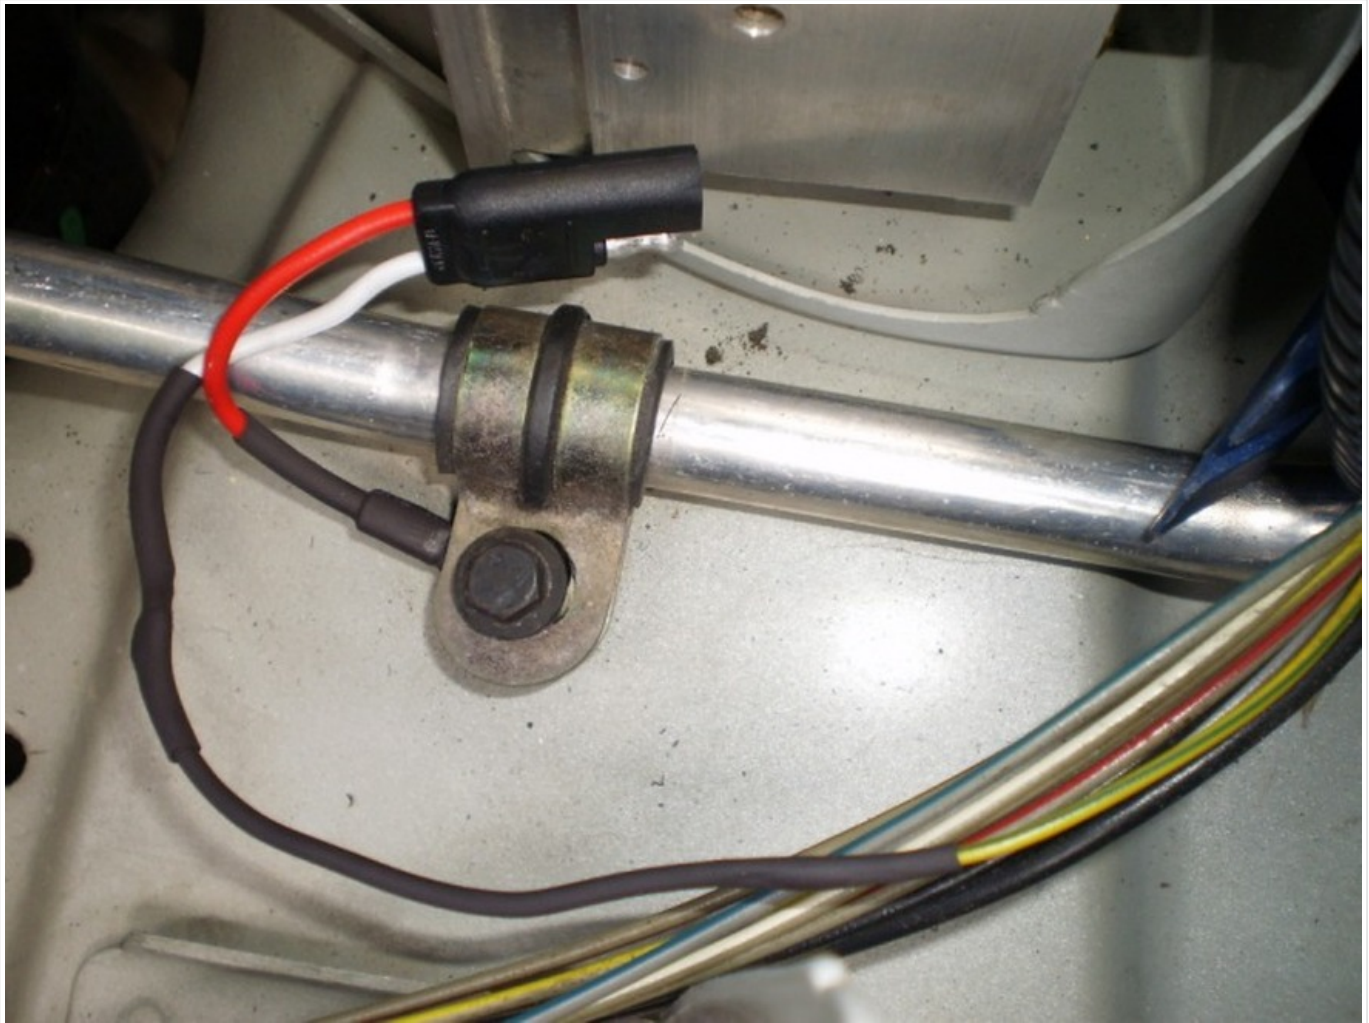
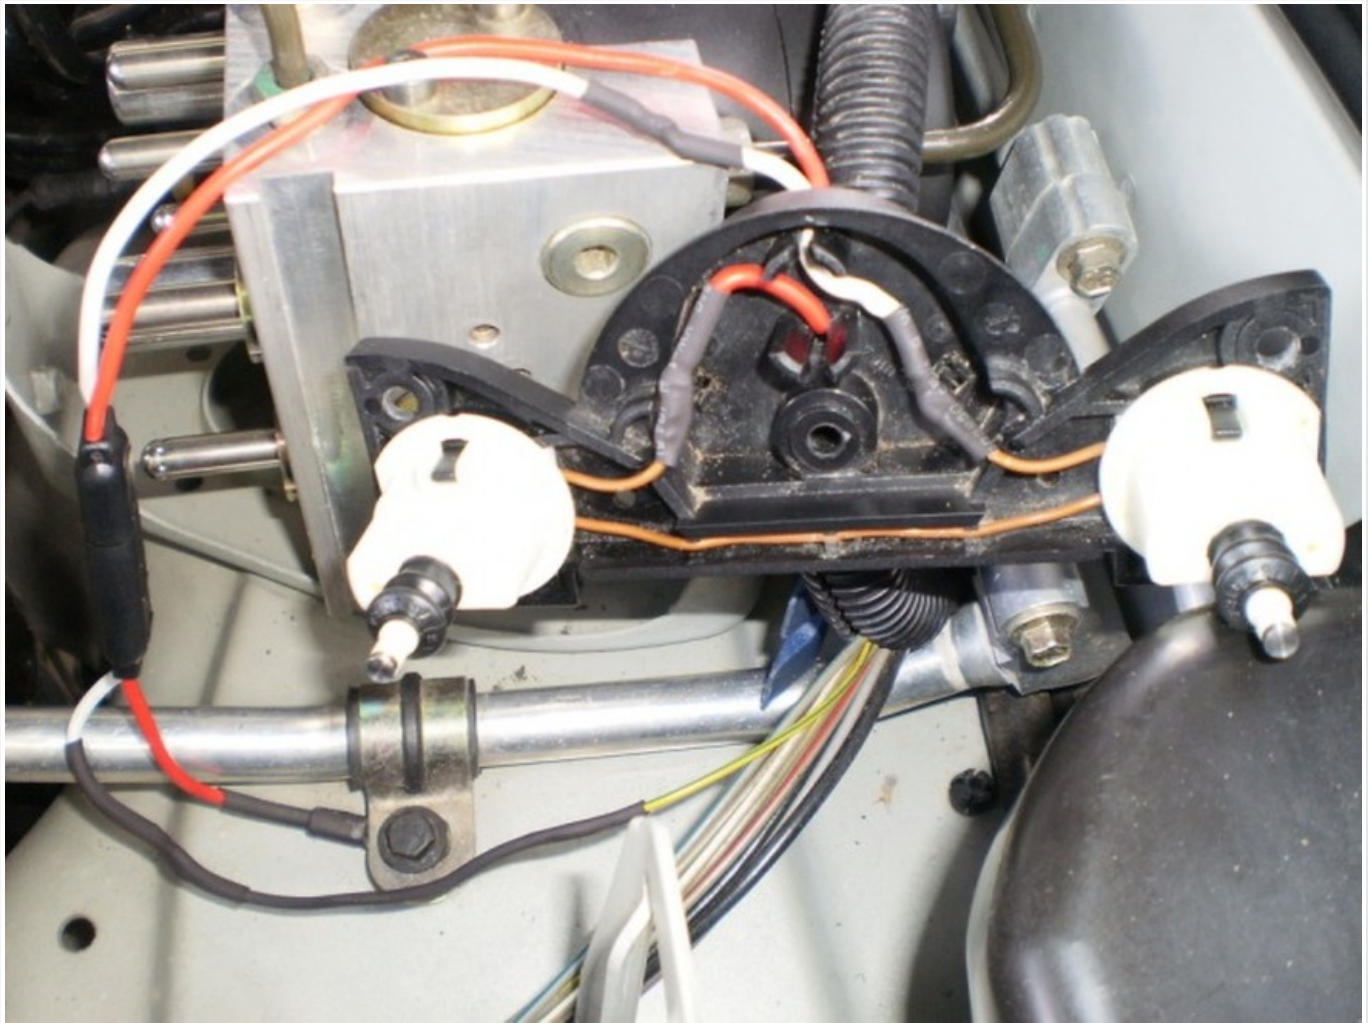
This is what it looks like plugged up.
