Disco 2 chirpy blower motor fix

Every time I use the heater for more than 15-20 minutes the blower motor (underneath the glove box) would start making a high pitch chirping sound, intermittent at first but irritatingly continuous in the end.

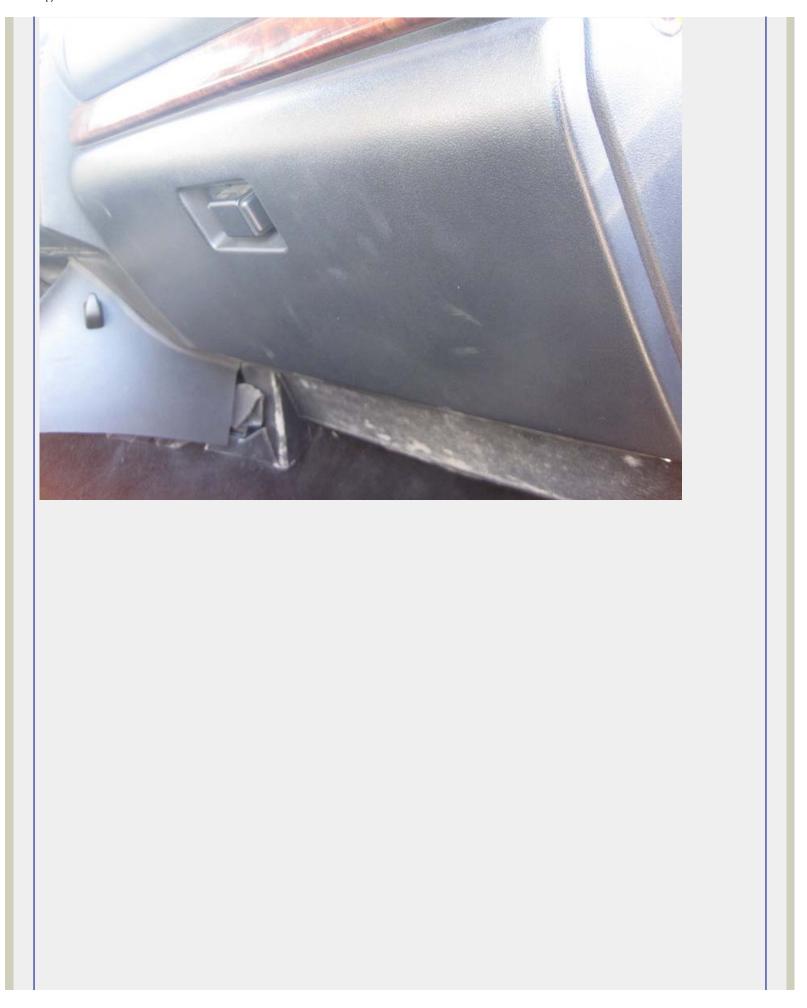
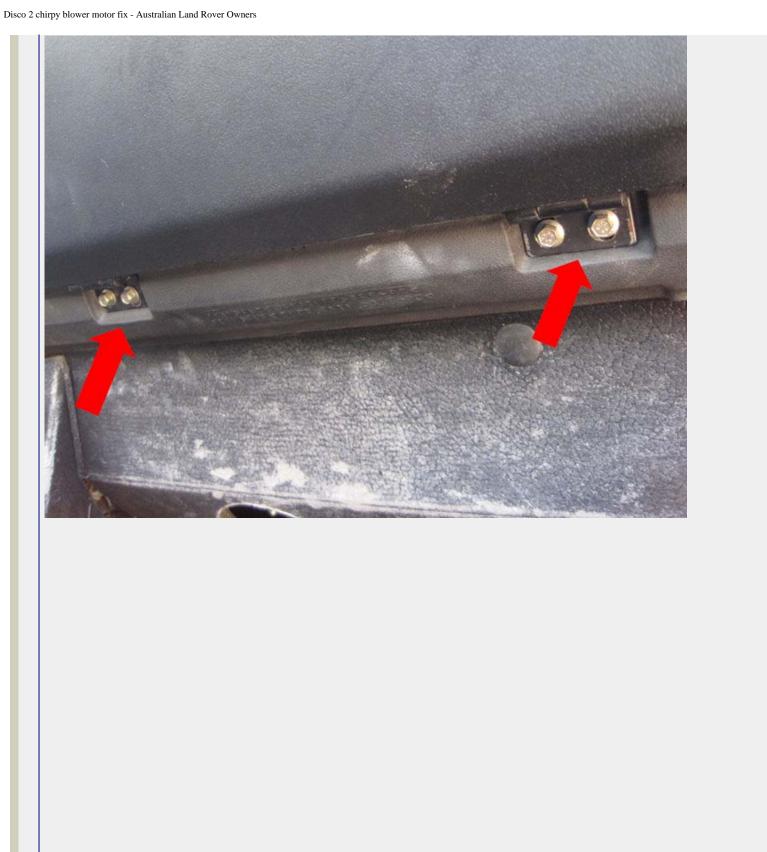
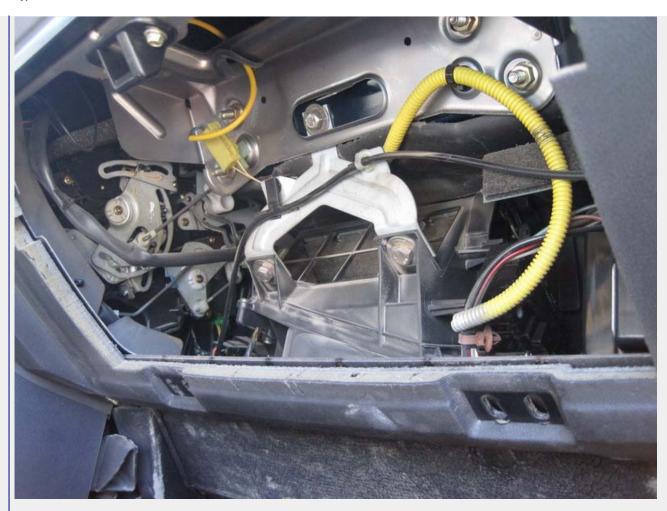
1- Remove glove box: unscrew (4) 7mm hex screws (2 per hinge). Recommend to mark position of screws on each hinge to facilitate alignment during reinstallation.

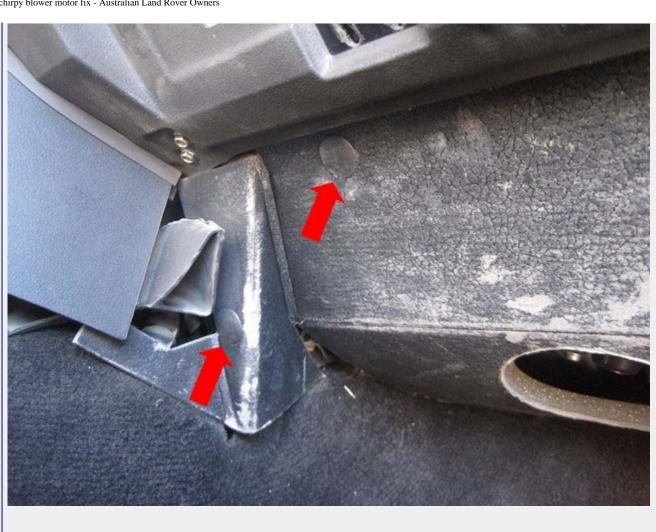
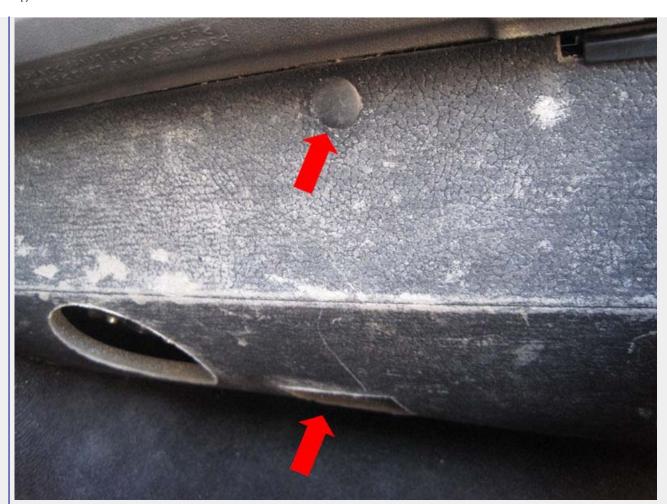
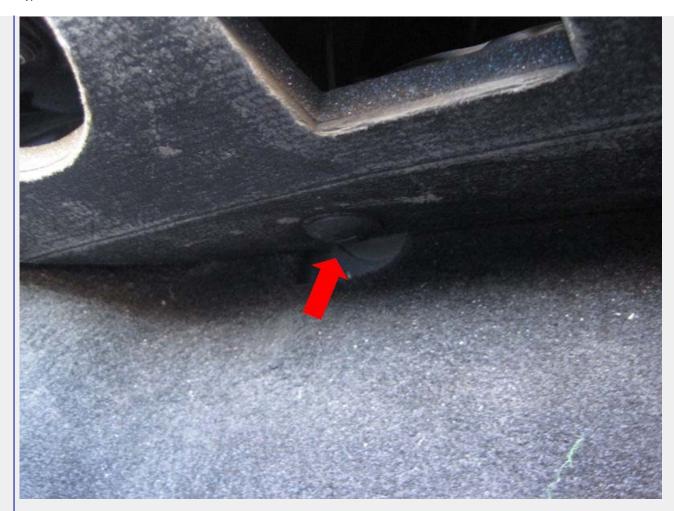
2- Remove bottom cover by pulling out 4 clips:

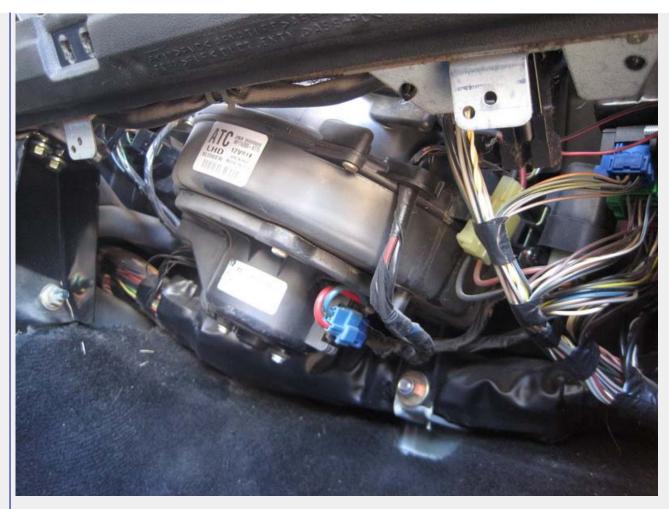
Blower on sight:

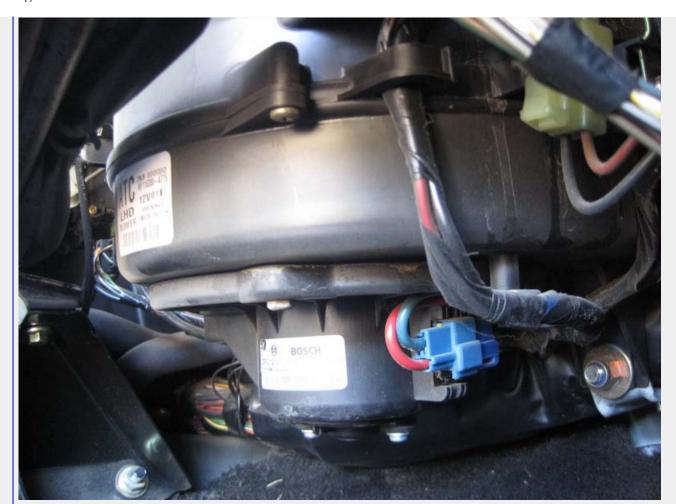
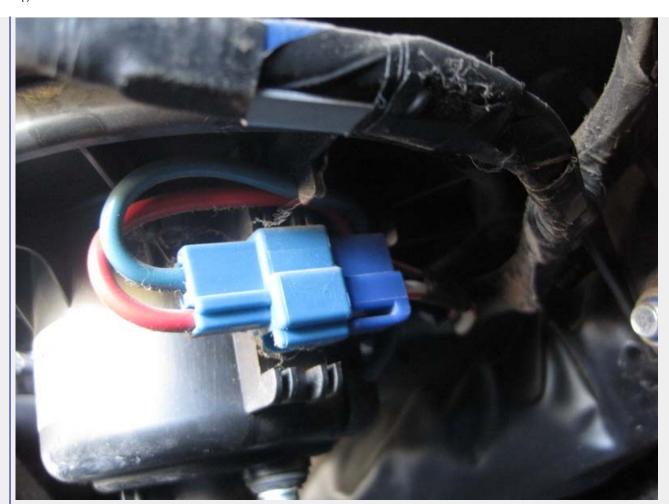
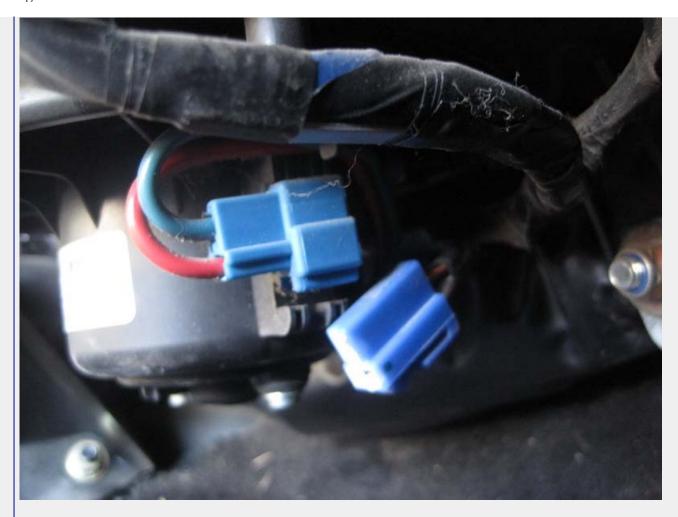
3- Disconnect blue plug from blower motor (male plug comes free towards back side):

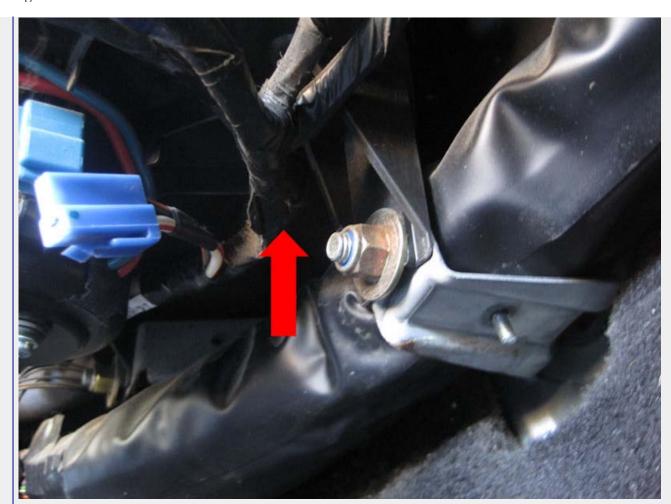
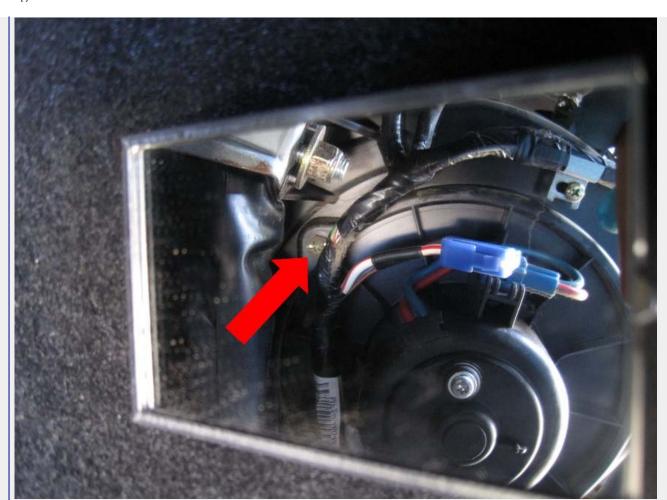
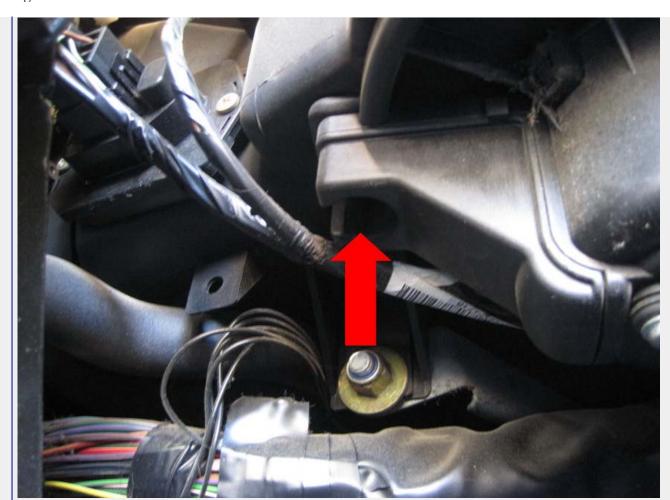
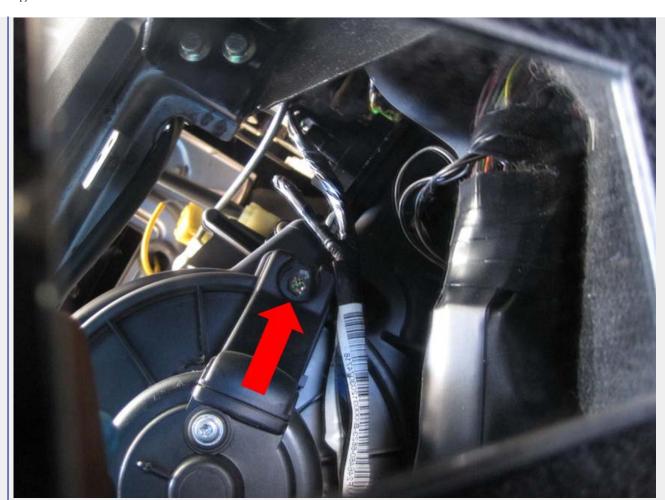
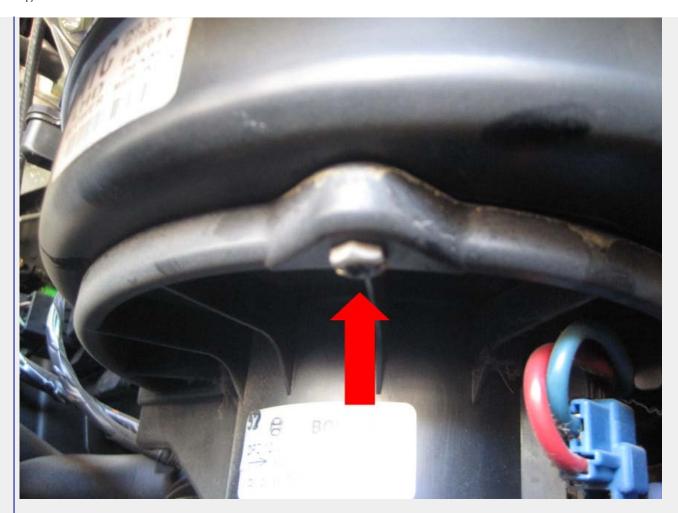
4- Blower motor is secured to blower assembly by (3) T27 torx screws located as shown:

Remove the shown screws. Easier to start with the back one (toughest to reach) and leave front one as last, so that motor stays in place.

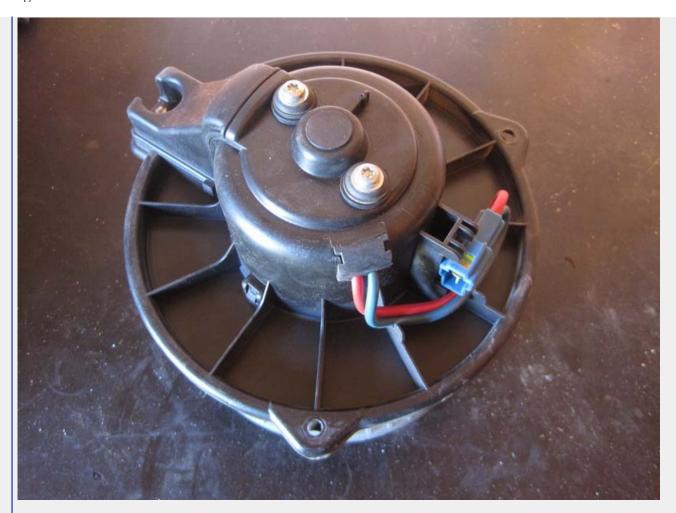
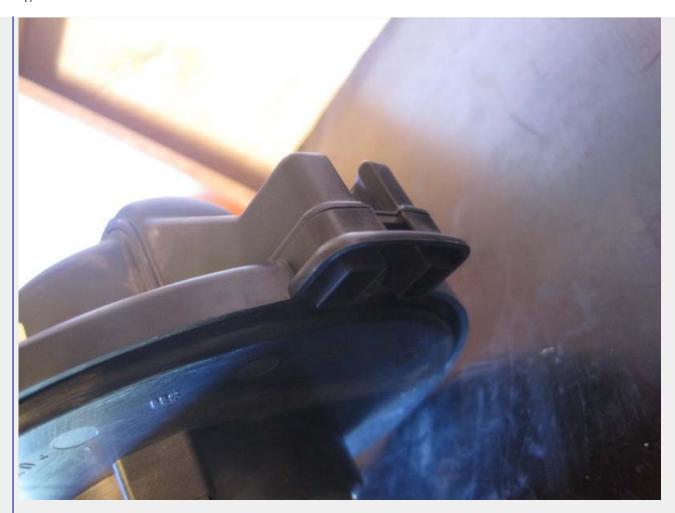
$\hbox{6- Carefully manoeuvre blower motor out-some tight cables to negotiate through but perfectly doable}...$

Note how the blower motor "cools" itself by taking air from the front of the casing and ducting it to the back, this design causes potentially dusty air to be blown through the motor bearings.

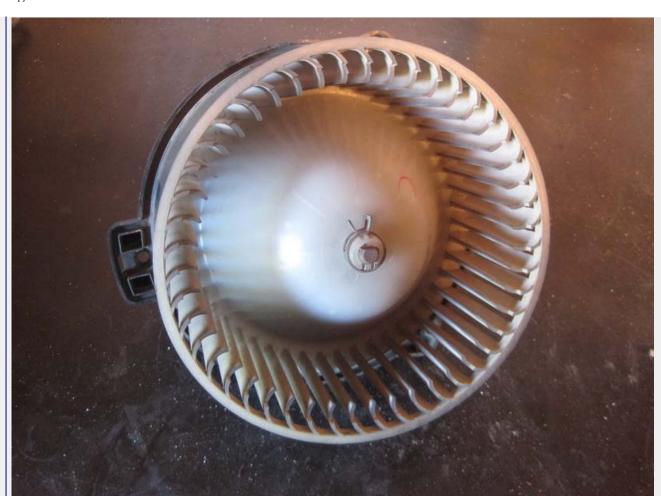
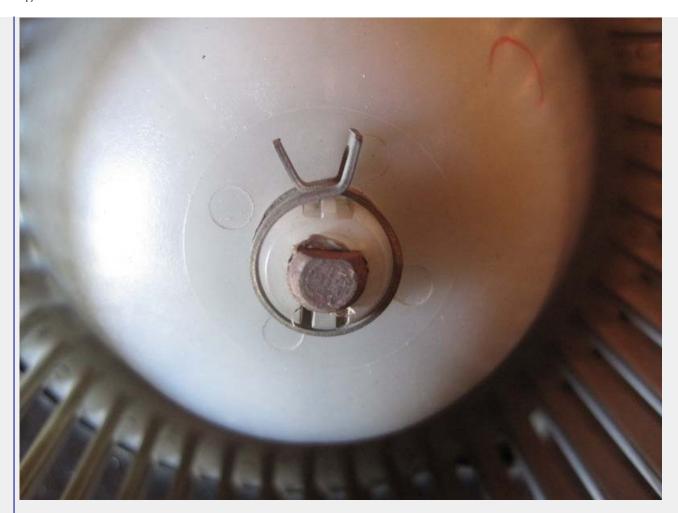
7- Prepare to release the "air wheel" by taking the clip out and slightly prying off the plastic tip out of the axle's groove.

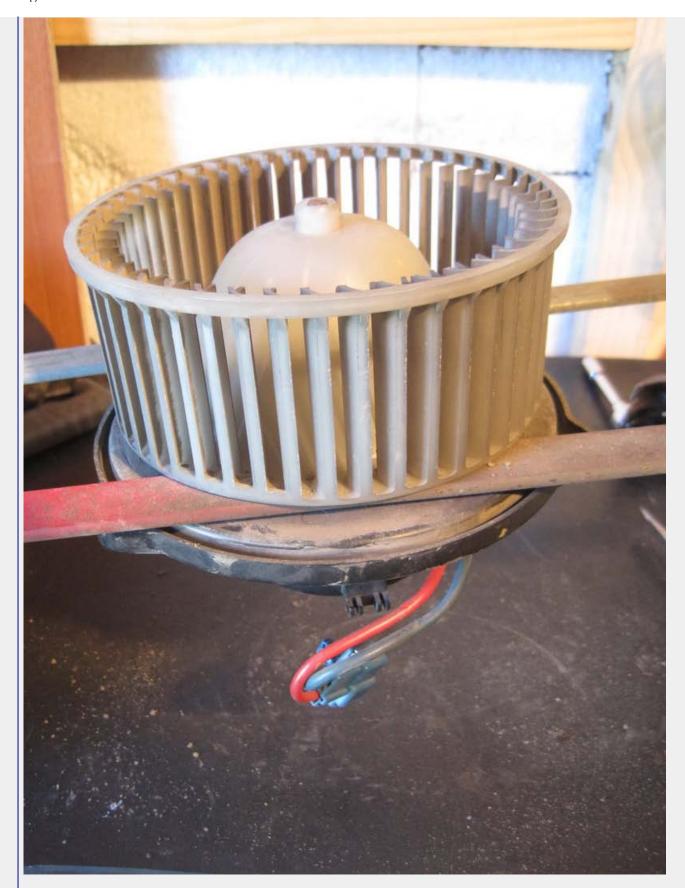
8- Then hold the wheel and pull the motor out (I suspended the wheel and carefully hammered down the axle). Give the wheel a good clean (sink, water, liquid soap & brush...).

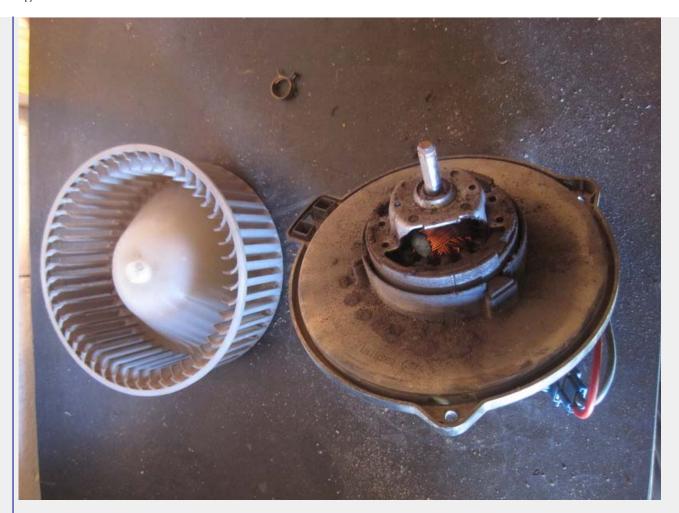
Note the amount of cr@p behind the wheel coming from within the motor:

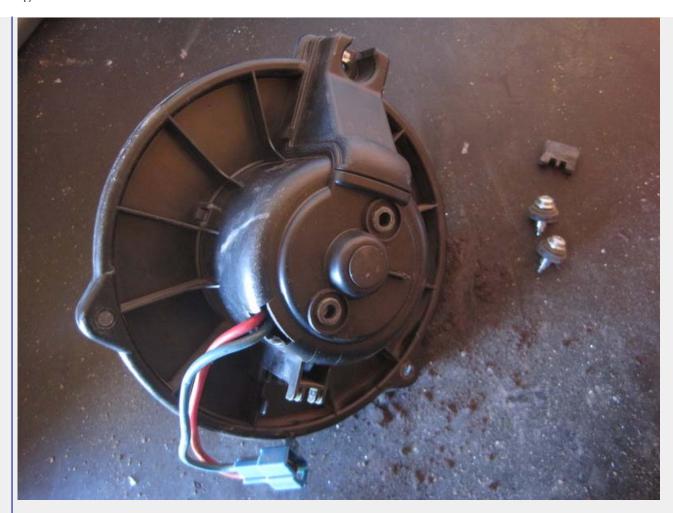
9- Release the blue plug and pull the rubber cover around the area where the cables enter the motor casing, undo the (2) T15 torx screws and free the motor:

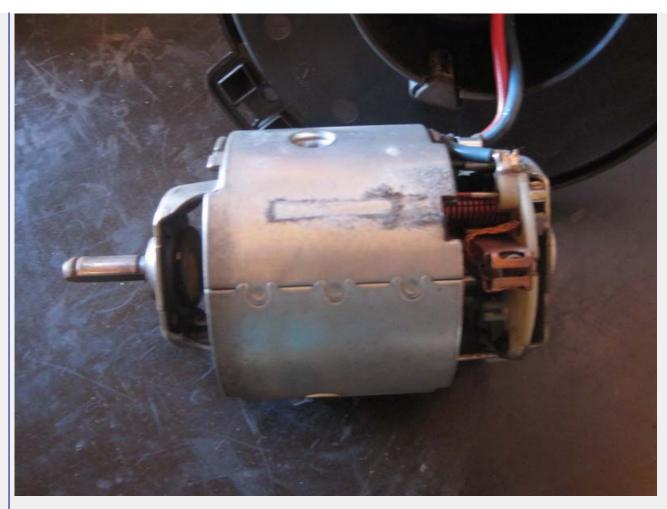
Pull the motor out of the casing:

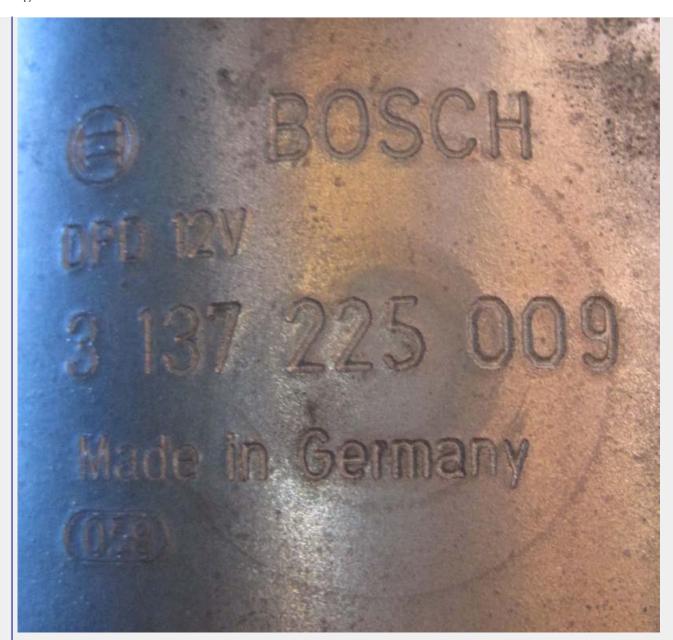
Motor details:

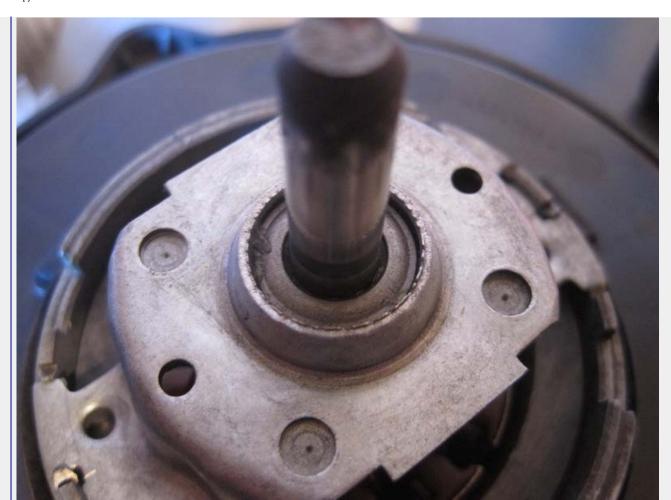
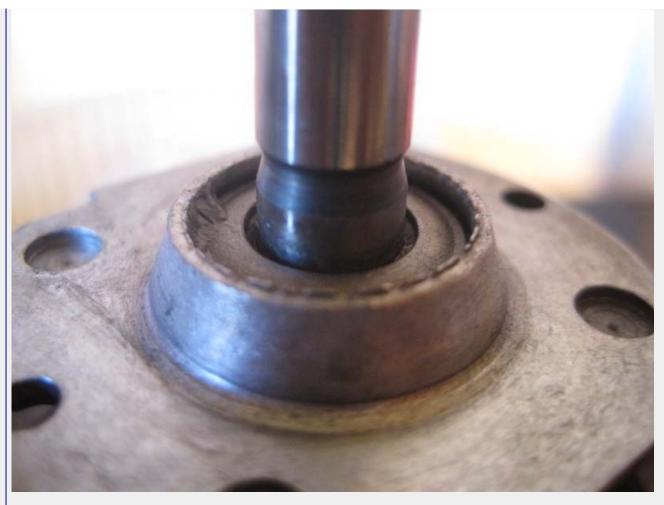
10- As seen the bearings are not serviceable.

- a- Cleaned the motor thoroughly with high pressure air
- b- Held the motor in vertical position, flooded the upper bearing with <u>dry Teflon bicycle chain lube</u> and let it stand for a few hours to allow it to gradually percolate (lube would not penetrate instantaneously), then turned upside down and did the opposite bearing
- c- Air blew rotor extensively as to remove any lube excess
- d- Reassembled motor & reinstalled in place (reverse work of what has been described).
