OPTION A

31. Since you are repairing the electrical fault at the SVS circuit board you need to test the SVS at the modulator side of the unit.

OPTION B

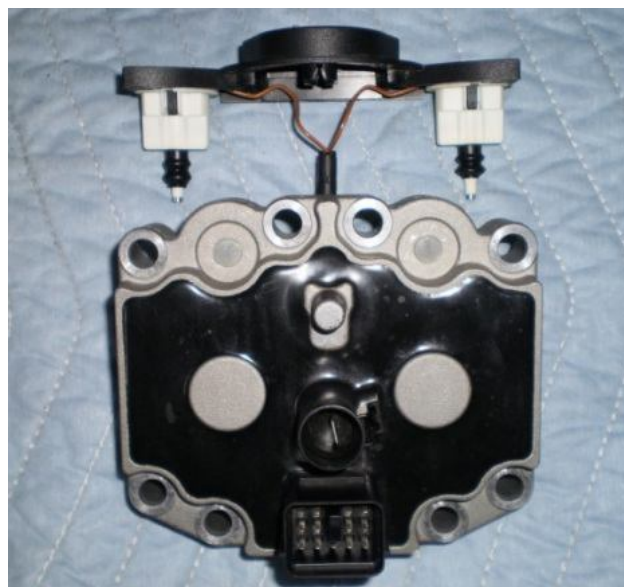
Connect the SVS plug to the SVS circuit board like pictured below.

Then turn it over on its side.

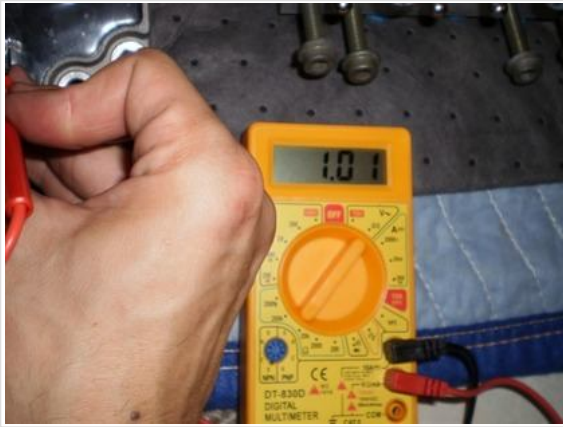
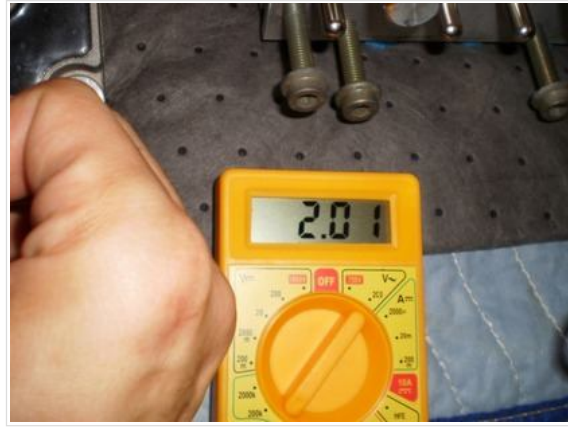
BOTH CLOSED ----- PASS

ONE CLOSED ----- PASS

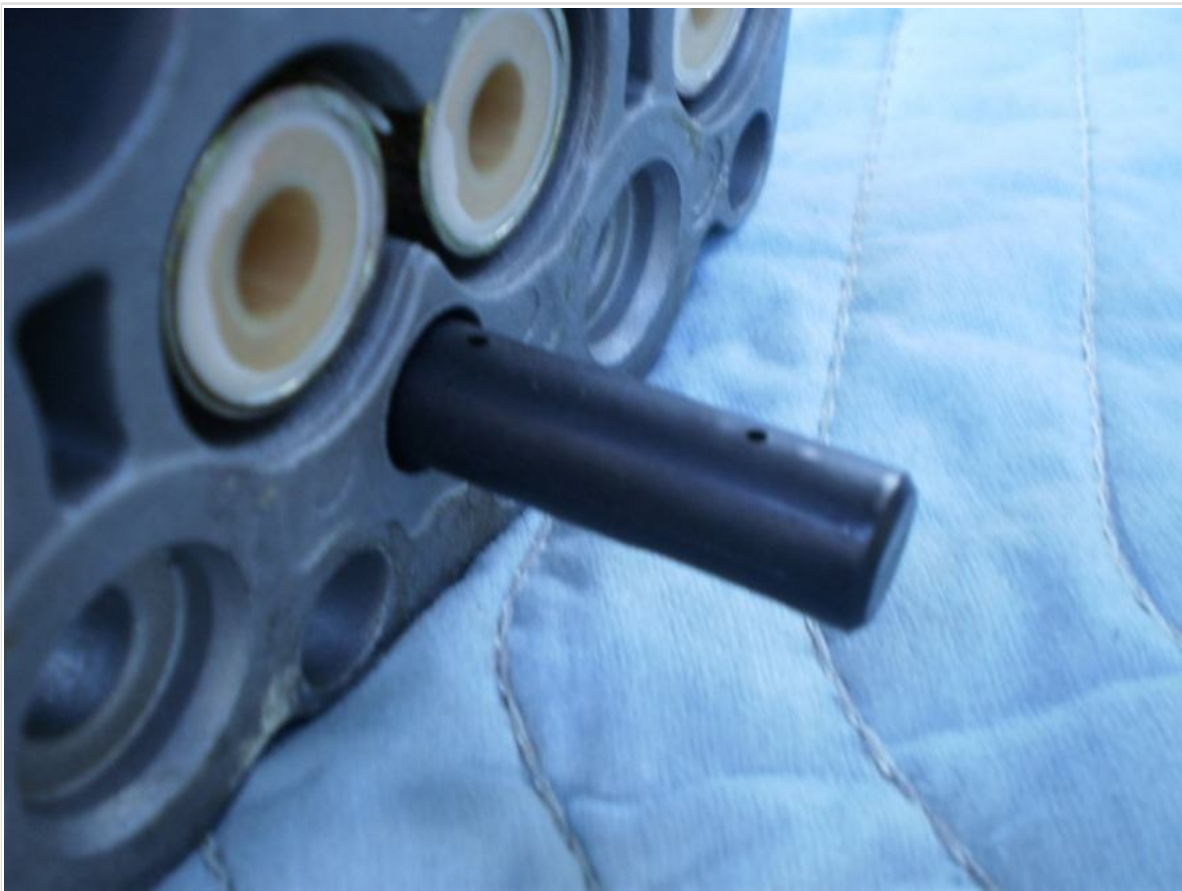
32. Disconnect the SVS plug. Flip the modulator side "right side up" so the SVS circuit board is at the bottom with the pins facing down. This is the part that requires surgery.

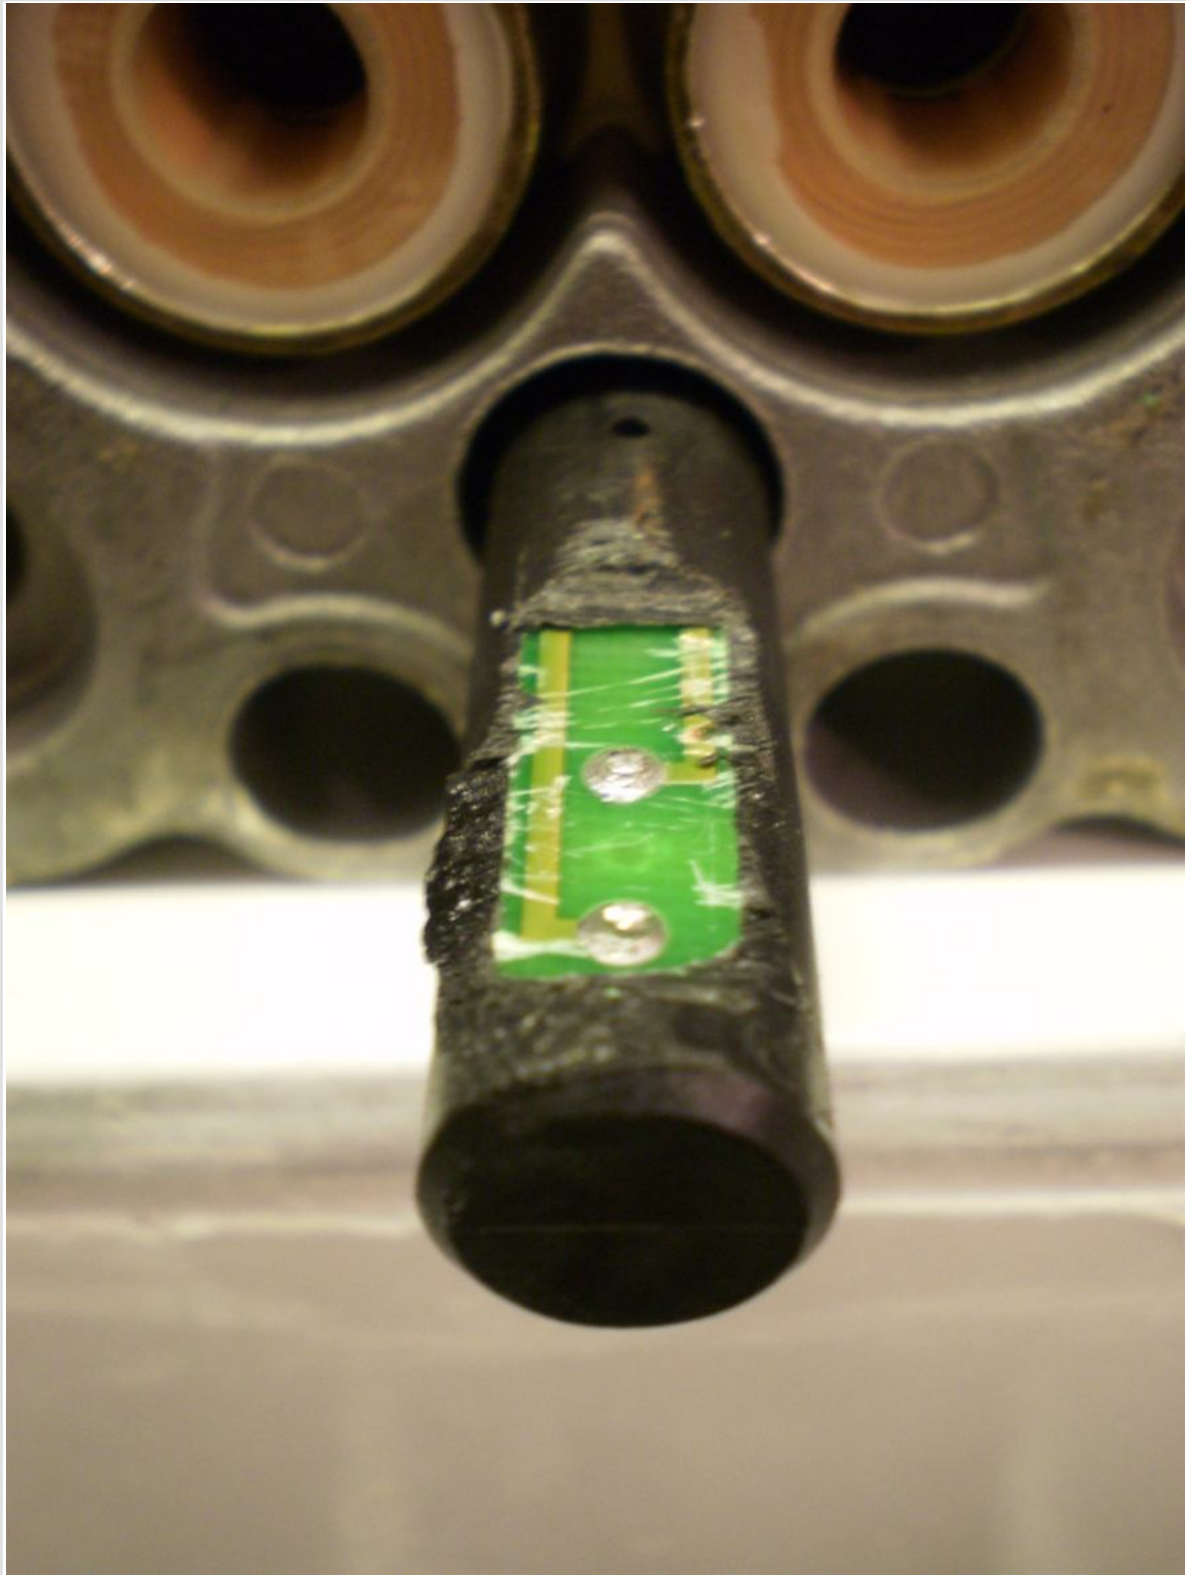
My surgery worked SO well that I cut too deep into the circuit board lines which made this whole repair worthless. FAIL....

The new challenge I had was that I completely destroyed the circuit board and even straight wiring it (Option C) would not work.

Since I severed the connections on the SVS circuit board, I created a permanent open scenario resulting in a permanent SVS Electrical Fault. The fix? Option B.

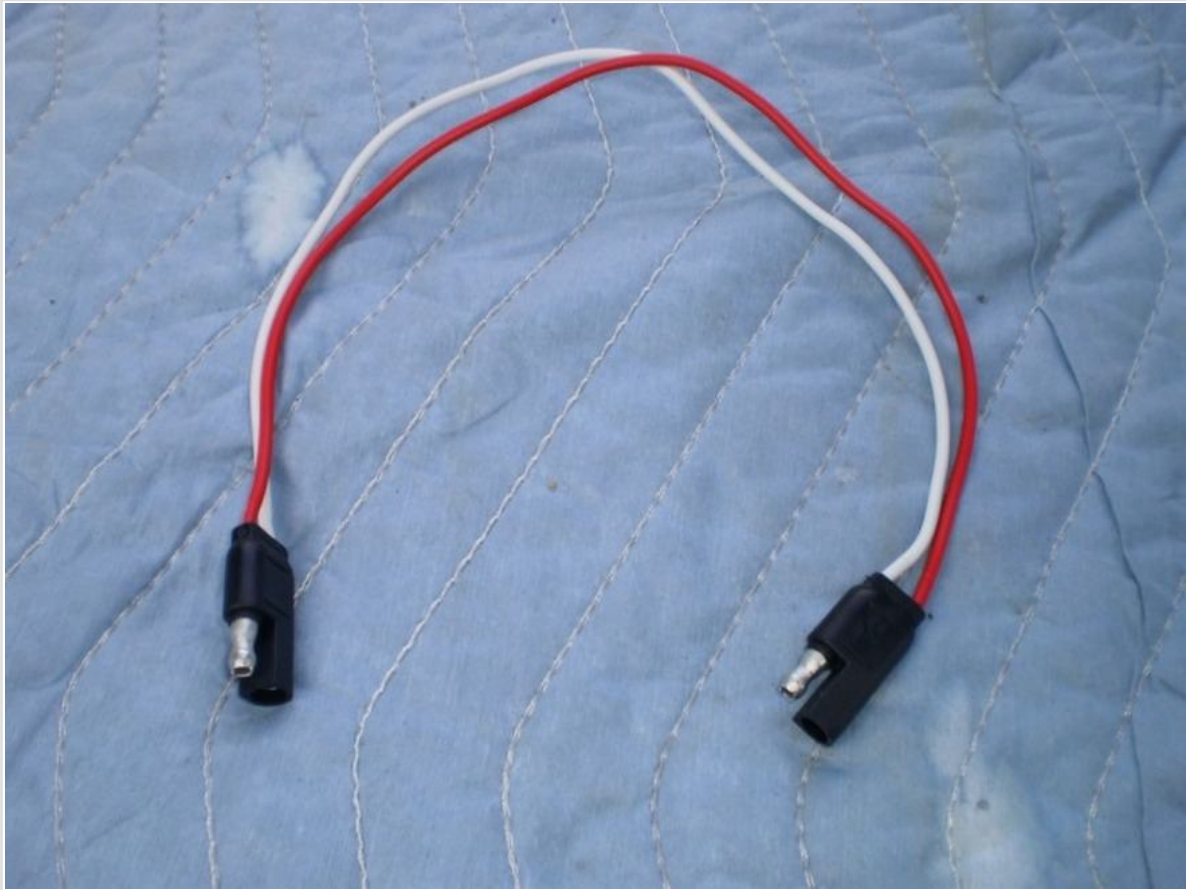
37. You need to decide how you want to connect and run the wires. Read through all of OPTION B to get a better understanding. I chose a trailer connector harness for a few bucks. I cut my connector 3/4 of the length.

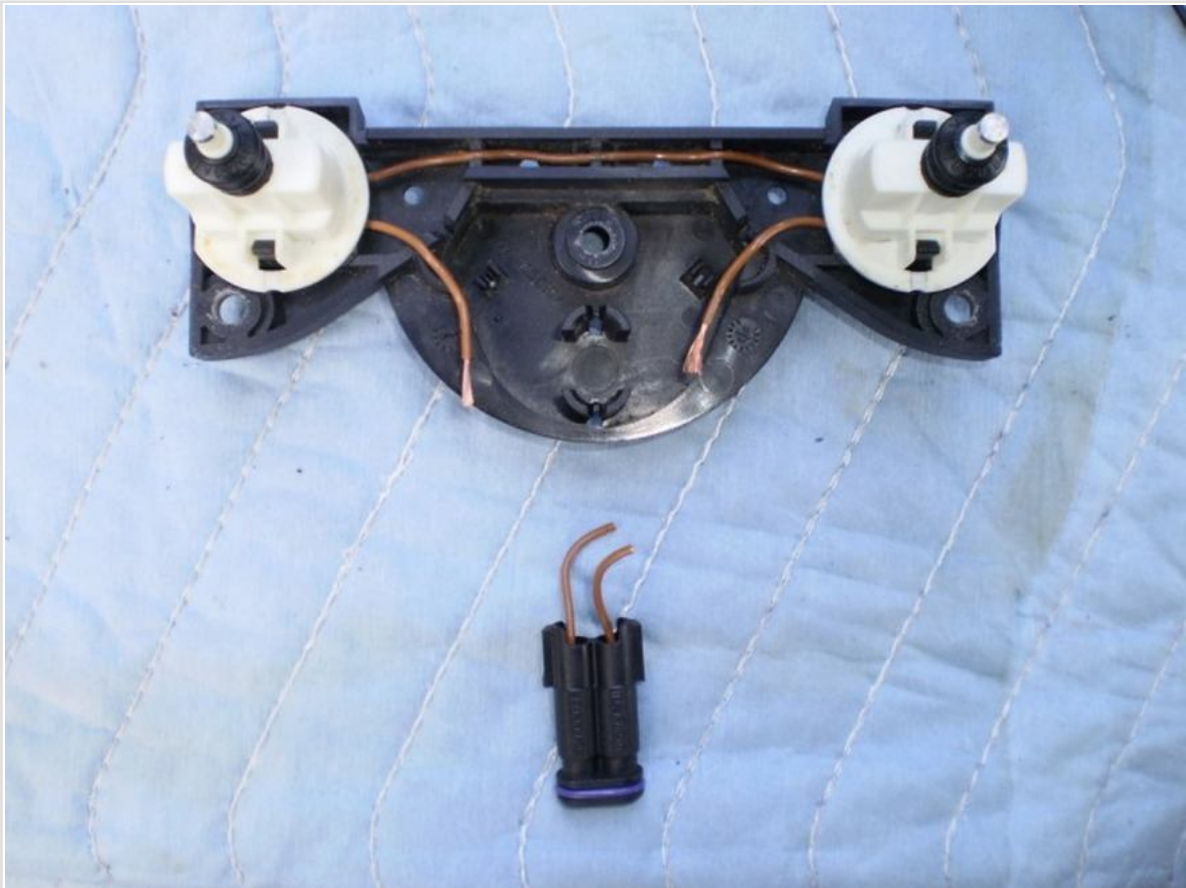
38. Remove your SVS any method you desire, Option A, or Option B without removing the modulator side (see steps # 25 through # 29) Cut SVS plug, but unlike my cut illustrated below, cut as close to the plug as possible.

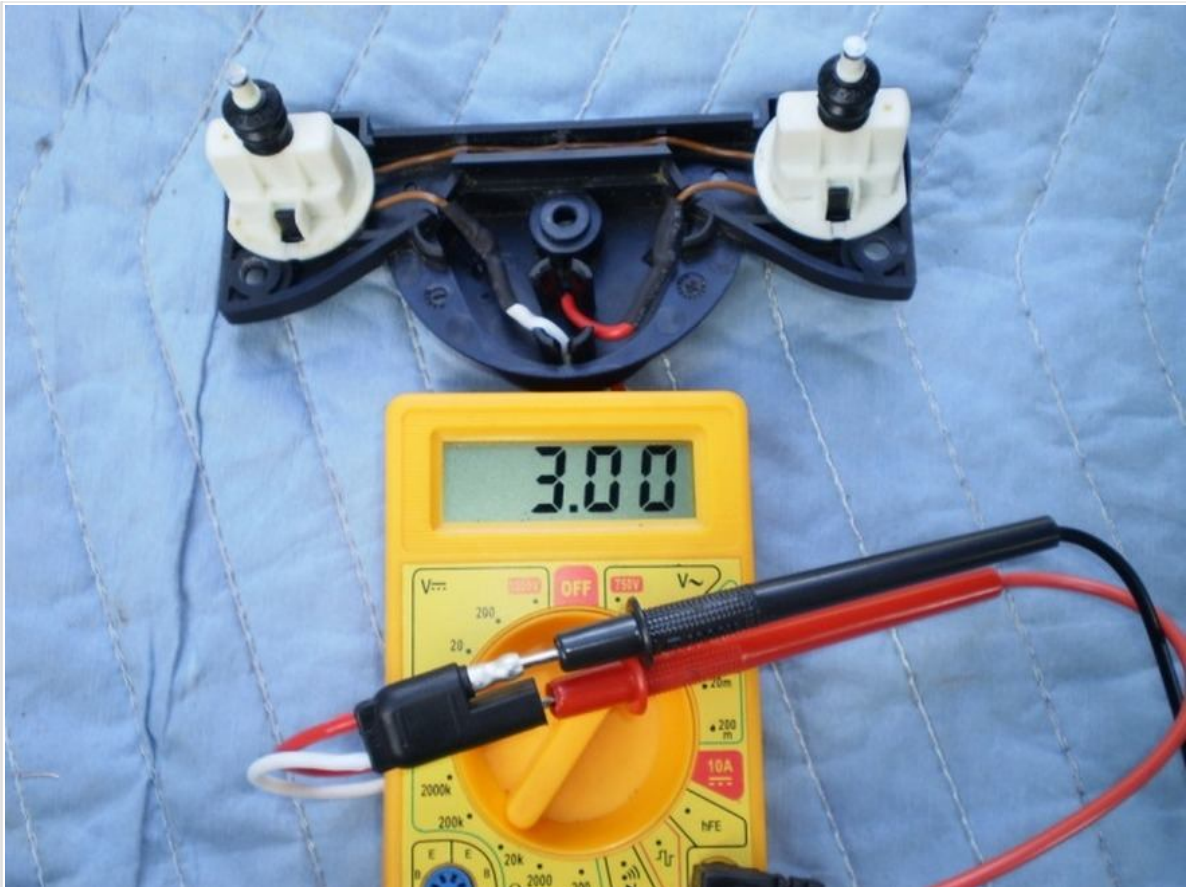
BOTH open, PASSED.

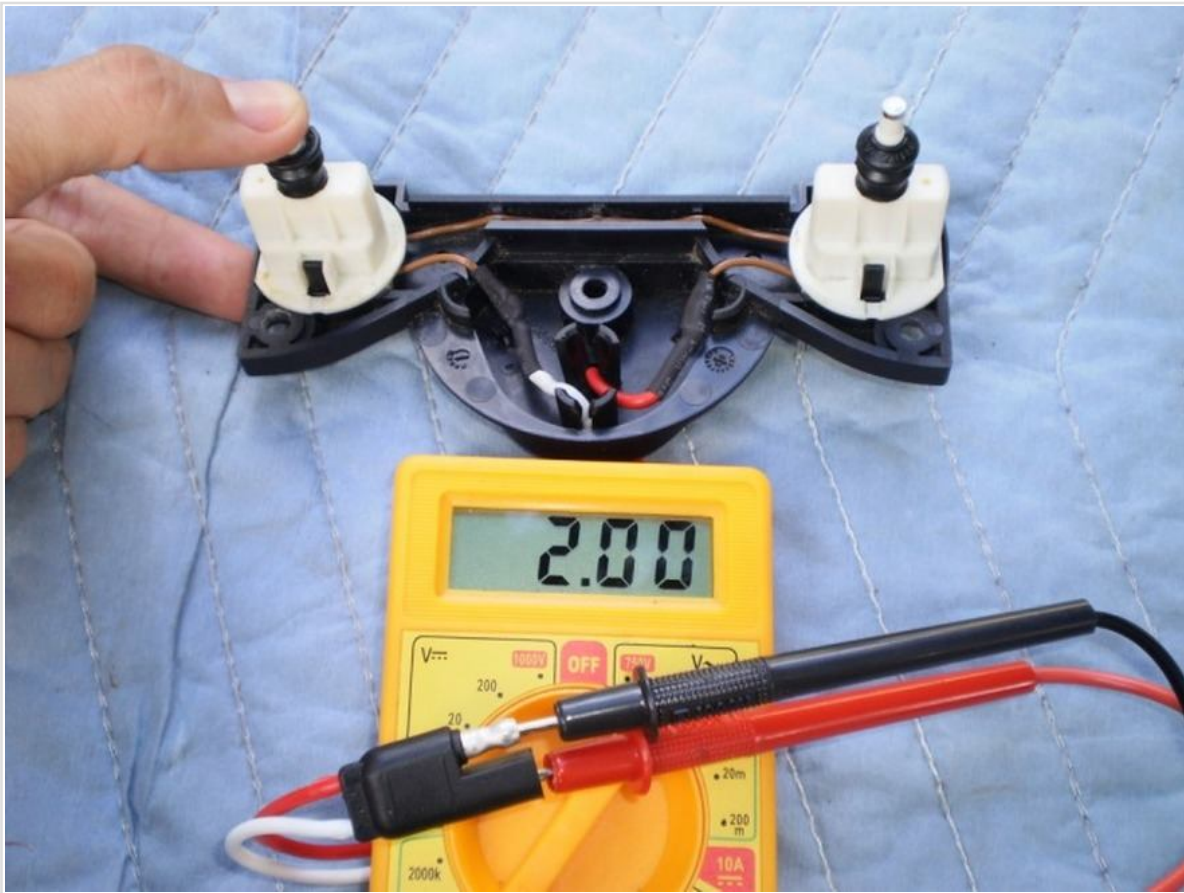
ONE Closed, PASSED.

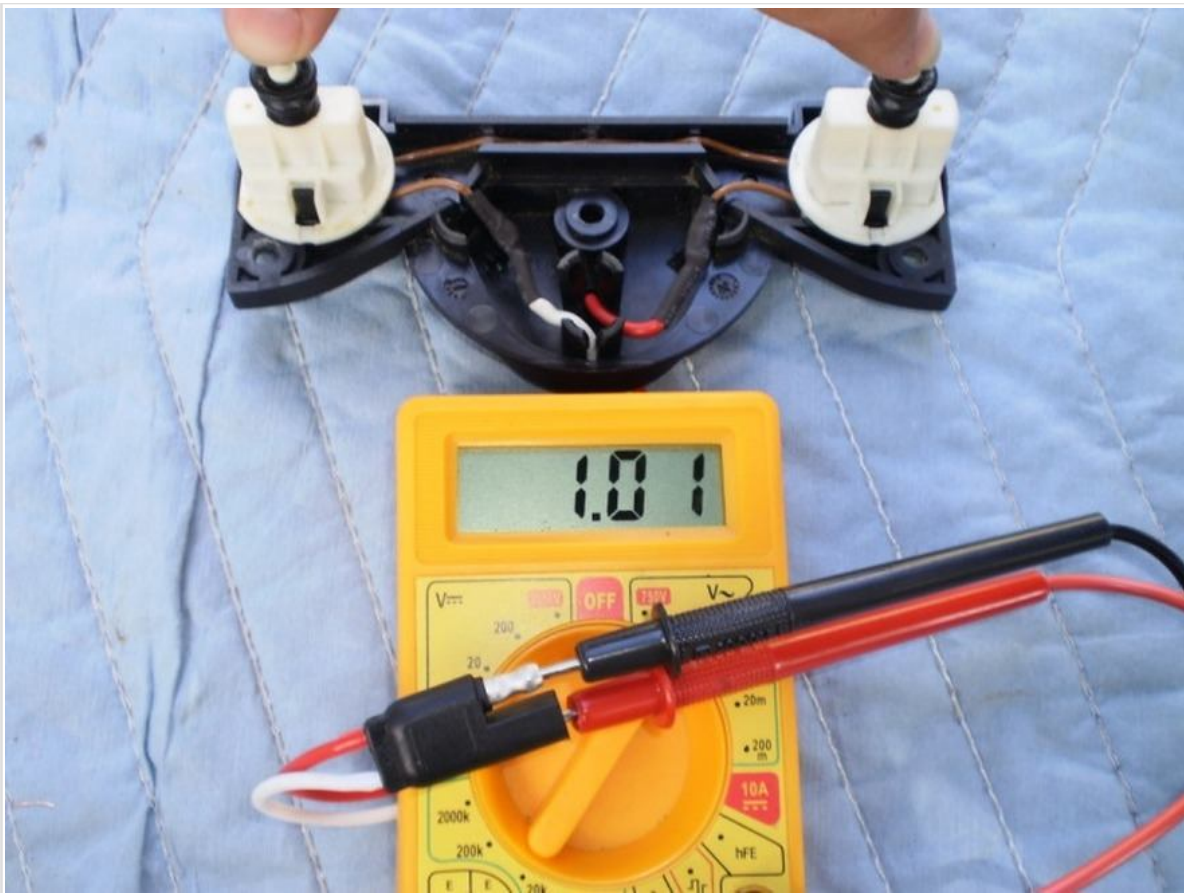
BOTH Closed, PASSED.
