# LAND ROVER CLUB V.I. (/web/20170823072904/http://landroverclubvi.weebly.com/)

## REPLACING SHUTTLE VALVE SEALS

7/2011

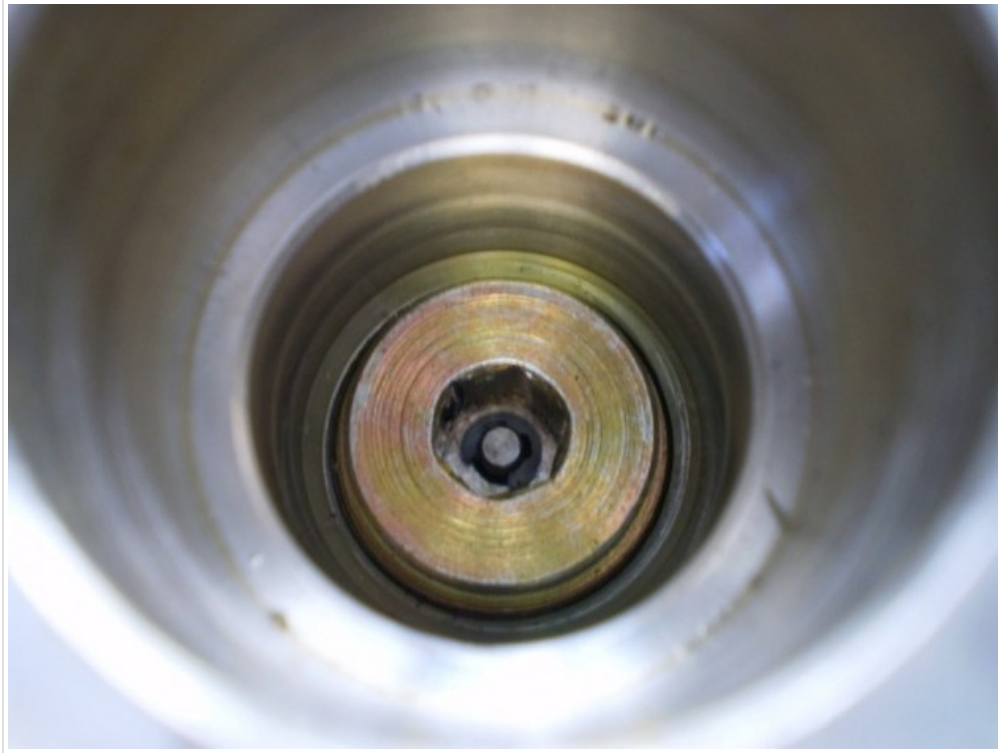
2. Remove the plug with a 6mm HEX key. Use magnet to lift out.

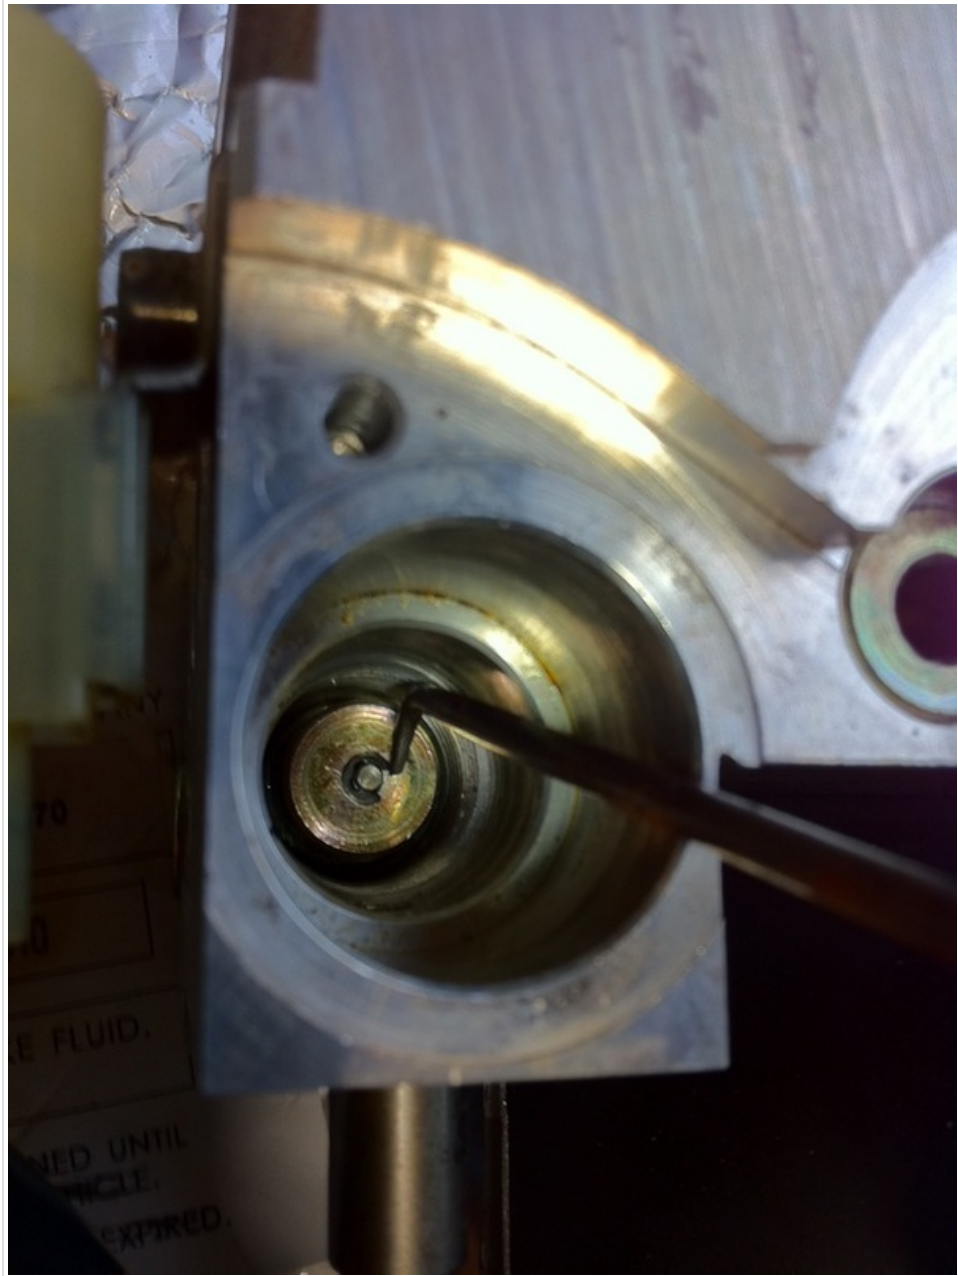
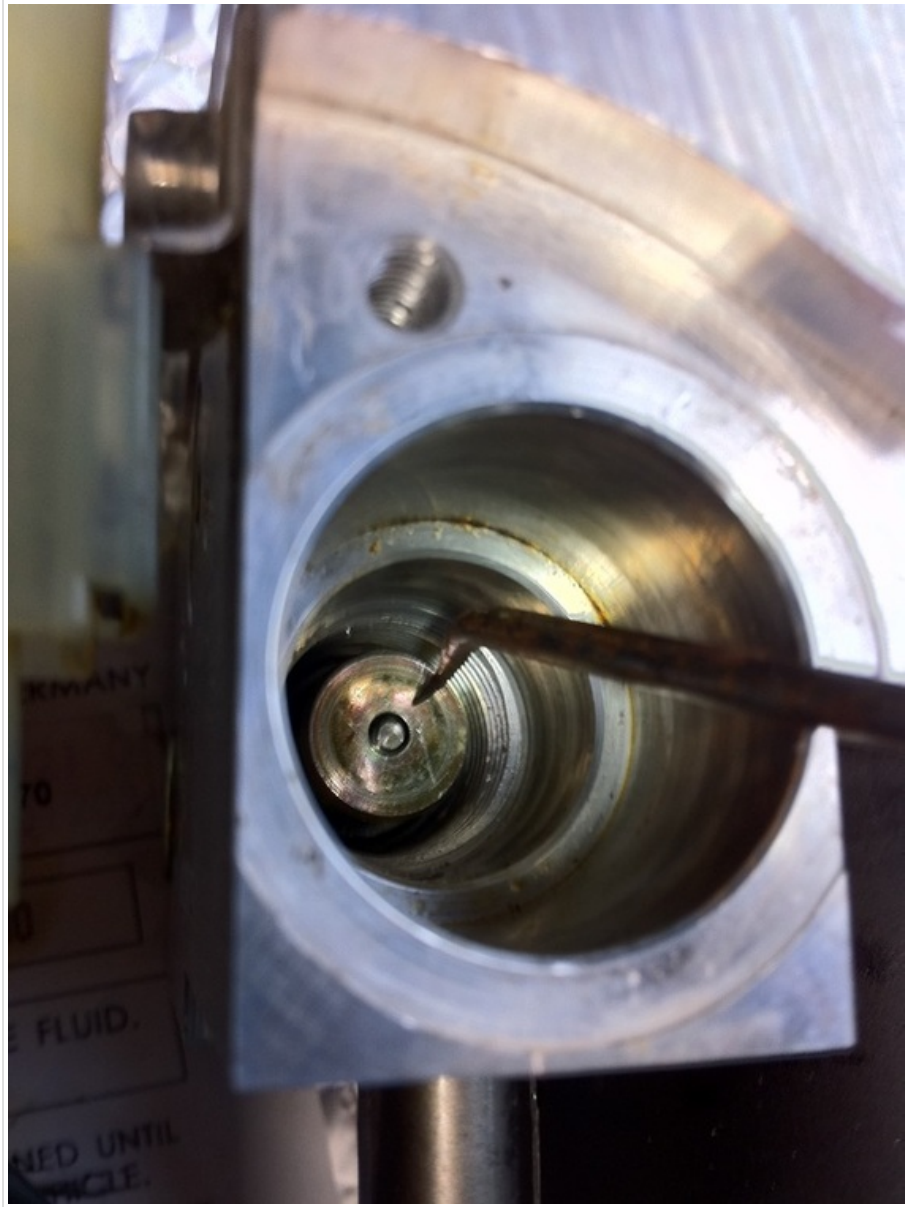
3. Carefully remove circlip.

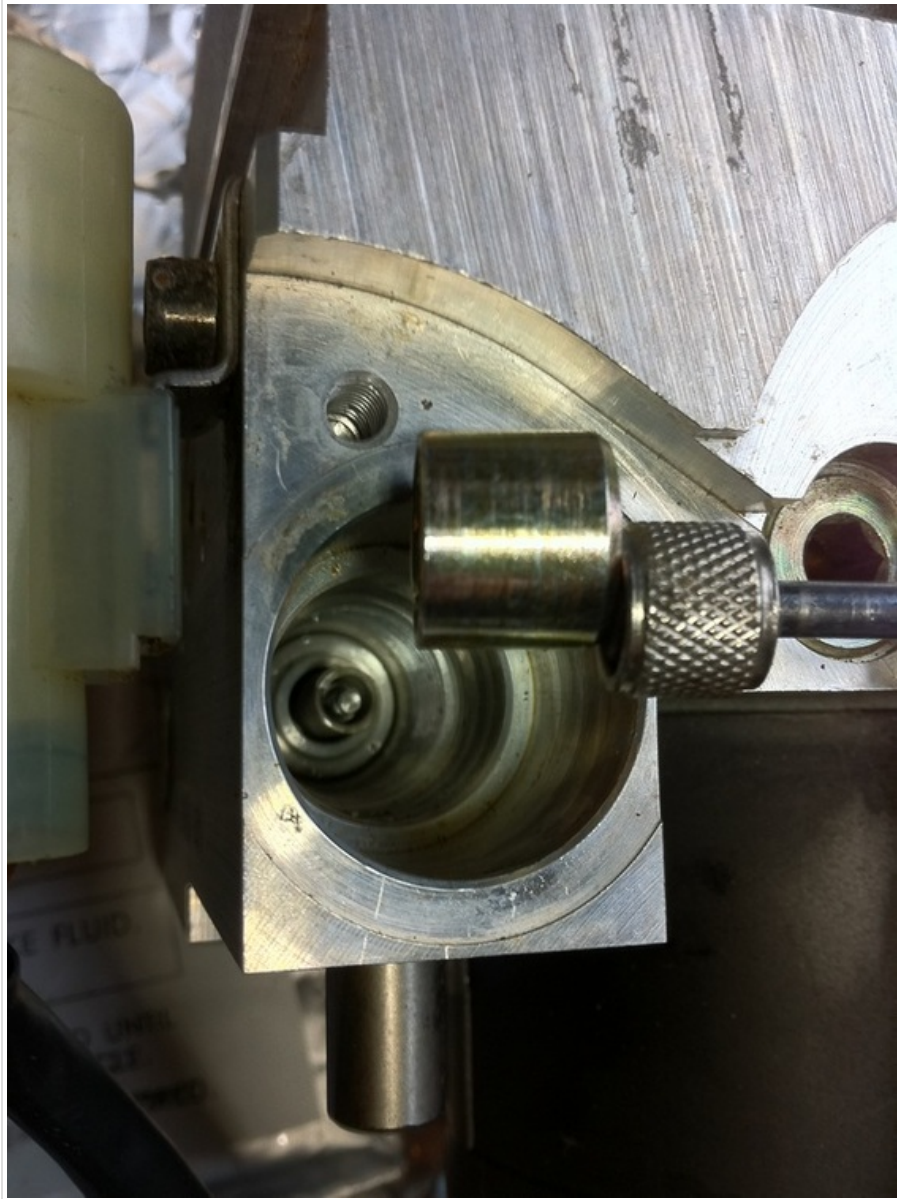
4. Use magnet and remove spacer.

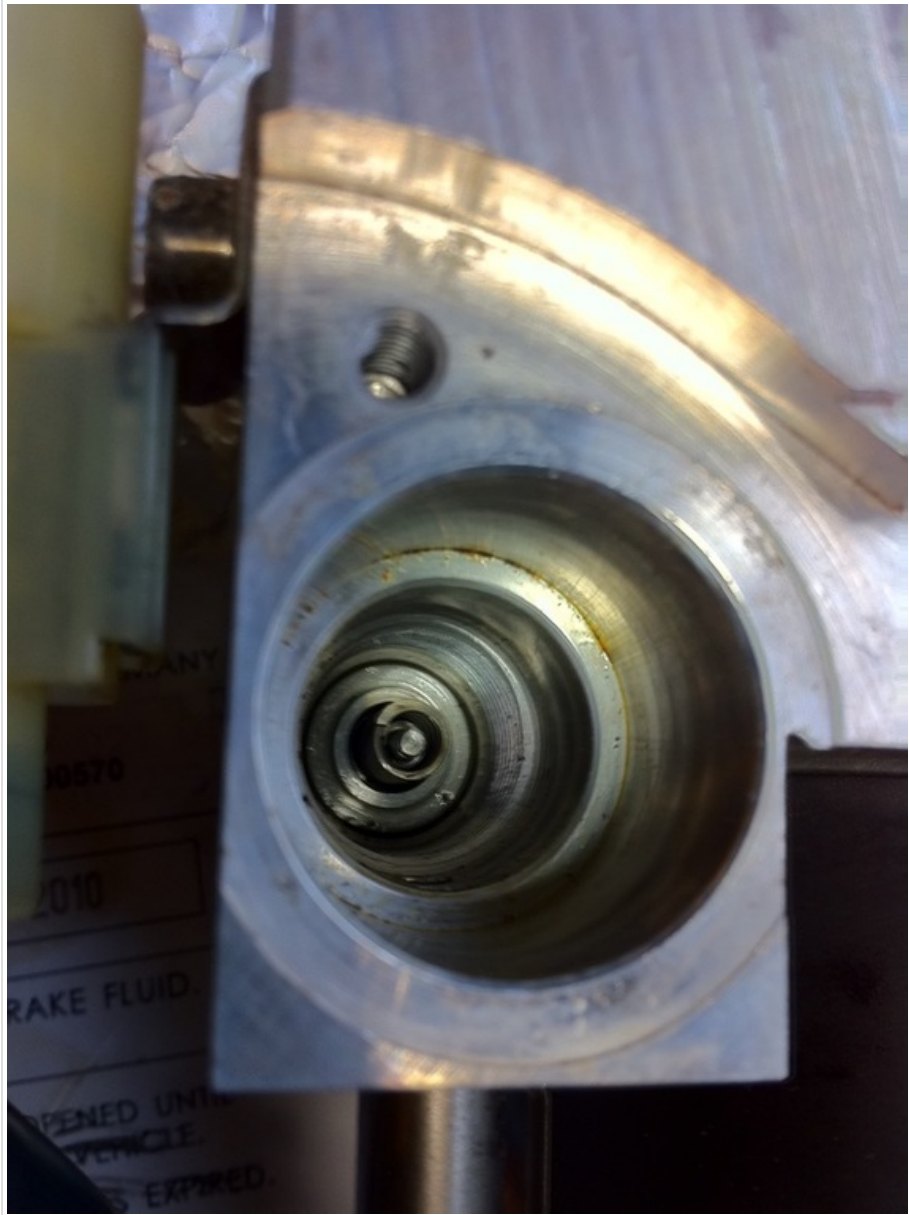
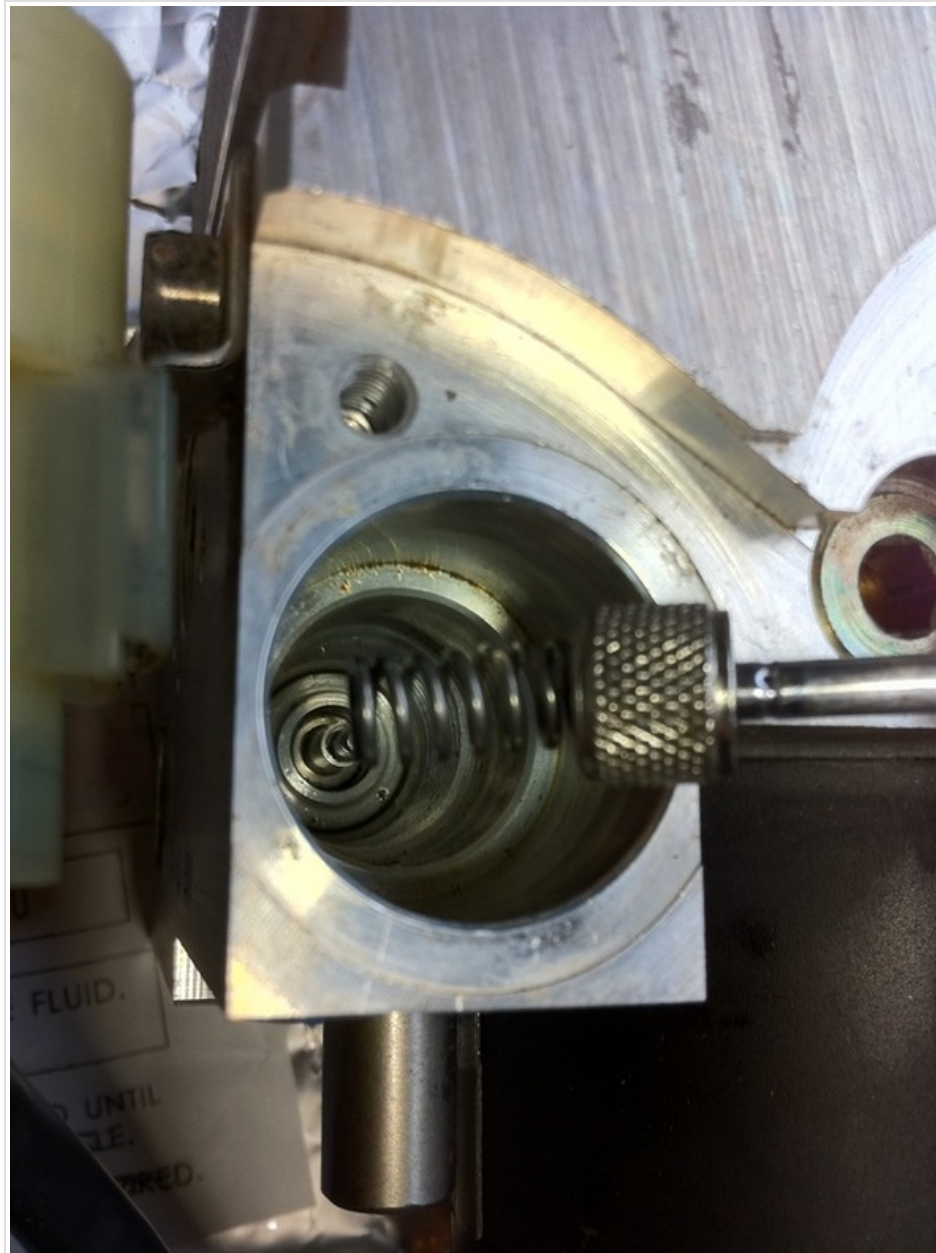
5. Use magnet and remove spring.

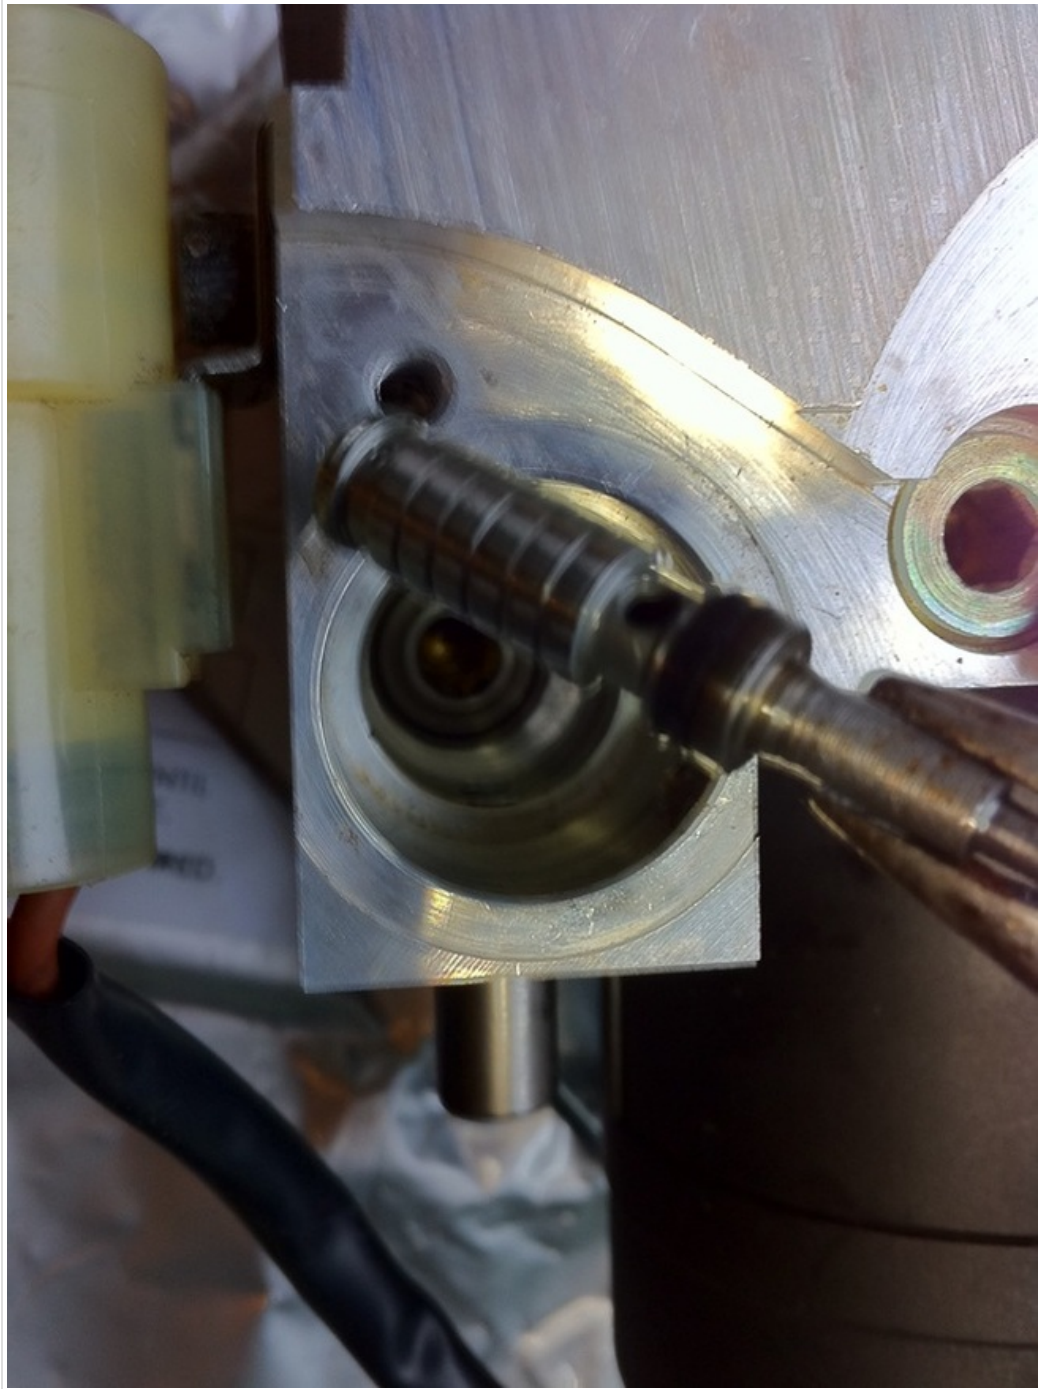
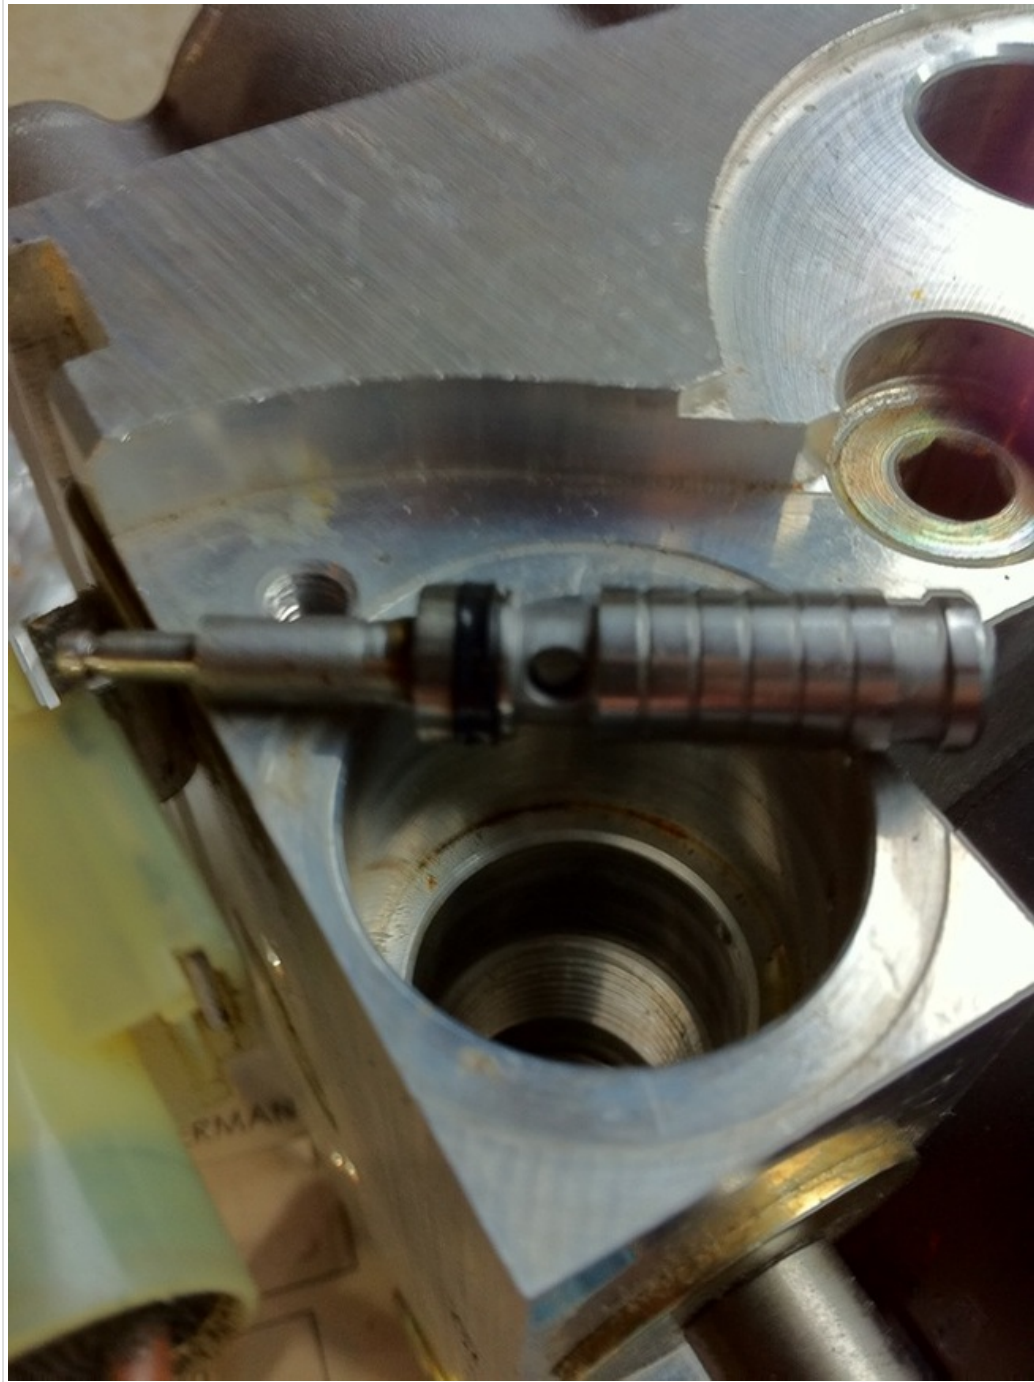
6. Use needle nose pliers (preferably with 45 degree bend) and pull upward on the plunger to remove.

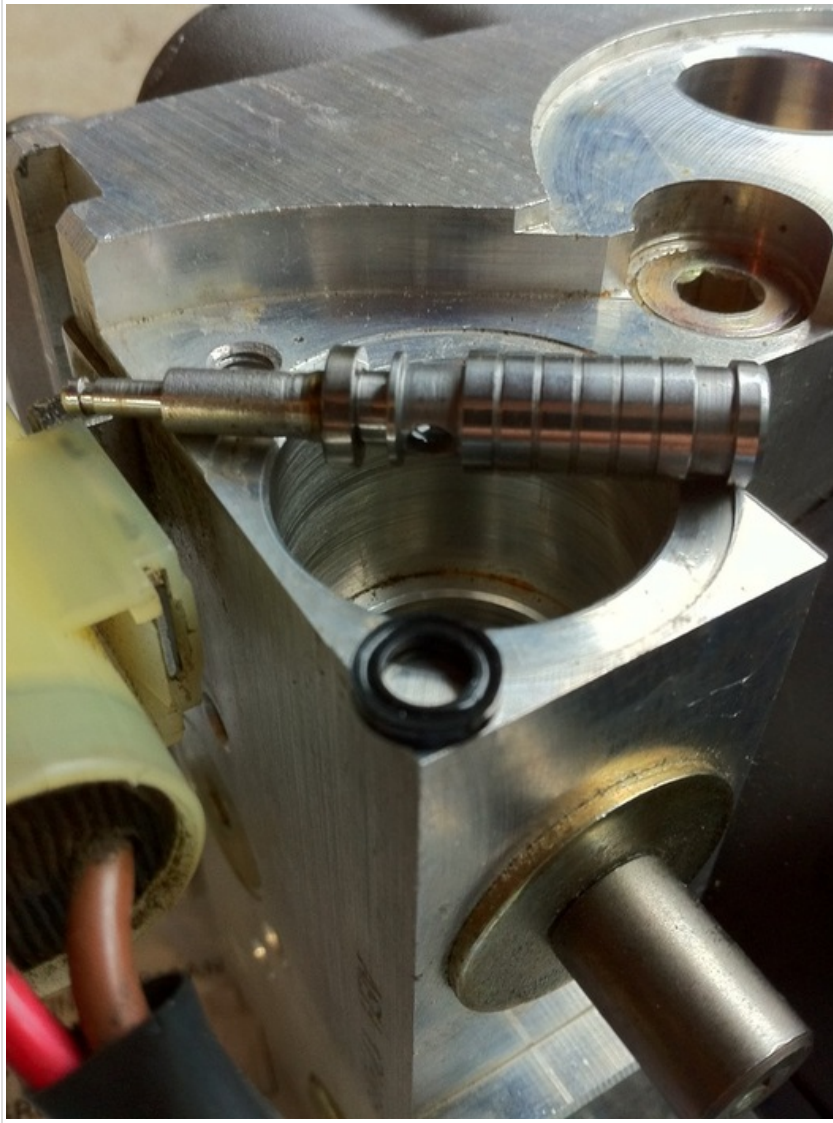
7. Remove seal from plunger.

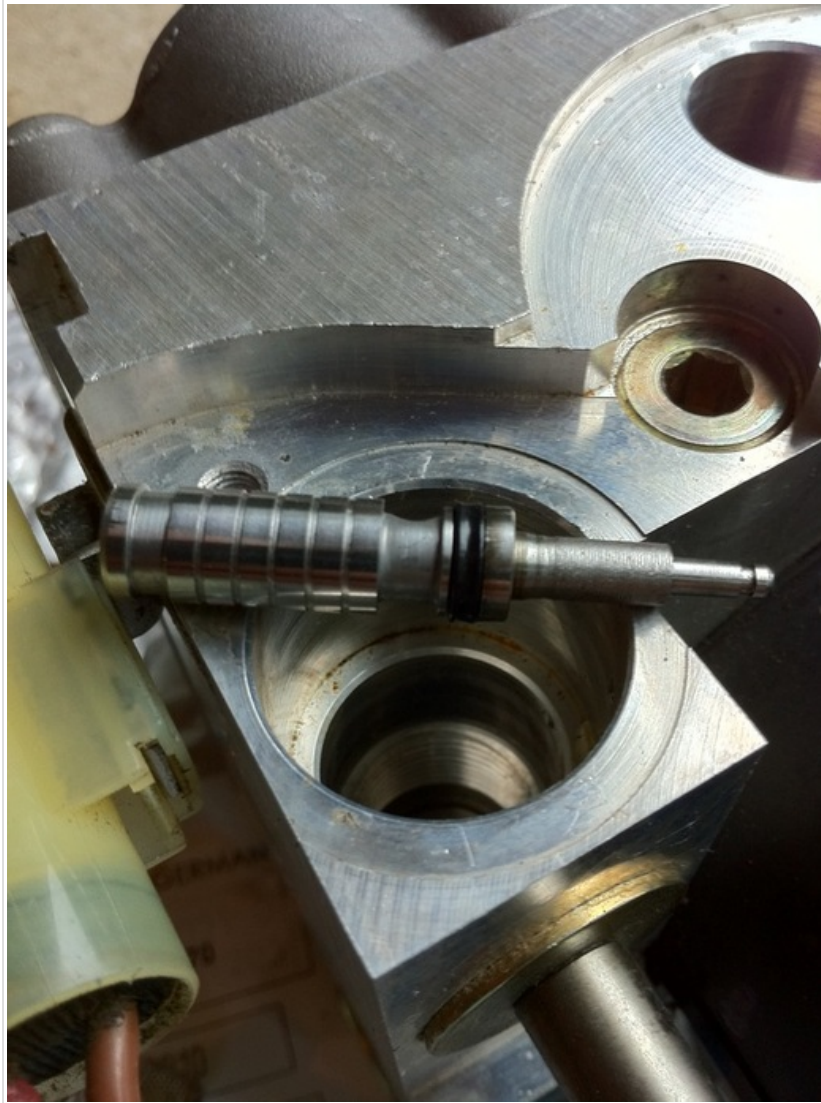
8. Install NEW o-ring.

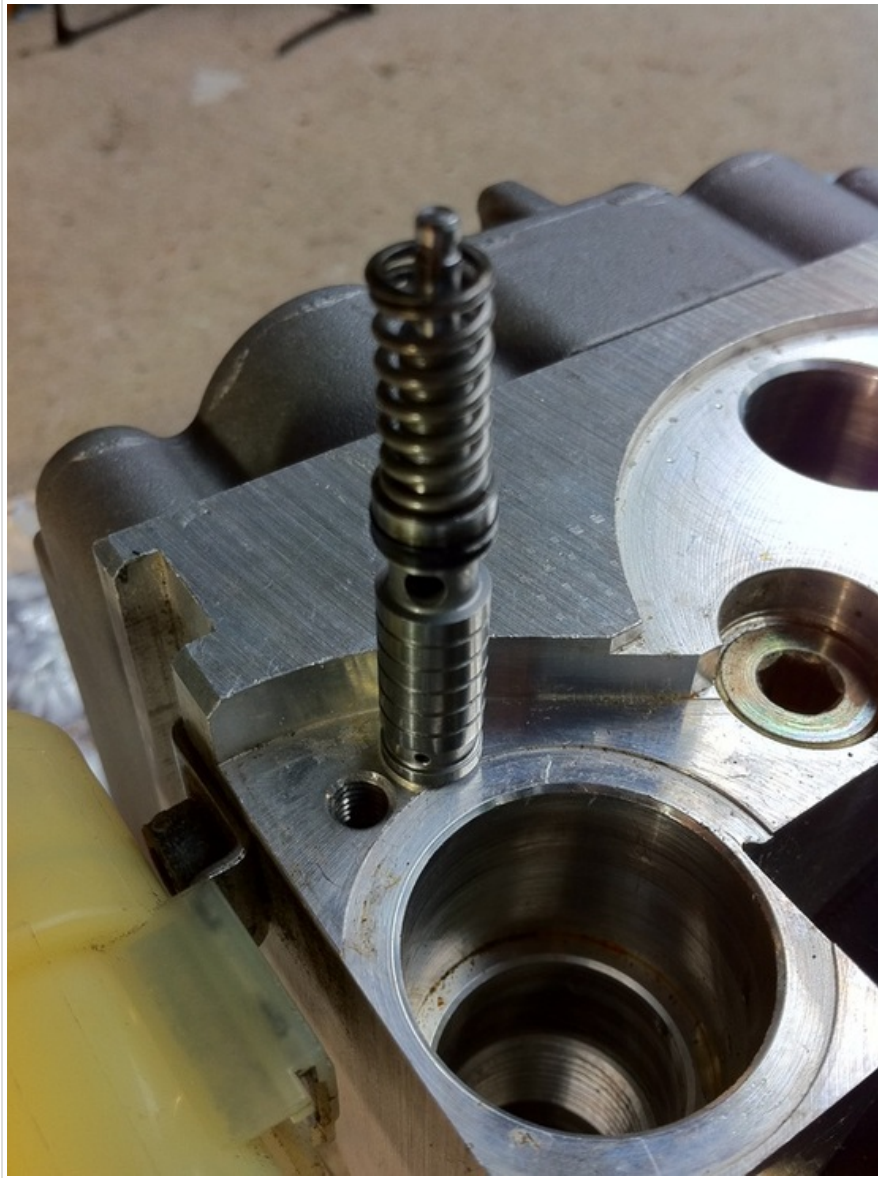
9. Assemble spring.

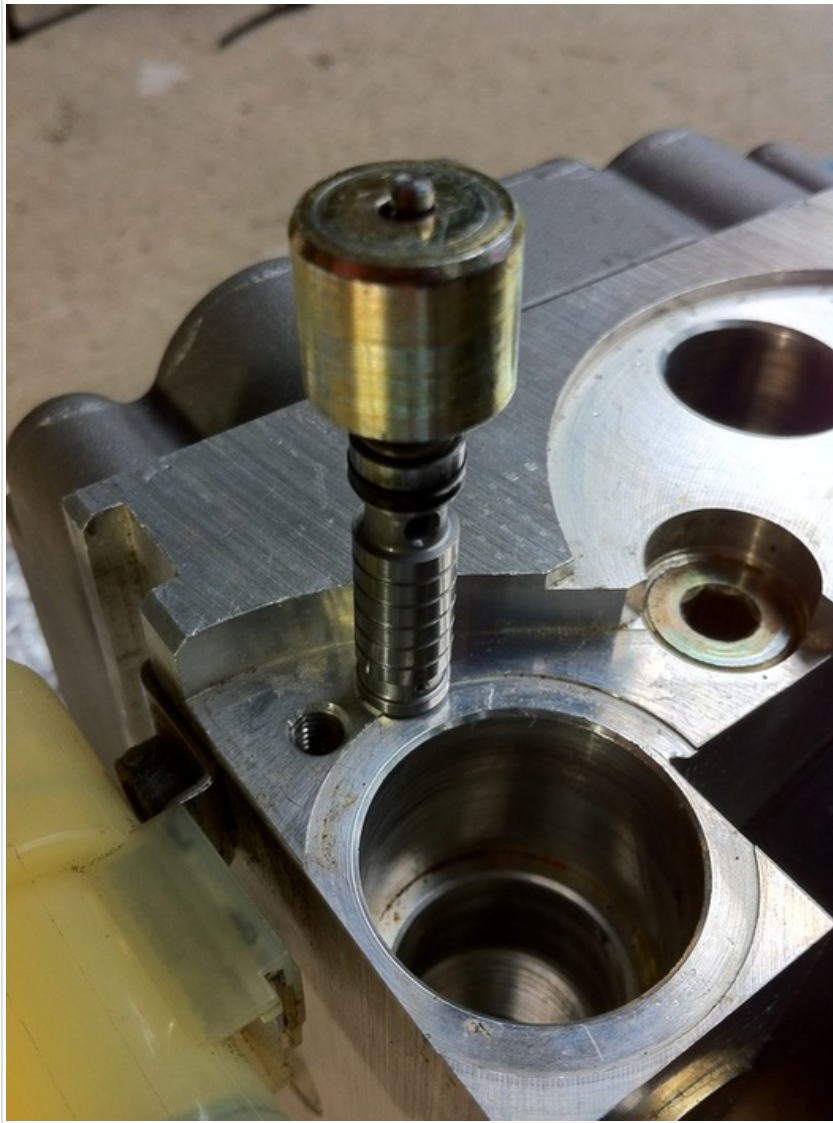
10. Assemble spacer.

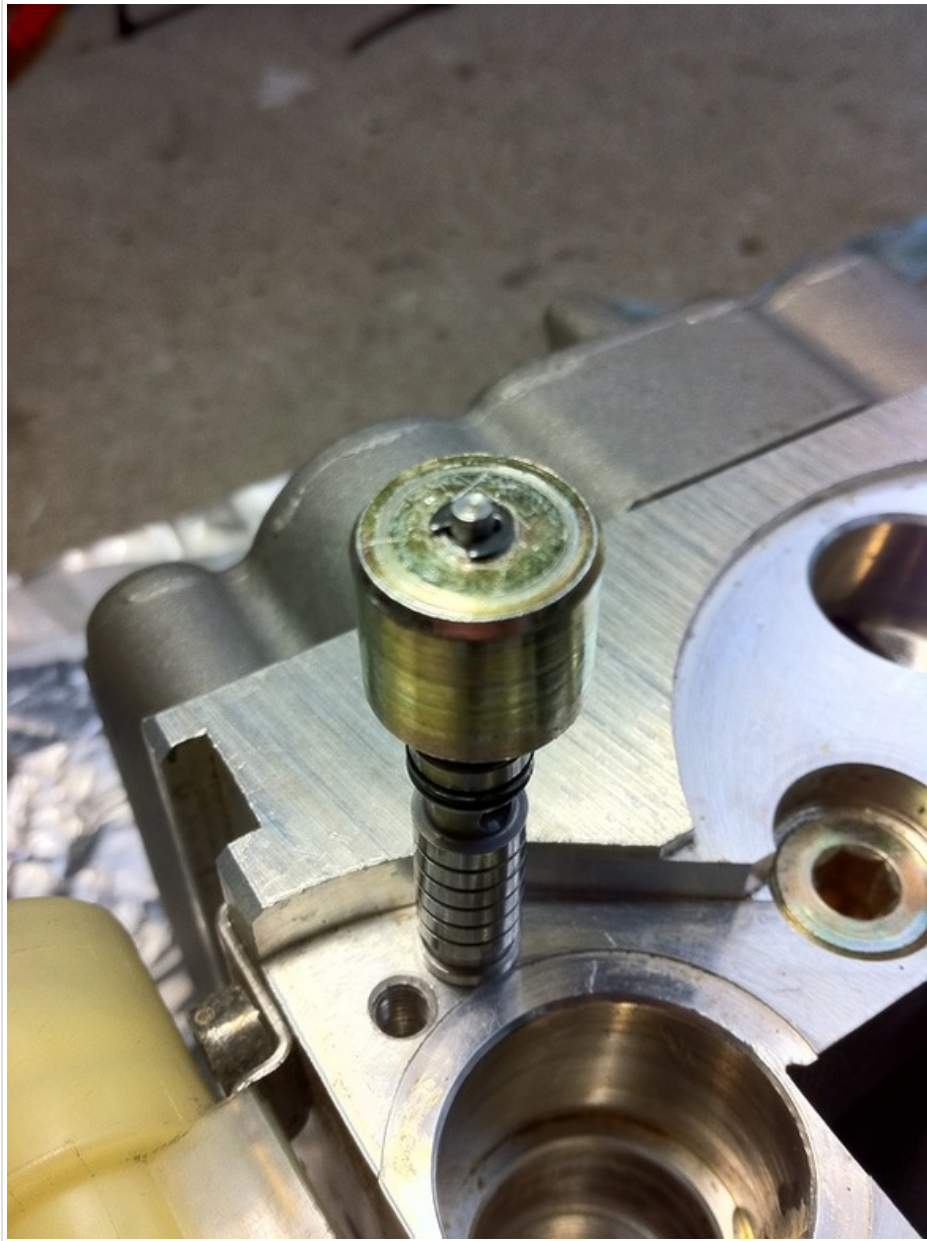
11. Install NEW circlip. (Falconworks instructions call for securing TWO circlips on each plunger)

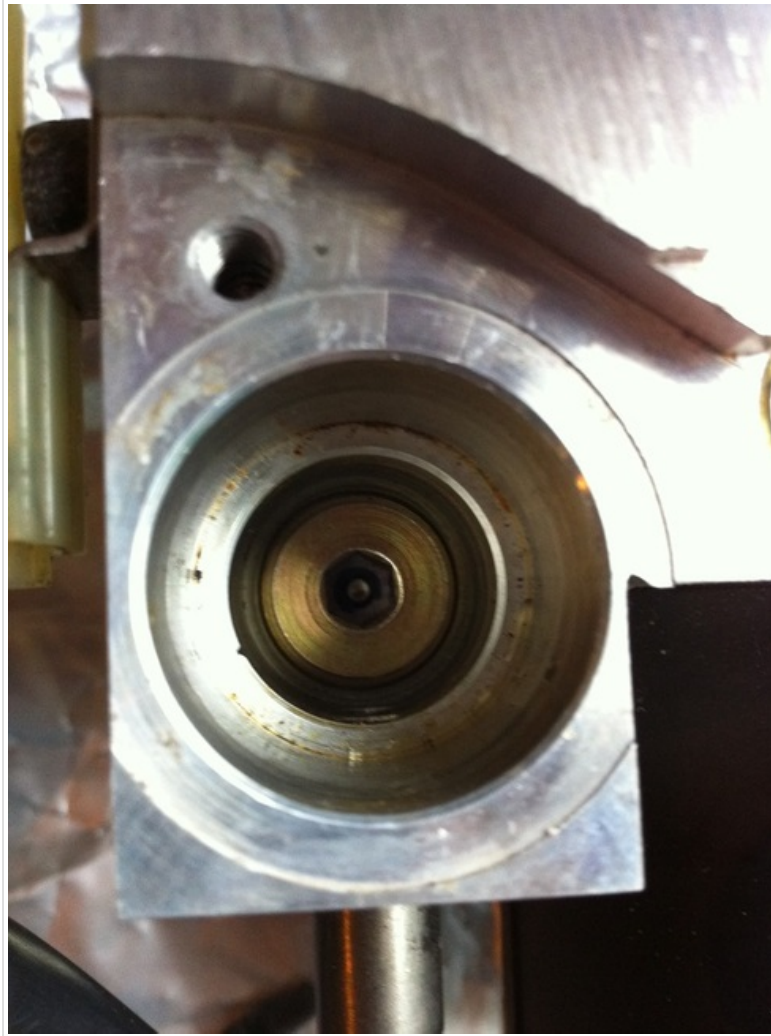
12. Install plunger assembly into modulator. Ensure it goes down fully seated.
