ABS MODULATOR ELECTRICAL FAULT REPAIR

11/2009

The Land Rover Discovery Series II uses the same ABS MODULATOR as the H1 Hummer. The company that manufactures it is **WABCO** (<https://web.archive.org/web/20170730071921/http://www.wabco-auto.com/>) (Meritor WABCO (https://web.archive.org/web/20170730071921/http://www.meritorwabco.com/Page.aspx?page_id=1)). If you have been experiencing an intermittent fault causing your ABS, HDC, and TC lights aka *Three Amigos*, your problem may be a result of a bad electrical connection.

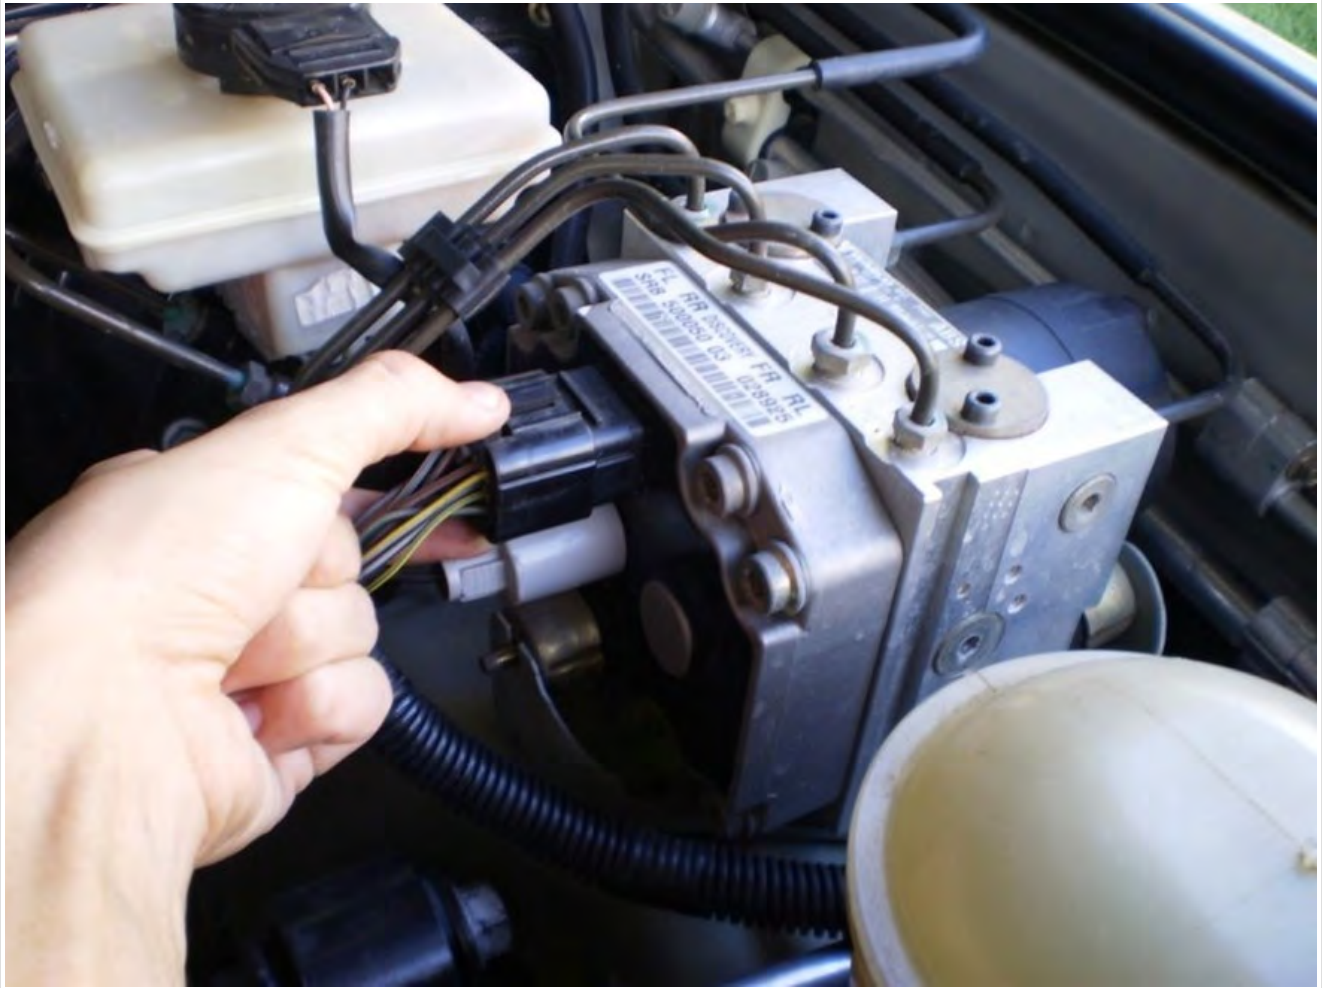
Removing black connector C0501 and grey connector C0500

3B. Remove the 3 electrical connectors form the modulator. Two on the front and one on the side.

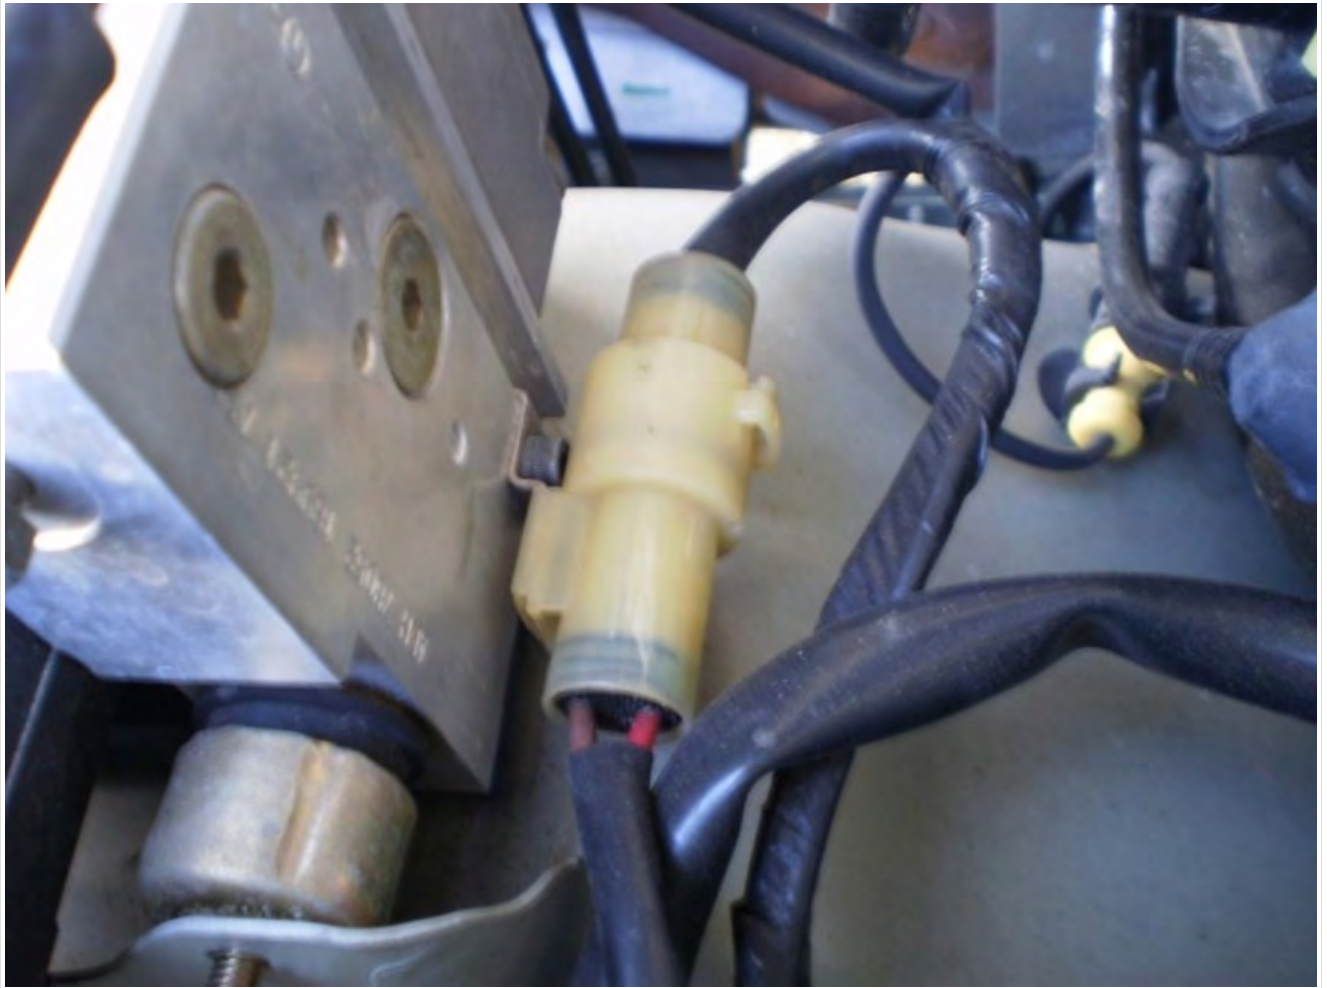
Side connector C0507

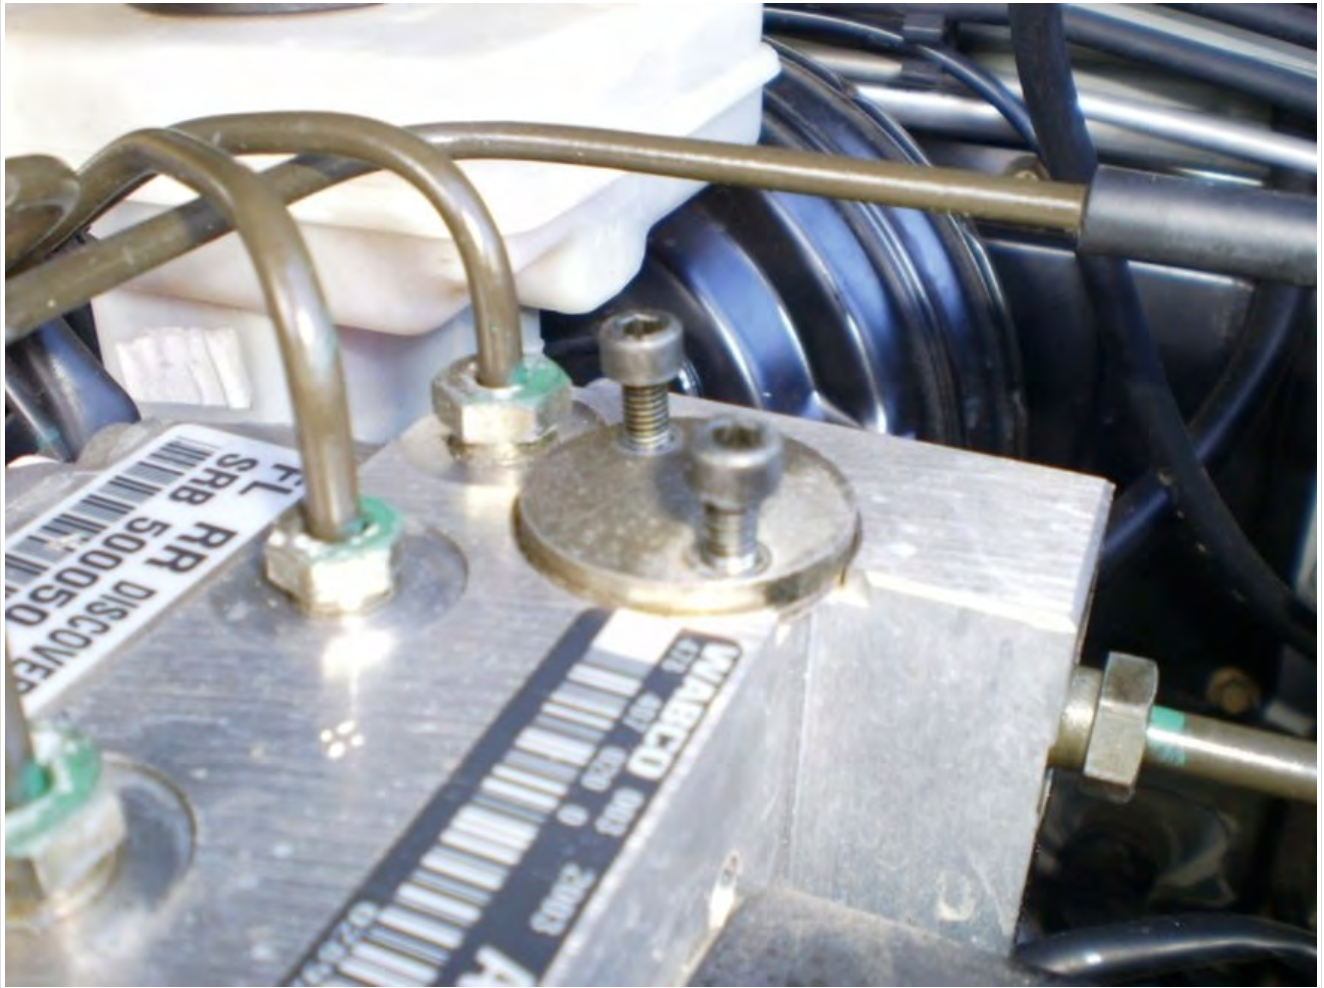
5. Brake loose the two bigger flare nuts using a 13mm wrench.

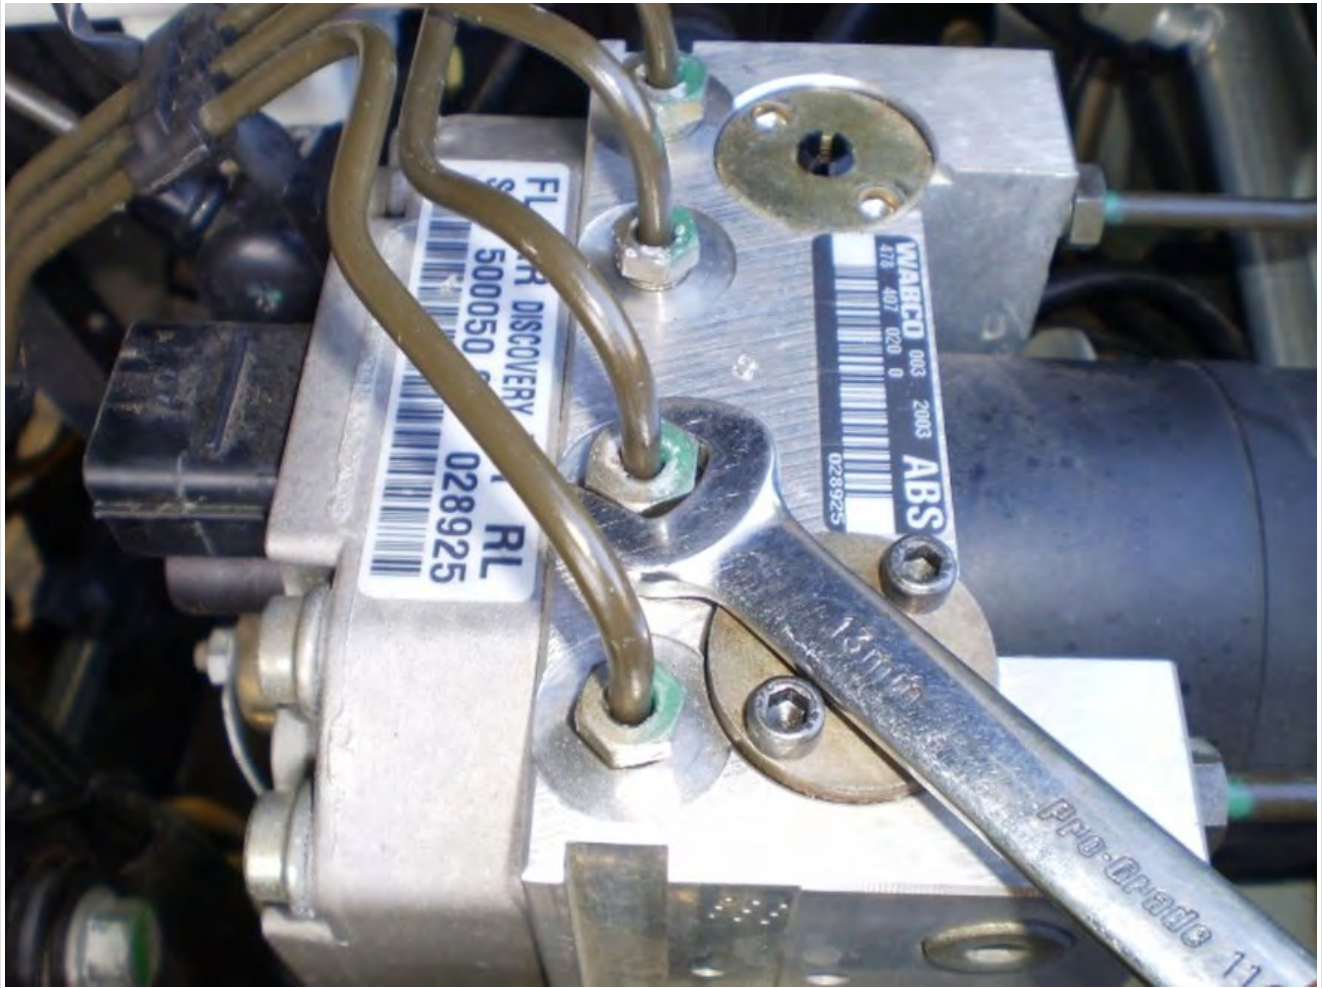
6. Brake loose the two smaller flare nuts using a 11mm wrench.

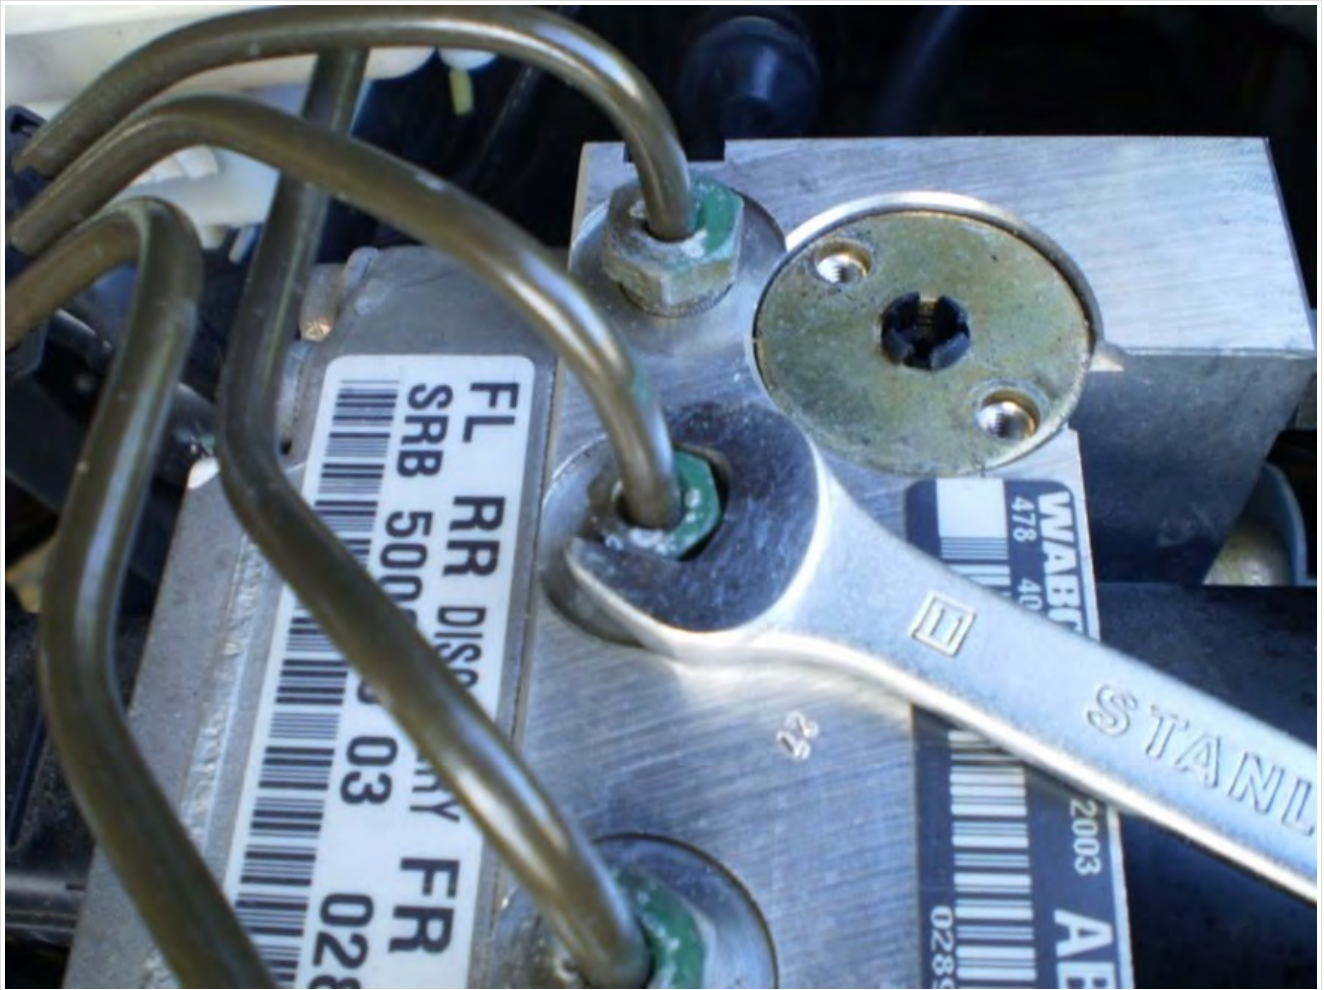
7. Brake loose the two side mounted brake line nuts using a 13mm wrench.

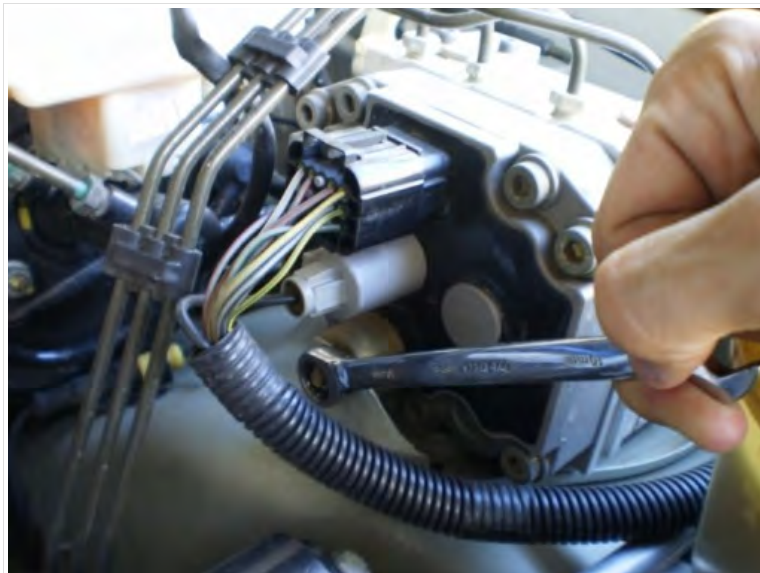
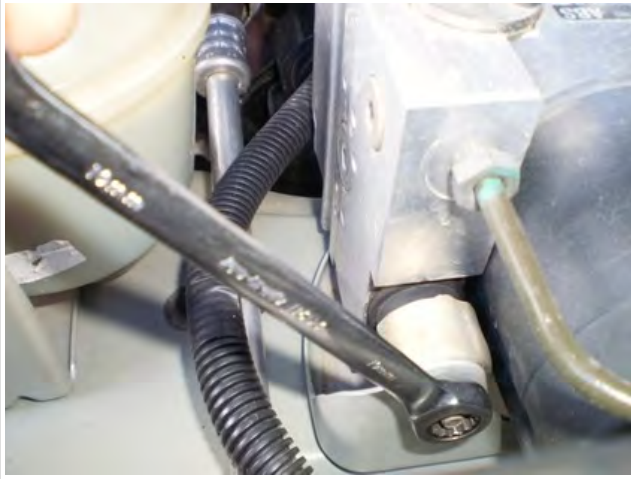
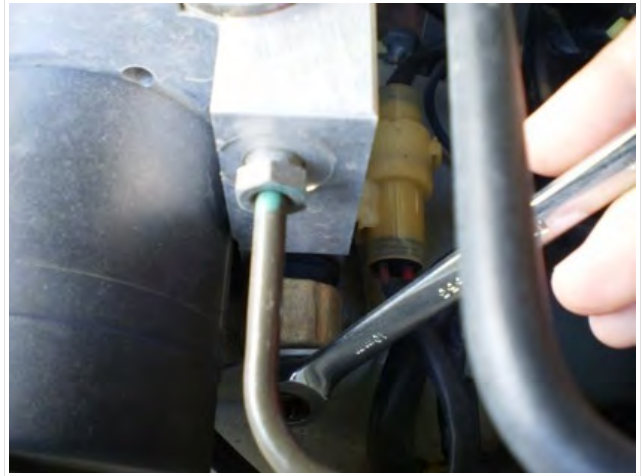
8. Once all 6 brake lines are broken loose, remove the 3 nuts securing the modulator on to its mounting bracket using a 10mm wrench.

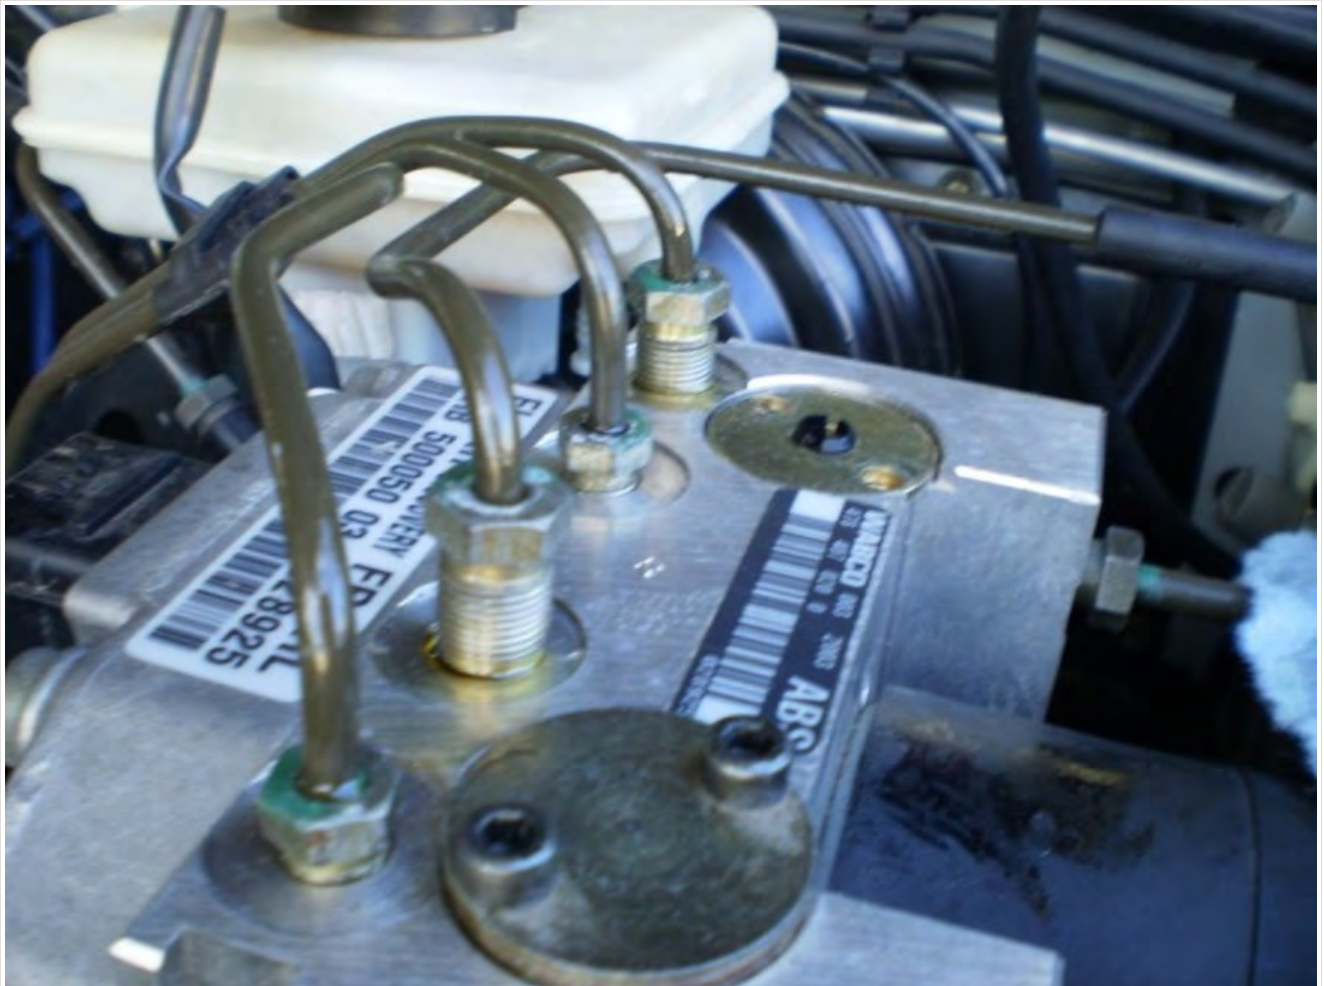
9. Unscrew and disconnect the two bigger brake lines. Brake fluid will be dispensed from both the lines and pump side. Have a shop towel nearby.

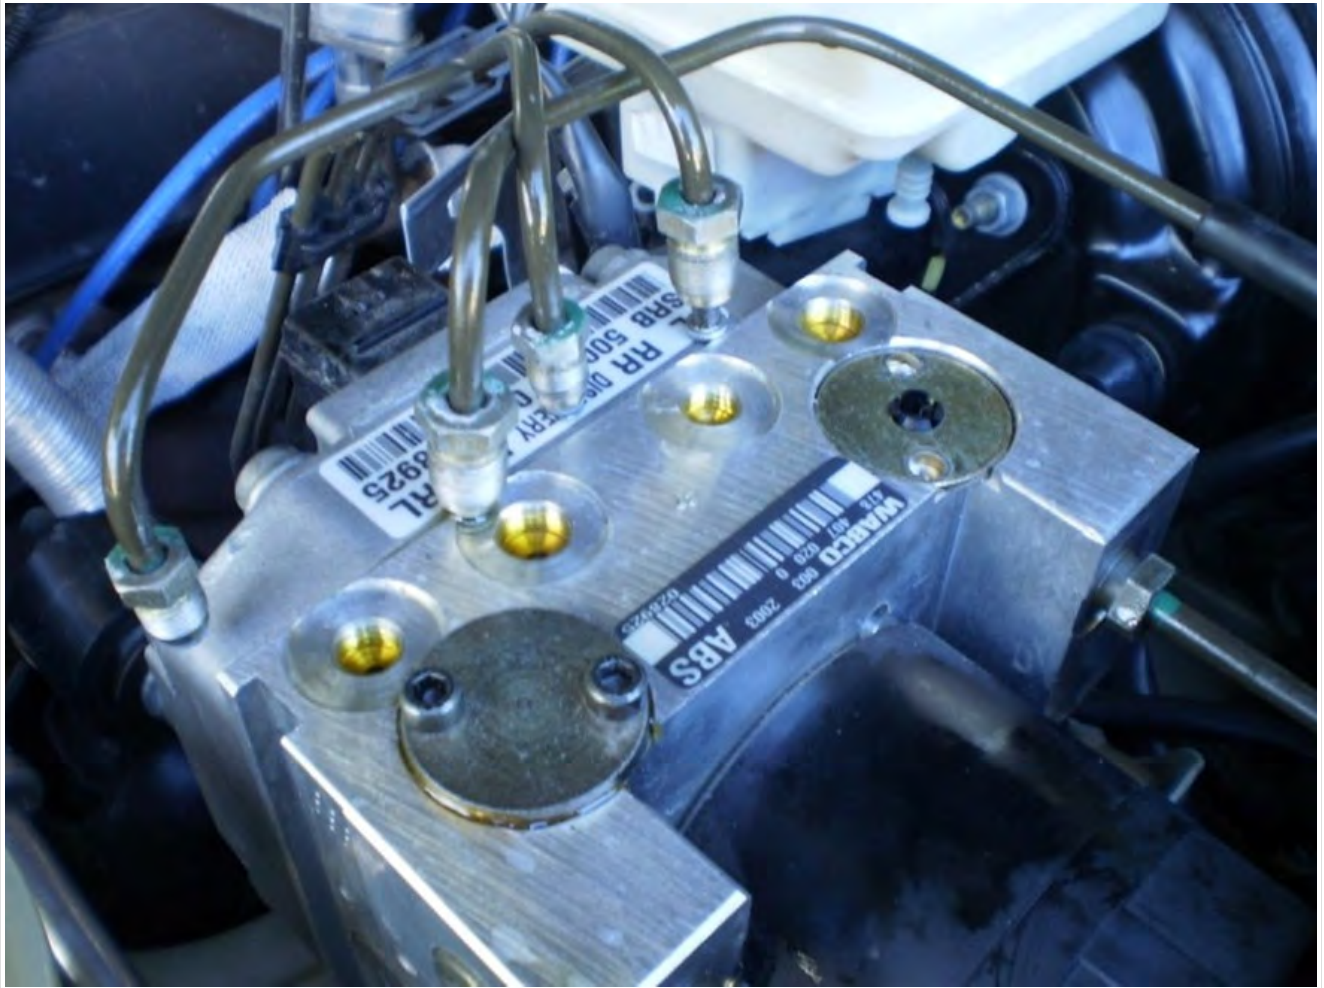
Luckily I had a second ABS modulator/pump that had plugs for all 6 brake line ports so I plugged them up. I also cut the fingers off a disposable rubber glove to keep the lines from dust contamination. It also helped catch some brake fluid. I recommend using a syringe or turkey baster to suck out the residual brake fluid from the modulator if you do not have brake plugs.

10. Unscrew and disconnect the two smaller brake lines. Brake fluid will be dispensed from both the lines and pump side. Have a second shop towel nearby.

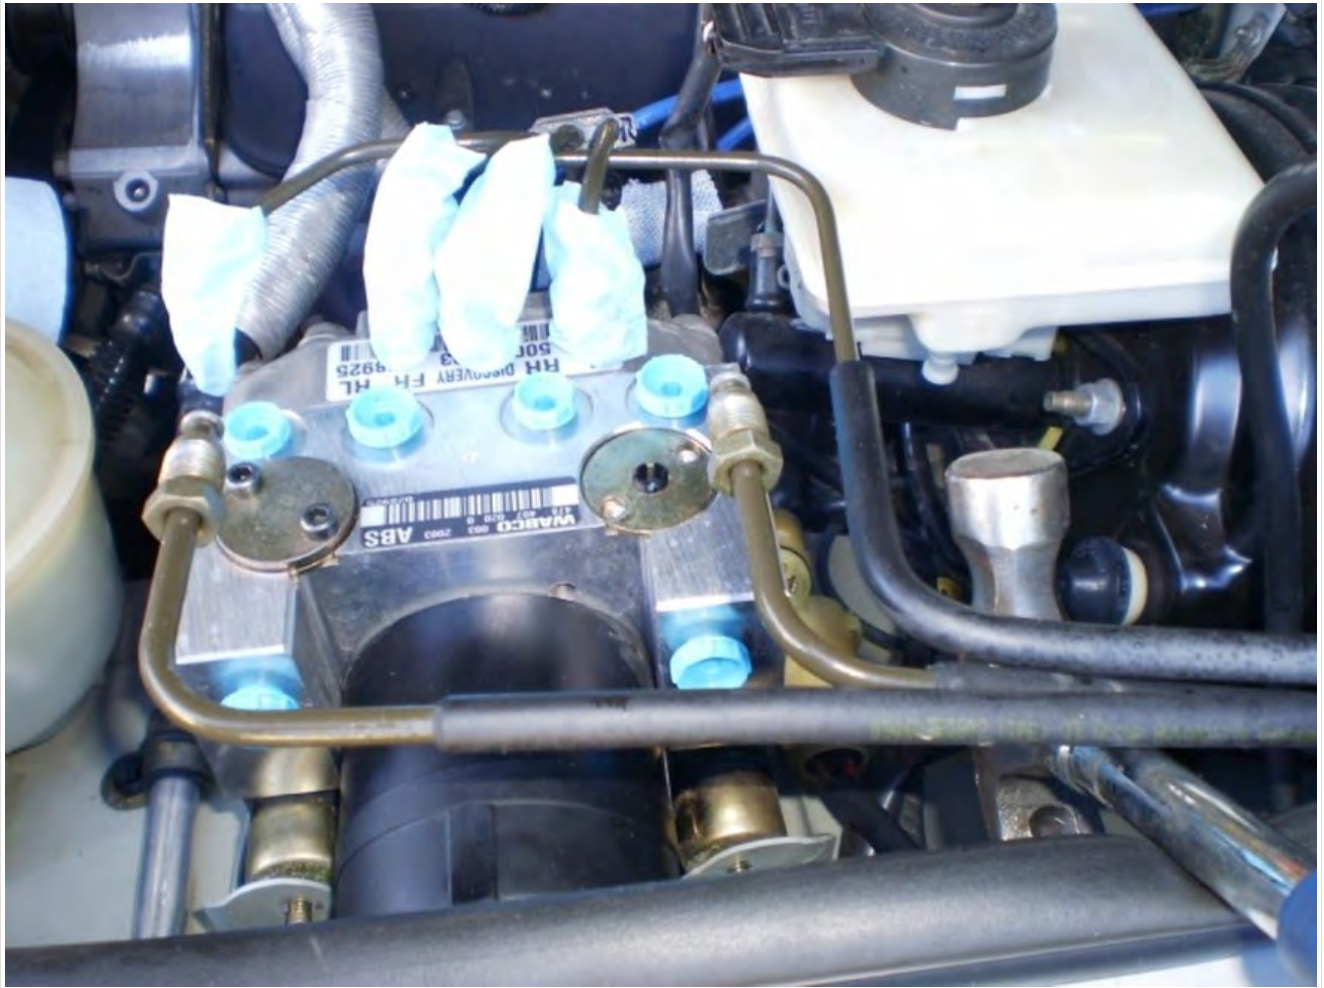
Because of the slight incline on my drive way, it was necessary for me to elevate the two side brake lines coming from the master cylinder to prevent brake fluid from continuing to pour out. I used a hammer at first and wedged it between the inside of the quarter panel.

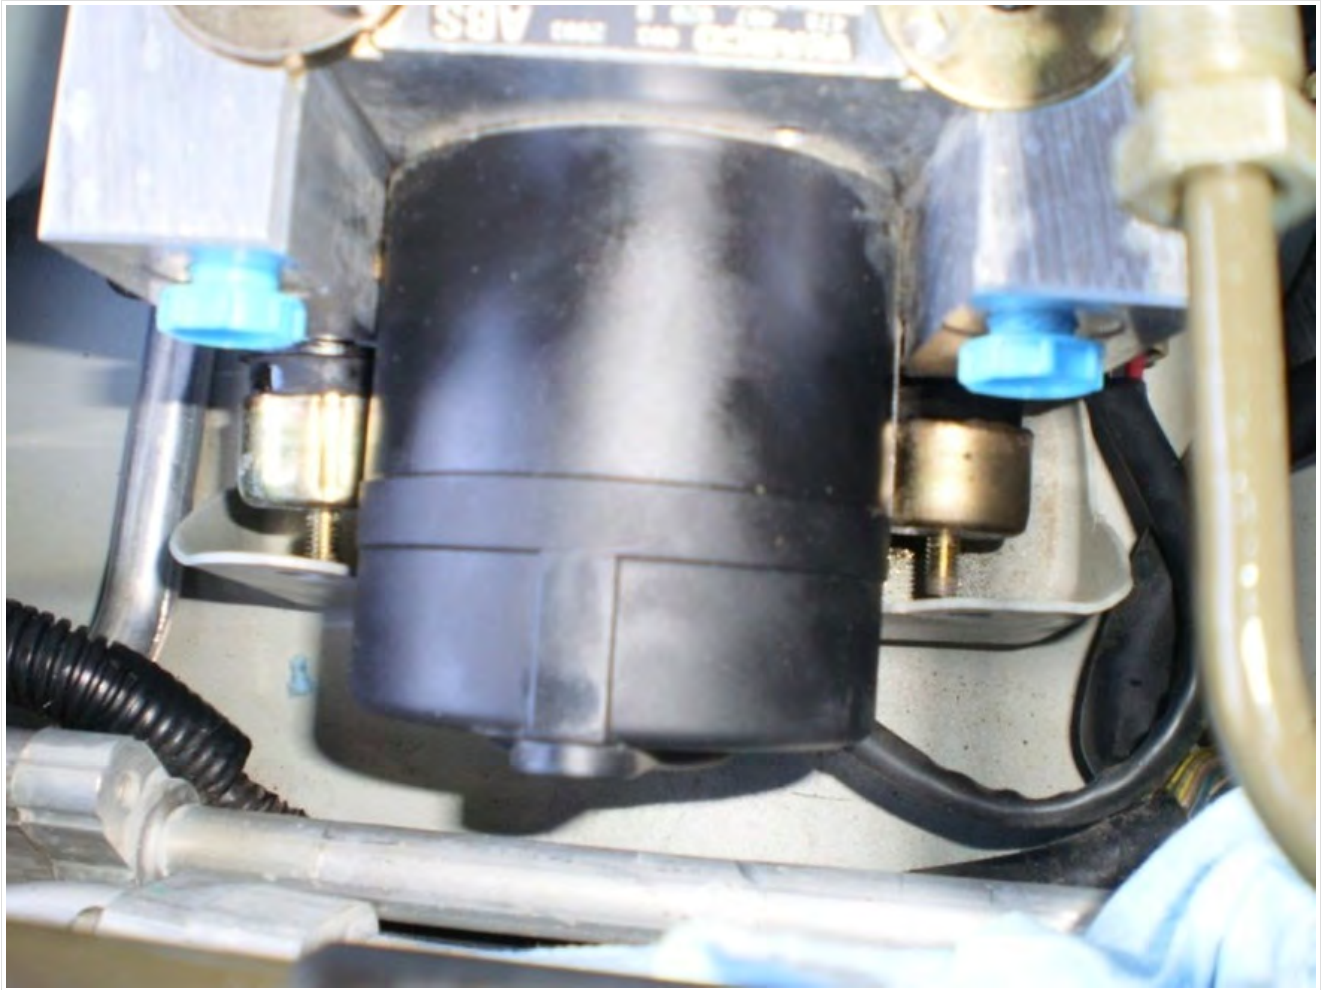
13. Carefully remove the ABS unit paying closing attention to the brake lines.

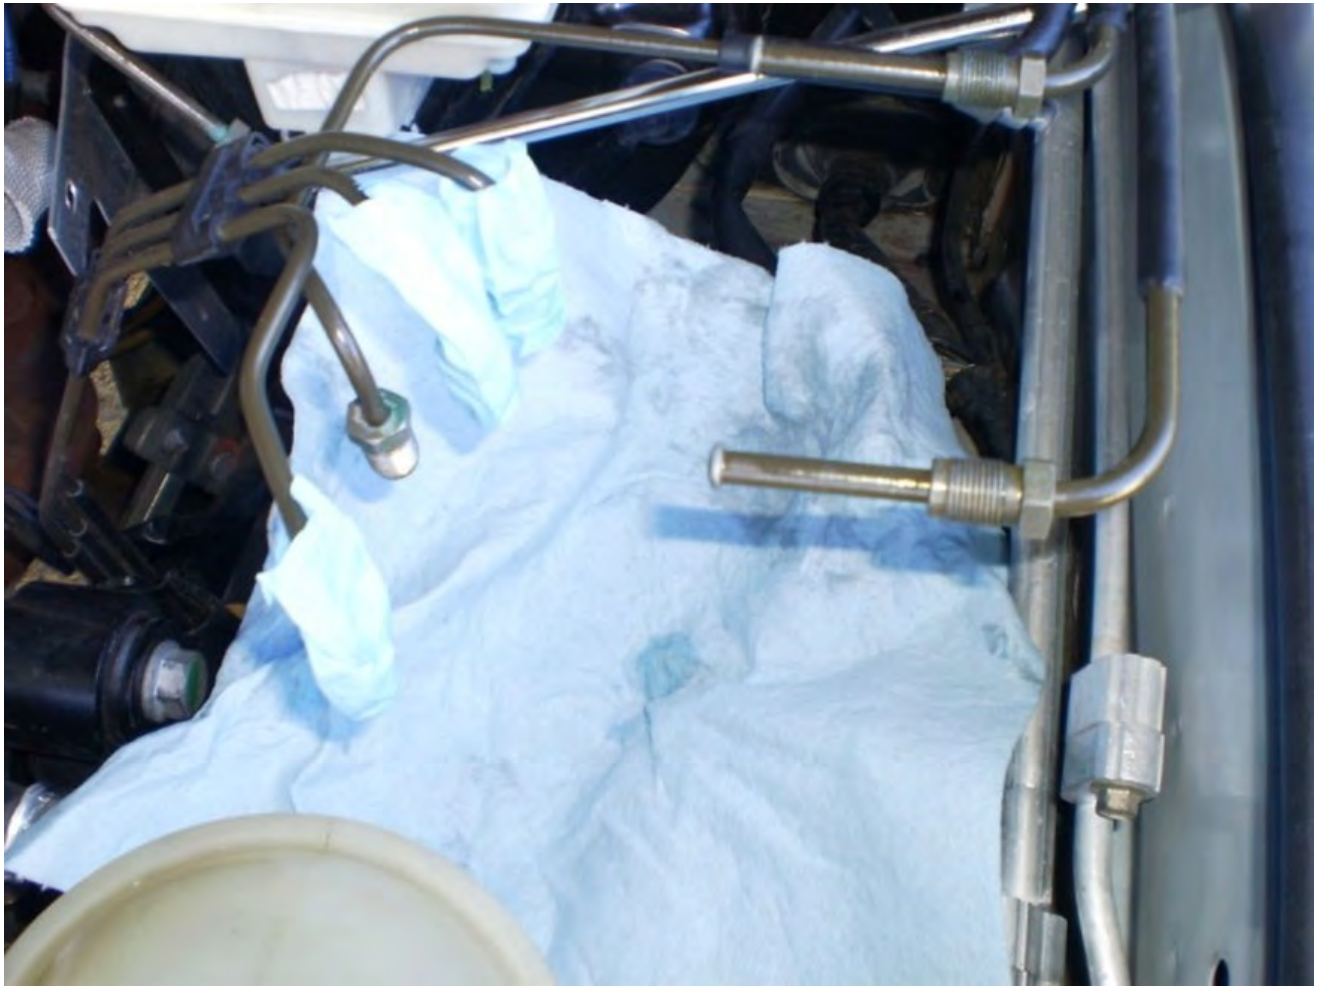
14A. Once removed, clean the area to prevent paint damage from spilled brake fluid. Place an absorbent shop towel or cloth to catch any brake fluid while you continue to work.

14B. Installation is the reverse of removal. However, when installing the 4 brake lines on top, ensure that they are screwing in flush and not cross threading. It took a couple of tries to get them seated right.

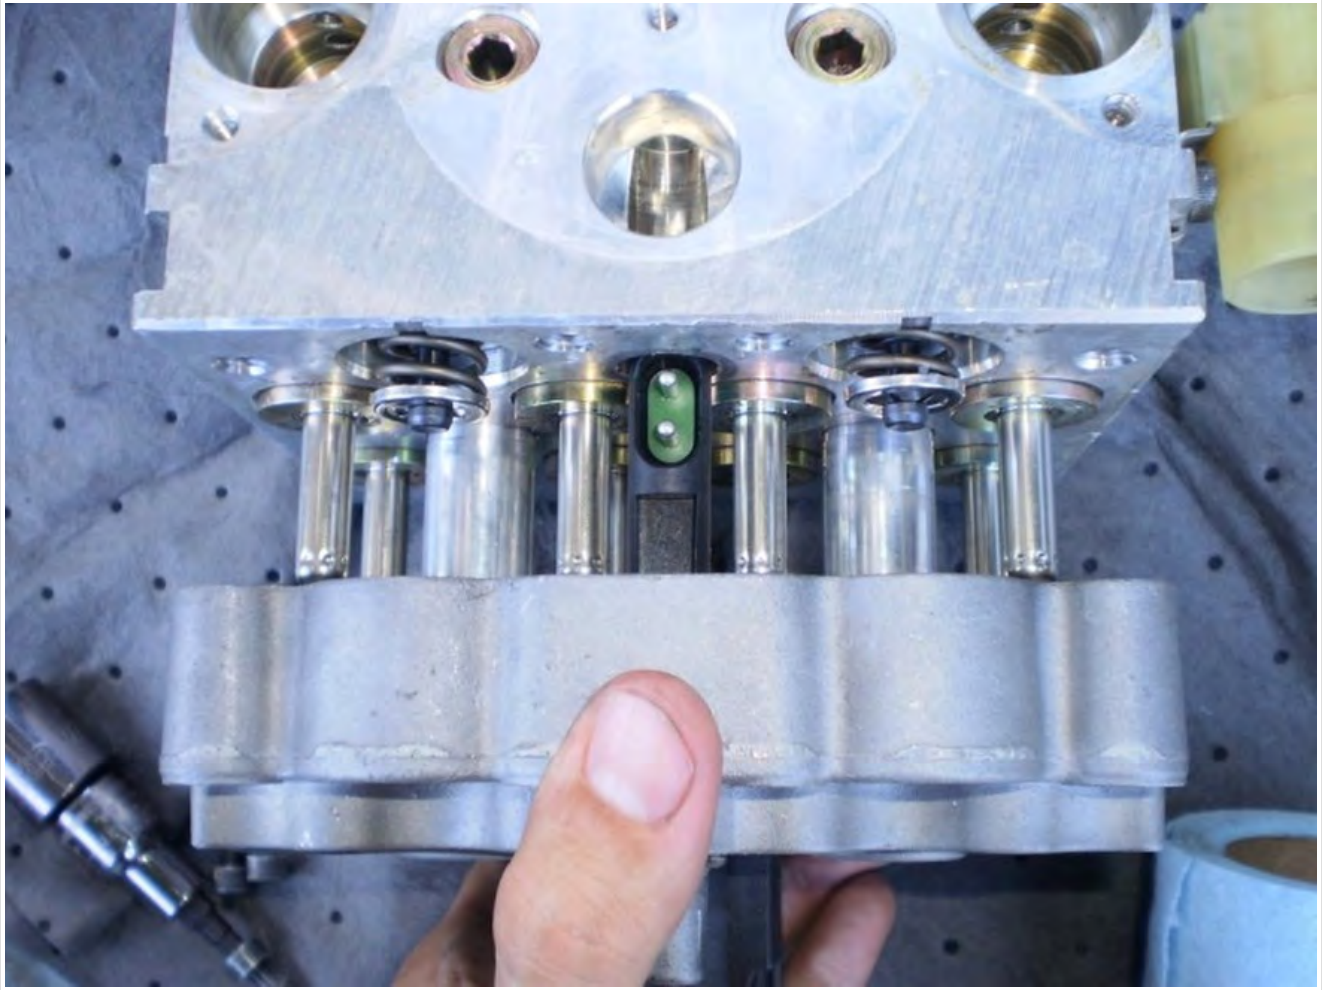
Pump side of the unit. Unit is upside down. Notice the brake line plugs at bottom.

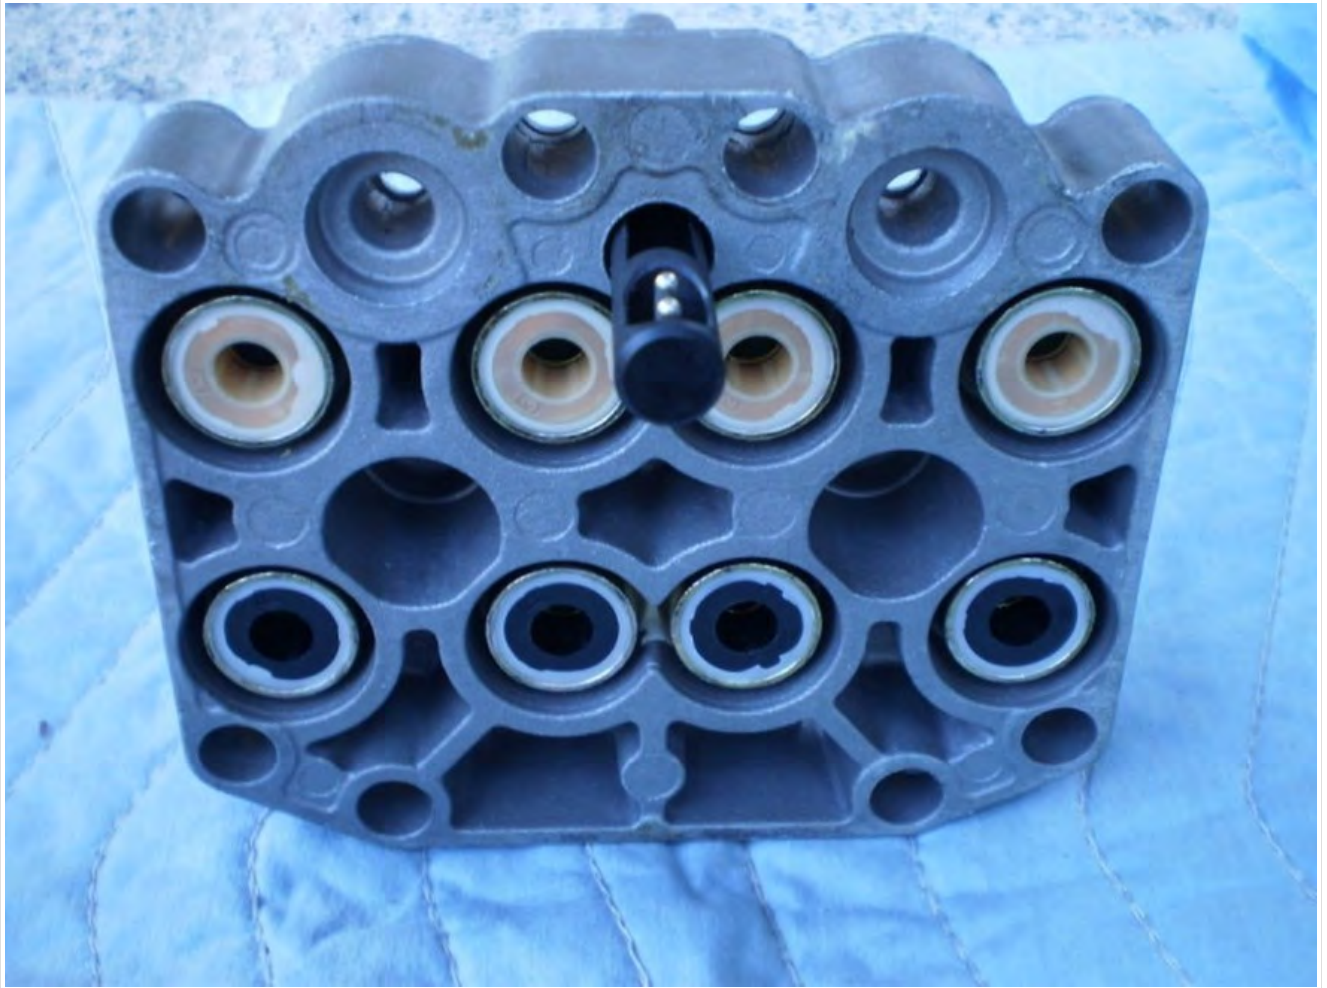
Modulator side of the unit

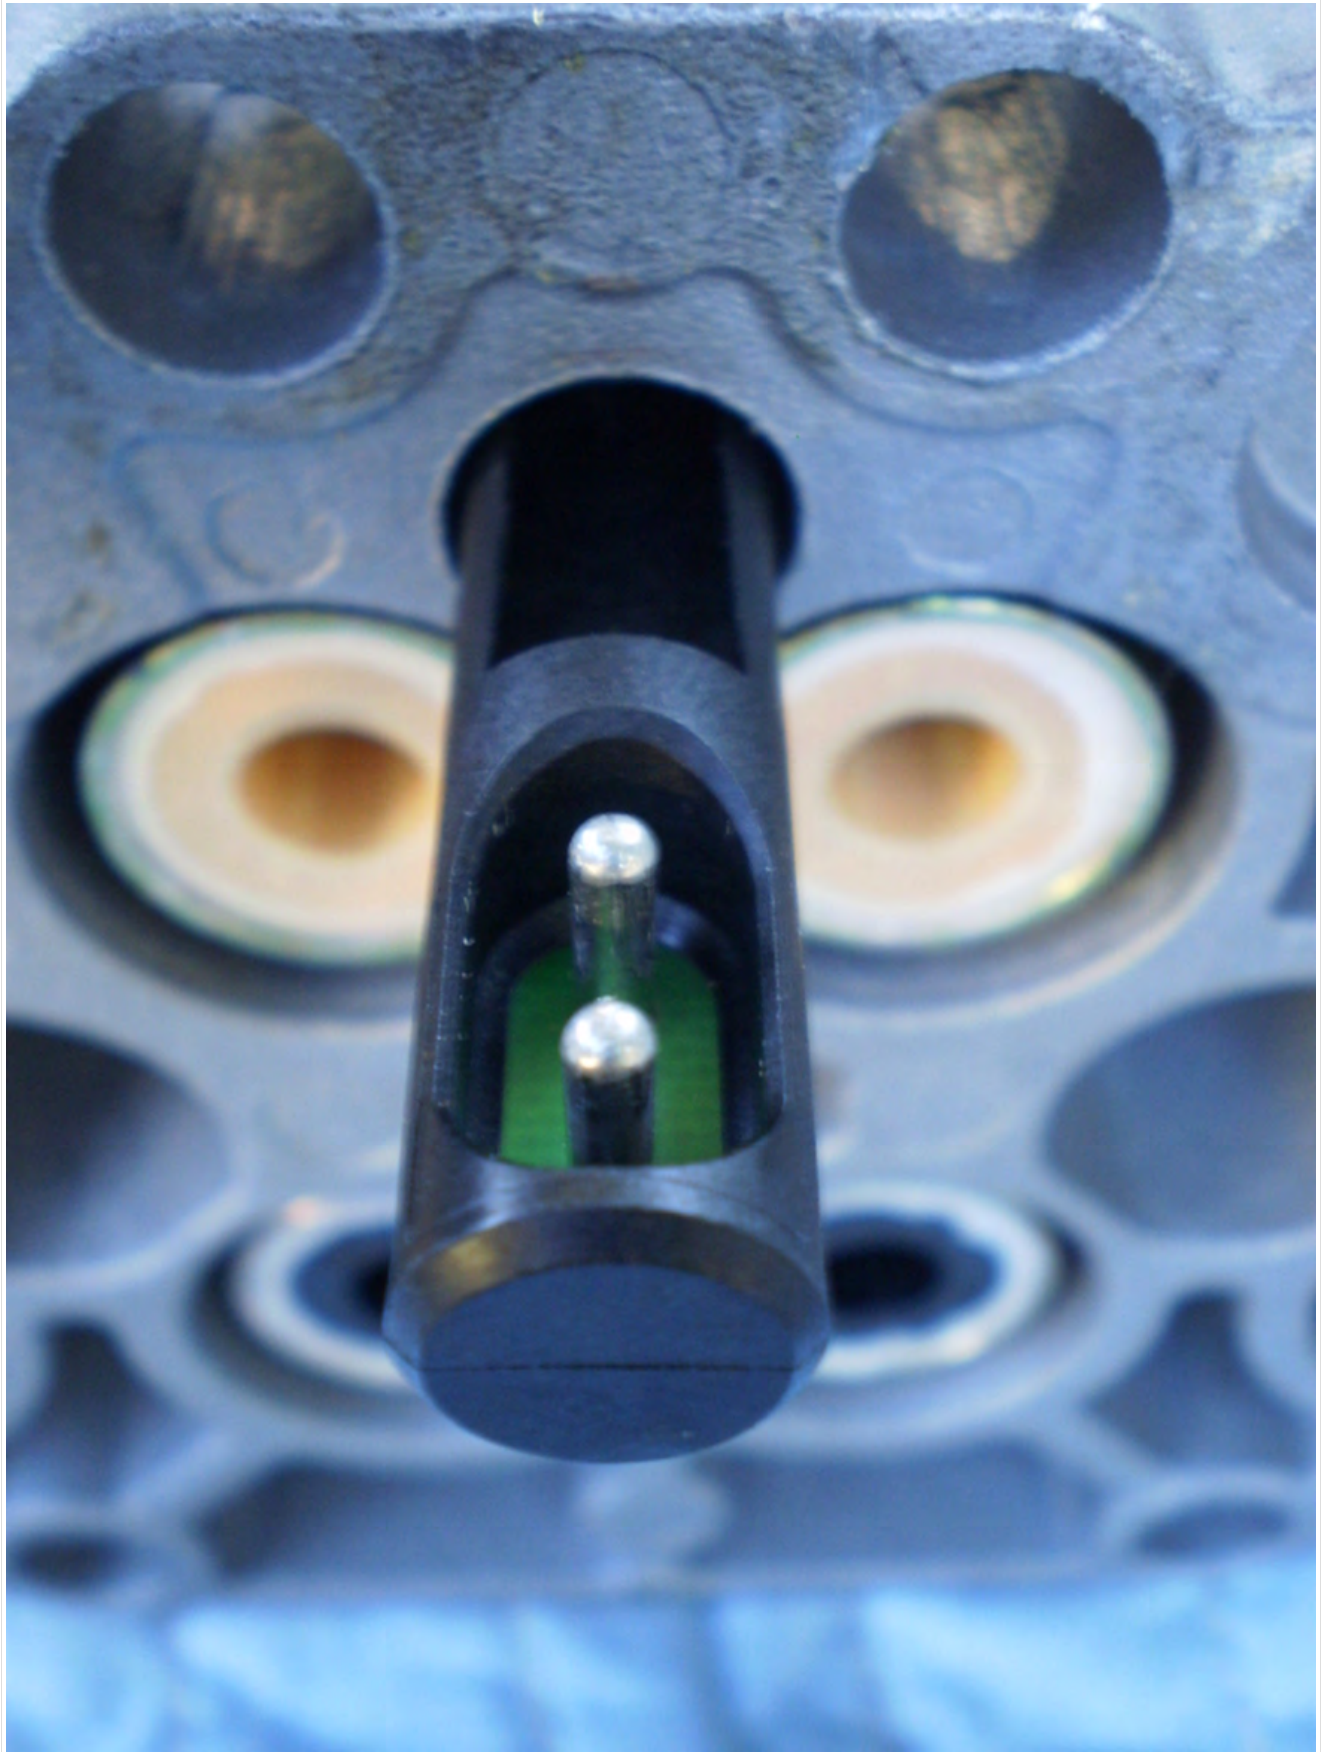
SVS modulator plug circuit board.

*If doing option A, the base of these pins need to be re-soldered. Underside of circuit board is what needs to be shaved off.
Installation is reverse of removal.*

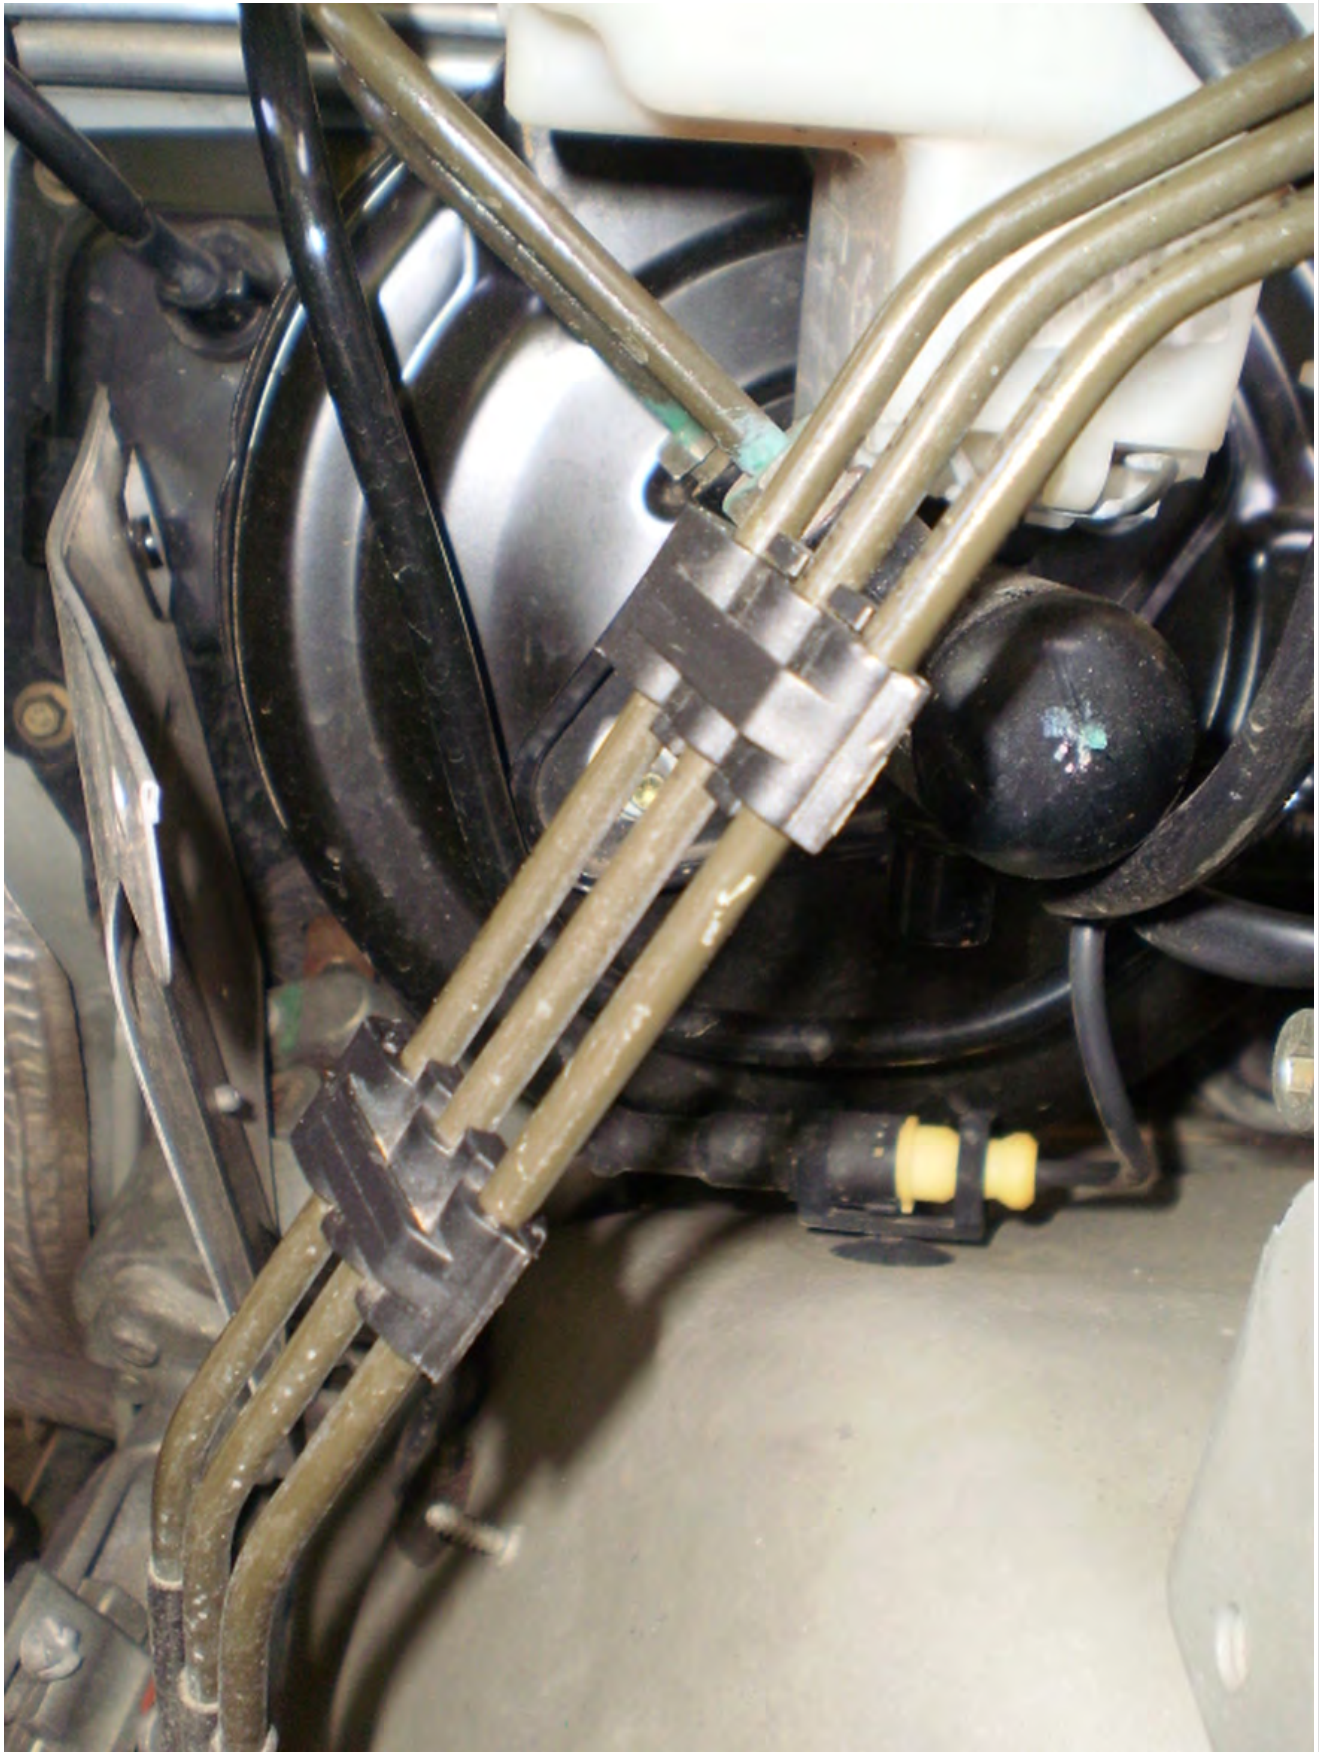
22. Remove two clips from the brake lines.
