ABS MODULATOR ELECTRICAL FAULT REPAIR

11/2009

The Land Rover Discovery Series II uses the same ABS MODULATOR as the H1 Hummer. The company that manufactures it is **WABCO** (<https://web.archive.org/web/20170730071921/http://www.wabco-auto.com/>) (Meritor WABCO (https://web.archive.org/web/20170730071921/http://www.meritorwabco.com/Page.aspx?page_id=1)). If you have been experiencing an intermittent fault causing your ABS, HDC, and TC lights aka *Three Amigos*, your problem may be a result of a bad electrical connection.

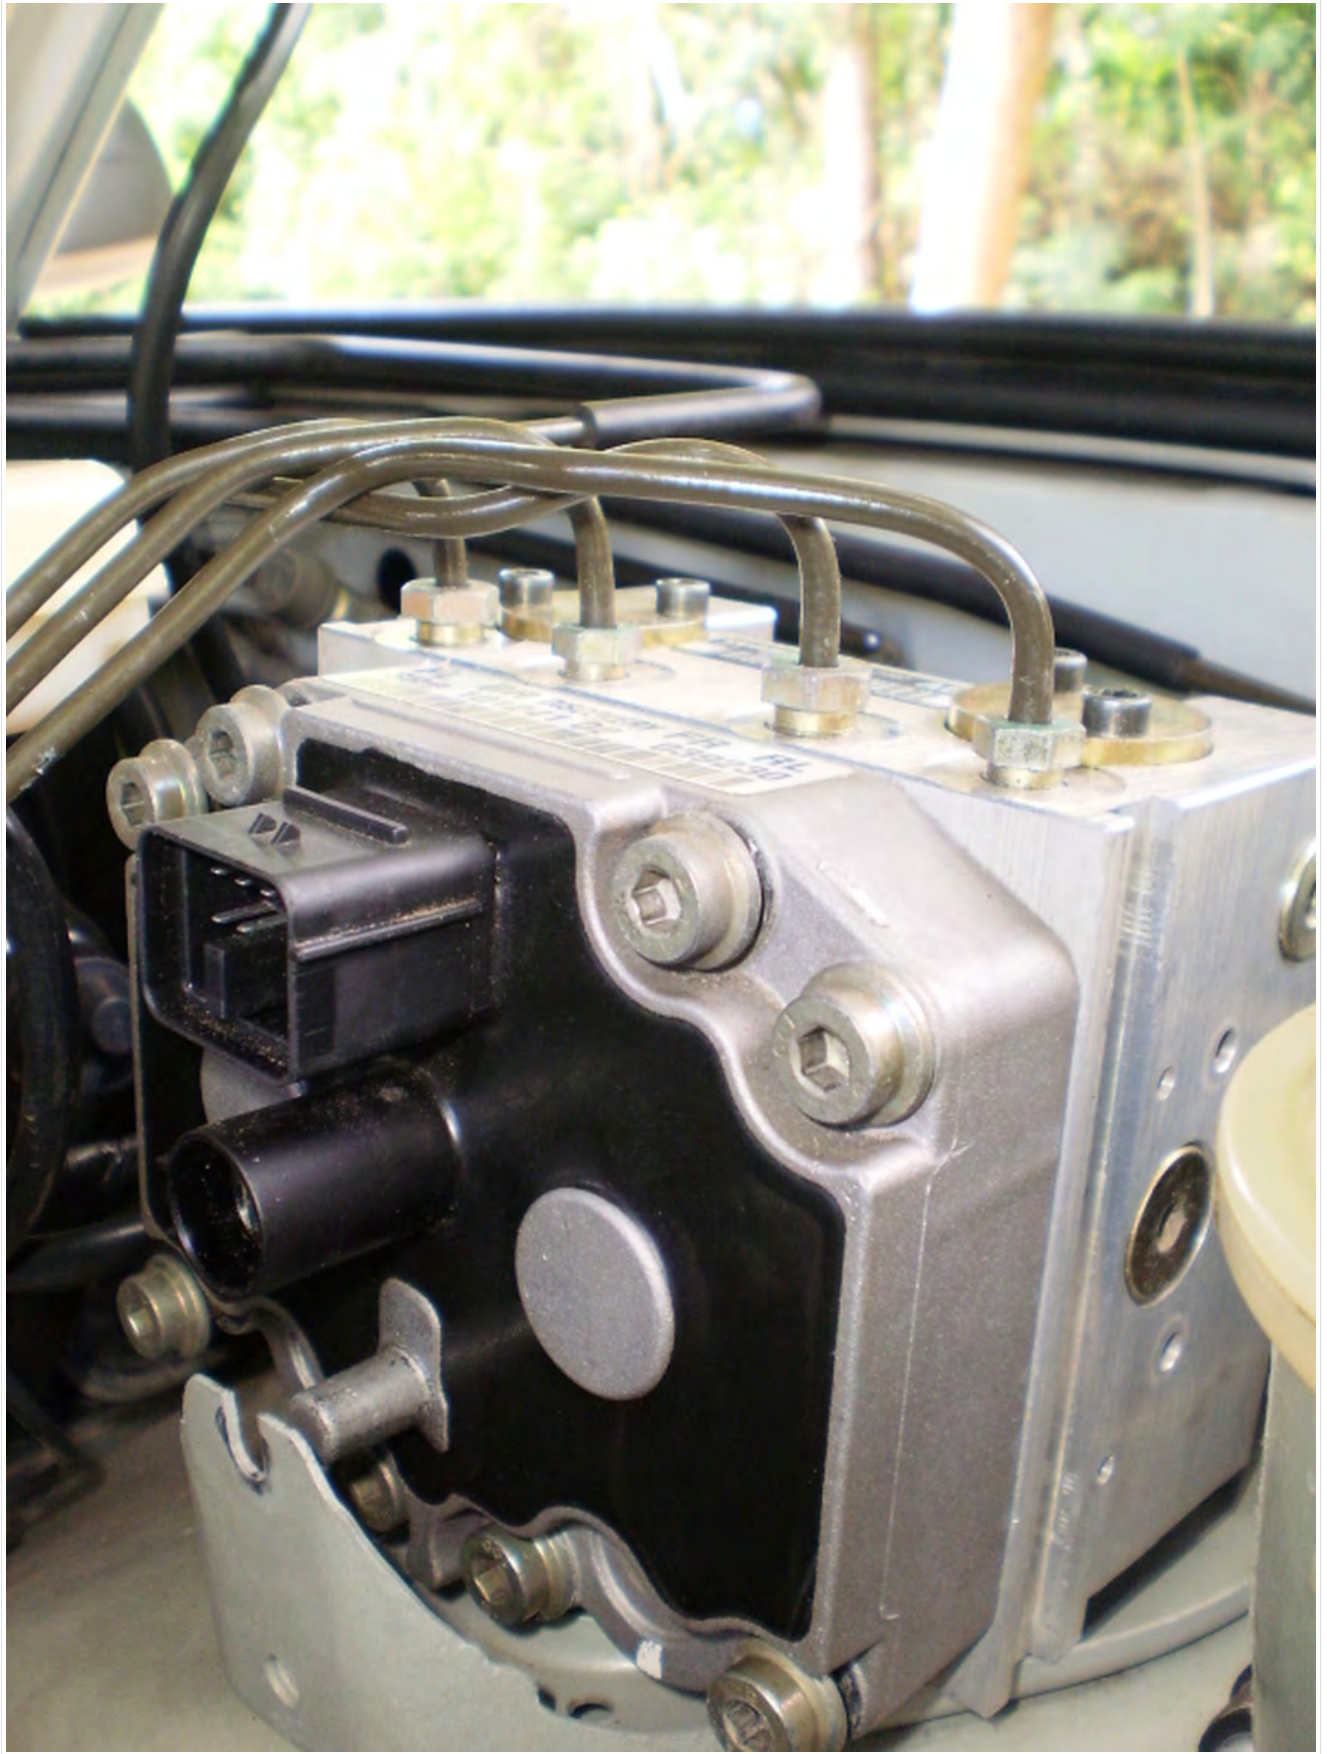
You will now have enough room to position the unit to remove the last two bolts.

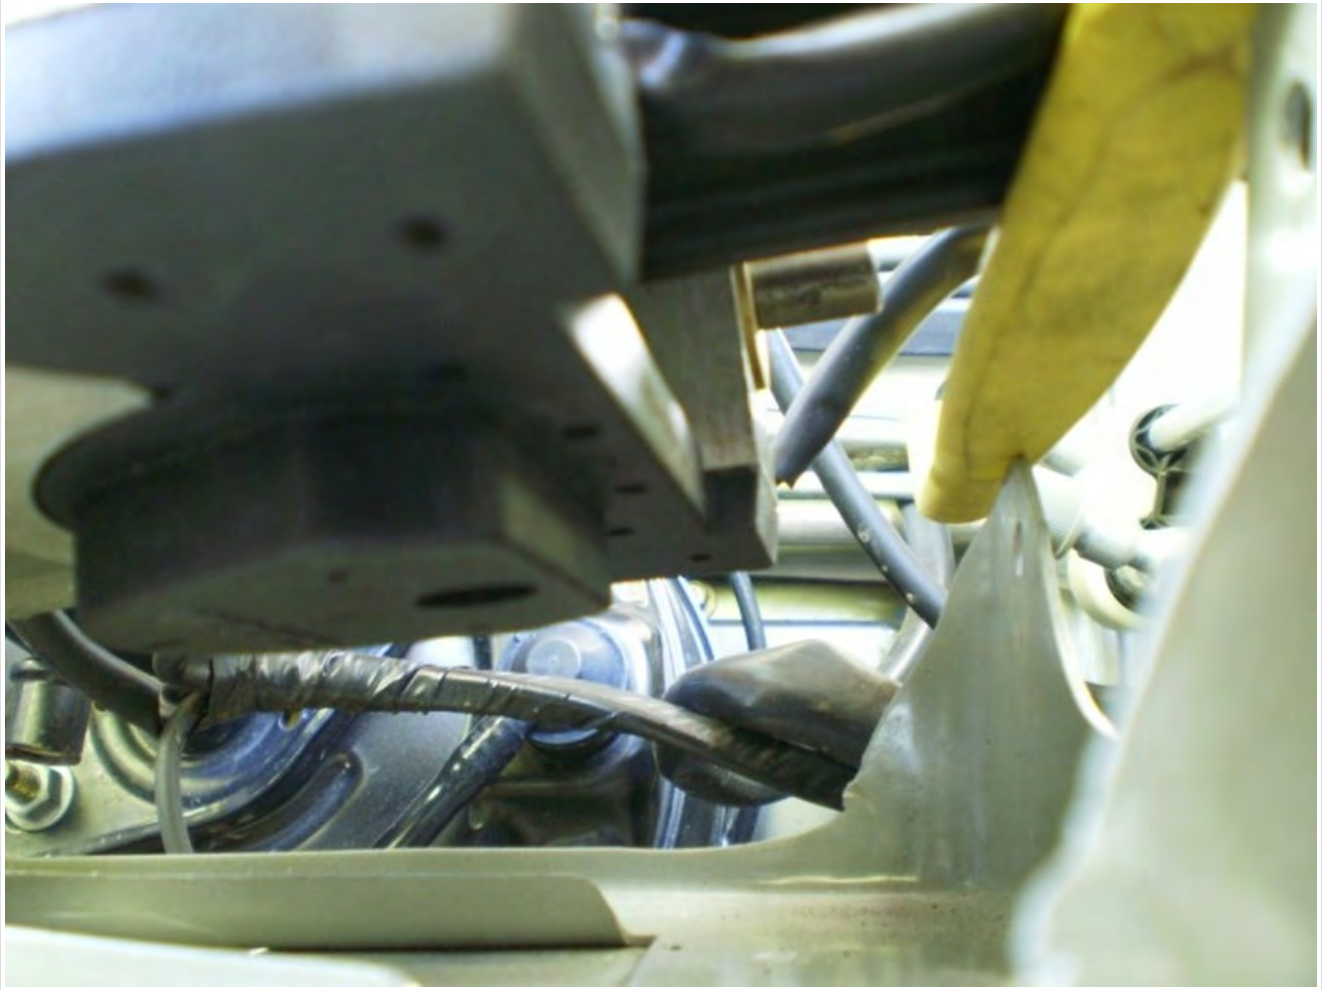
25. In order to have room underneath the ABS unit to access the SVS cover plate screws, raise the pump side of the unit and support it using the top of the rear side of the mounting bracket. I used a plastic trim removal tool to rest it on.

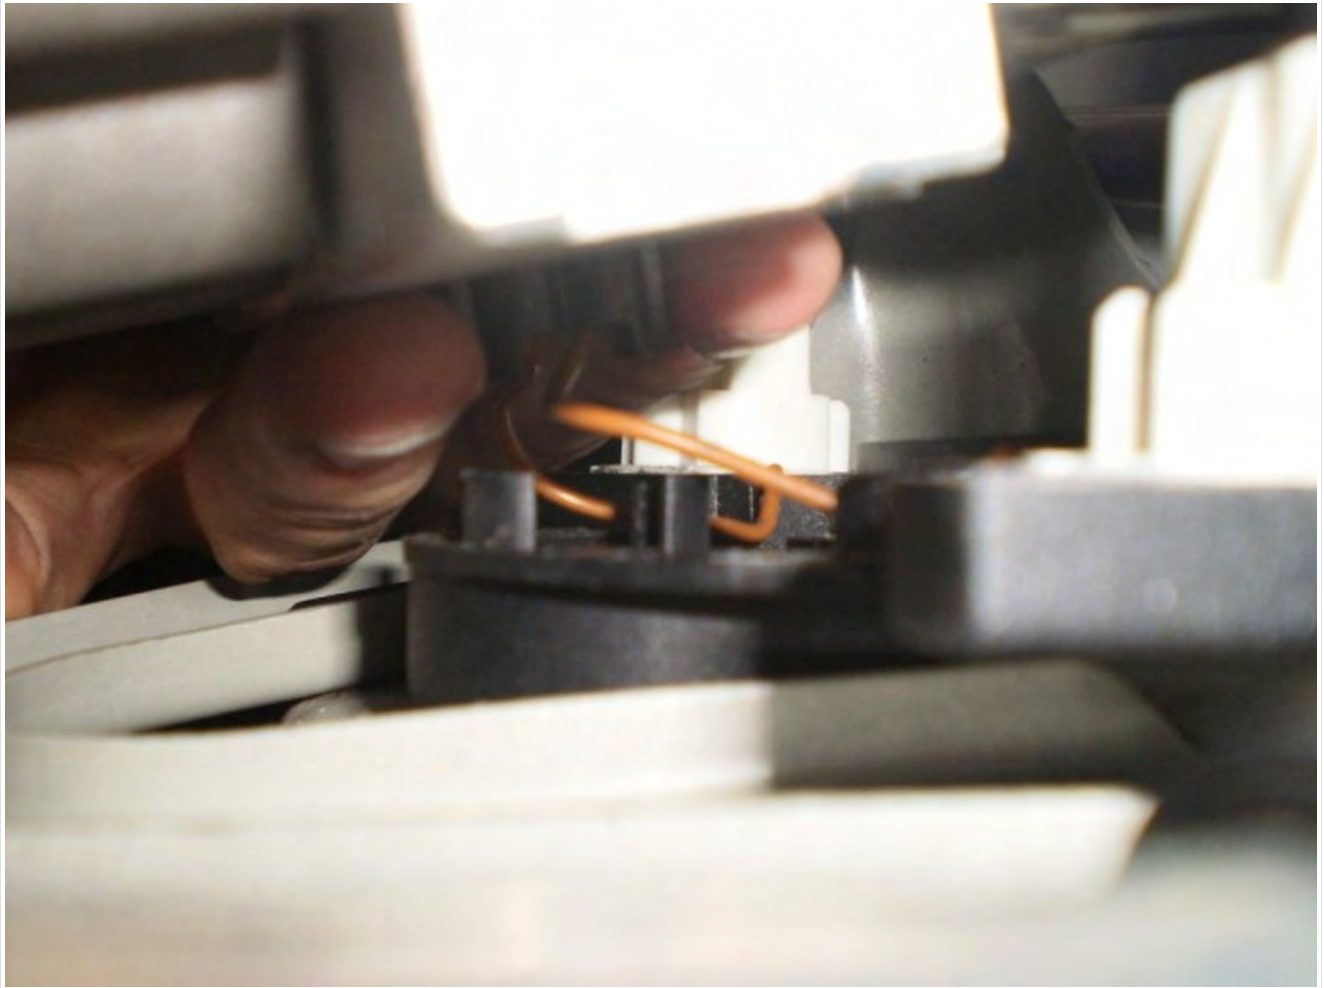
You can see the SVS plug between my fingers

Once unplugged, carefully remove the SVS assembly out from under the unit.

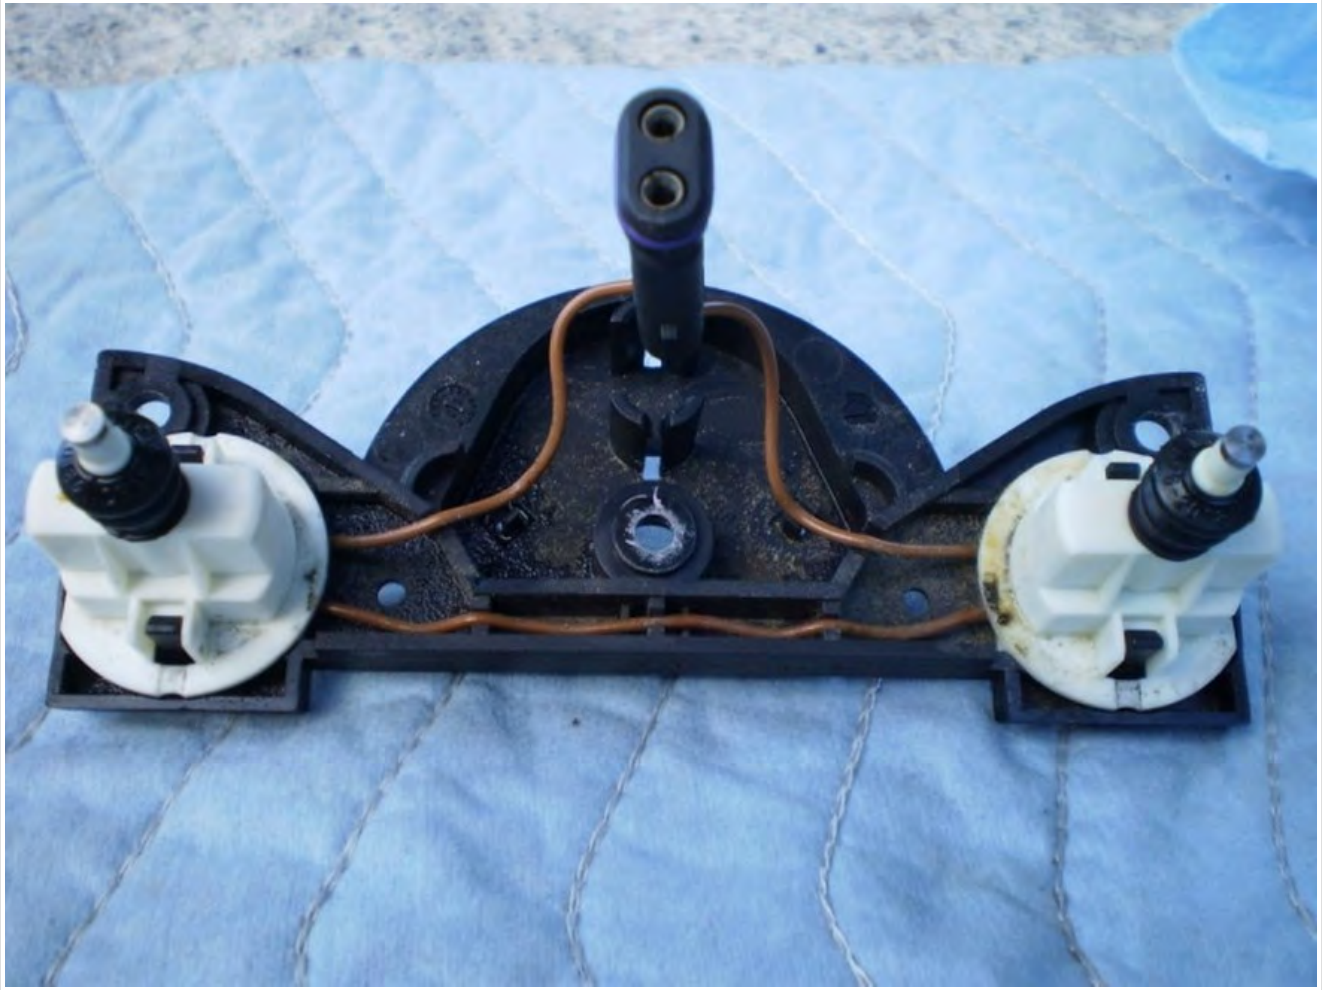
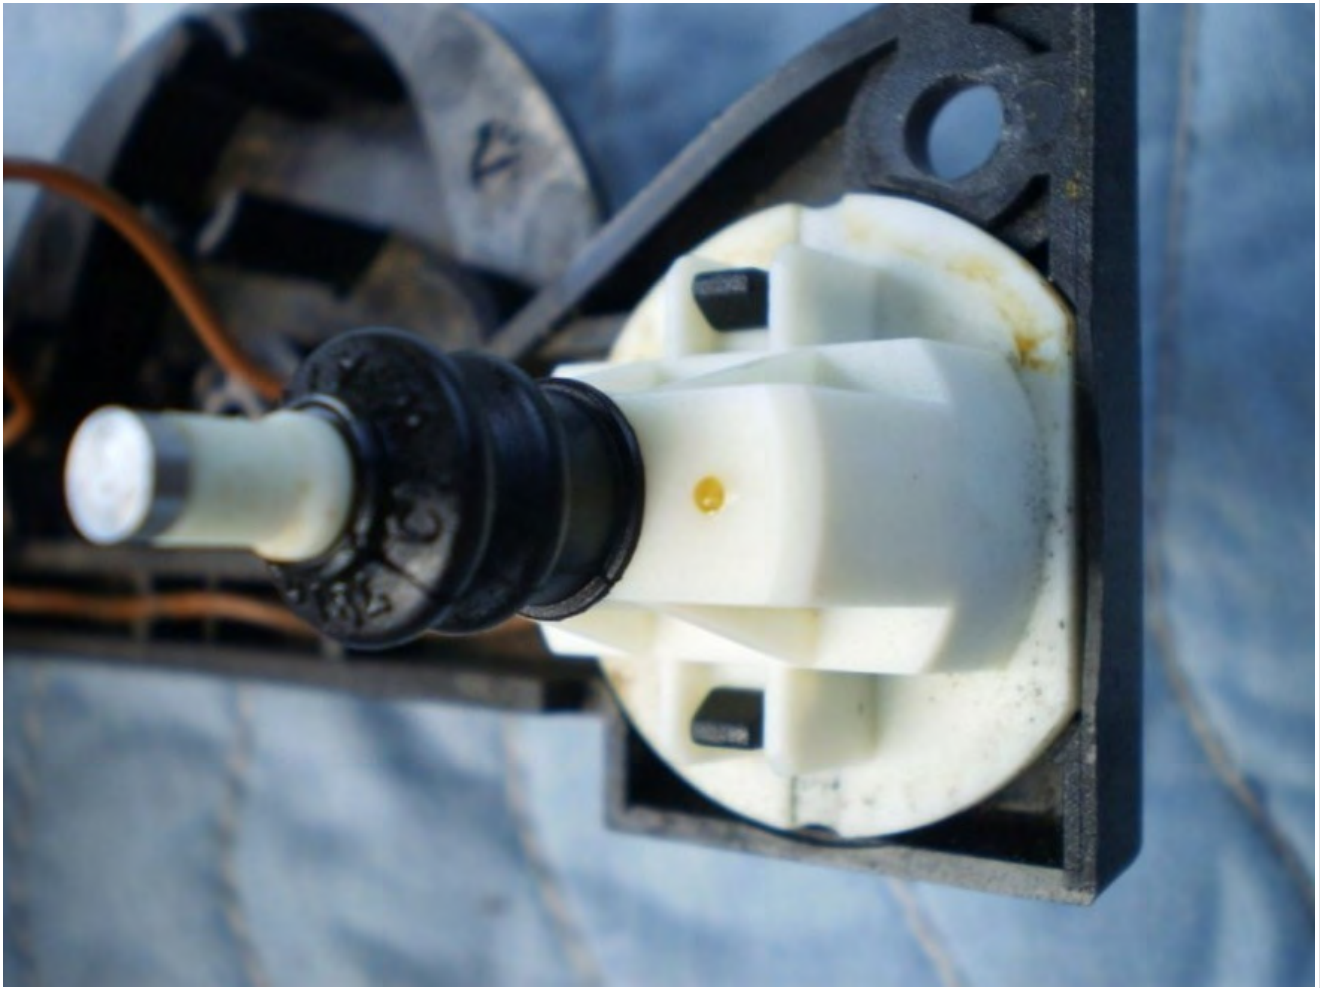
A CLOSER LOOK AT SVS (SHUTTLE VALVE SWITCHES) AND SV (SHUTTLE VALVES)

The rubber boot is what prevents brake fluid from seeping out of the shuttle valves and getting inside fouling the switch. If the shuttle valves are leaking, they may be the cause of your THREE AMIGOS, you can replace the seals with this Shuttle Valve seal KIT from Falconworks in Arizona (https://web.archive.org/web/20170730071921/http://www.jewellameroil.com/sales/index.php?main_page=product_info&cPath=65_67&products_id=247)

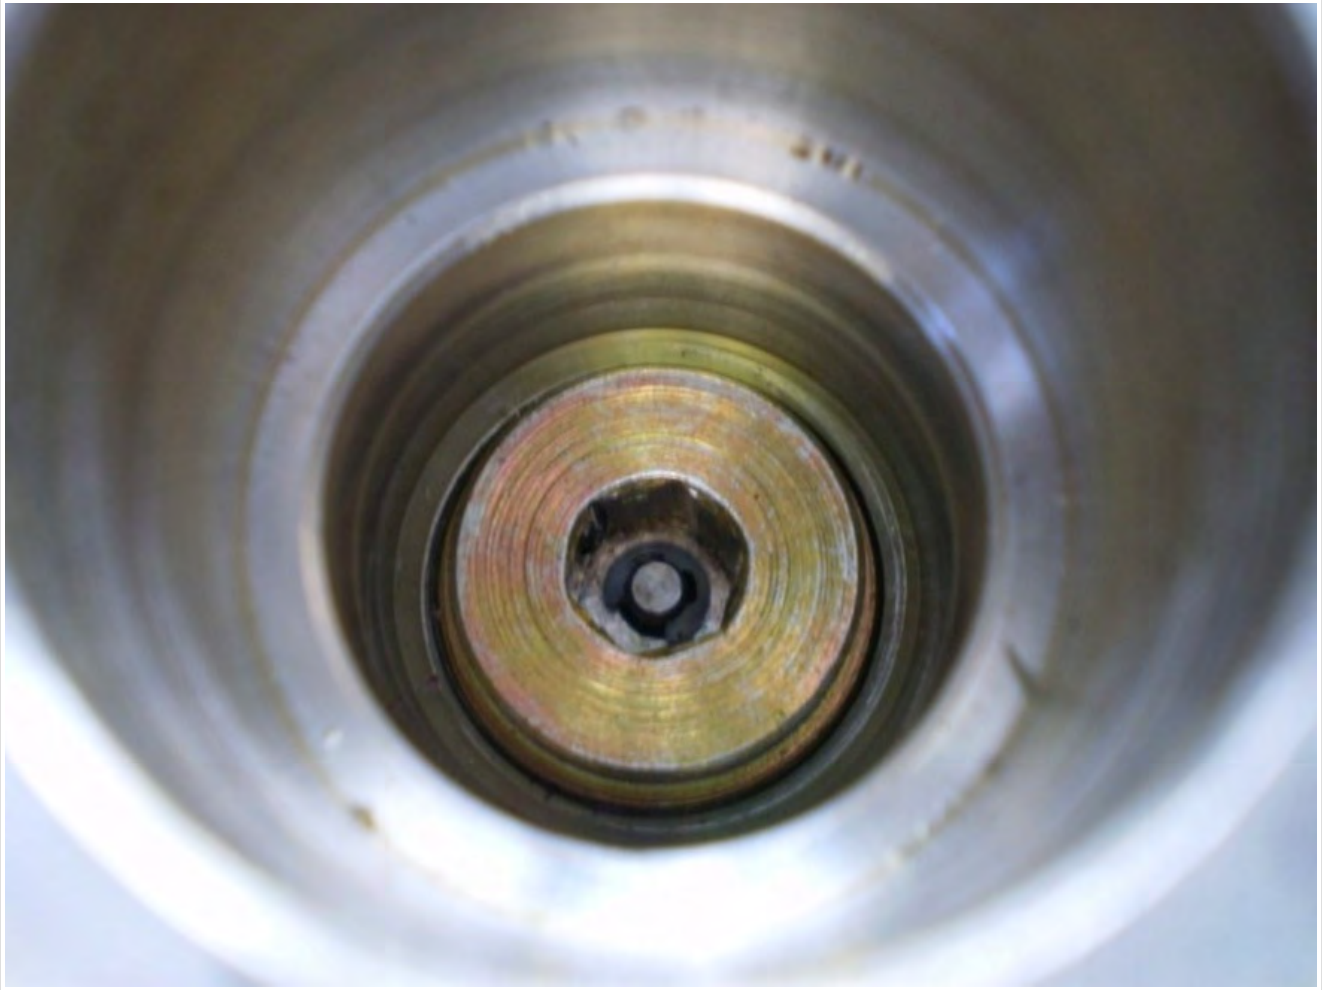
Shuttle Valve. You can see the SMALL circlip that comes in the kit mentioned above.

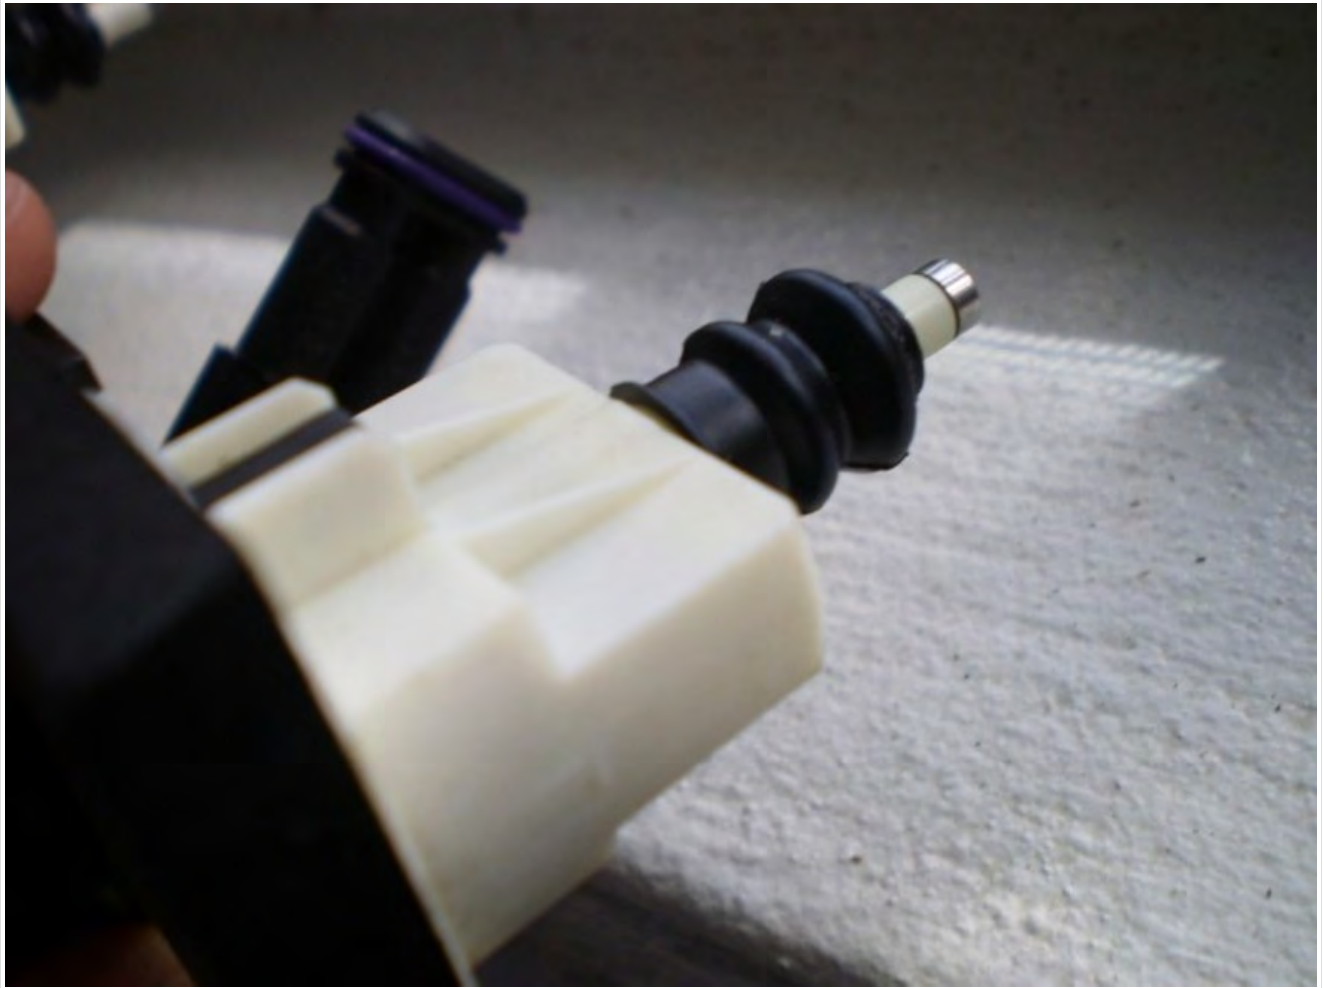
Upon removing the boot I did find some fluid but not enough to cause any problems since they tested withing normal range.

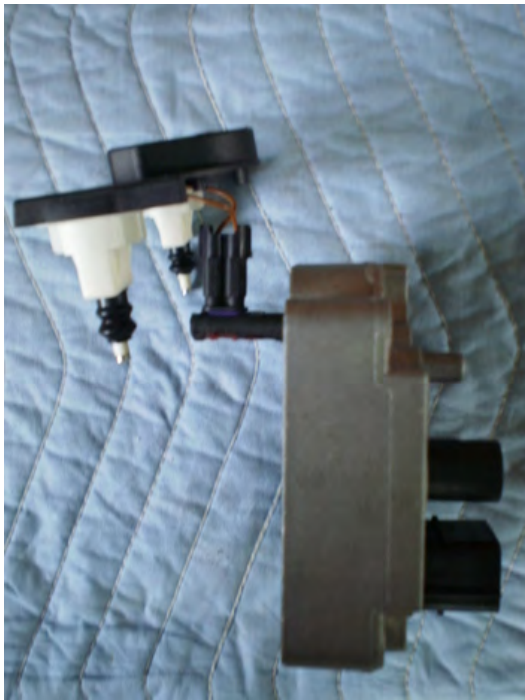
Connect the SVS plug to the SVS circuit board like pictured below.

Get your handy DMM and check ohms between pin 9 (red) and 6 (black) All you need to do is have a helper push the switches while you get the readings.

Component	Resistance, ohms
Shuttle valve switches, both open (brakes off)	2977 - 3067
Shuttle valve switches, both closed (brakes on)	1007 - 1037
Shuttle valve switches, one open, one closed	1992 - 2052

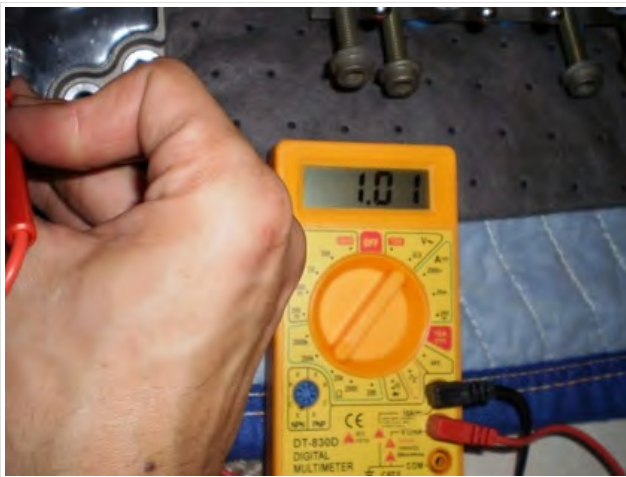
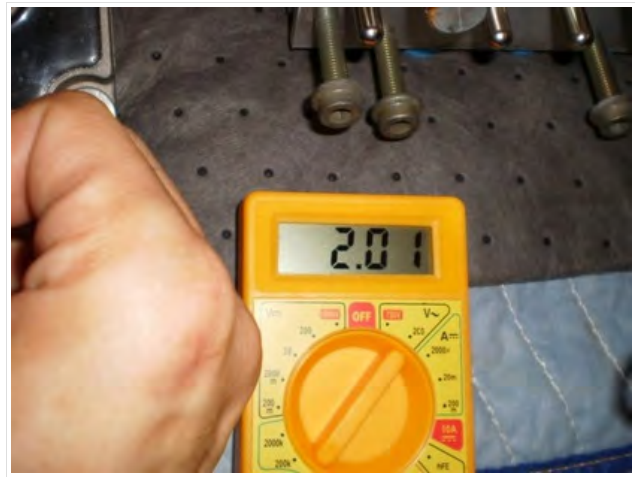
BOTH CLOSED ----- PASS

ONE CLOSED ----- PASS

If you didn't pass the test, your SVS may be faulty and may need replacing.

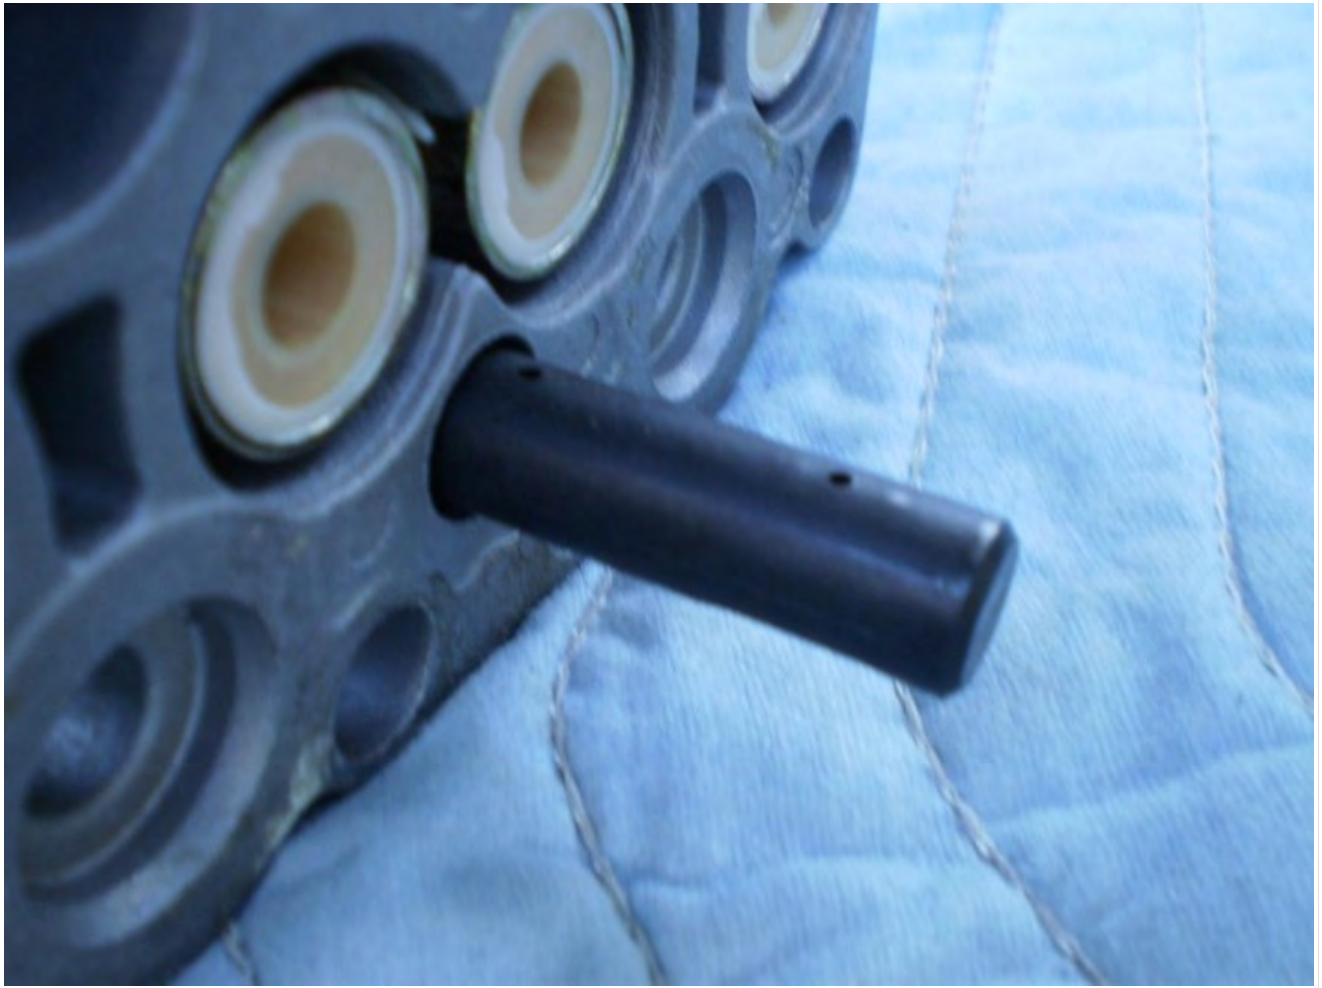
32. Disconnect the SVS plug. Flip the modulator side "right side up" so the SVS circuit board is at the bottom with the pins facing down. This is the part that requires surgery.

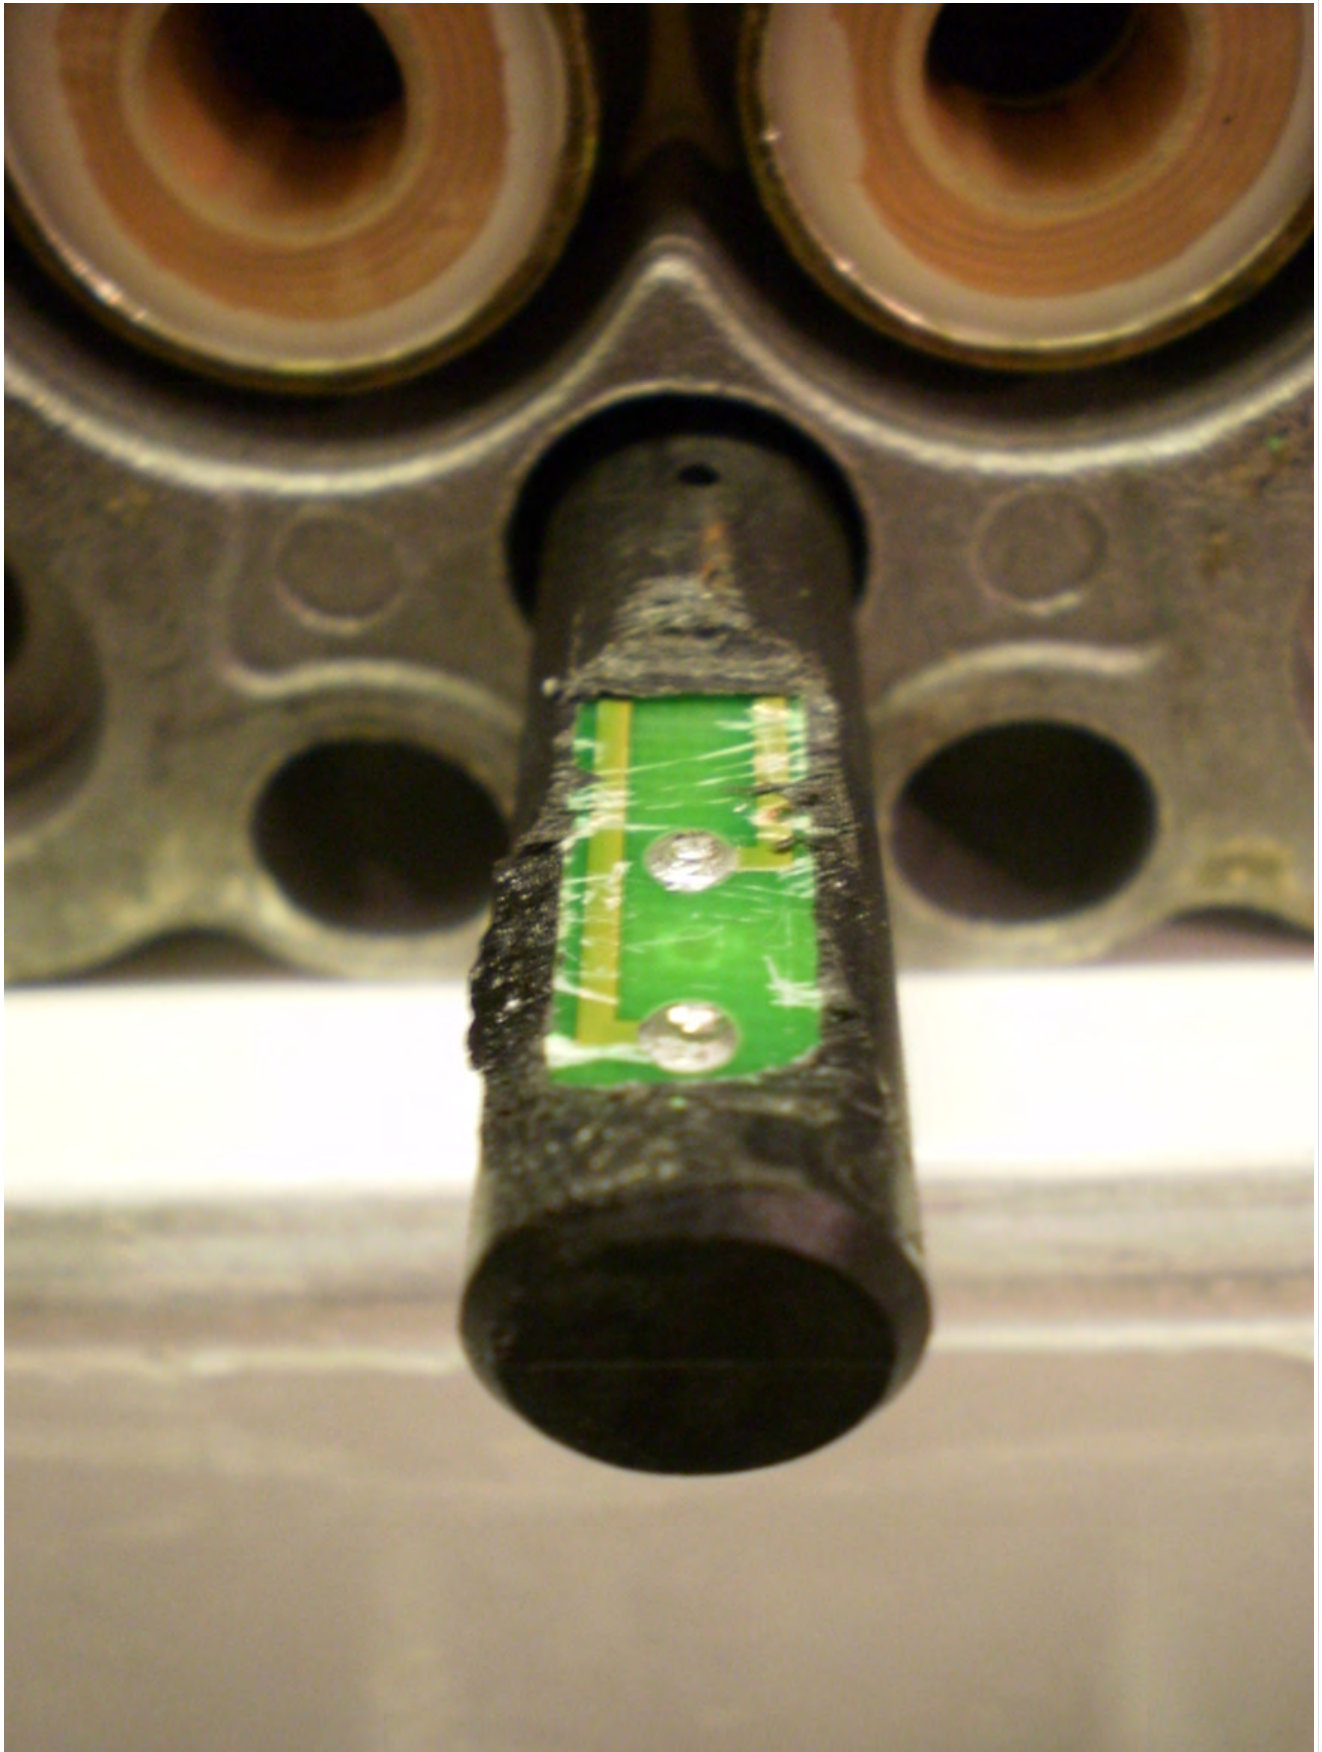
My surgery worked SO well that I cut too deep into the circuit board lines which made this whole repair worthless. FAIL....

The new challenge I had was that I completely destroyed the circuit board and even straight wiring it (Option C) would not work.

So why does it not work? Well if you remember the SVS ohm test procedure, you place the DMM prongs onto pins 9 and 6 on the modulator to test ohms on the SVS various positions. As it so happens, the SLABS ECU detects and monitors the ohms using ONE wire which turned out to be the YG wire on connector C0501- pin 9. Pin 9 continues

on to meet the SVS harness via that circuit board encased in hard plastic then through the SVS plug. Pin 6 is grounded internally within the modulator so there is no wire going to that pin via connector C0501- pin 6. (Hence the discovery of Option B)

Since I severed the connections on the SVS circuit board, I created a permanent open scenario resulting in a permanent SVS Electrical Fault. The fix? Option B.

If you accidentally cut too much... go to Option B (# 37) If not, read on.

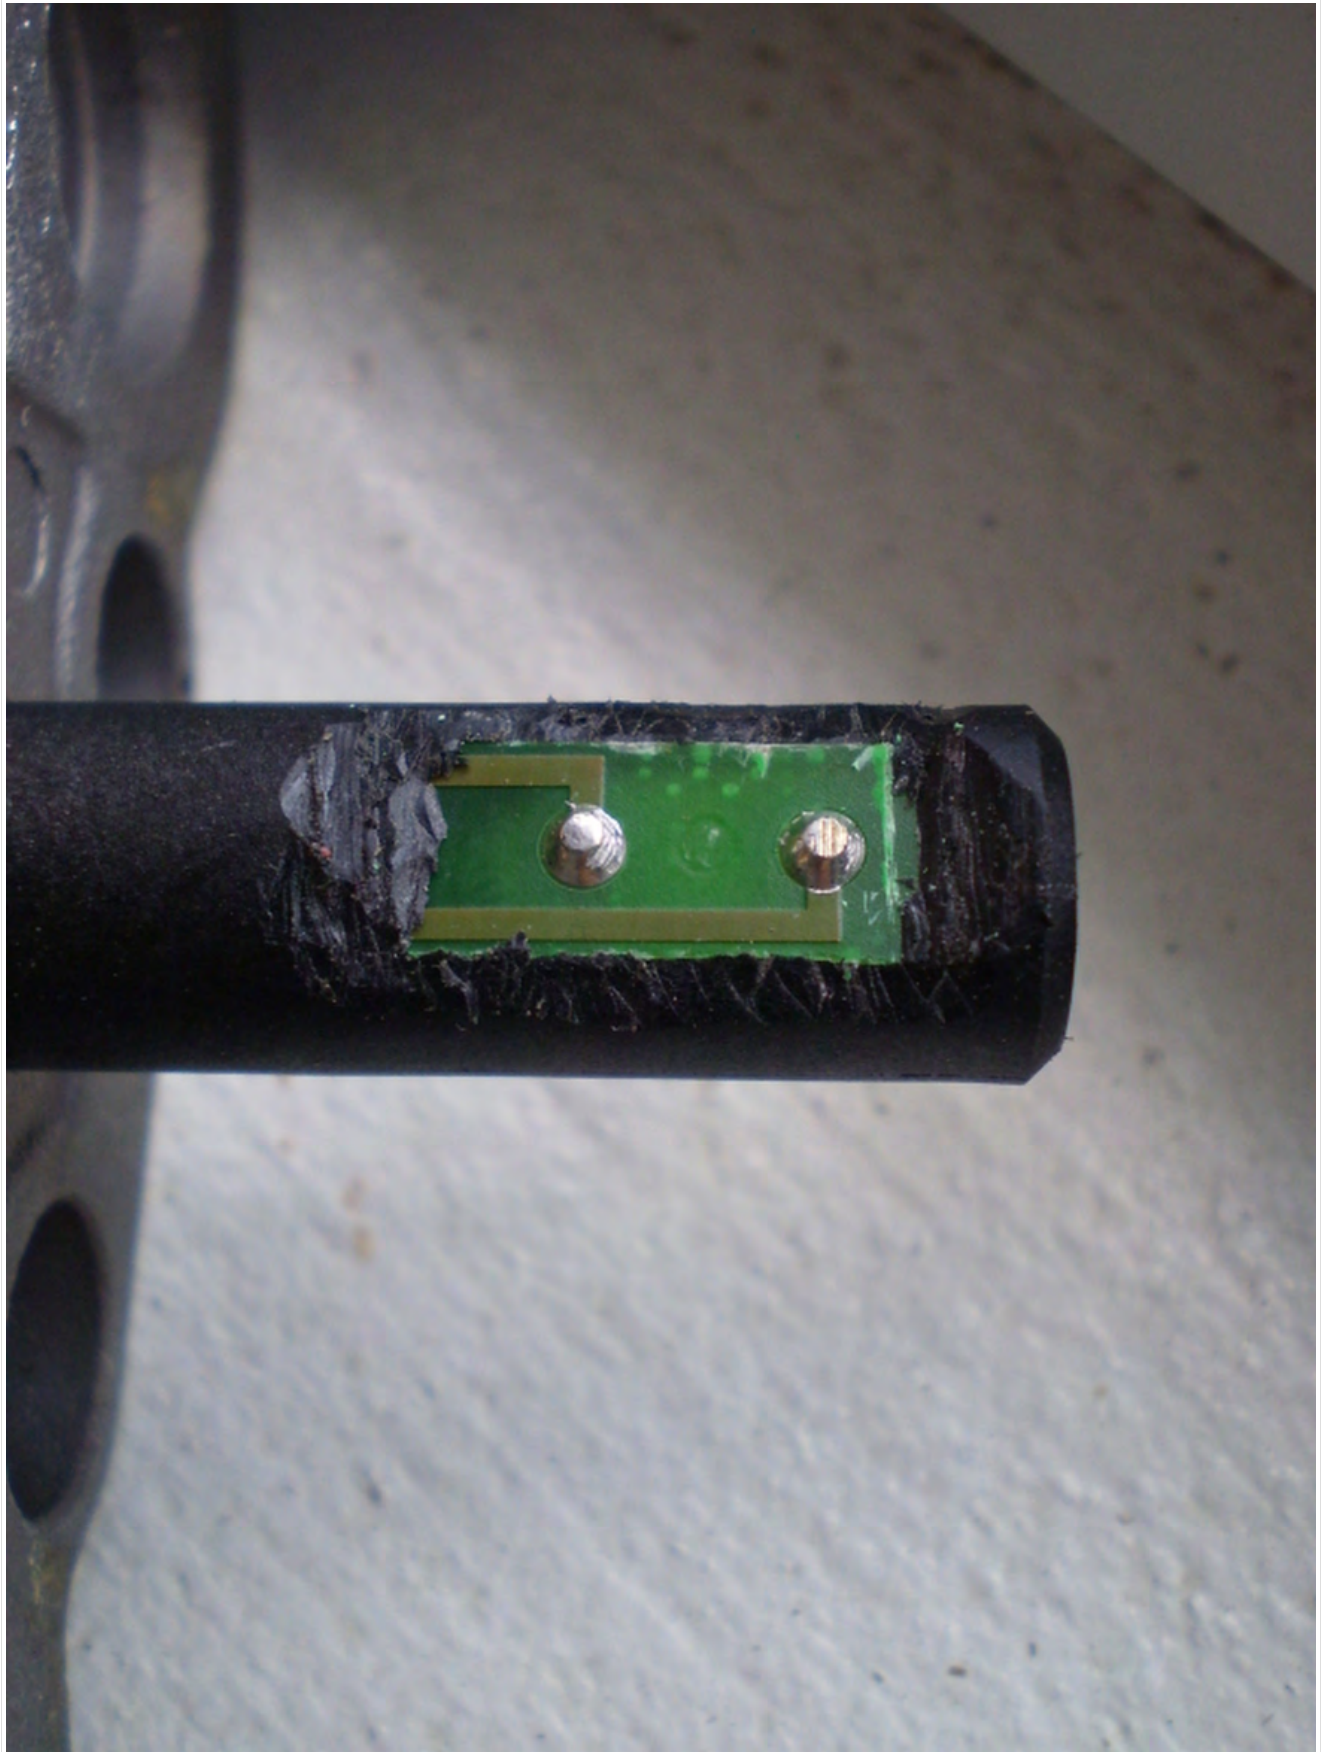
34. Luckily I had that spare modulator and I continued on with the repair. Except this time I used a very sharp serrated steak knife. **WHAT A DIFFERENCE!!!** I basically shaved it of little by little.

35. Upon inspection of my circuit board and that of the spare's, I found it very hard to tell if the soldered joints were bad. Both pins remained on the circuit board when I removed the SVS plug but I could tell they weren't 100% solid. I re-soldered the pins on the spare unit. Be careful as the pins may fall out. while soldering. One did fall out but I was able to reinsert it with pliers and re-soldered it. I re-tested the SVS on all three positions and passed.

I was concerned that the fallen pin would not be soldered strong enough but surprisingly it held very well and it passed the ohm tests after about 10 tries plugging and unplugging the SVS plug just to make sure.

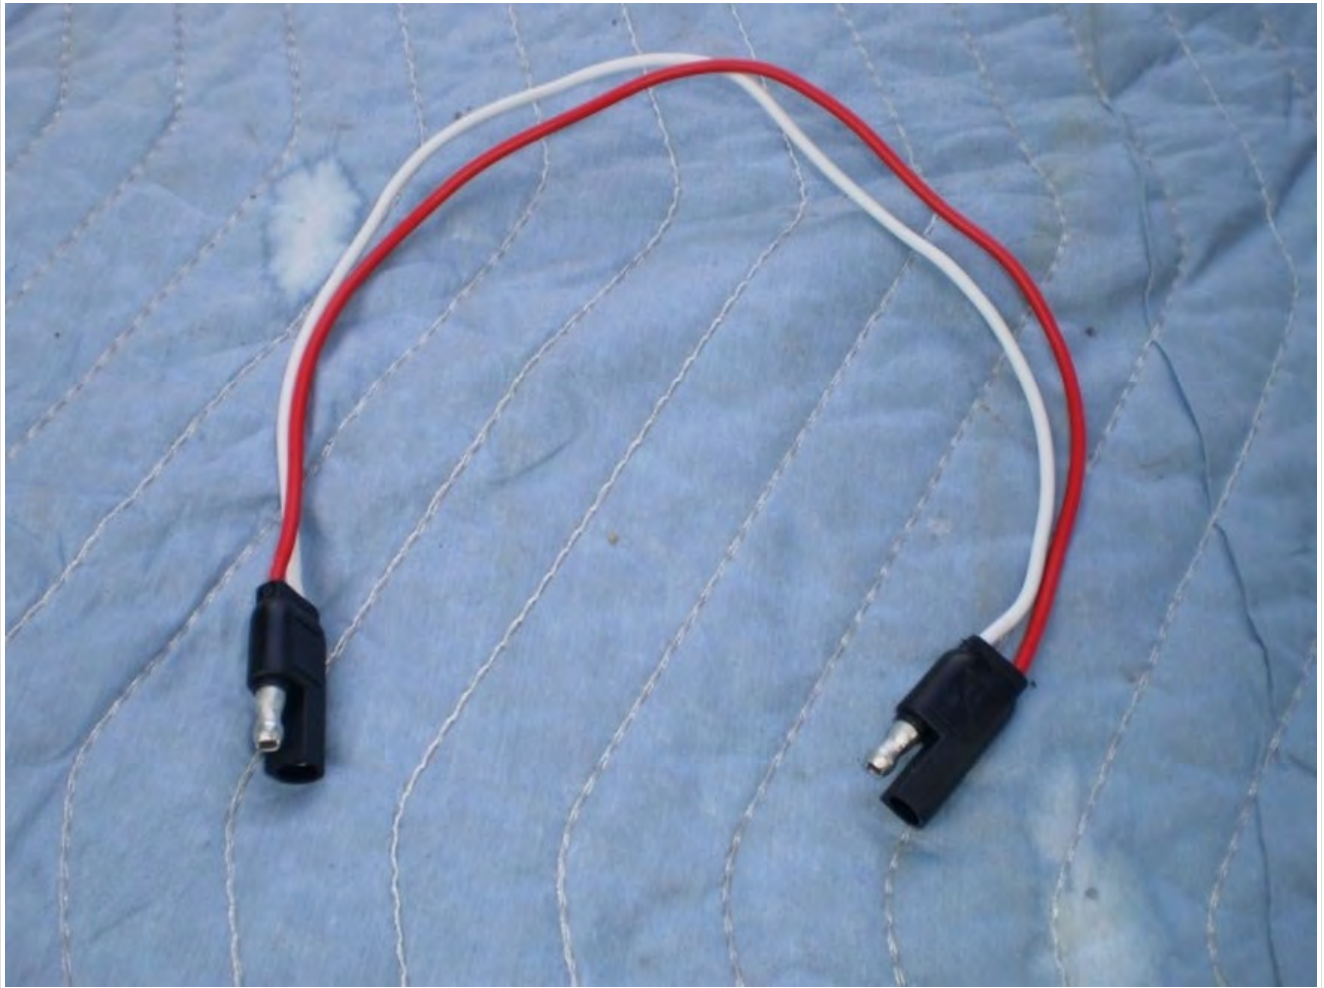
37. You need to decide how you want to connect and run the wires. Read through all of OPTION B to get a better understanding. I chose a trailer connector harness for a few bucks. I cut my connector 3/4 of the length.

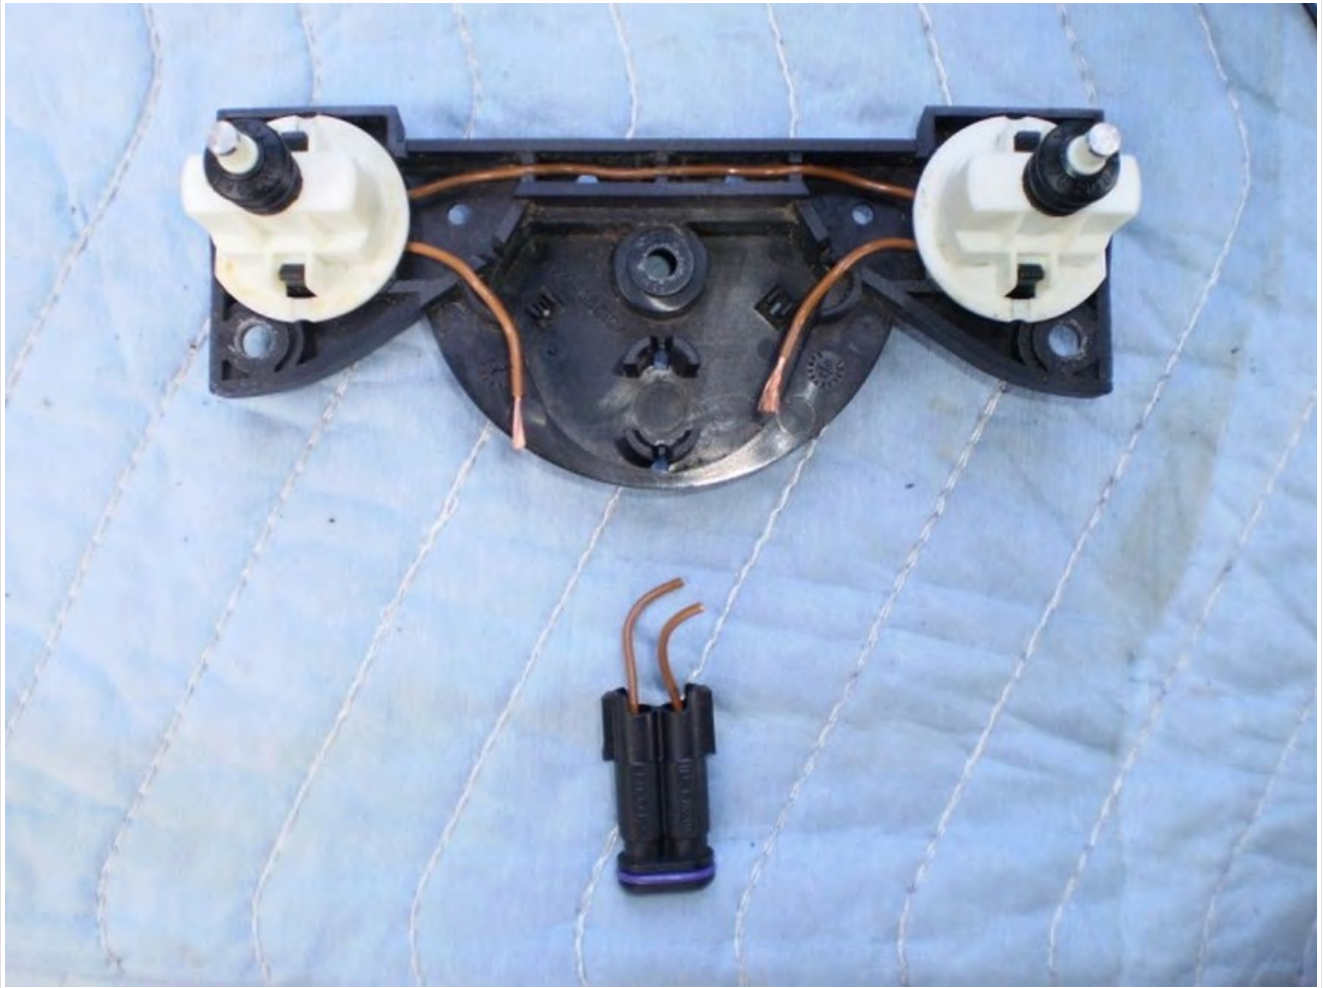
38. Remove your SVS any method you desire, Option A, or Option B without removing the modulator side (see steps # 25 through # 29) Cut SVS plug, but unlike my cut illustrated below, cut as close to the plug as possible.

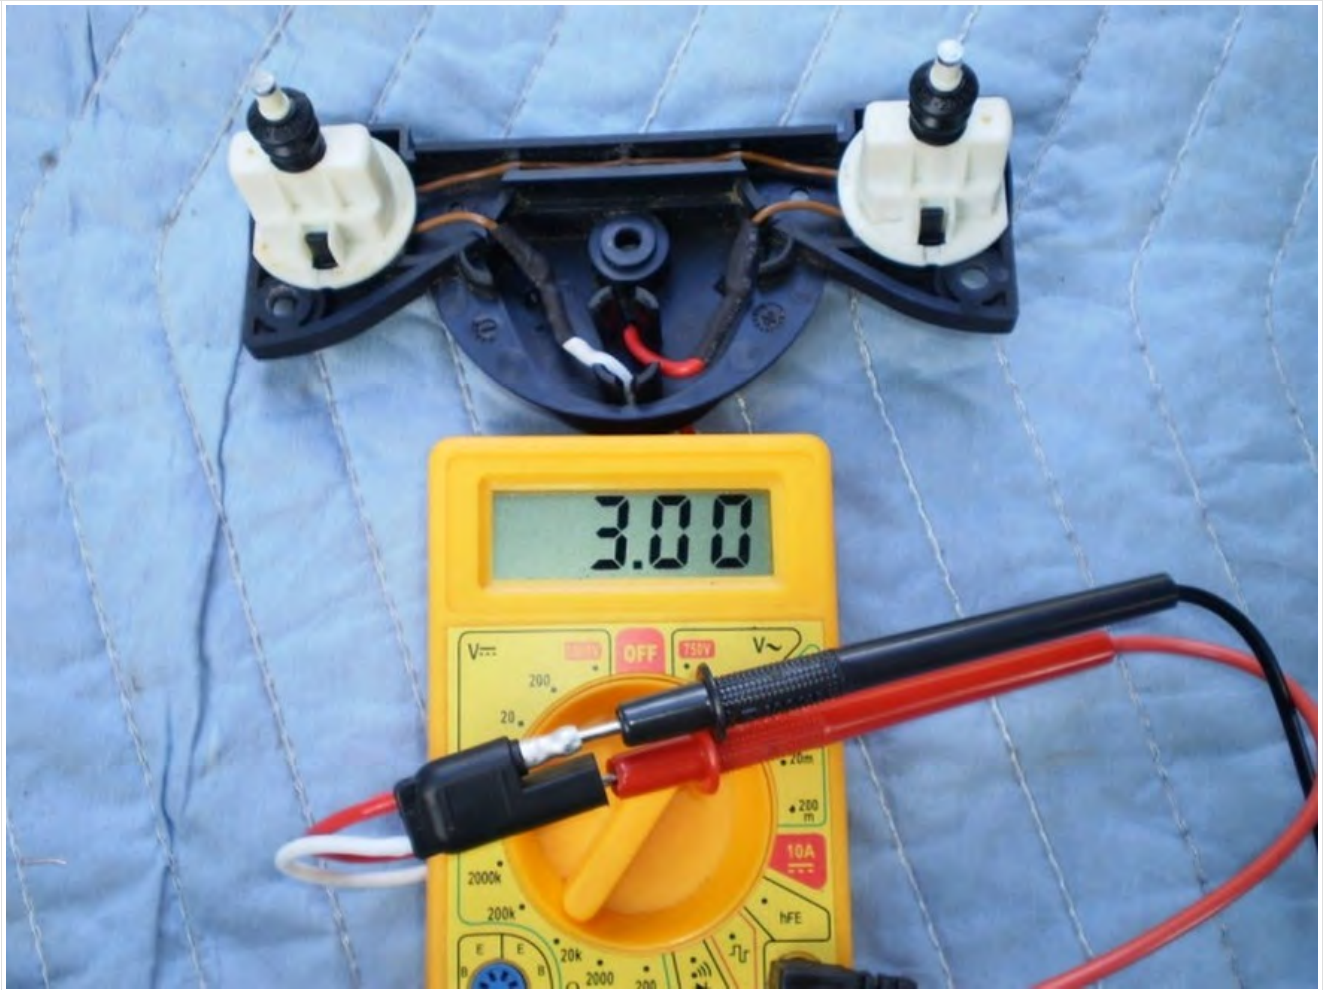
40. Now to test the connections.

BOTH open, PASSED.

ONE Closed, PASSED.

BOTH Closed, PASSED.
