ABS MODULATOR ELECTRICAL FAULT REPAIR

11/2009

The Land Rover Discovery Series II uses the same ABS MODULATOR as the H1 Hummer. The company that manufactures it is **WABCO** (<https://web.archive.org/web/20170730071921/http://www.wabco-auto.com/>) (Meritor WABCO (https://web.archive.org/web/20170730071921/http://www.meritorwabco.com/Page.aspx?page_id=1)). If you have been experiencing an intermittent fault causing your ABS, HDC, and TC lights aka *Three Amigos*, your problem may be a result of a bad electrical connection.

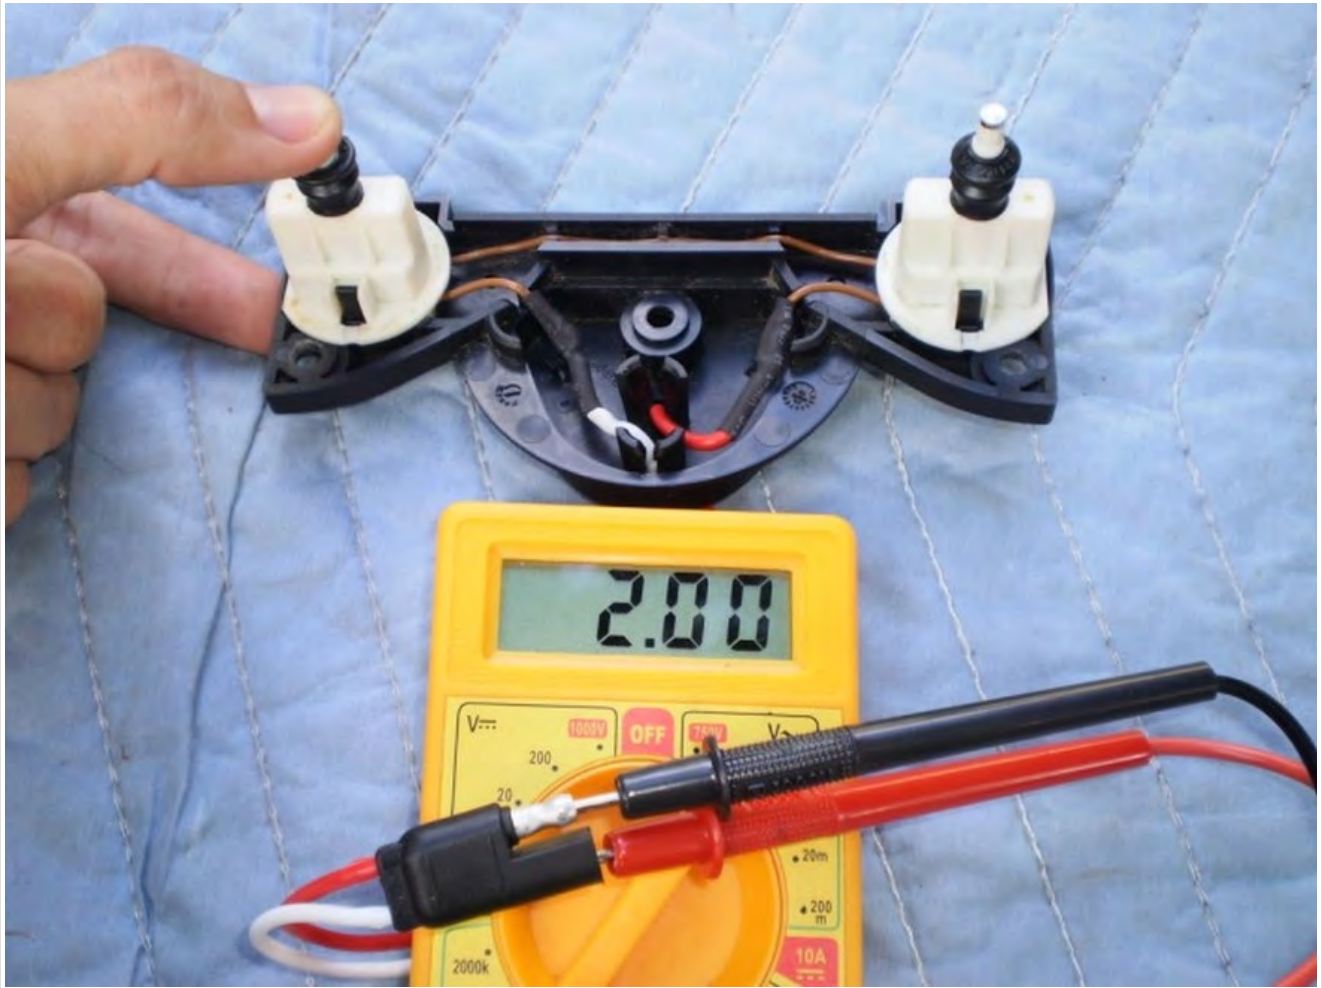
BOTH open, PASSED.

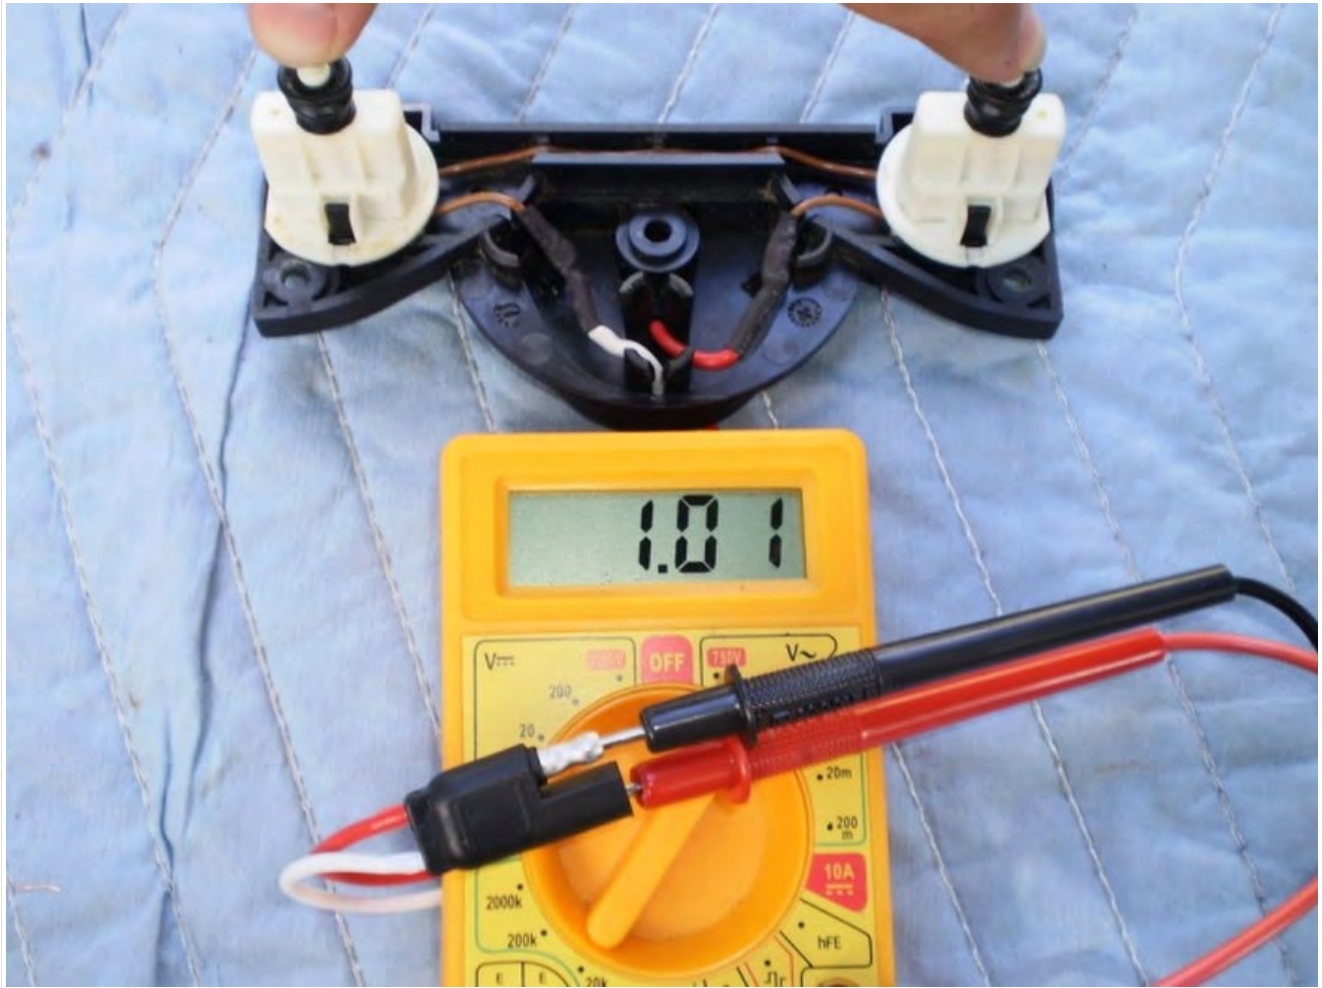
ONE Closed, PASSED.

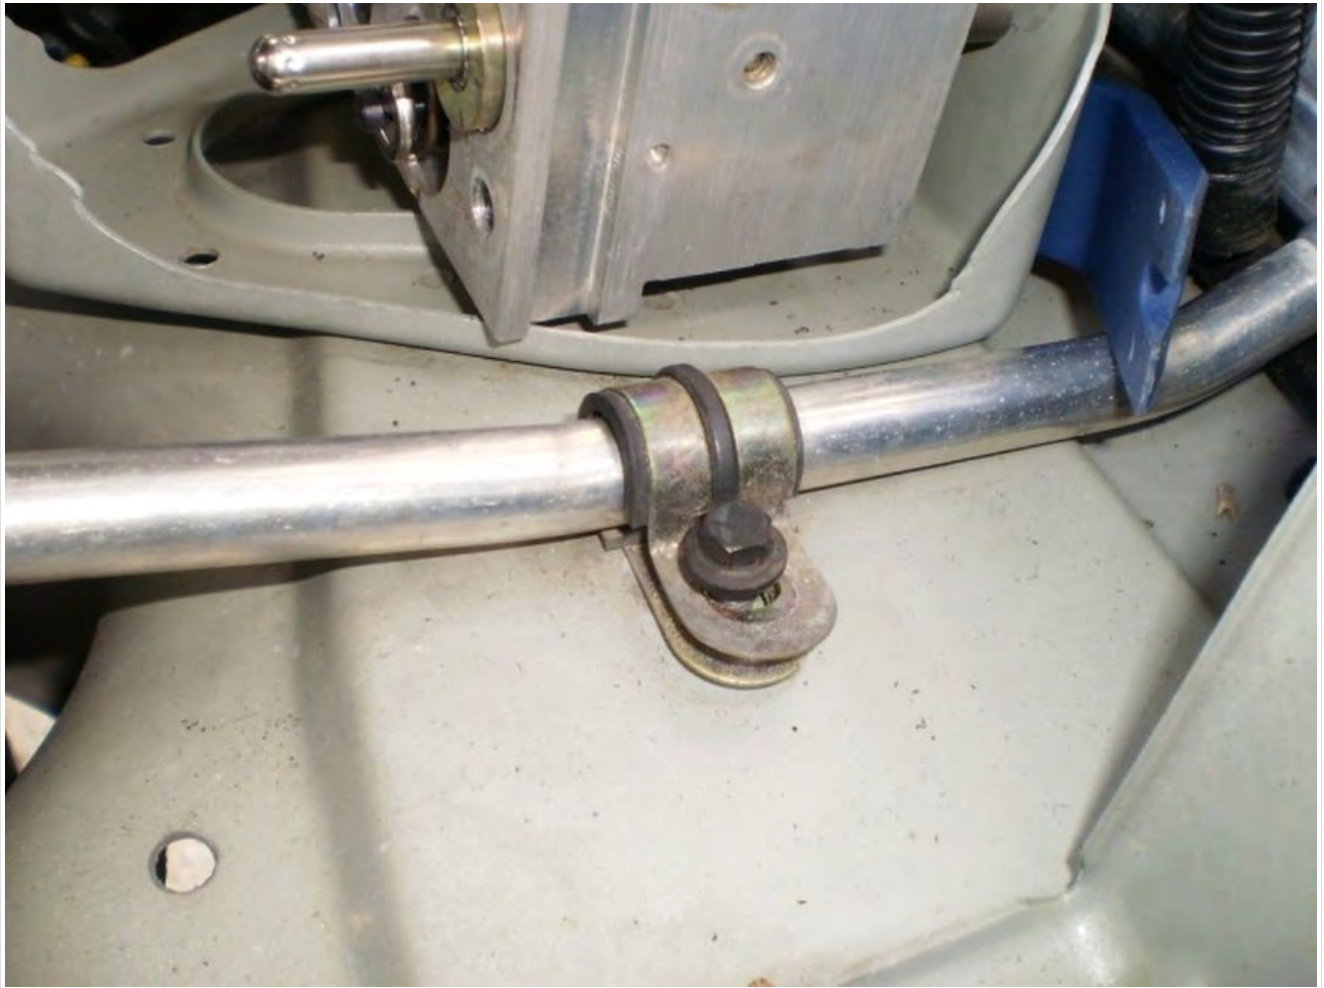
41. Now to find a close ground.... Since the YG wire we need to tap into runs along side the A/C line bracket retaining bolt.. Why not use it?

The Three Amigos returned in April 2010 as a result of this bolt coming loose. I may not have tightened it well when I did it the first time back in November 2009 so torque it good, and add loctite. I plan to check the bolt every oil change. In addition to using that bolt as a ground, ensure that it is free of dirt or rust or anything that would diminish a good electrical contact.

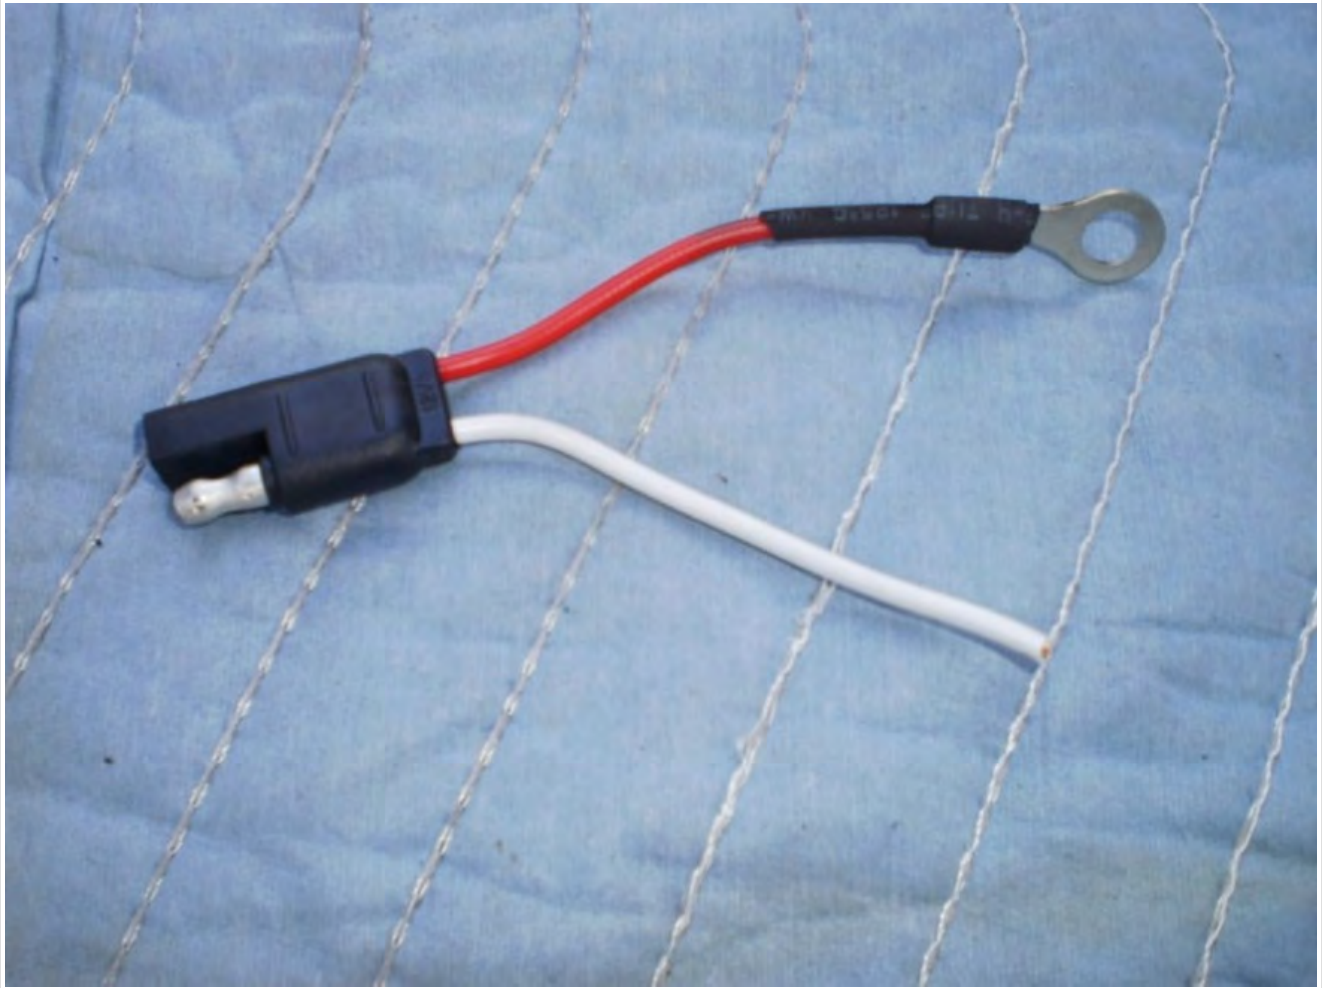
42. Take your other end of the harness and crimp a connector to secure to the ground bolt. Heat shrink it to provide better protection and it also just looks better.

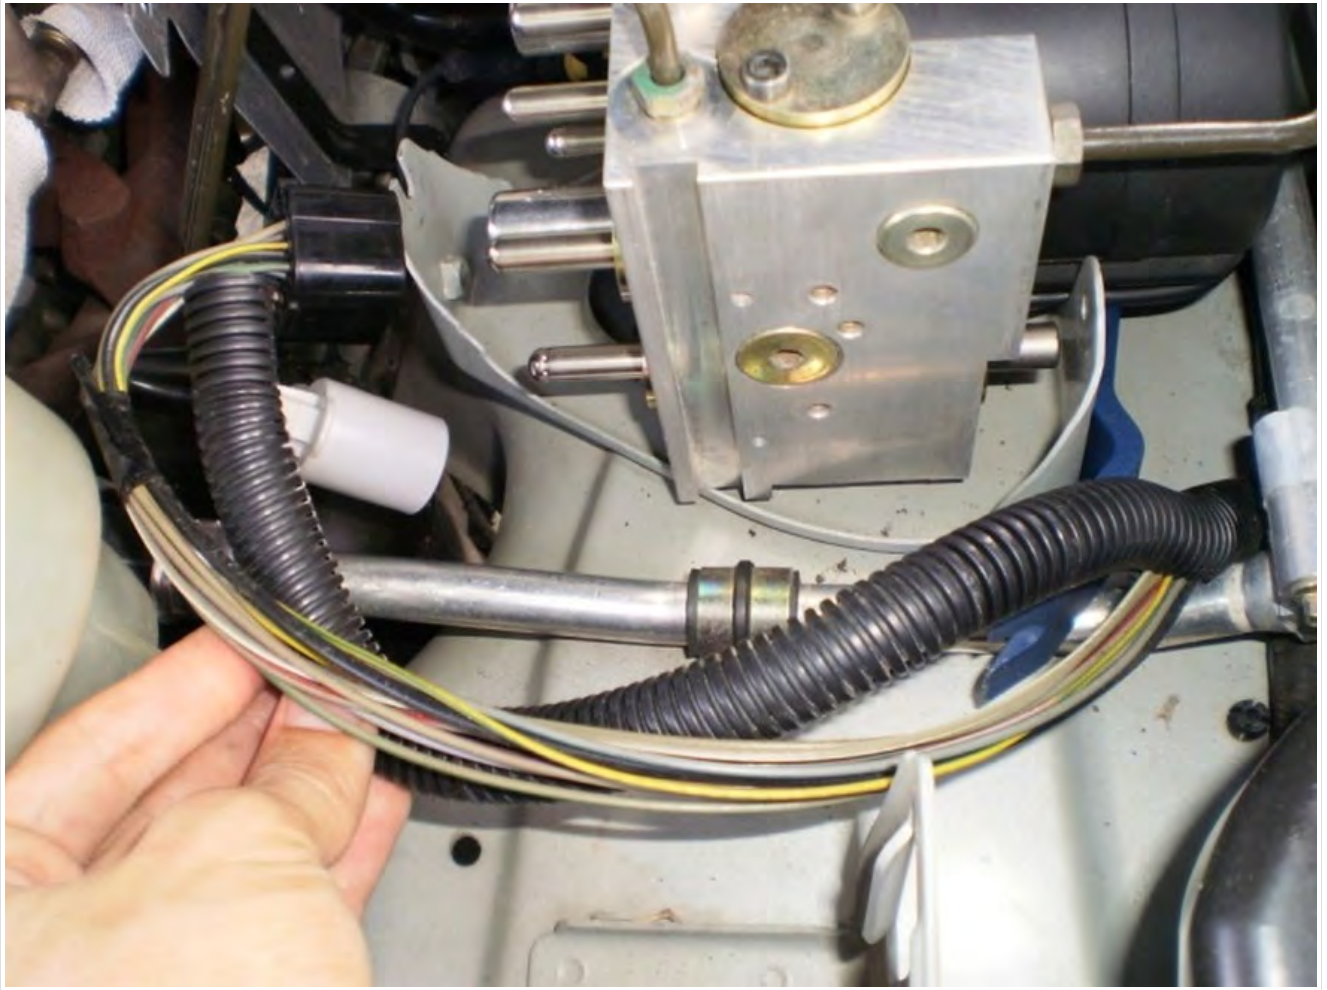
43. Peel off the wire loom shield off of the ABS Modulator wire harness. Locate the YG wire. Cut it in half but in such a way to leave enough length for your harness.

44. Take the second wire from your trailer harness and splice, solder, and heat shrink it into the YG wire coming from the main harness end NOT the end going back to the modulator plug.

Based on comments and feed back, I should add and clarify that the remaining end of the YG wire (the end attached to the plug) will just get tucked back into the loom as it is now dead.

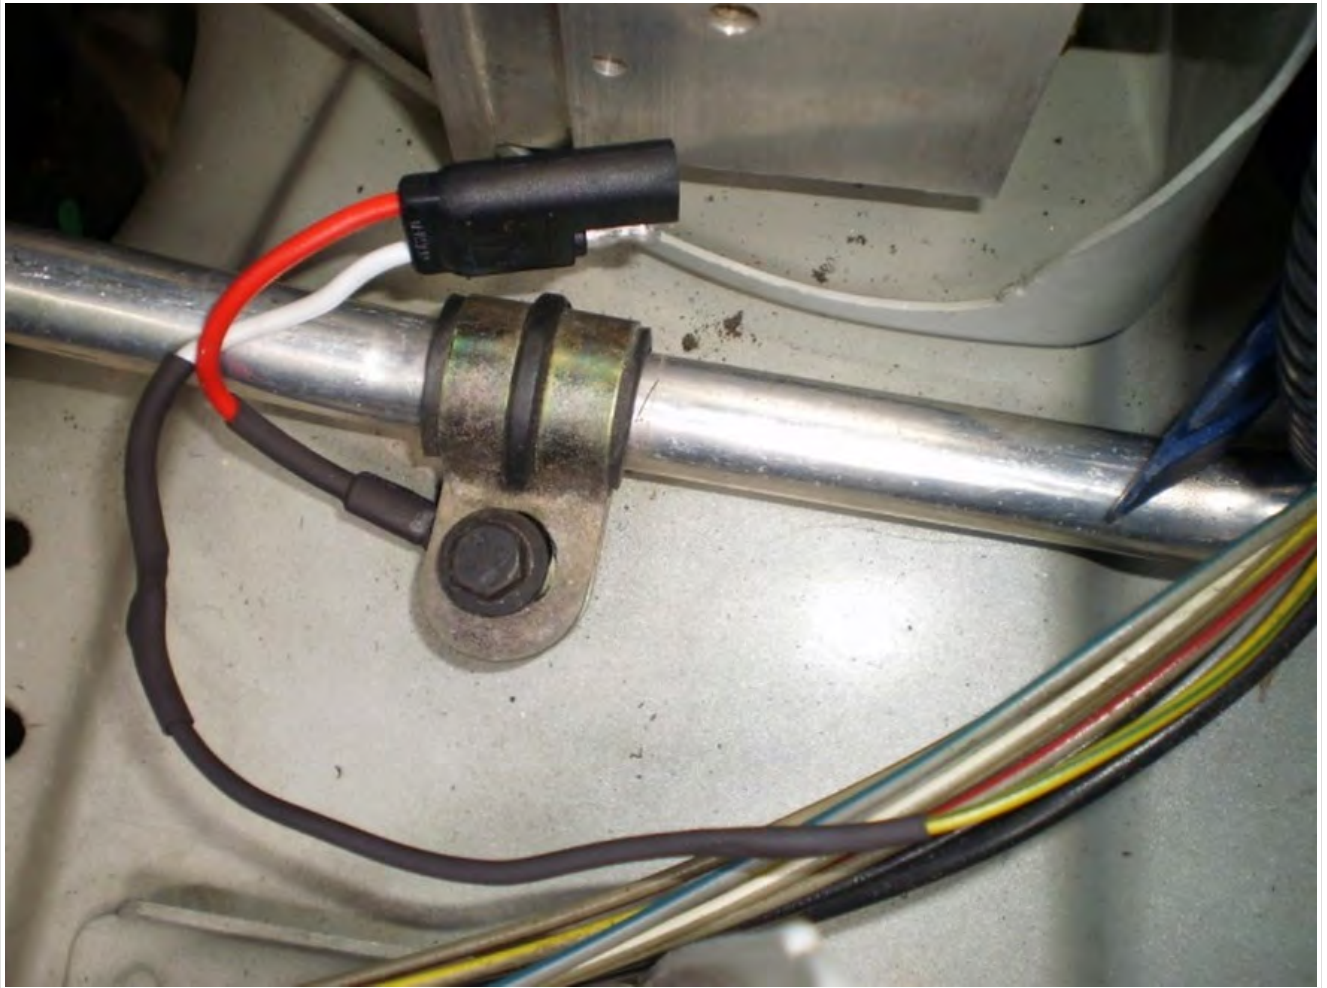
This is what it looks like plugged up.

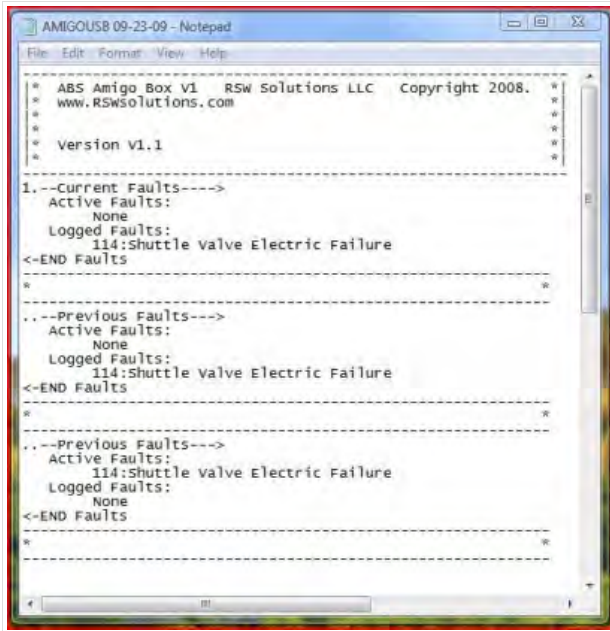
FROM THIS.....

```
AMIGOUSB 09-23-09 - Notepad
File Edit Format View Help
* ABS Amigo Box V1 RSW Solutions LLC Copyright 2008.
* www.RSWsolutions.com
*
* Version V1.1
*
-----
1.--Current Faults---->
Active Faults:
None
Logged Faults:
114:Shuttle Valve Electric Failure
<-END Faults
-----
..--Previous Faults---->
Active Faults:
None
Logged Faults:
114:Shuttle Valve Electric Failure
<-END Faults
-----
..--Previous Faults---->
Active Faults:
None
Logged Faults:
114:Shuttle Valve Electric Failure
None
<-END Faults
-----
```
