# LAND ROVER CLUB V.I.

## ABS MODULATOR ELECTRICAL FAULT REPAIR

11/2009

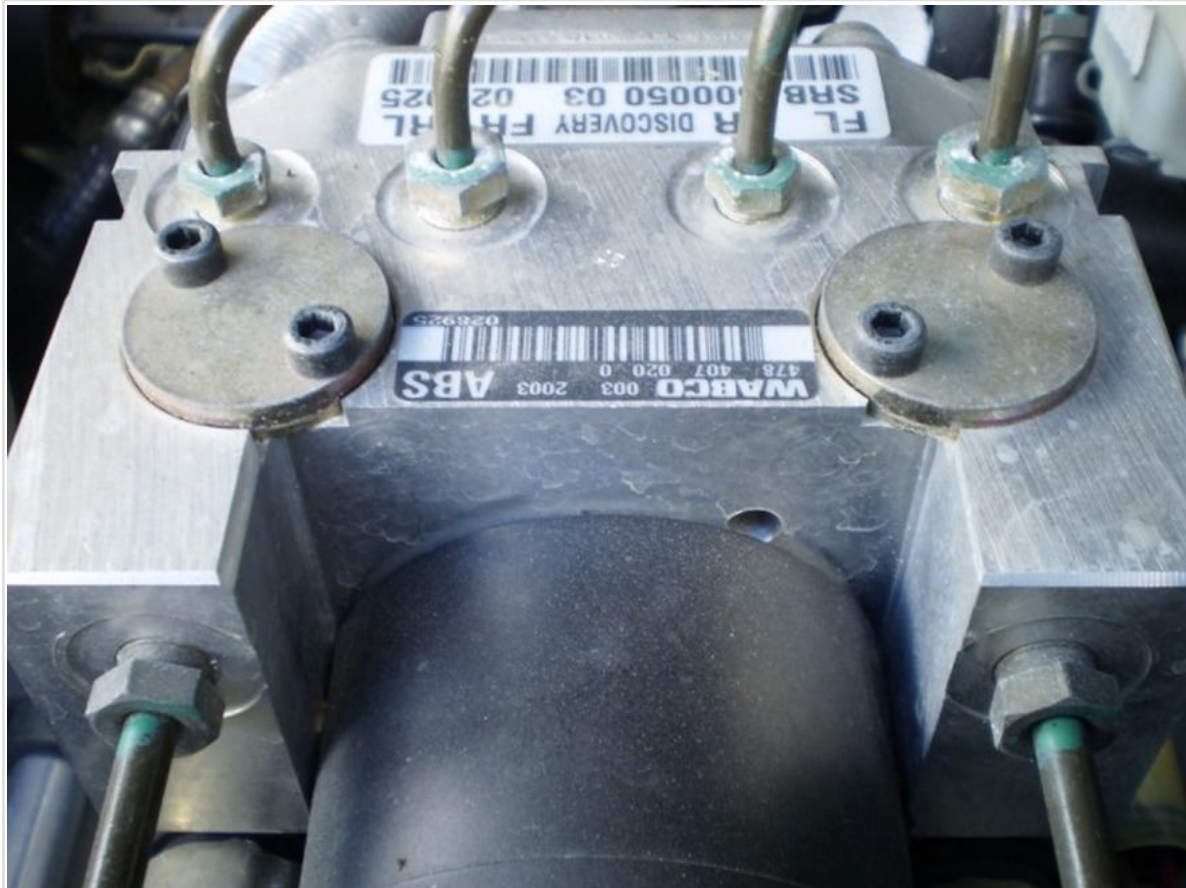
1. Spray Liquid Wrench on the 6 brake line nuts (4 on top and 2 on the side).
2. Also spray the four hex screws on the cover plates. Removal of the screws and plate will help remove the brake lines but it is not required.

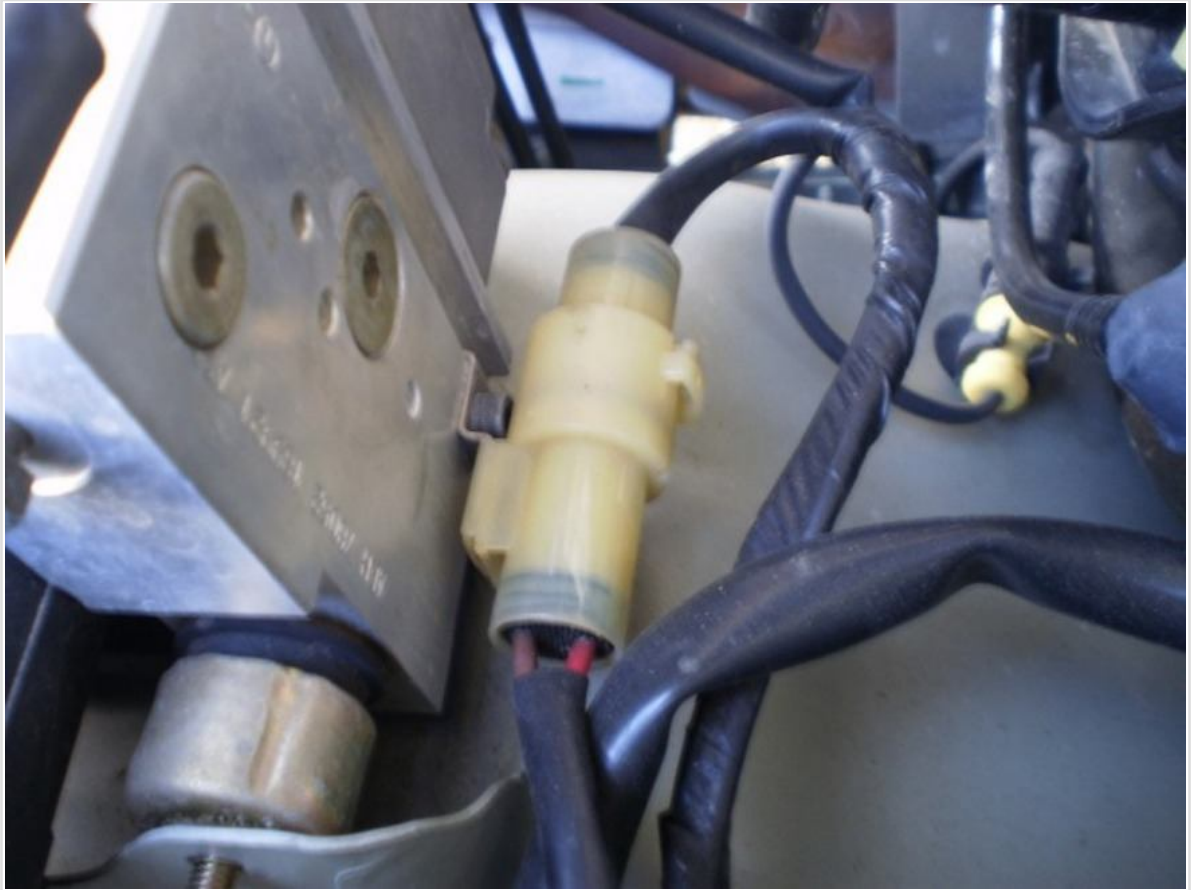
Removing black connector C0501 and grey connector C0500

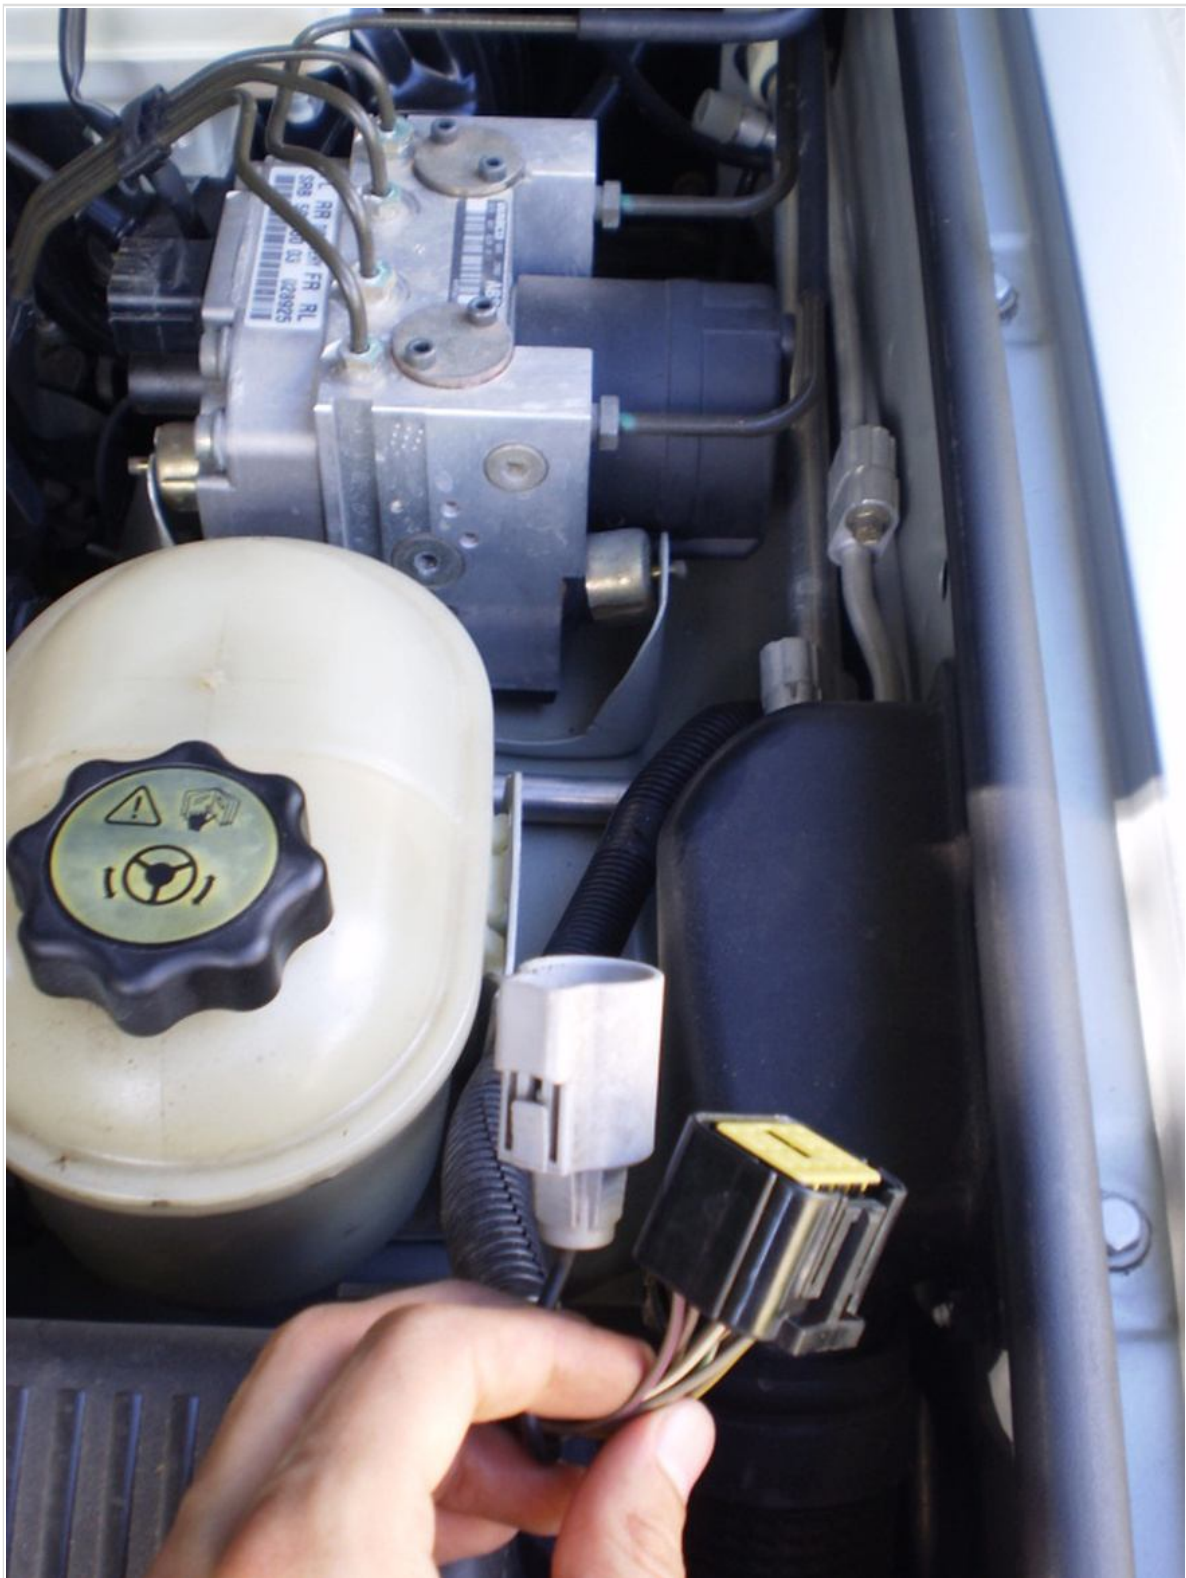
Side connector C0507

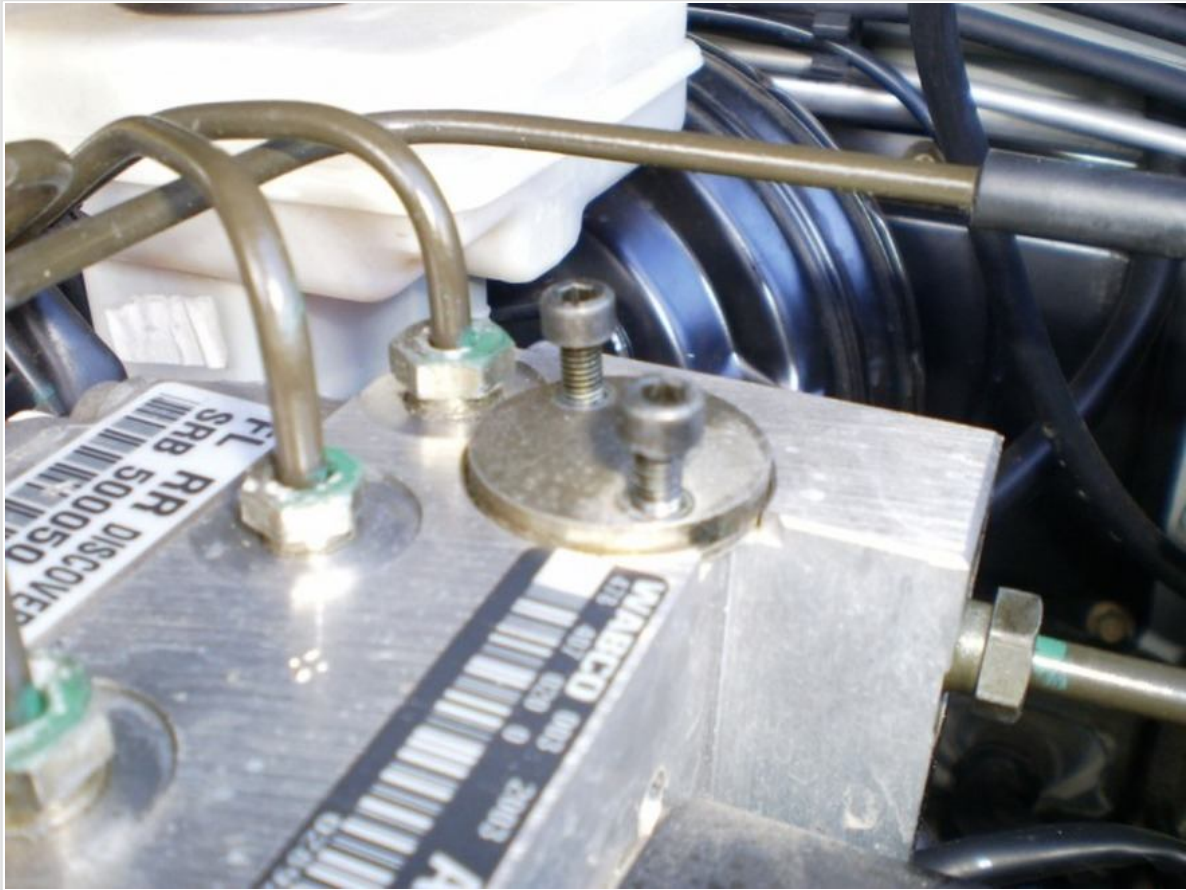
4. Using a 4mm hex bit, remove the two hex screws and cover plate.

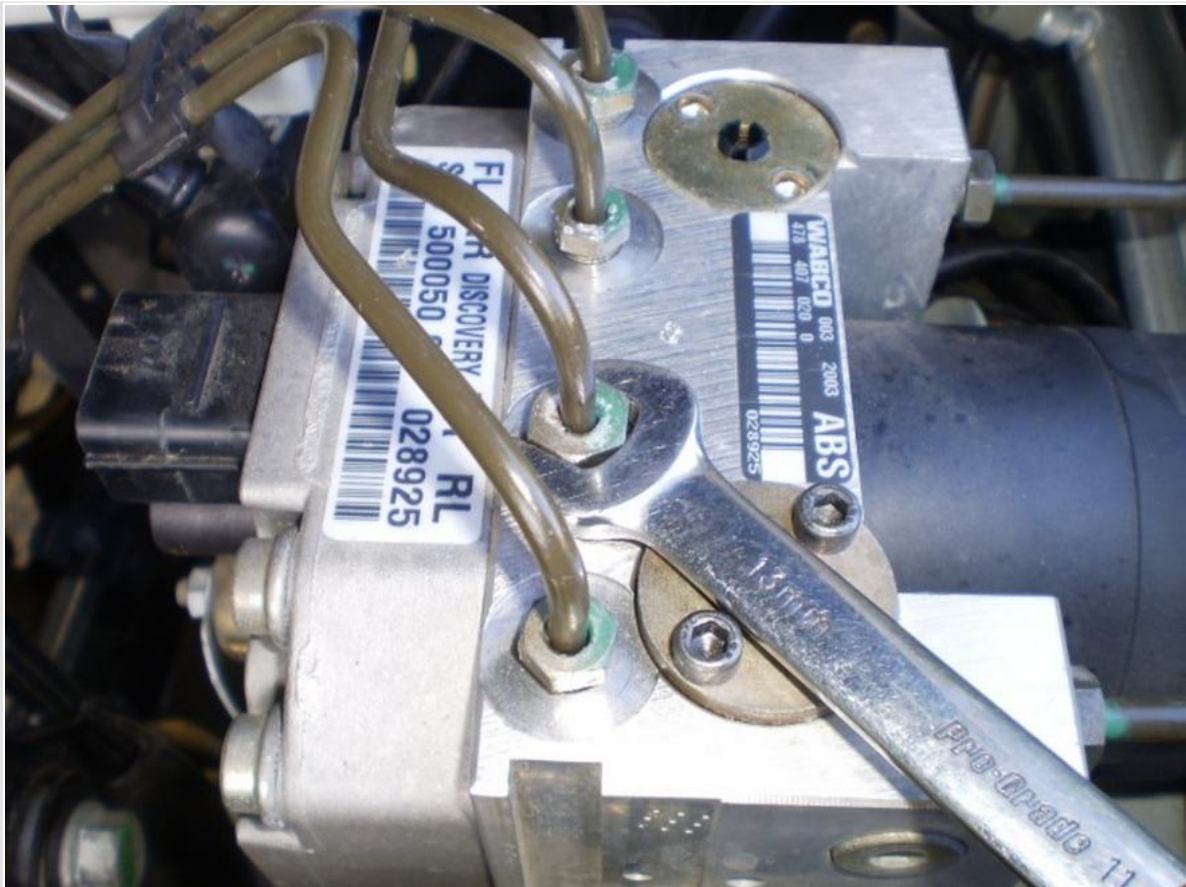
5. Brake loose the two bigger flare nuts using a 13mm wrench.

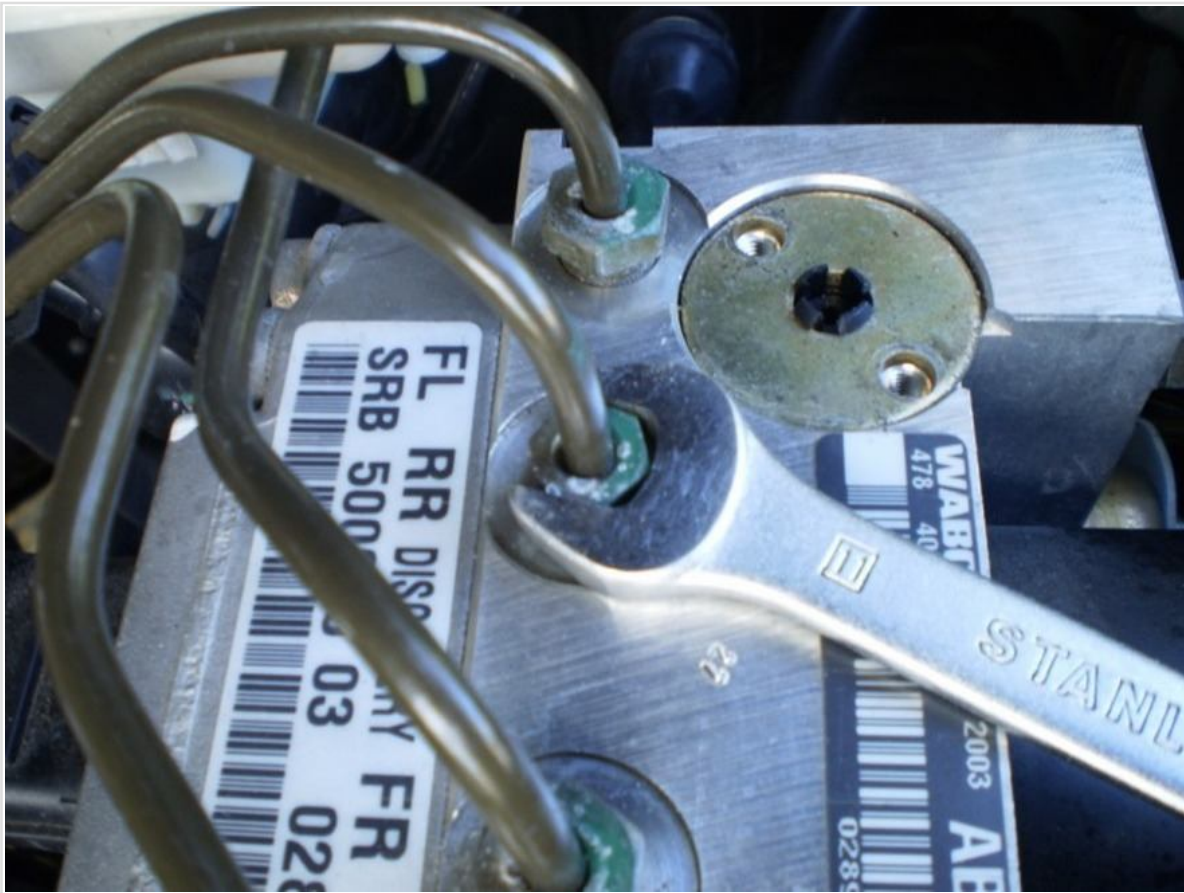
6. Brake loose the two smaller flare nuts using a 11mm wrench.

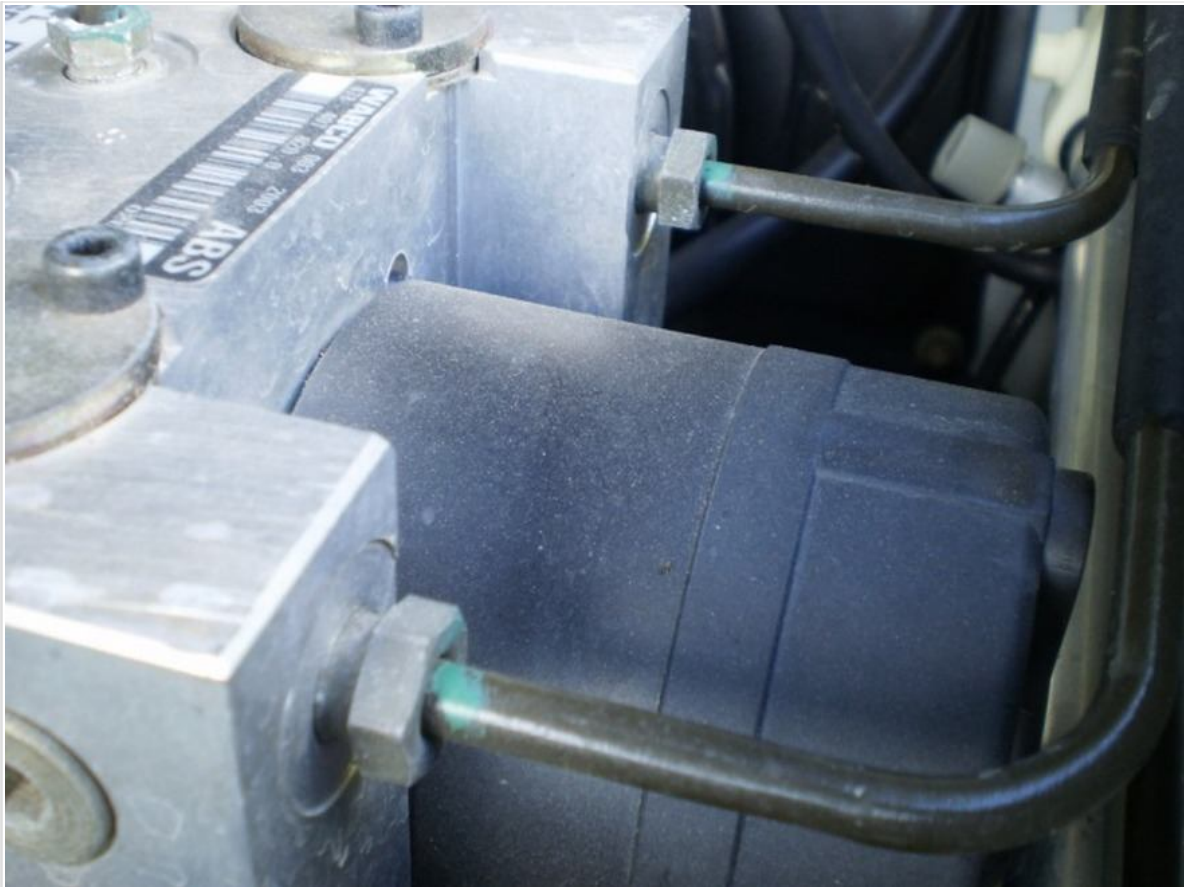
7. Brake loose the two side mounted brake line nuts using a 13mm wrench.

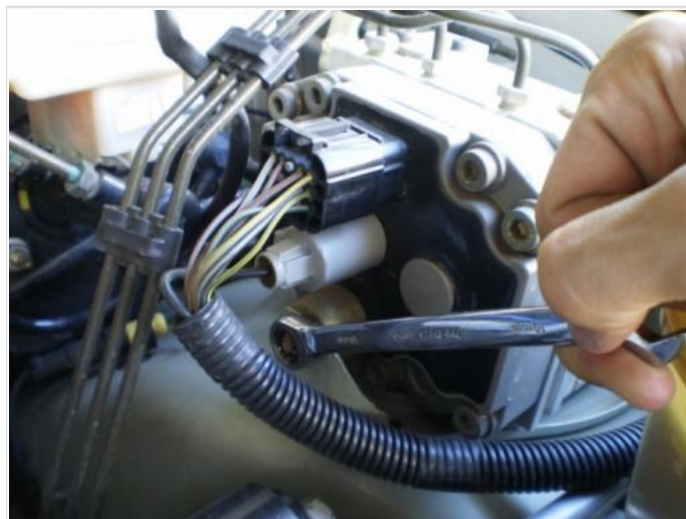
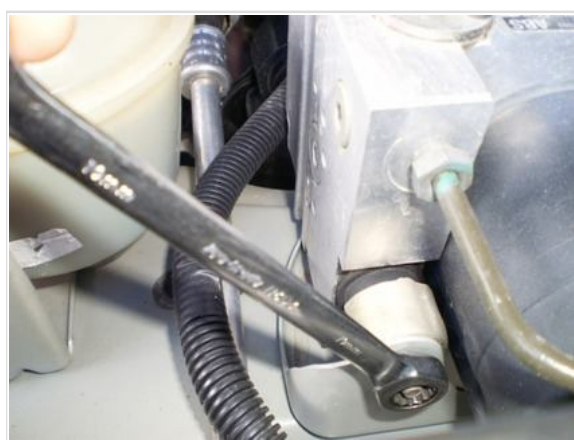
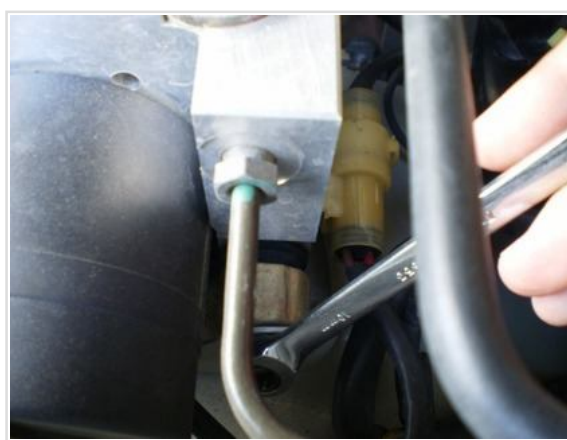
8. Once all 6 brake lines are broken loose, remove the 3 nuts securing the modulator on to its mounting bracket using a 10mm wrench.

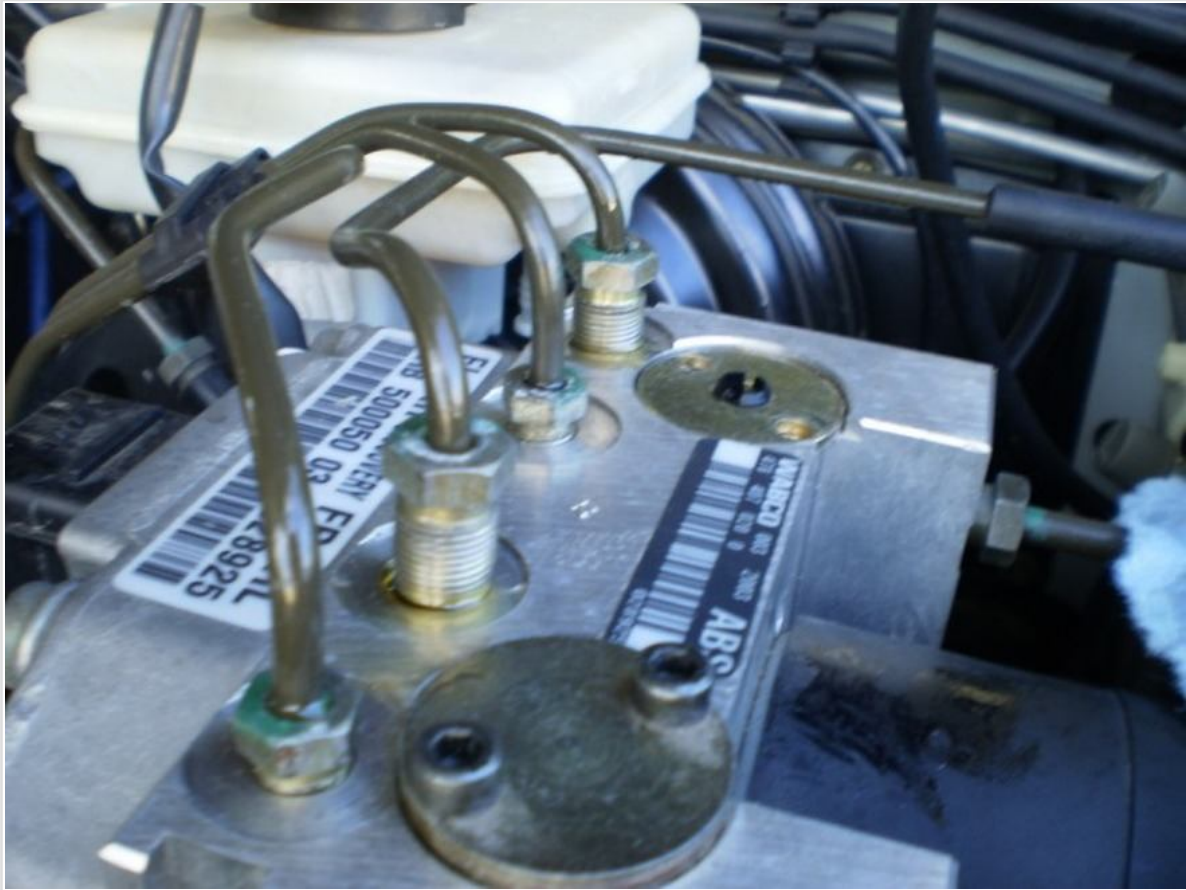
9. Unscrew and disconnect the two bigger brake lines. Brake fluid will be dispensed from both the lines and pump side. Have a shop towel nearby.

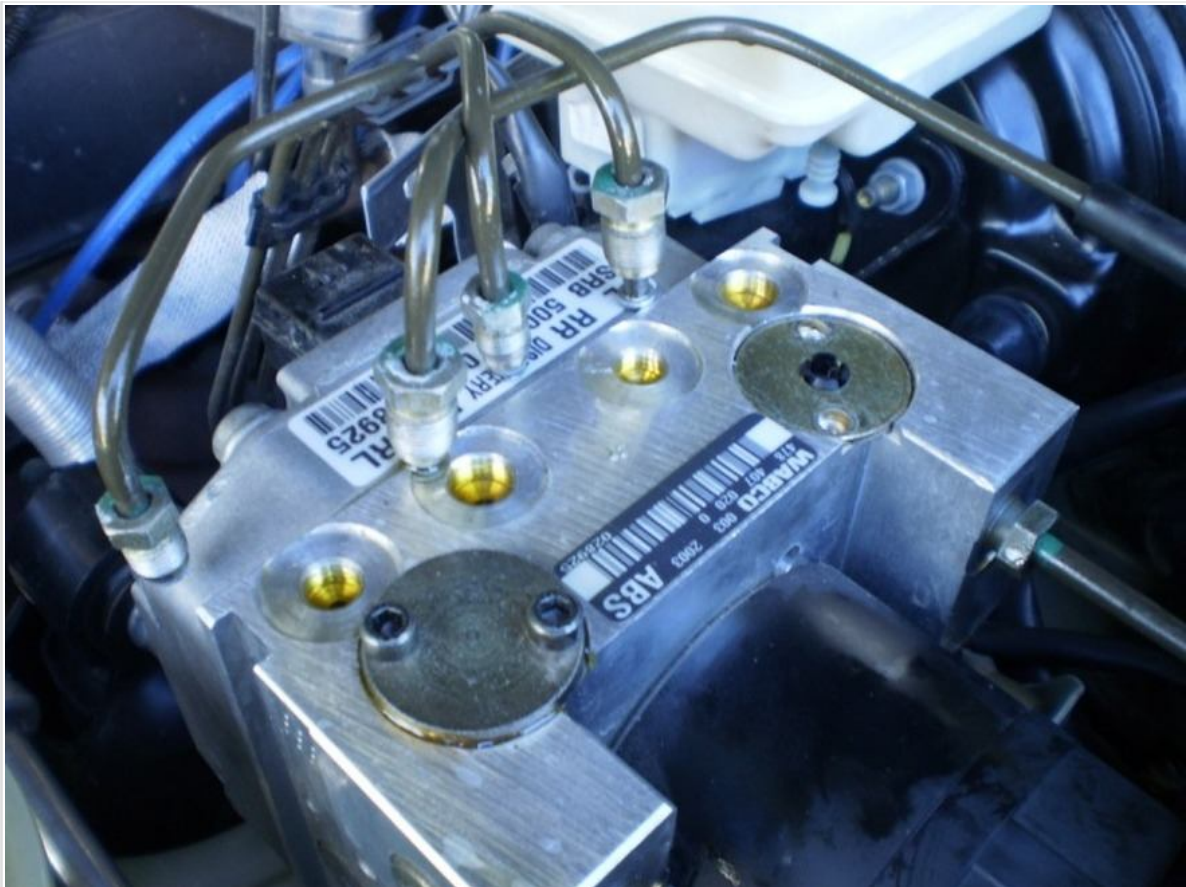
10. Unscrew and disconnect the two smaller brake lines. Brake fluid will be dispensed from both the lines and pump side. Have a second shop towel nearby.

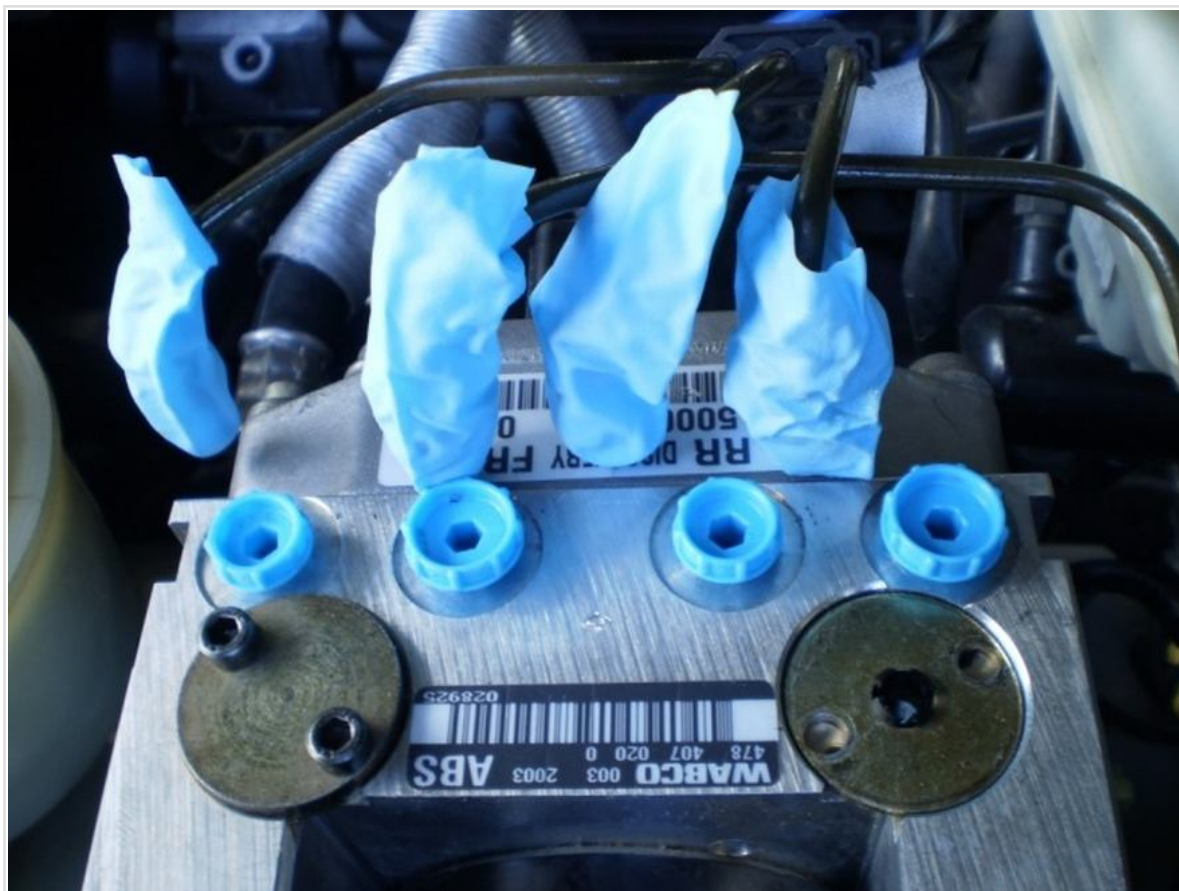
*Luckily I had a second ABS modulator/pump that had plugs for all 6 brake line ports so I plugged them up. I also cut the fingers off a disposable rubber glove to keep the lines from dust contamination. It also helped catch some brake fluid. I recommend using a syringe or turkey baster to suck out the residual brake fluid from the modulator if you do not have brake plugs.*

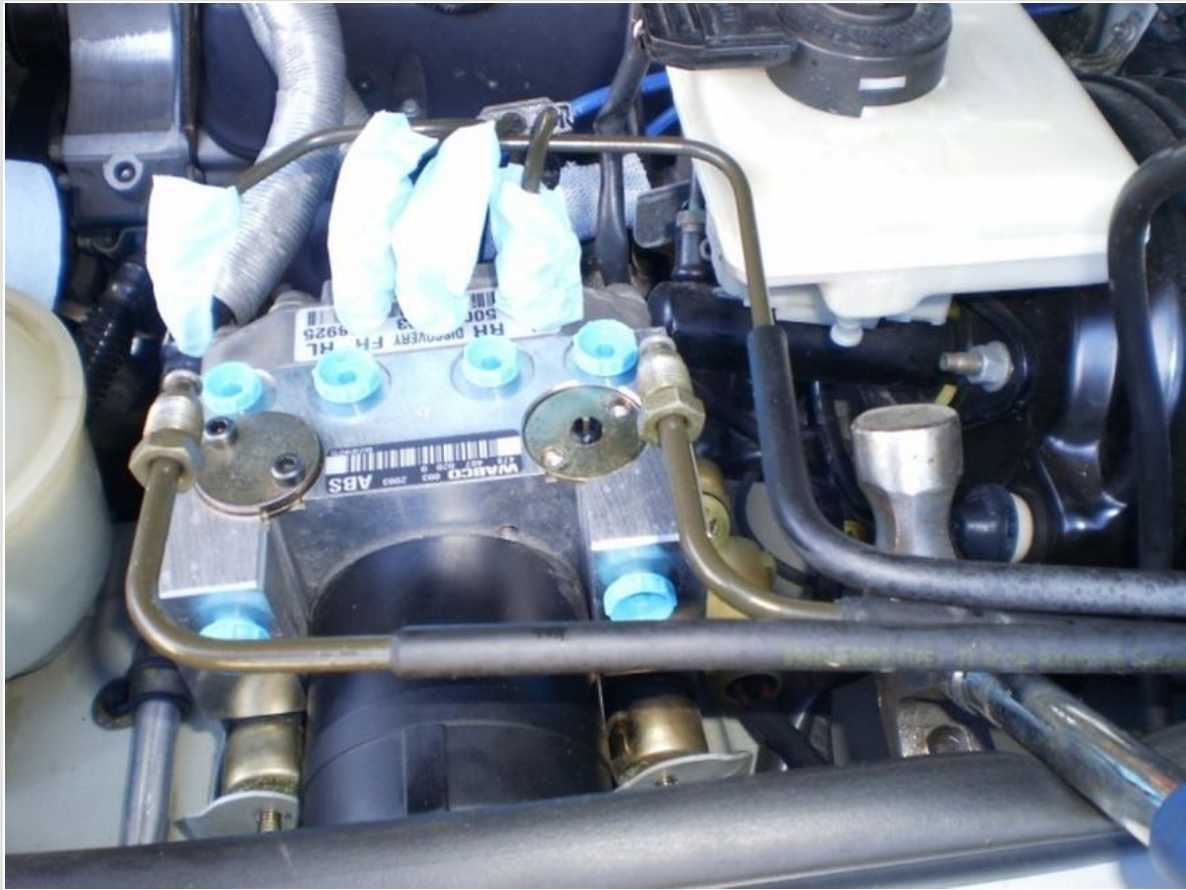
11. Disconnect the two side lines. Brake fluid will be dispensed from the lines and pump side. Have that third shop towel nearby.

*Because of the slight incline on my drive way, it was necessary for me to elevate the two side brake lines coming from the master cylinder to prevent brake fluid from continuing to pour out. I used a hammer at first and wedged it between the inside of the quarter panel.*

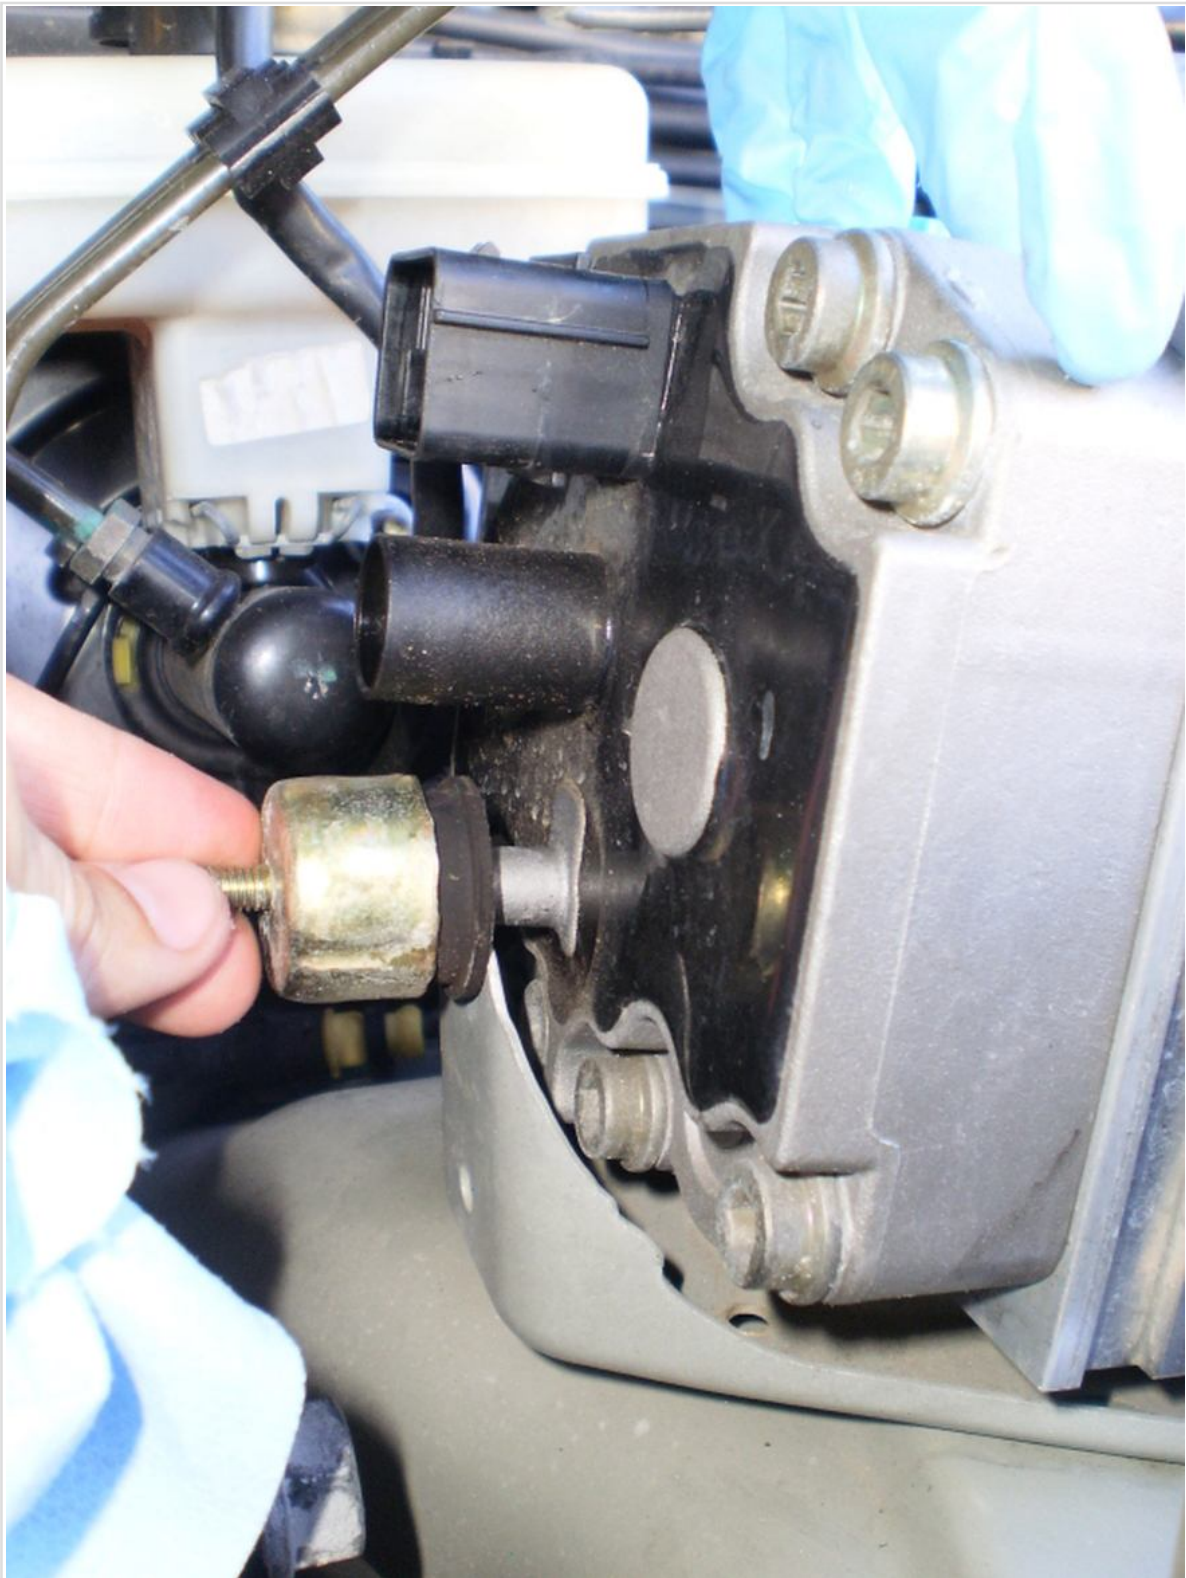
12. Lift the front of the modulator and remove the front rubber mount.

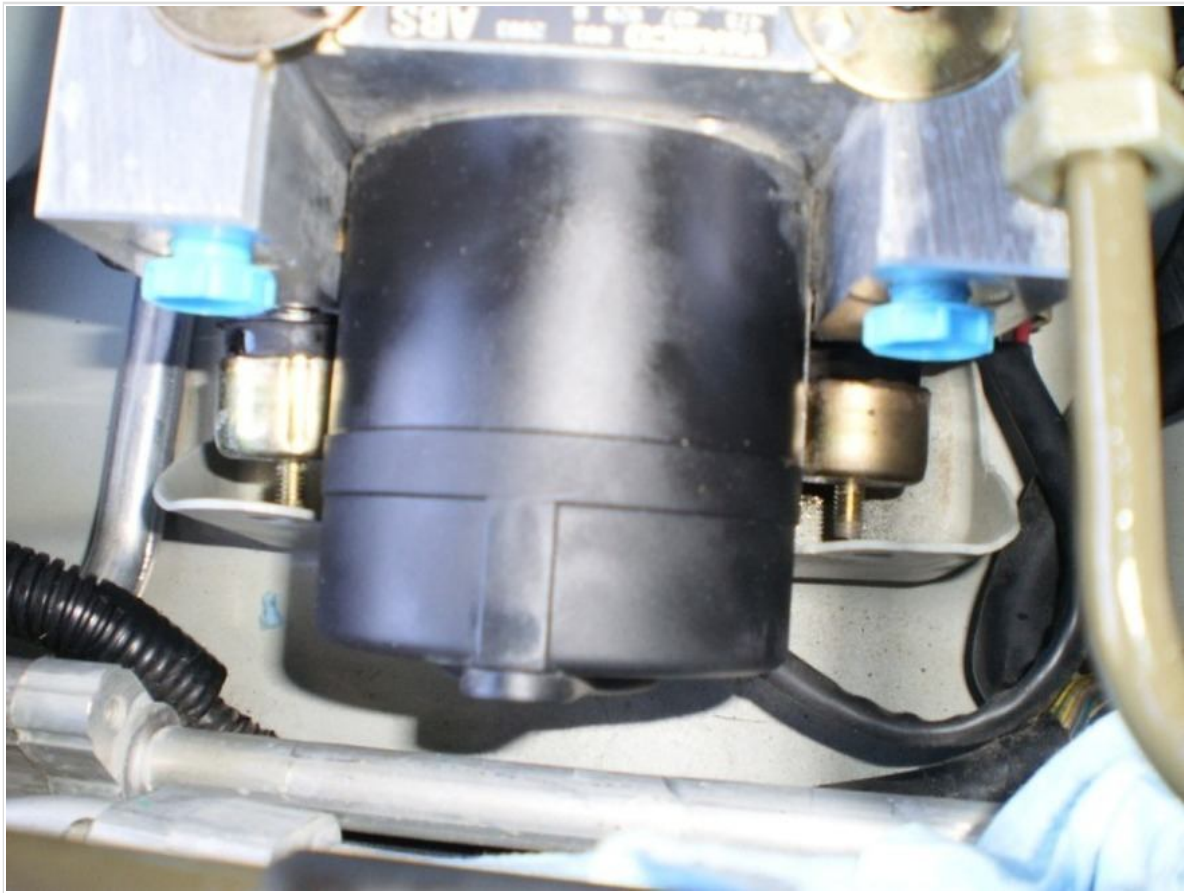
13. Carefully remove the ABS unit paying closing attention to the brake lines.

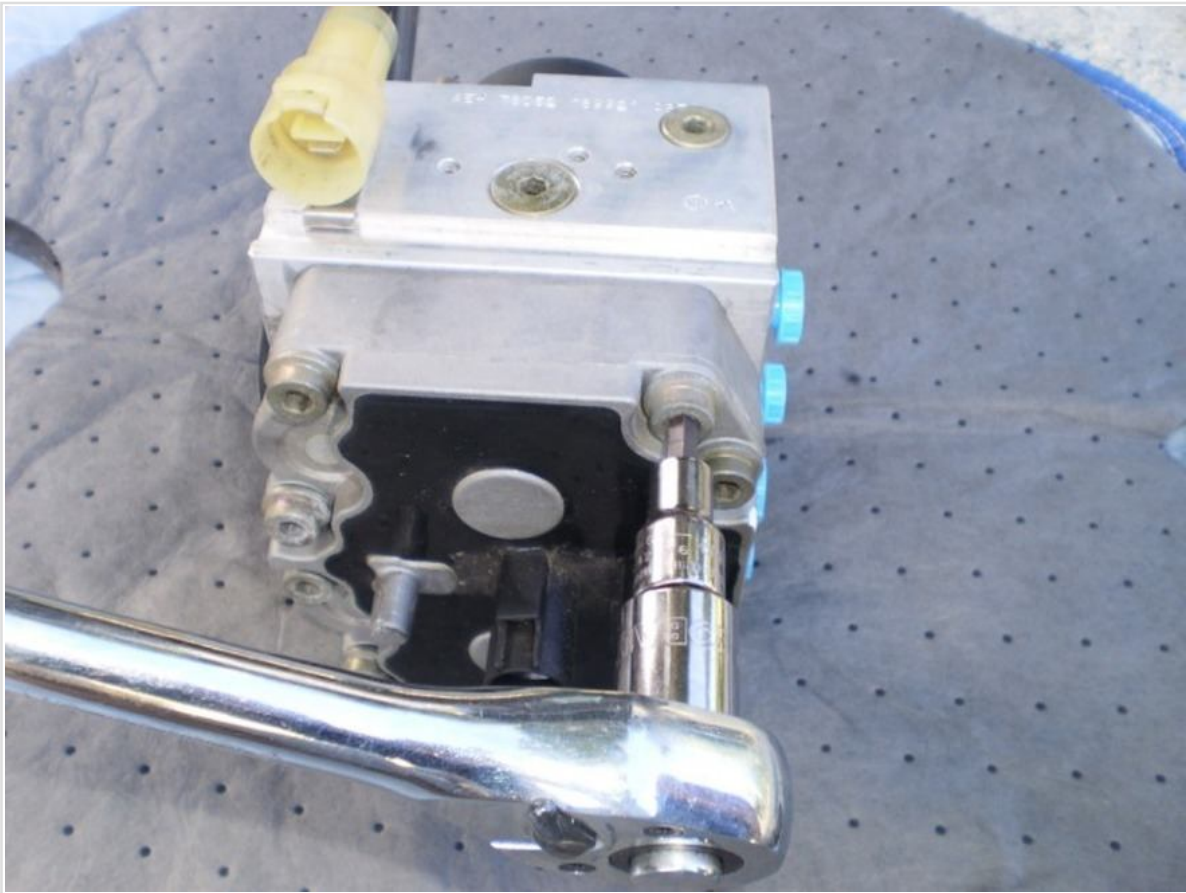
15. Clean off the modulator. Using a 6mm hex tool, remove 8 bolts on the modulator.

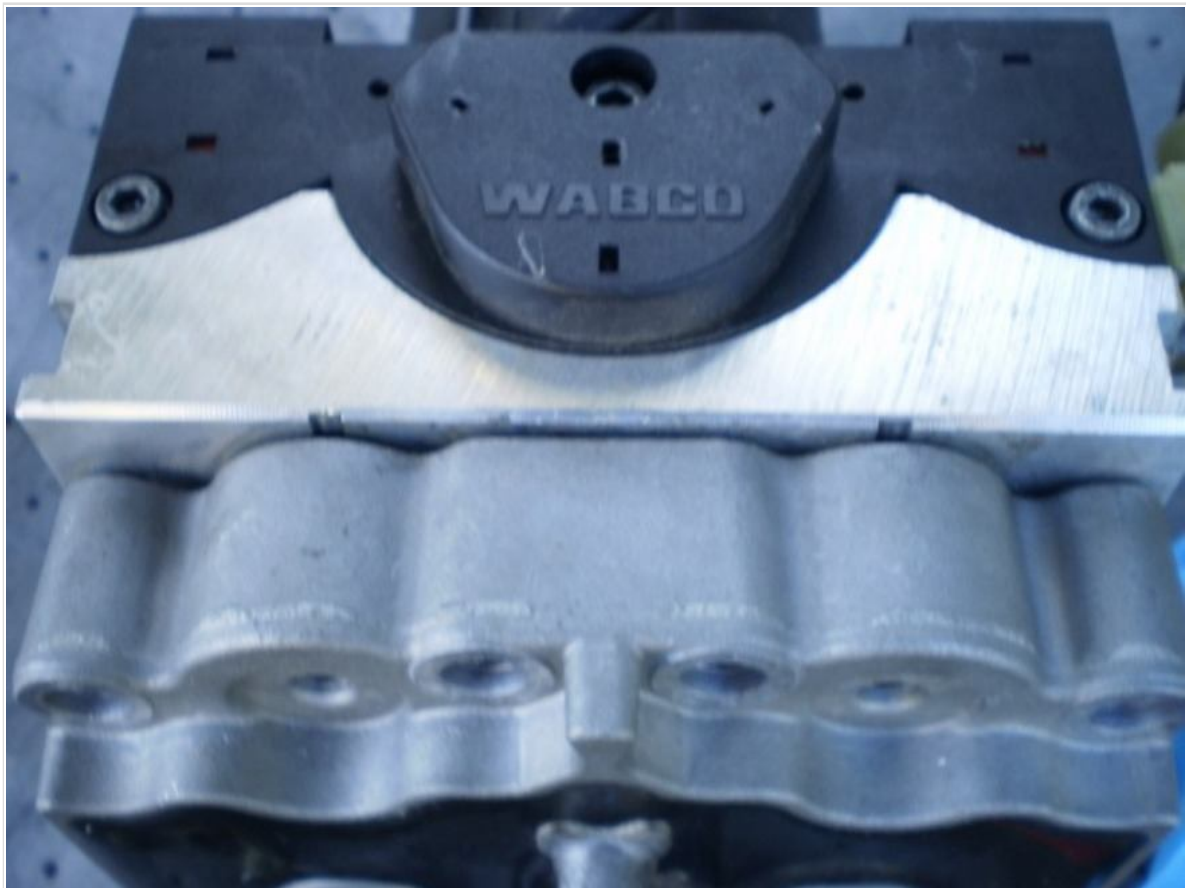
16. Turn the unit upside down. The SVS cover plate reading "WABCO" should now be on top. Using the 4mm hex bit, remove the 3 hex screws. They are installed with blue or red loctite, so let them soak in penetrating fluid to ease removal and prevent stripping.

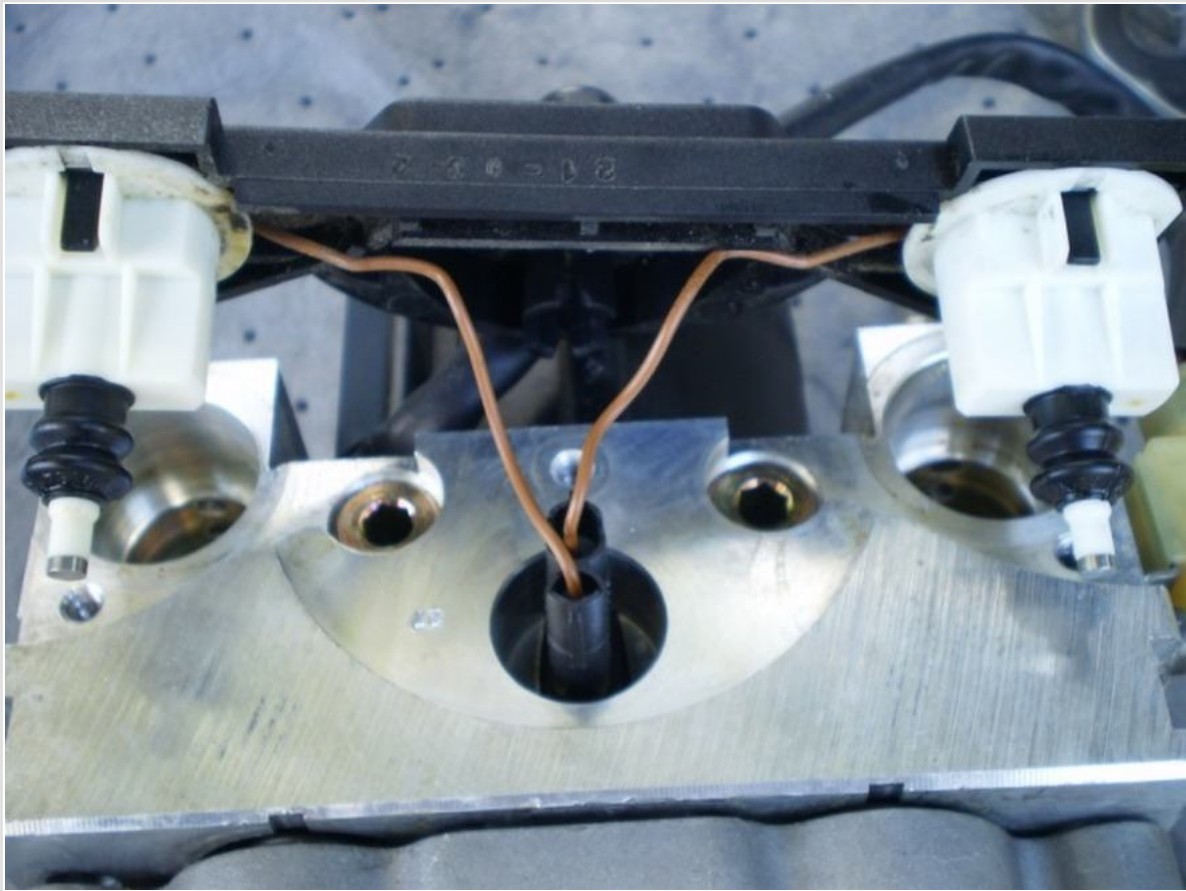
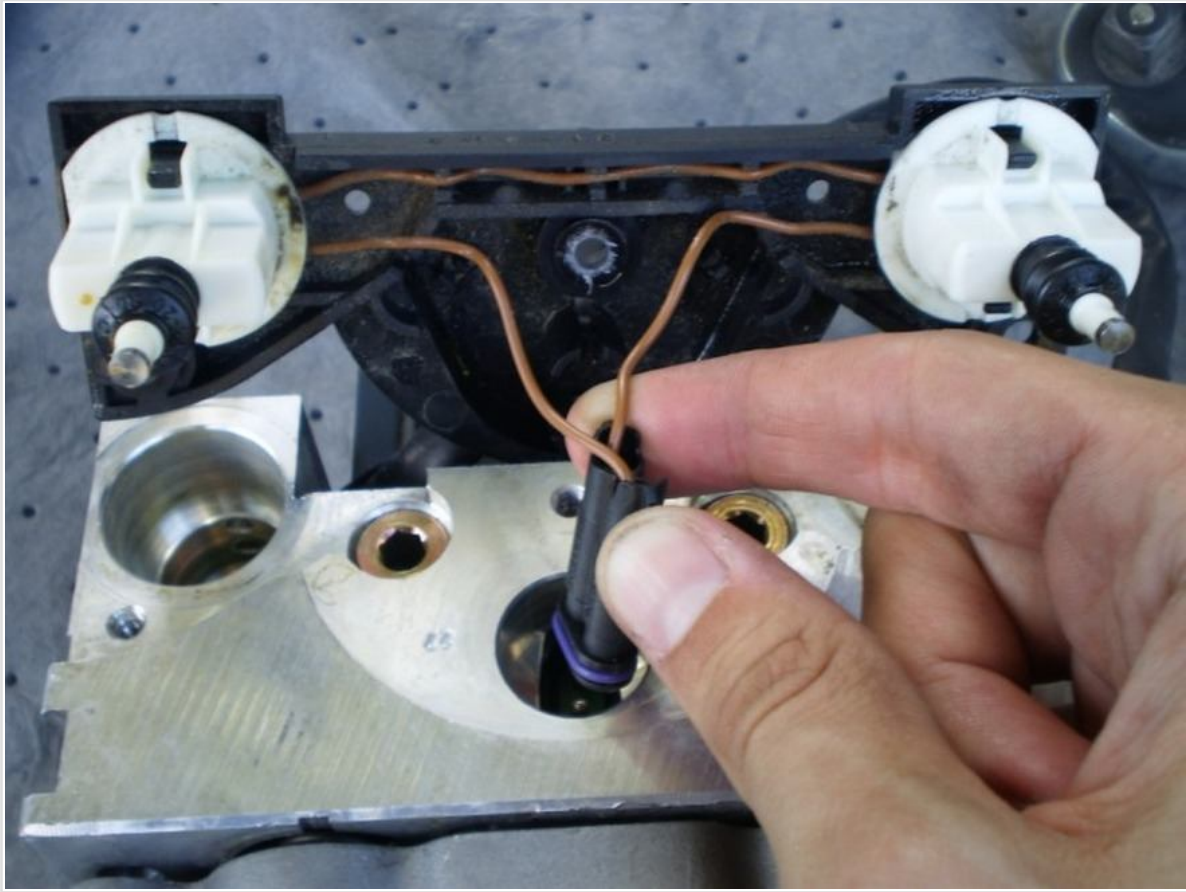
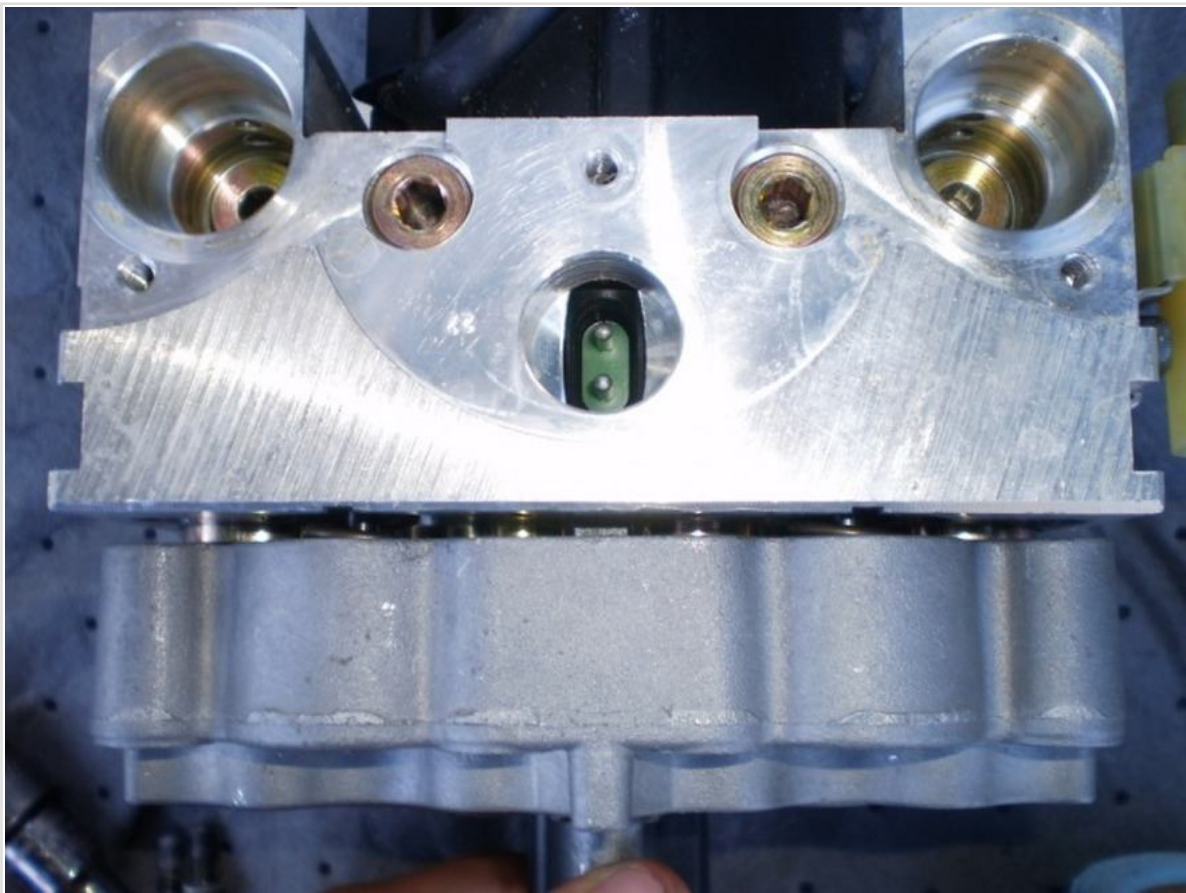
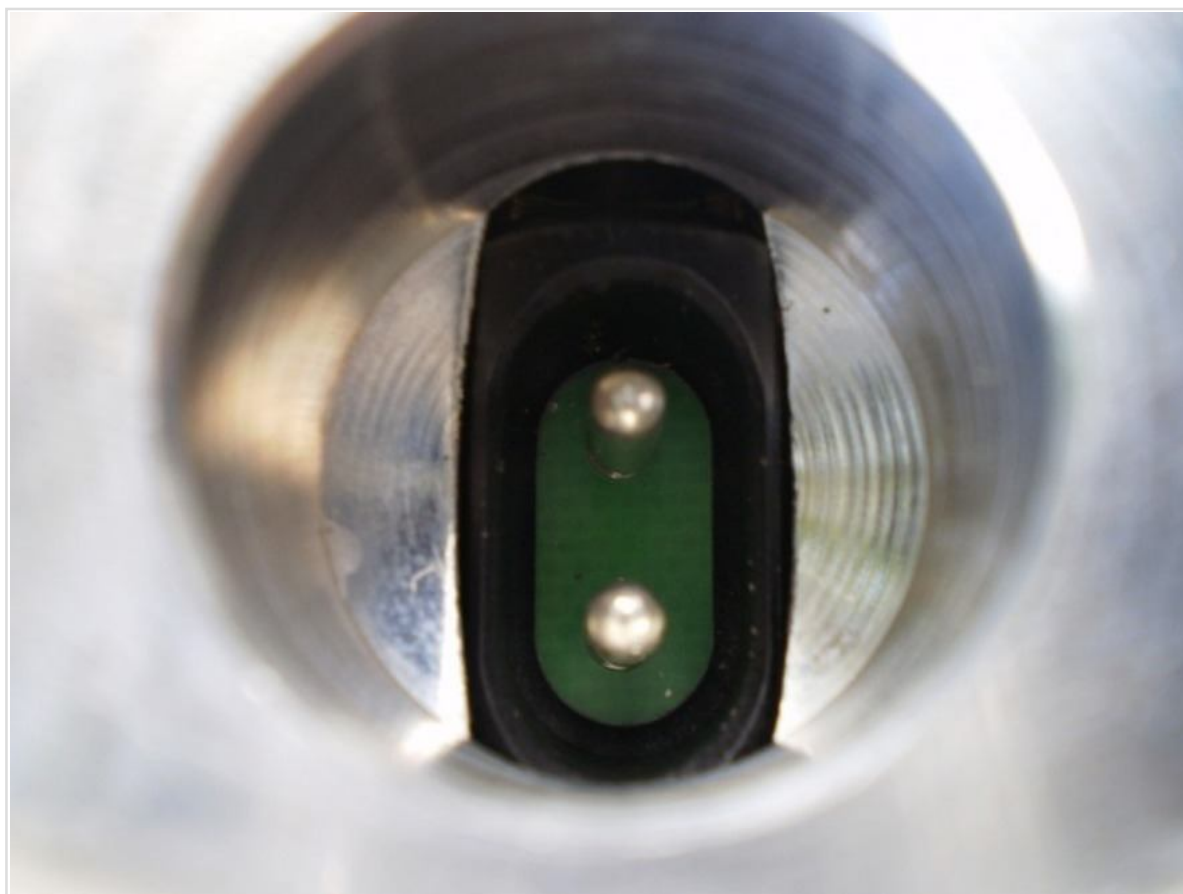
17. Carefully remove the SVS cover plate and disconnect the SVS plug. The plug should dislocate from the cover plate with minimal effort or hold it in place as you pry the cover out. If you find that a pin is lodged in the plug upon removal, and it did not remain in the SVS circuit board then you may have found your intermittent fault.
