# LAND ROVER CLUB V.I.

## ABS MODULATOR ELECTRICAL FAULT REPAIR

11/2009

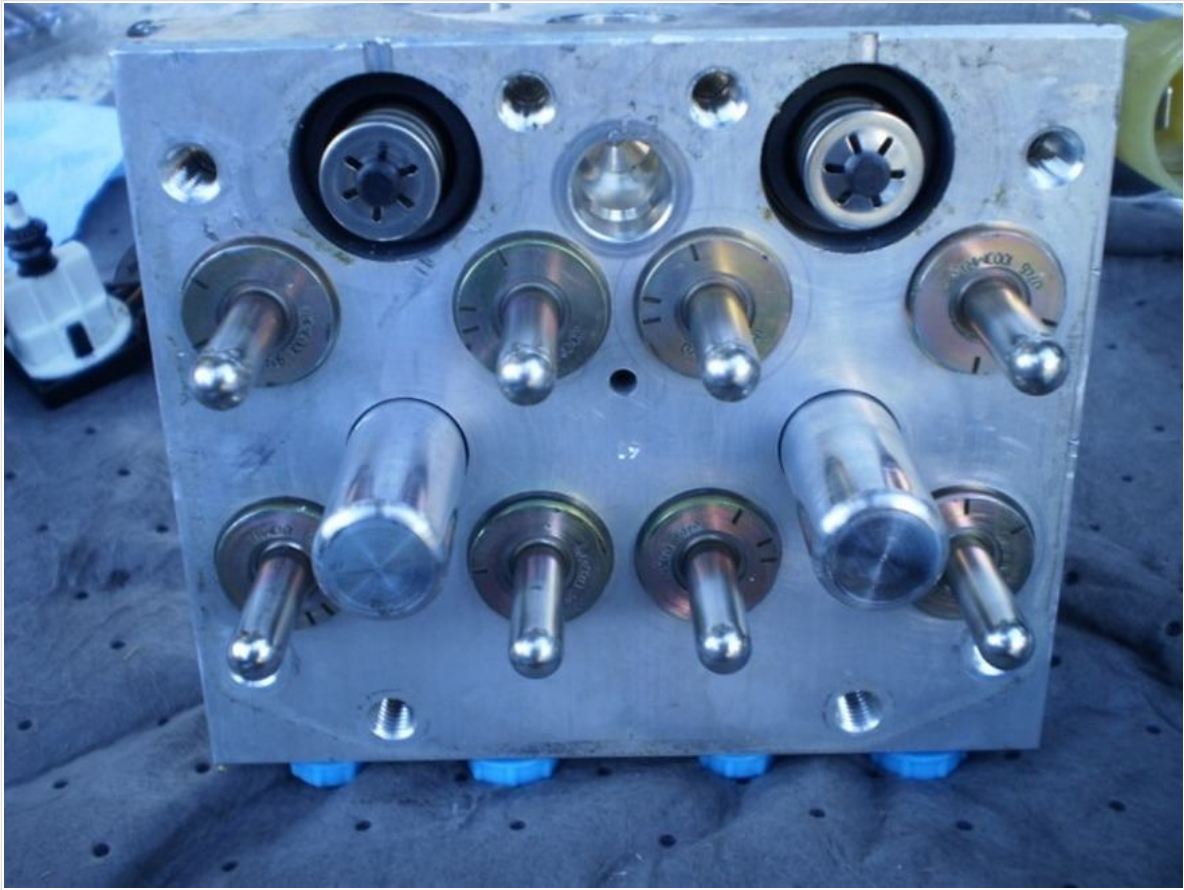
Pump side of the unit. Unit is upside down. Notice the brake line plugs at bottom.

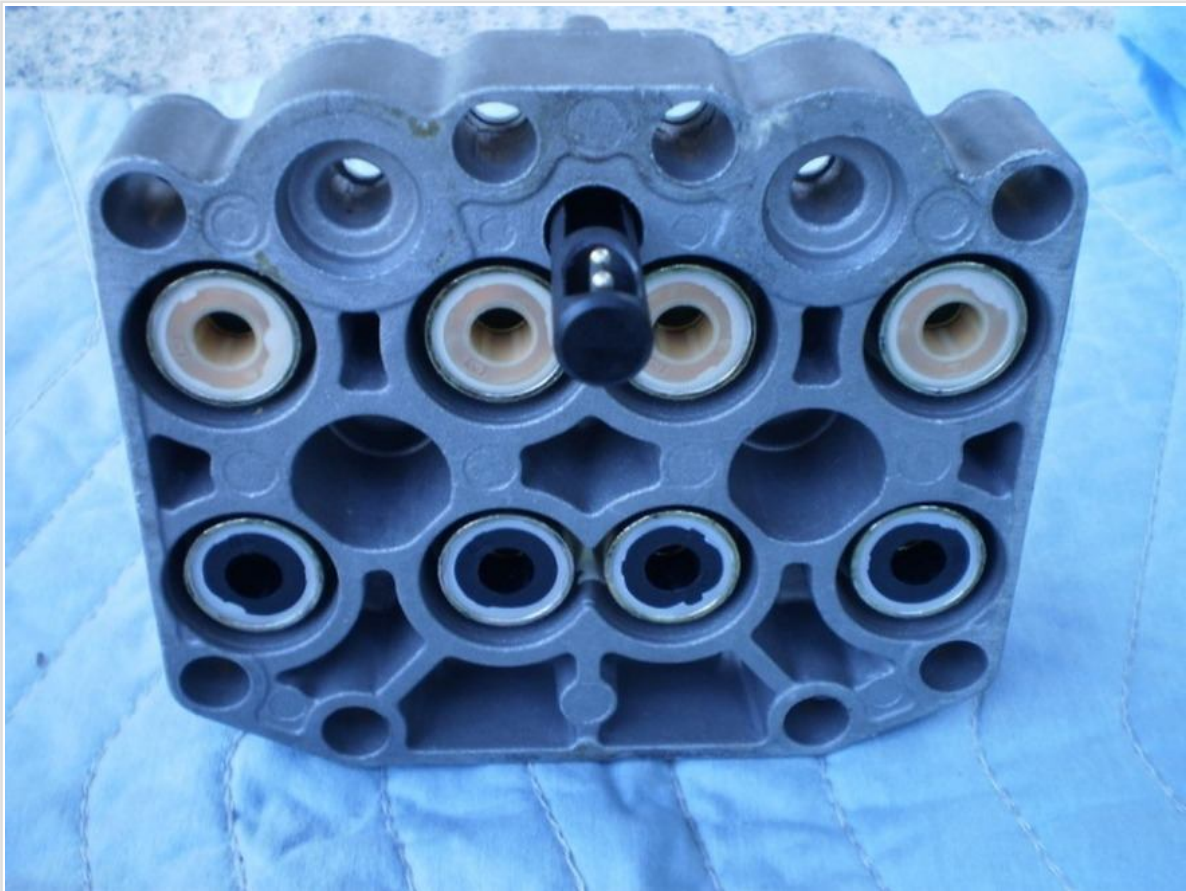
Modulator side of the unit

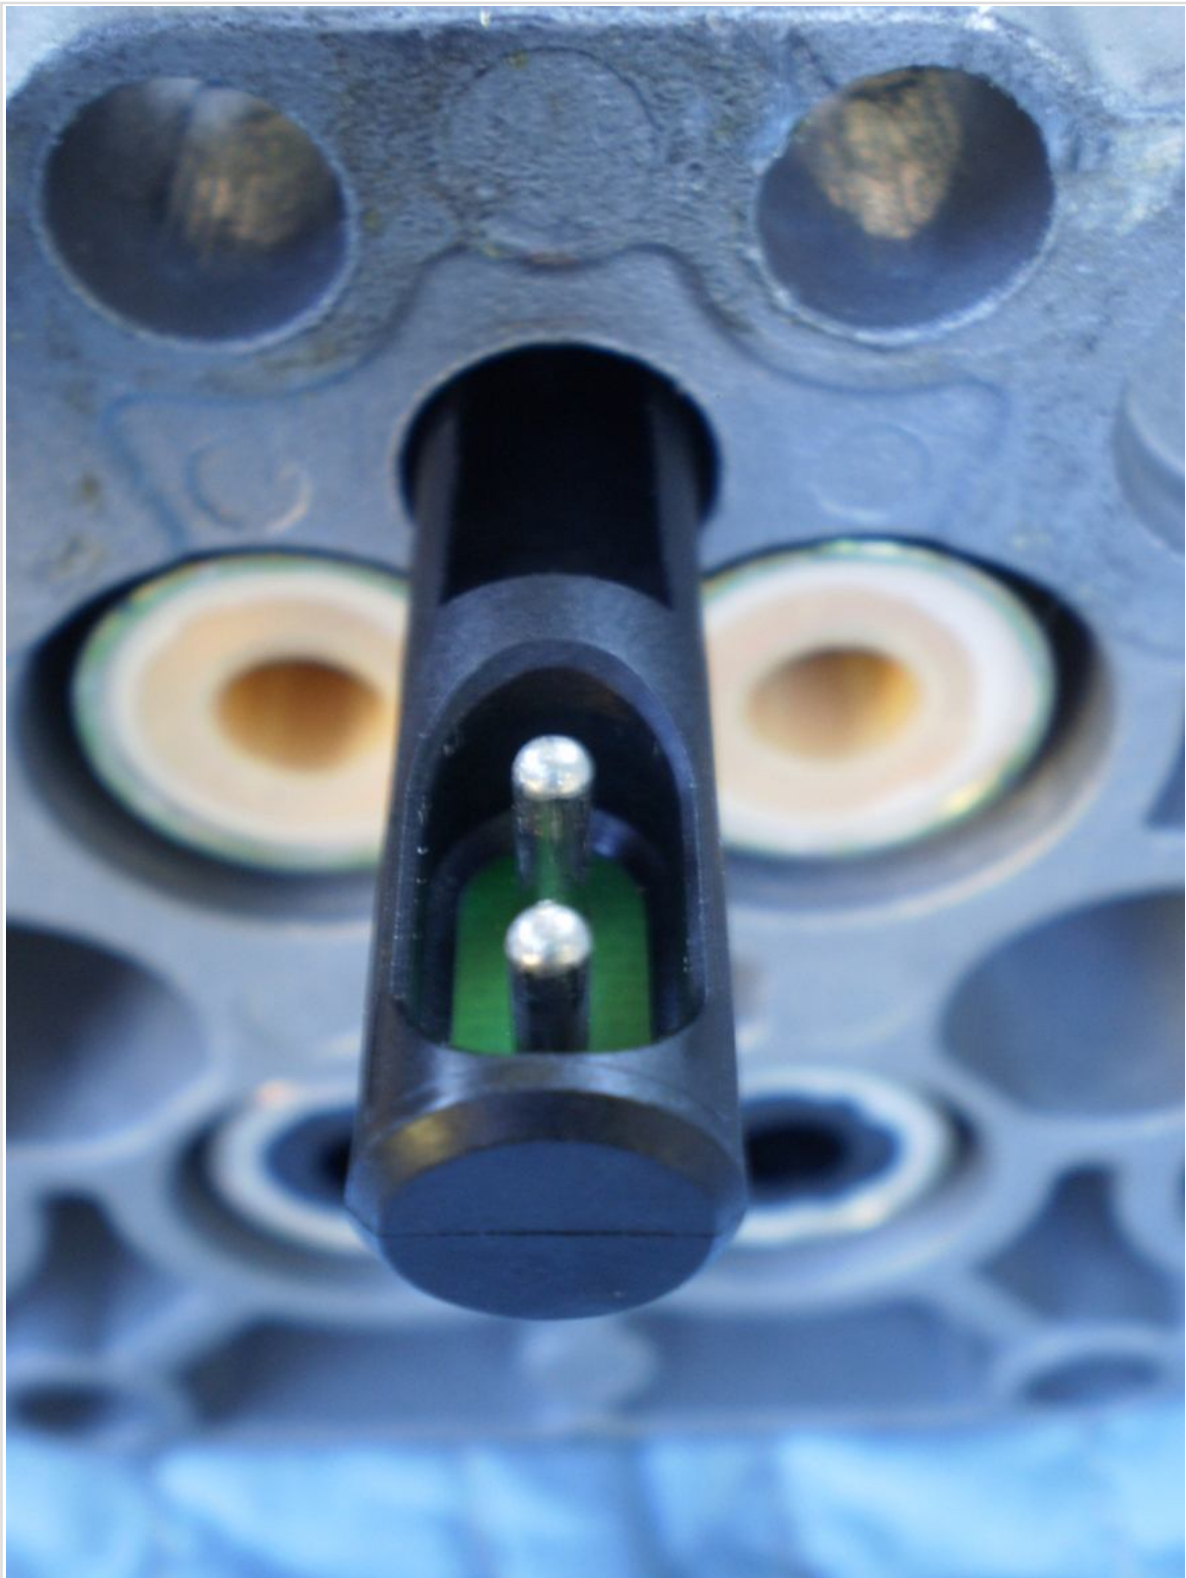
SVS modulator plug circuit board.

*If doing option A, the base of these pins need to be re-soldered. Underside of circuit board is what needs to be shaved off.  
Installation is reverse of removal.*

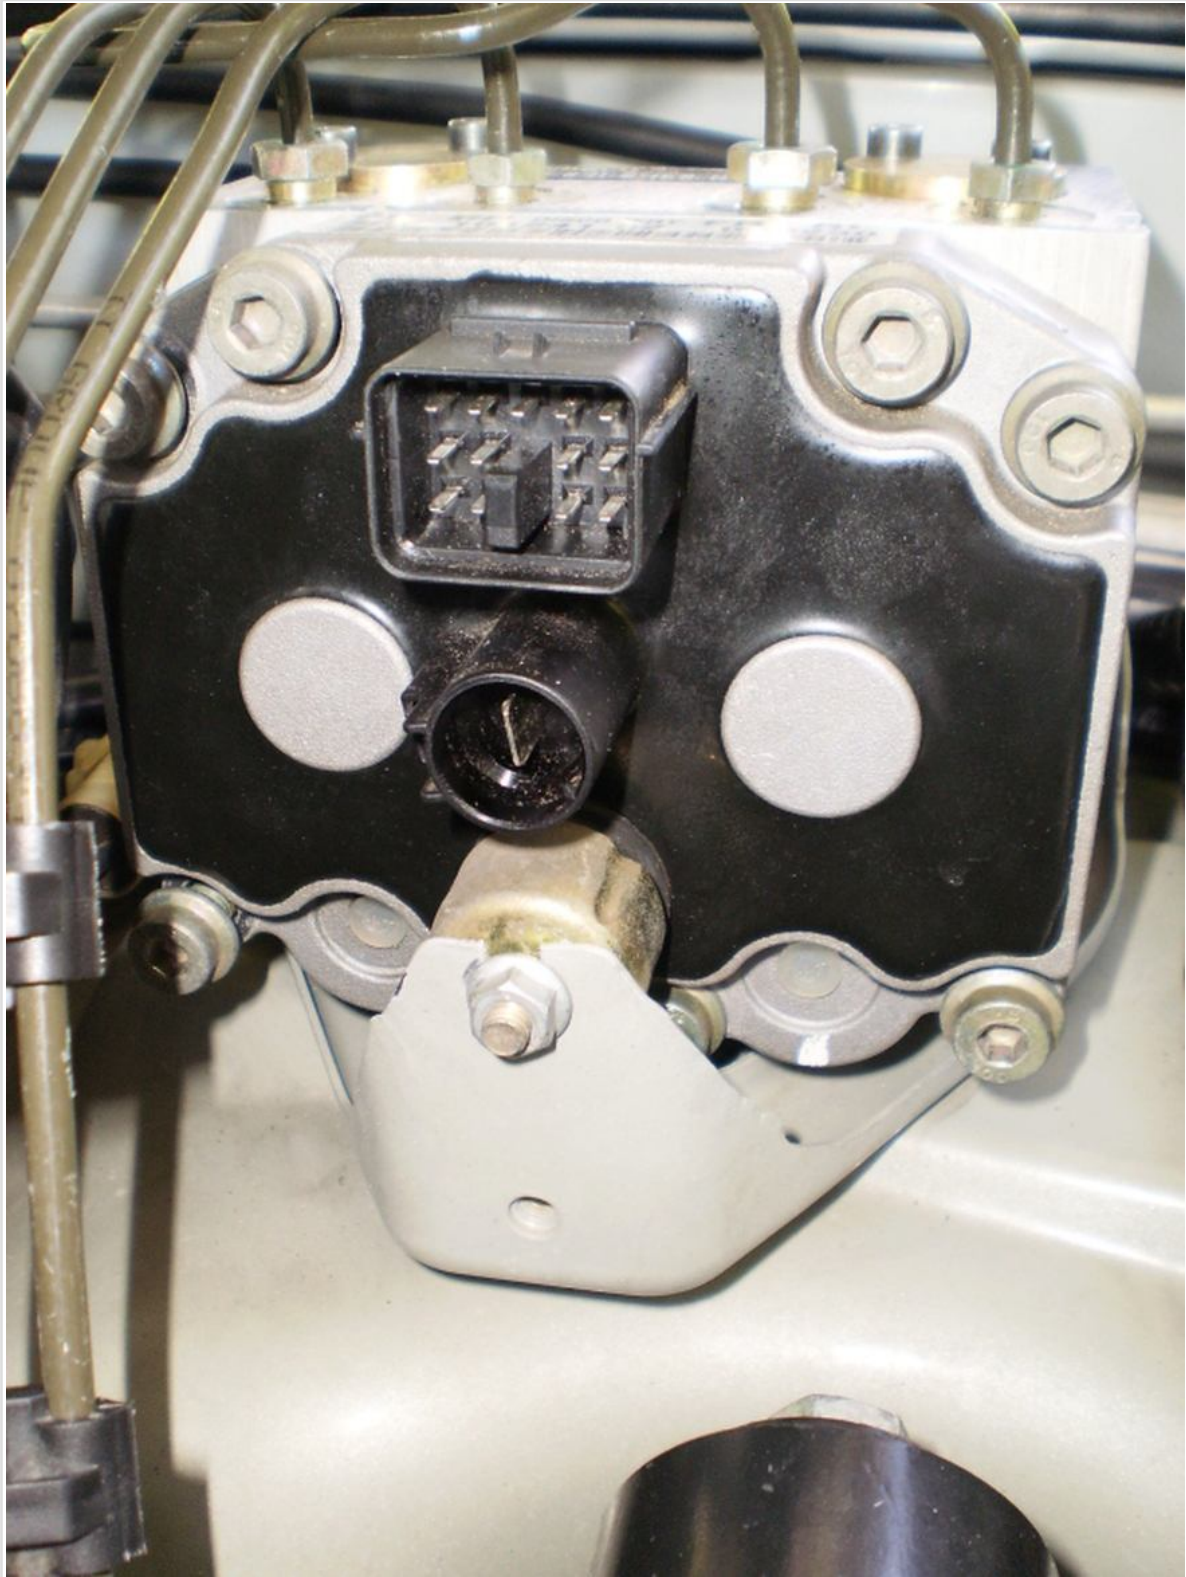
19. Remove two electrical connectors on modulator side.
20. Release the brake pipes from the clips on the bulkhead. Remove intake arm.
21. Brake loose 6 of the 8 modulator bolts (That is the TOP 4, and the BOTTOM 2 on the OUTSIDES). The two closest to the rubber mount will need to be removed later.

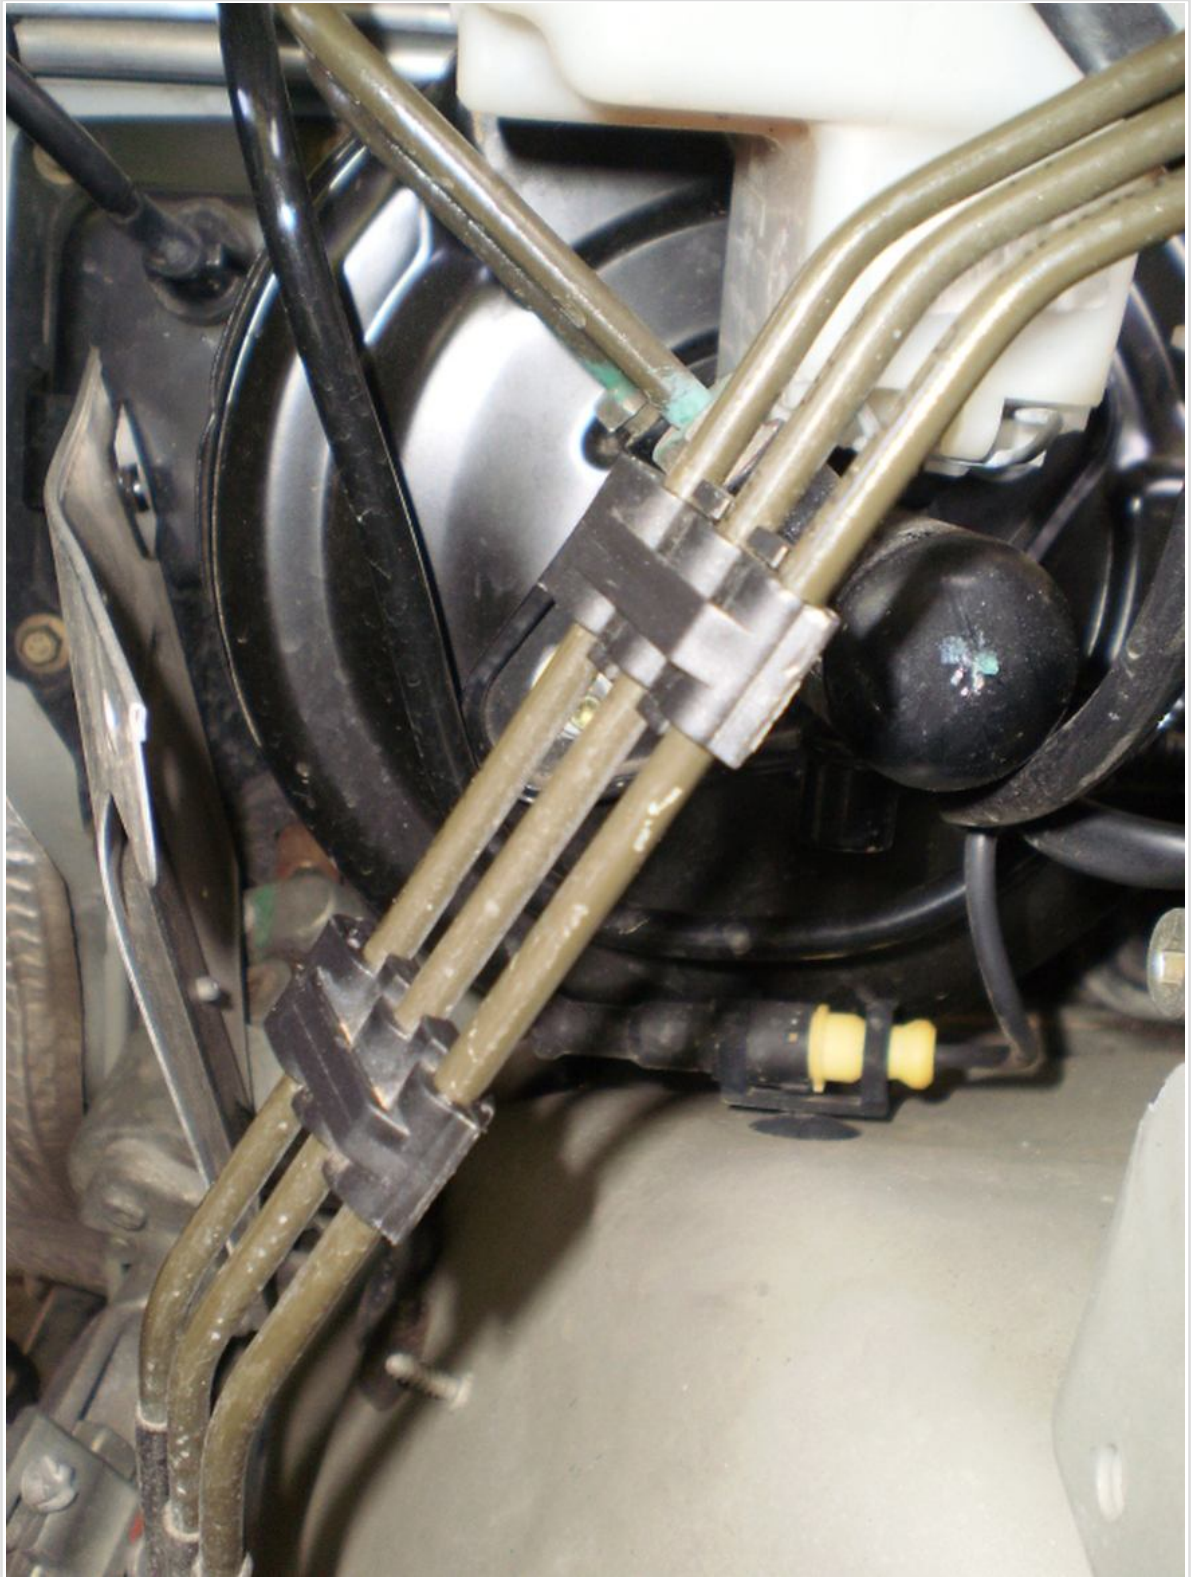
22. Remove two clips from the brake lines.

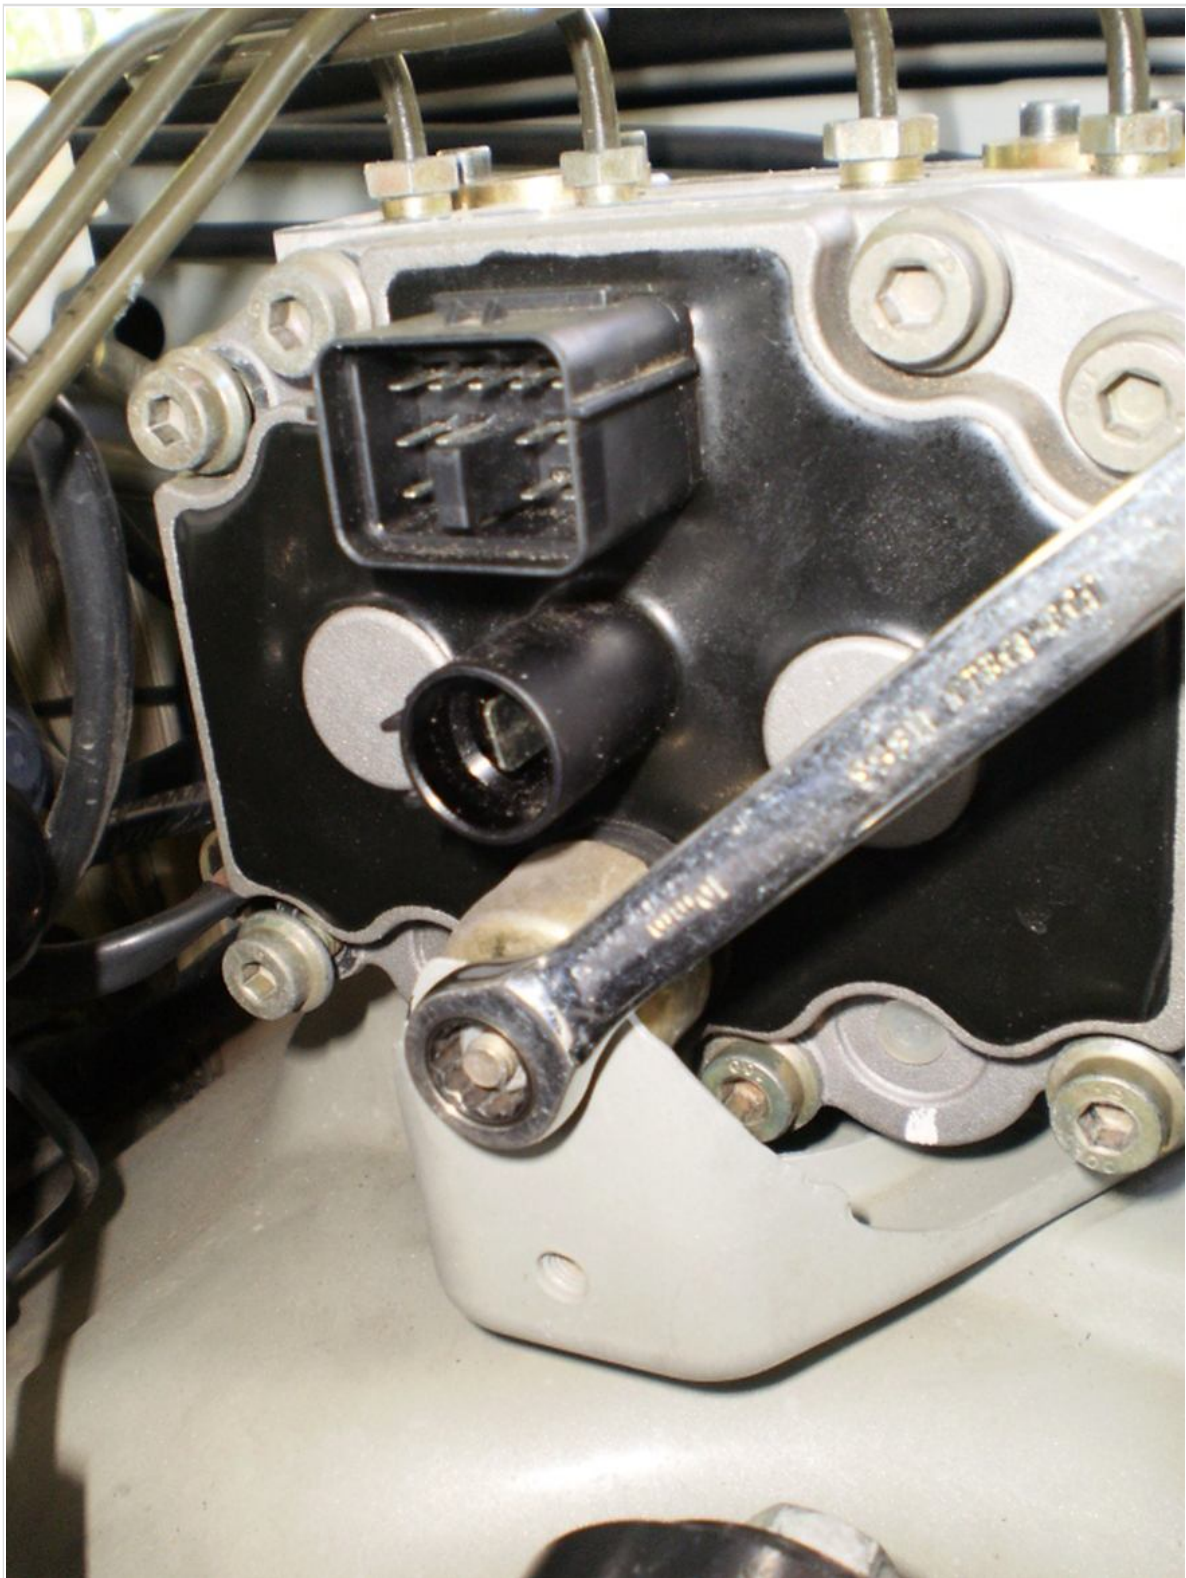
23. Remove the three rubber mounts. One front and two rear.

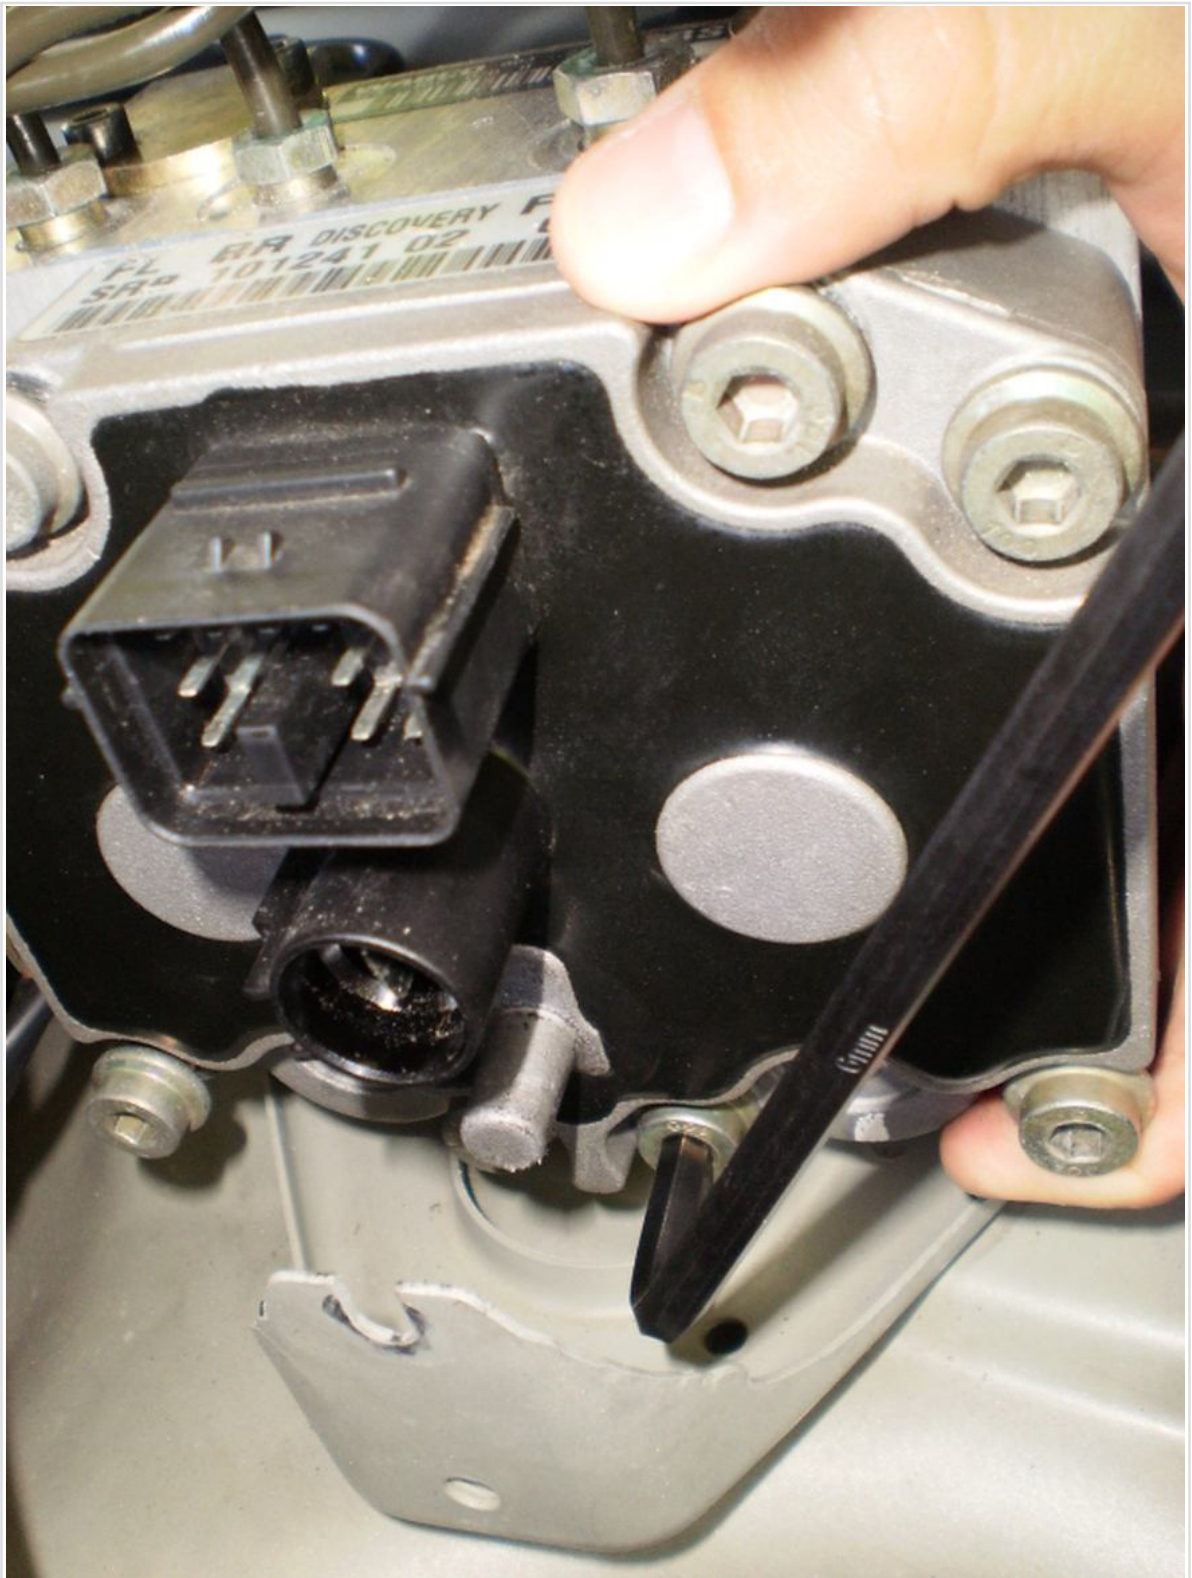
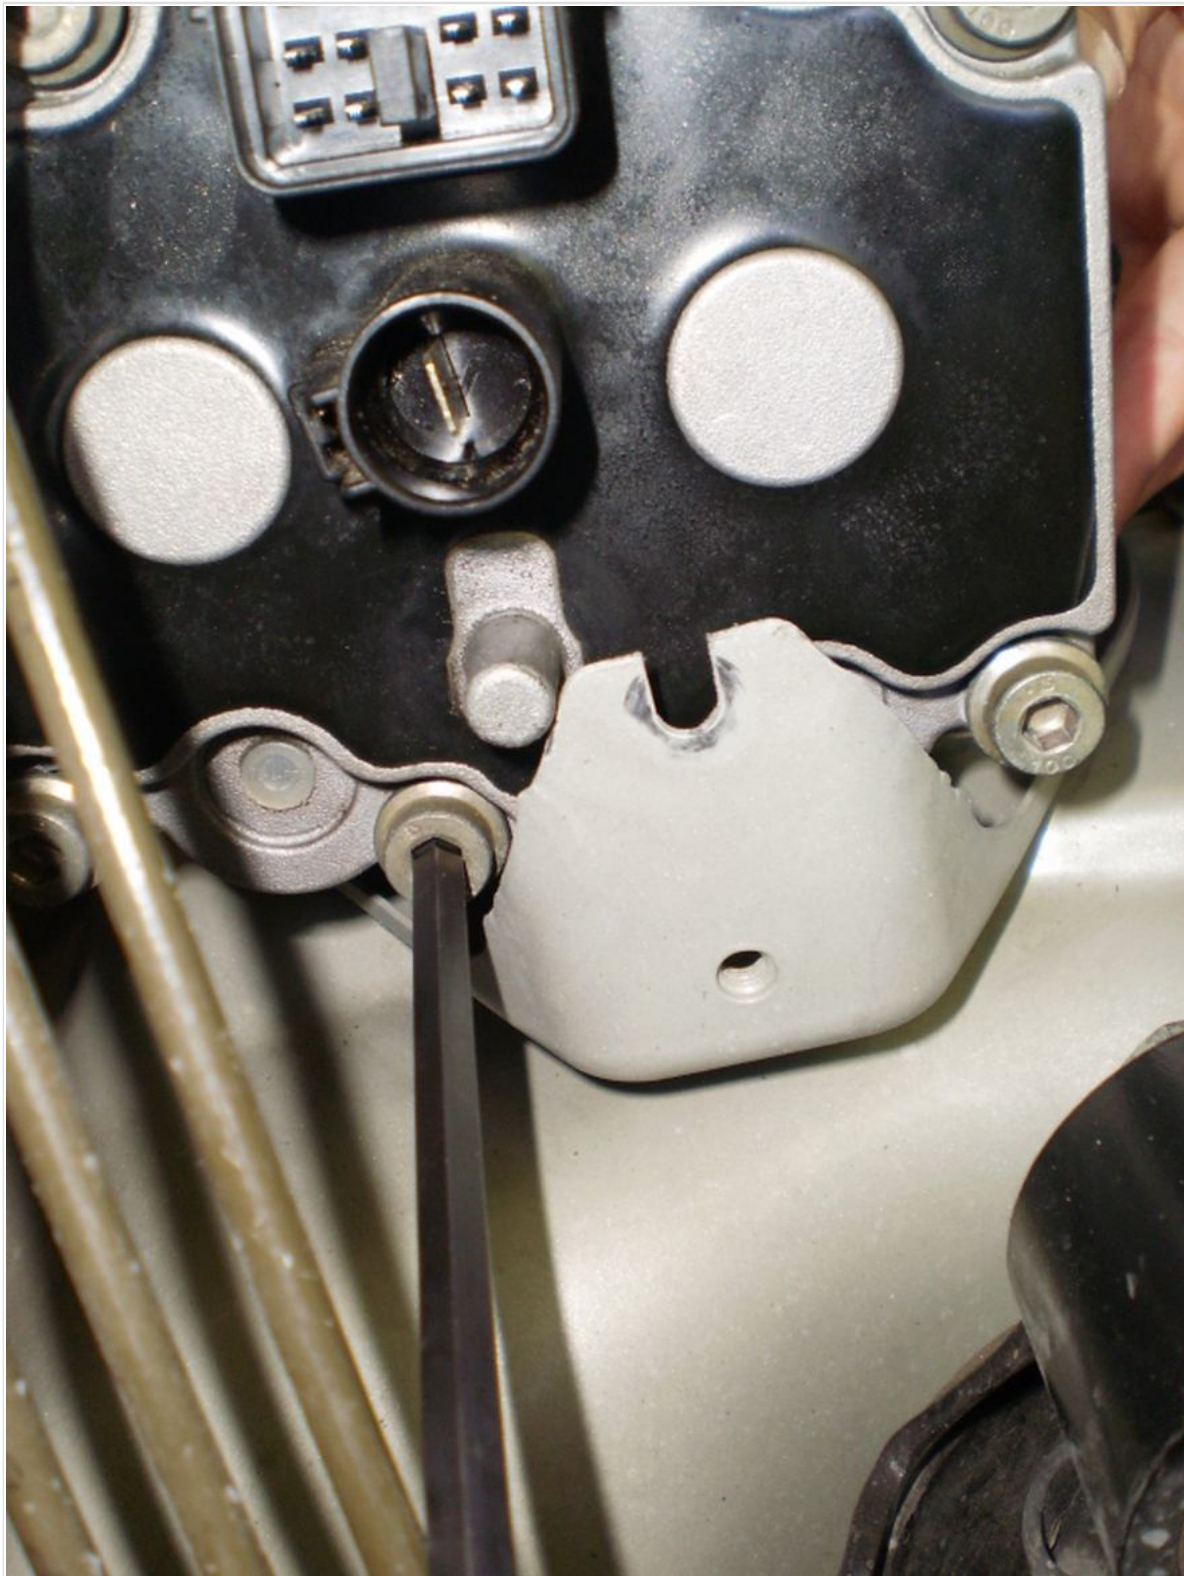
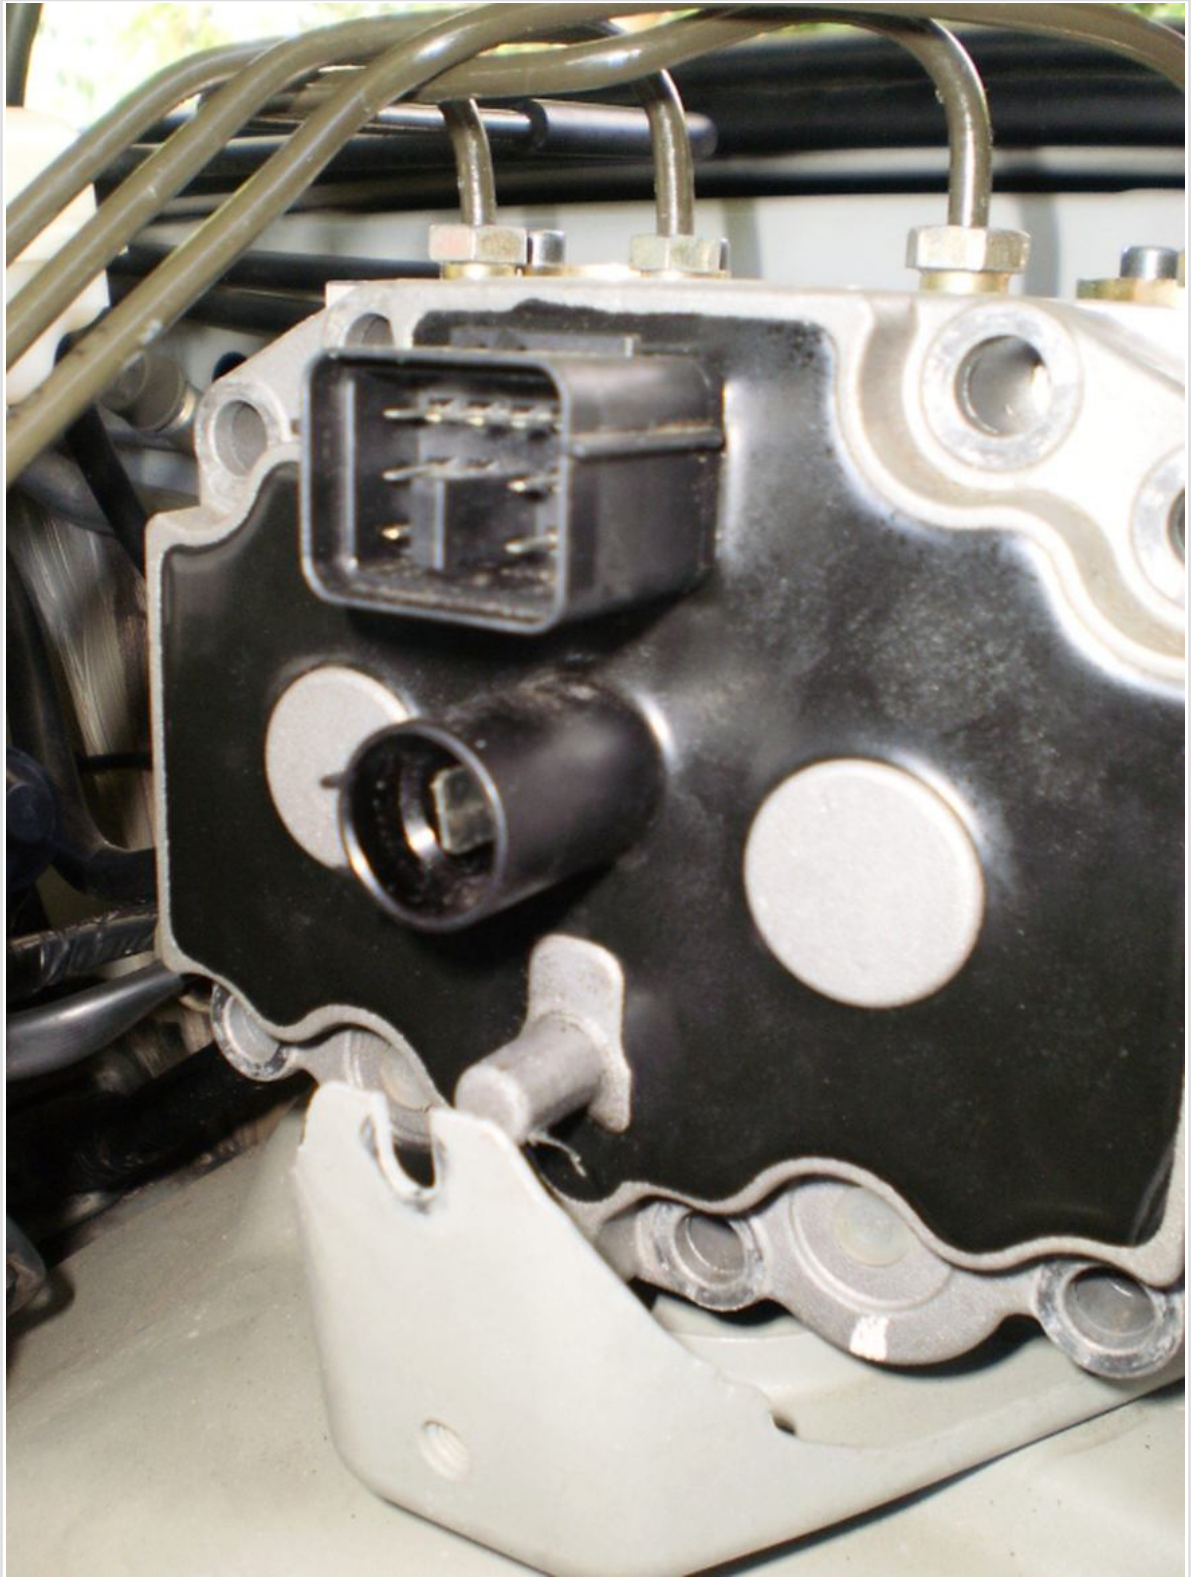
24. Remove the two bolts nearest front mount.

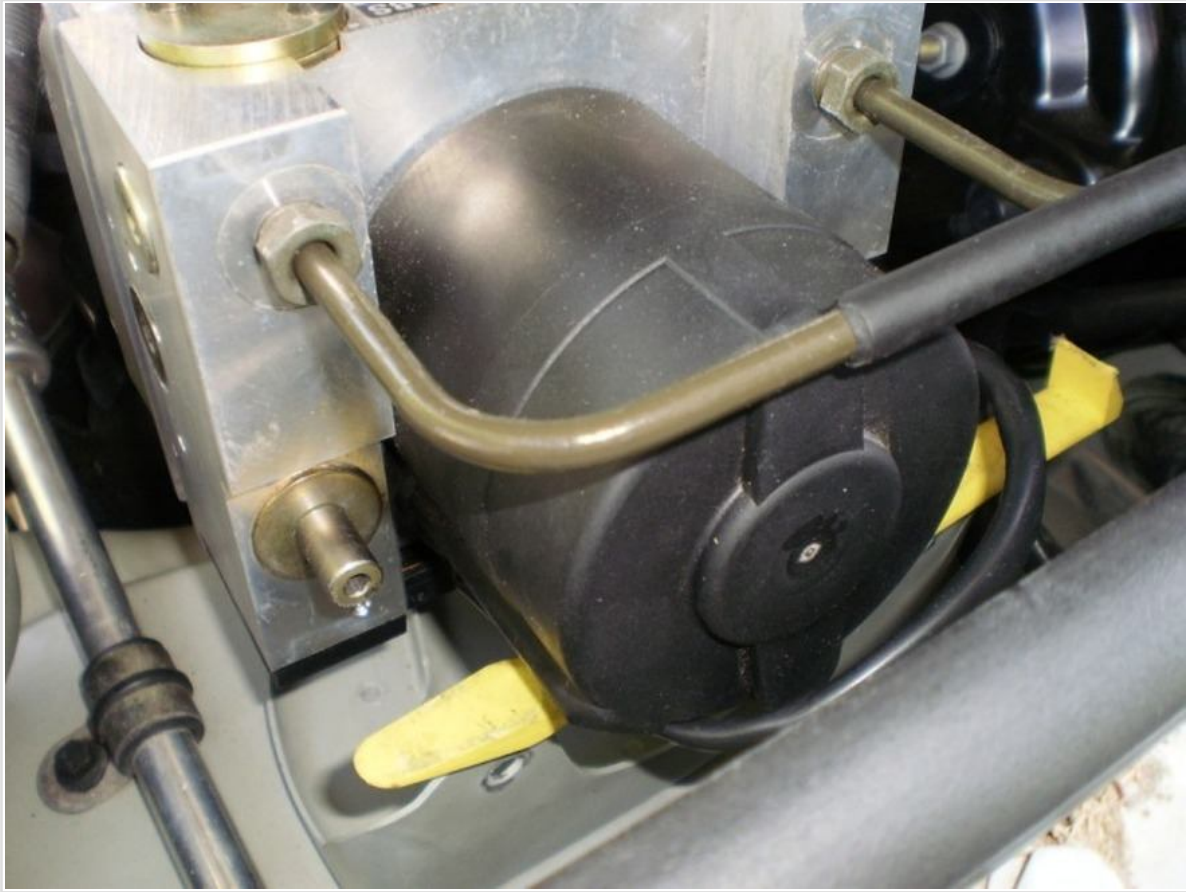
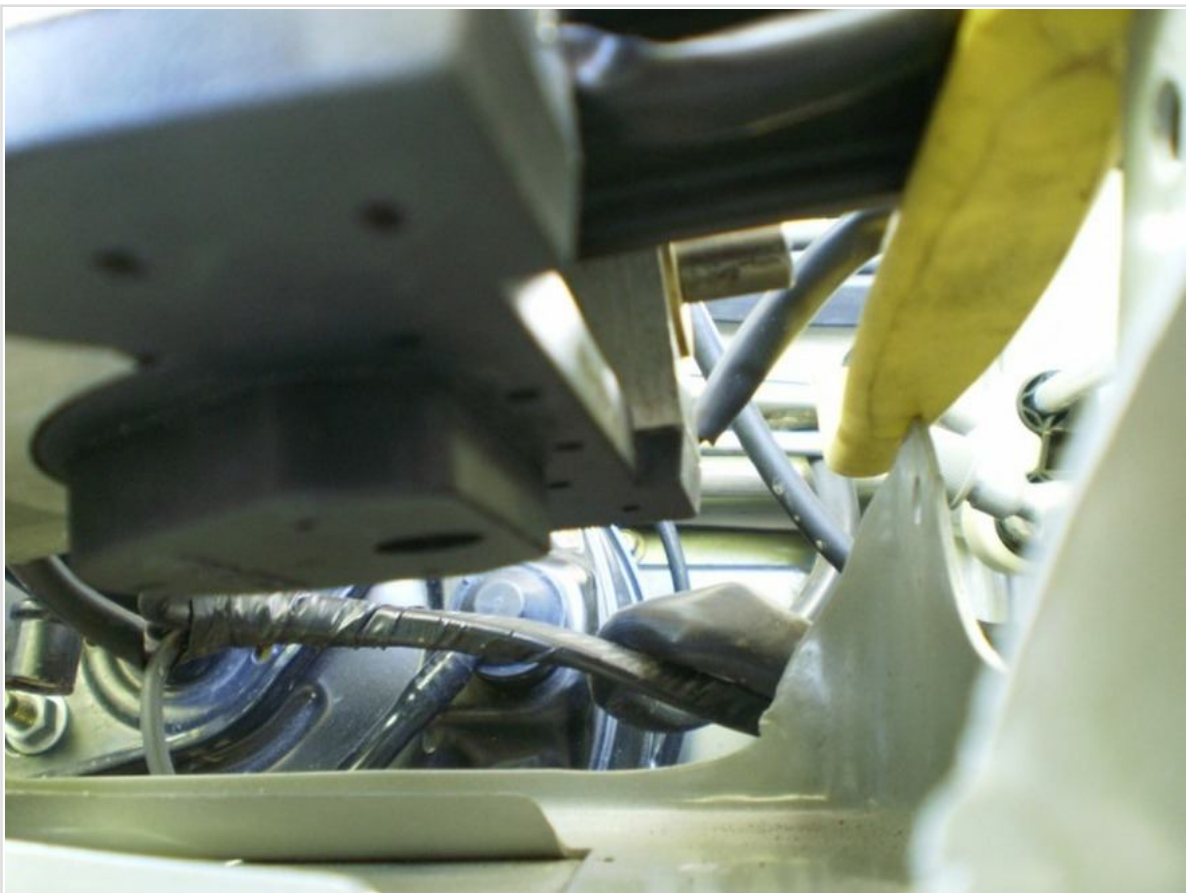
25. In order to have room underneath the ABS unit to access the SVS cover plate screws, raise the pump side of the unit and support it using the top of the rear side of the mounting bracket. I used a plastic trim removal tool to rest it on.

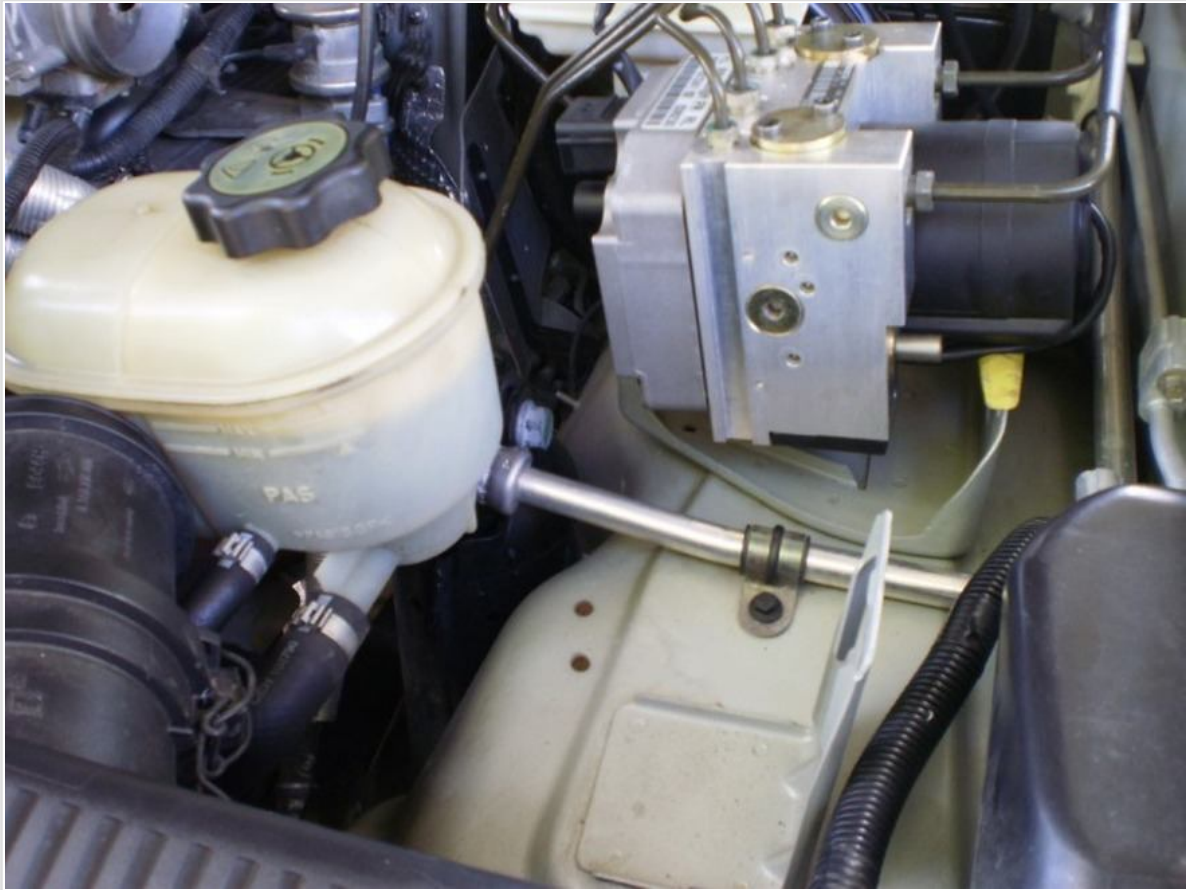
26. Reposition the PAS Fluid reservoir.

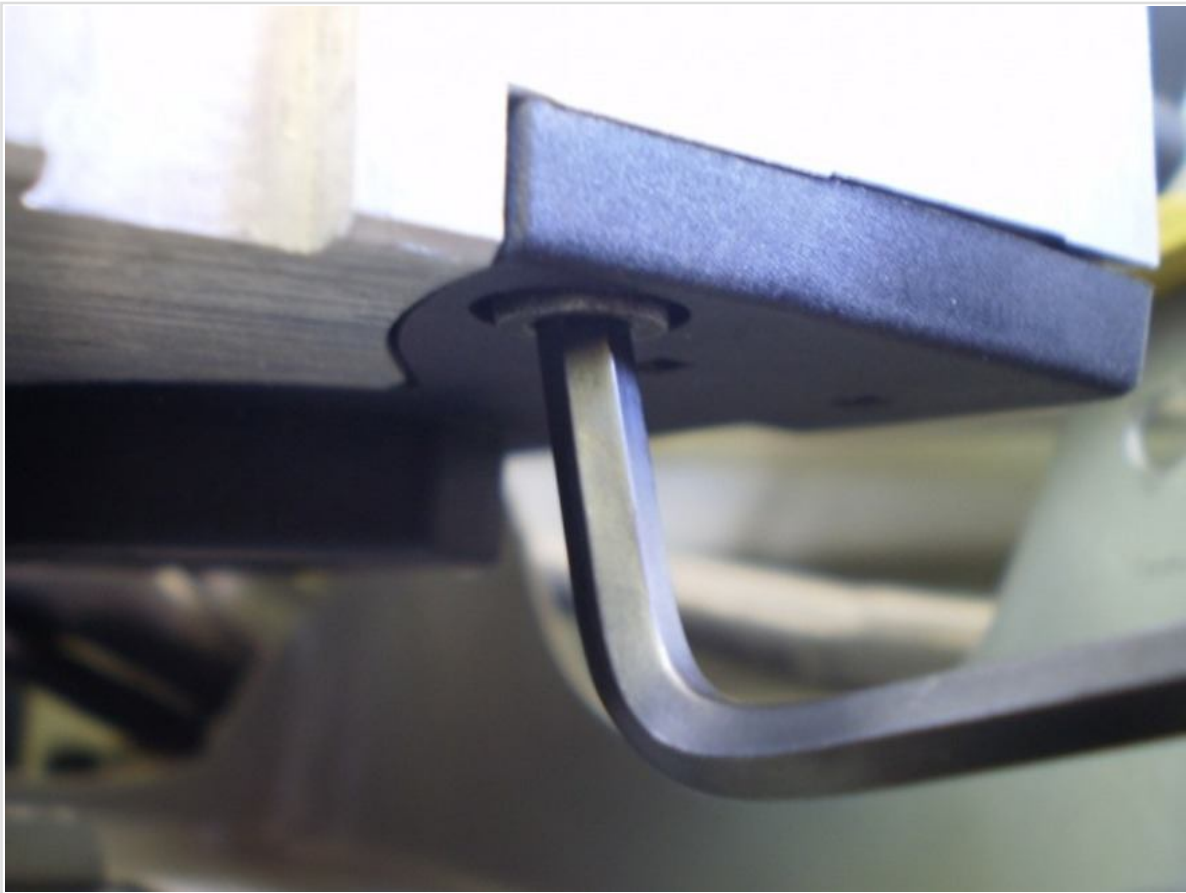
27. Using a 4mm hex key, remove the three SVS cover plate screws. The shorter the hex key the better, as it will allow you to spin around without having to take the key out the screw head.

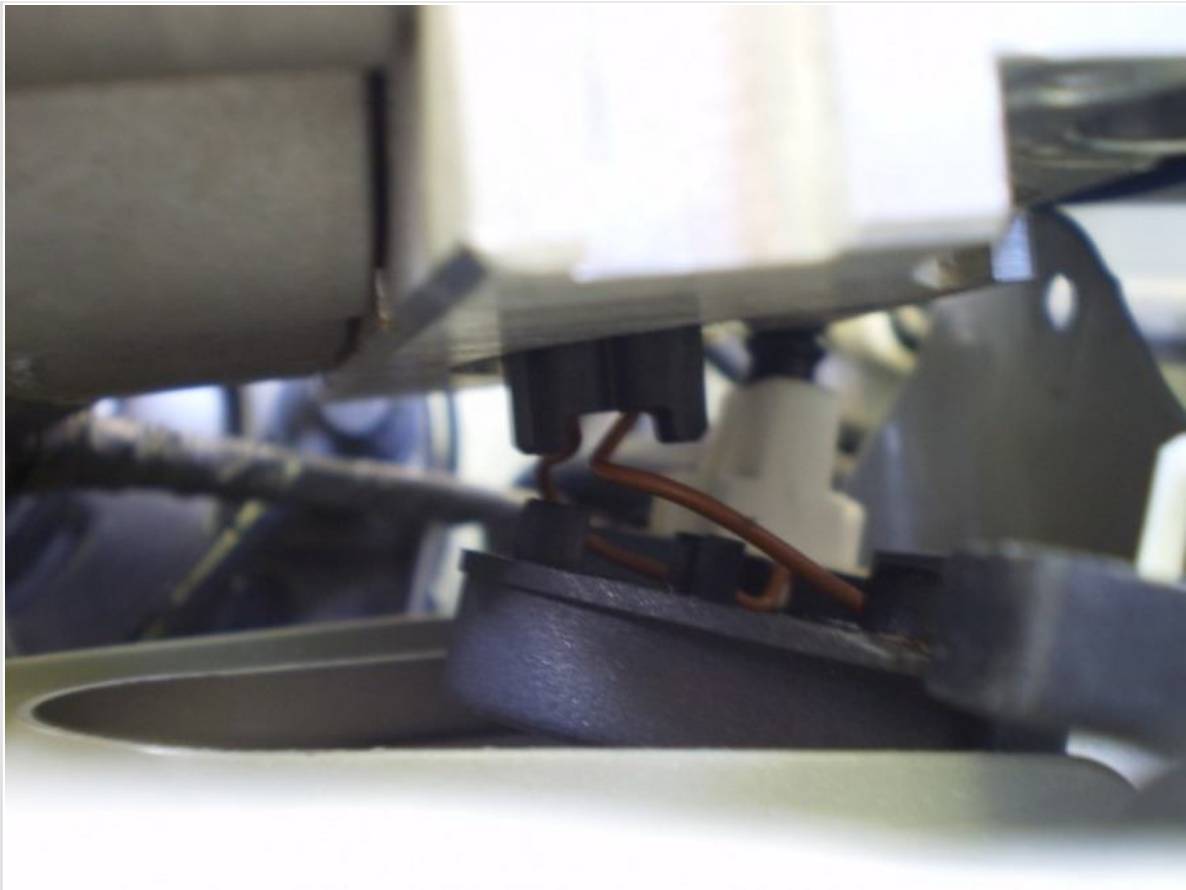
28. Once all three screws are out, carefully pry down the SVS cover plate.

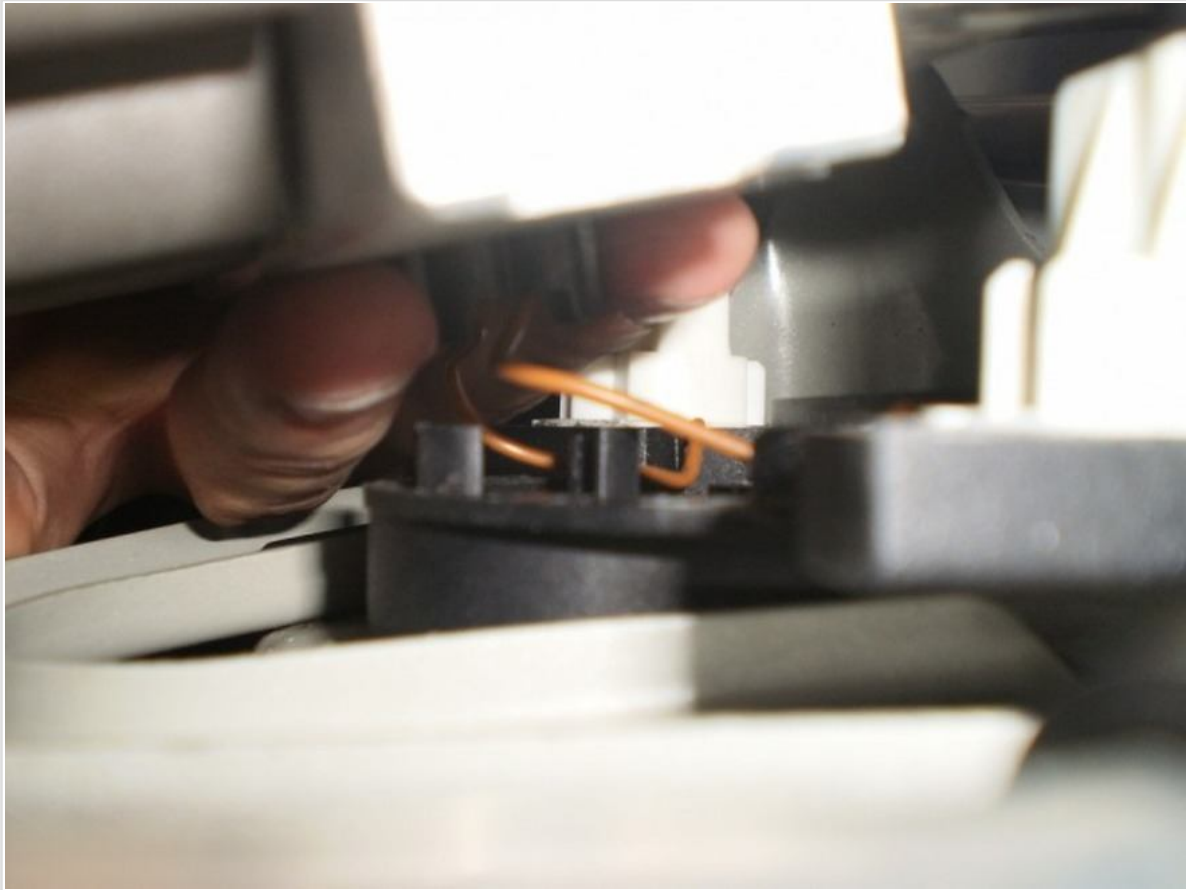
29. You should have enough room to get your fingers underneath and pull the SVS plug down. I needed my assistant to raise the ABS modulator/pump an inch or two so I could use my thumb to unplug it.

You can see the SVS plug between my fingers
