# LAND ROVER CLUB V.I.

## ABS MODULATOR ELECTRICAL FAULT REPAIR

11/2009

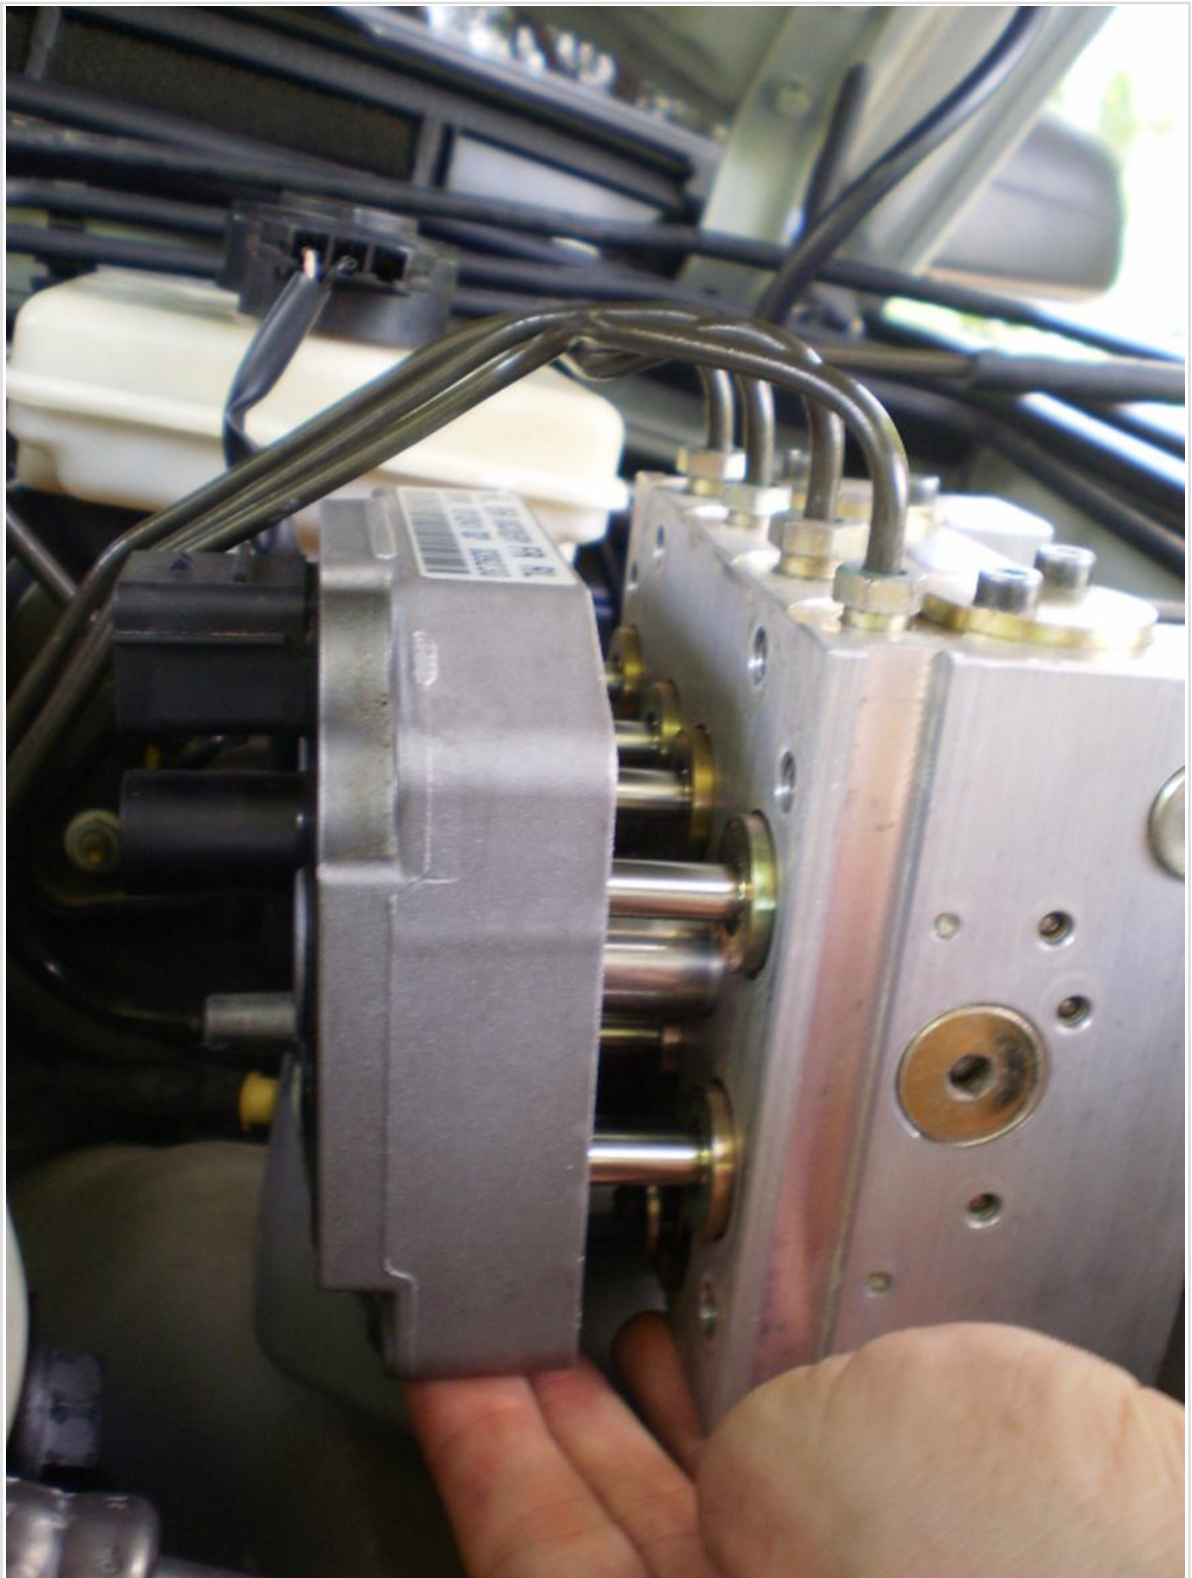
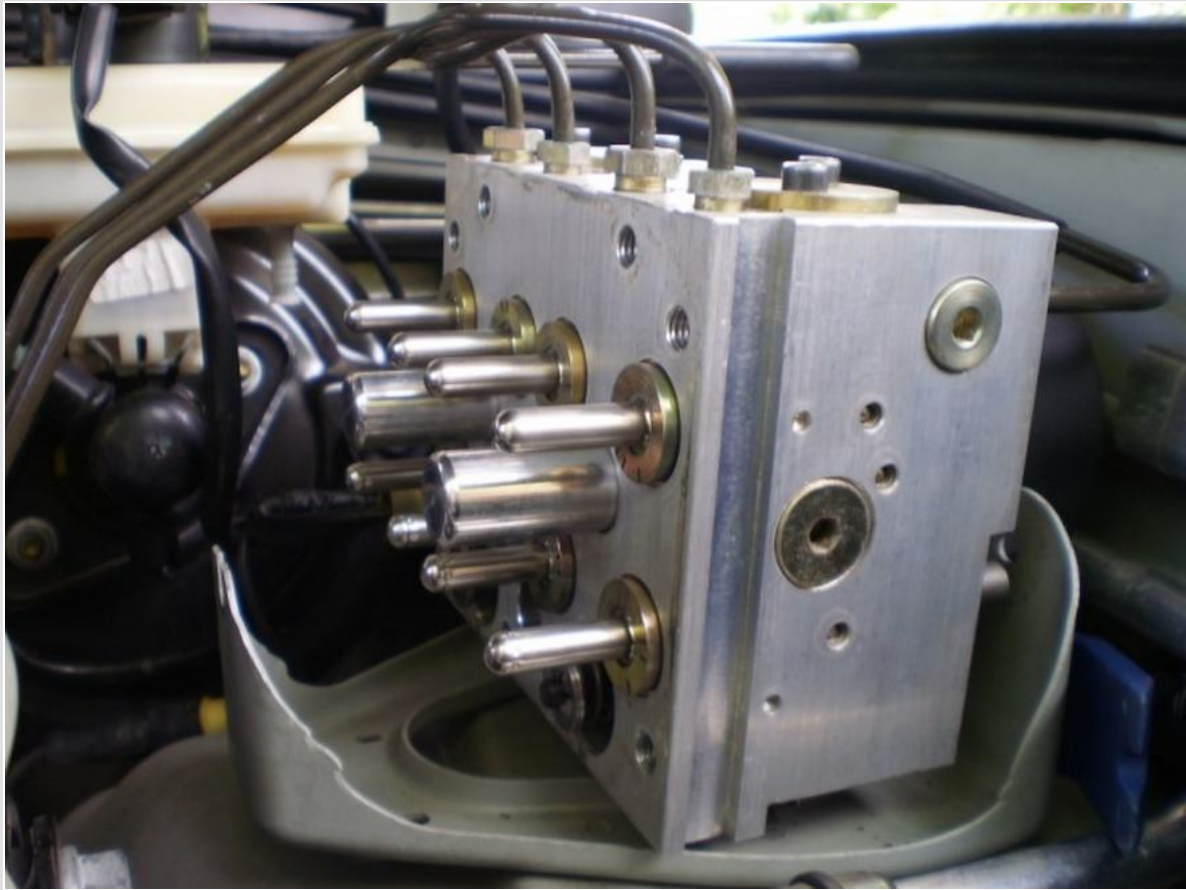
30. The modulator side can now be removed. Slide it out until the SVS plug circuit board is completely out of the pump side being cautious not to bend it or remove it at an angle.

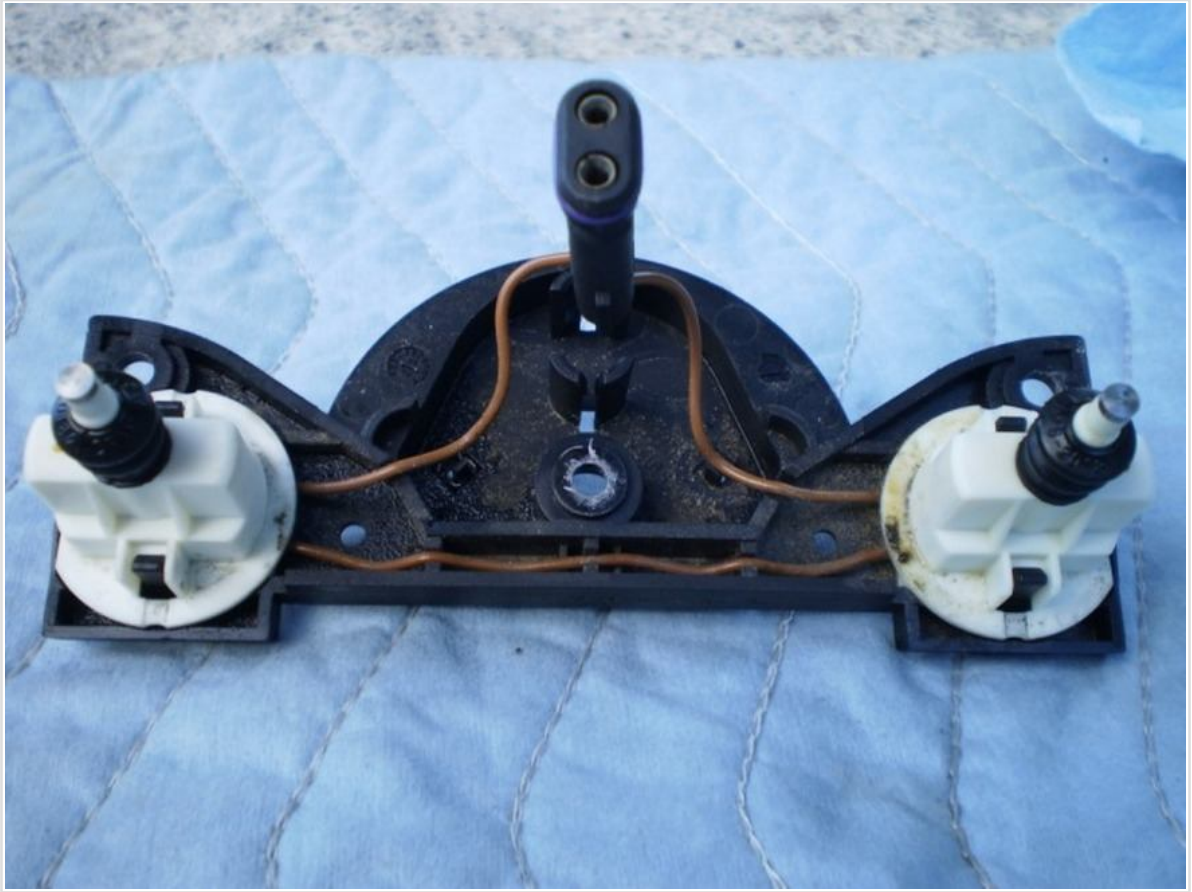
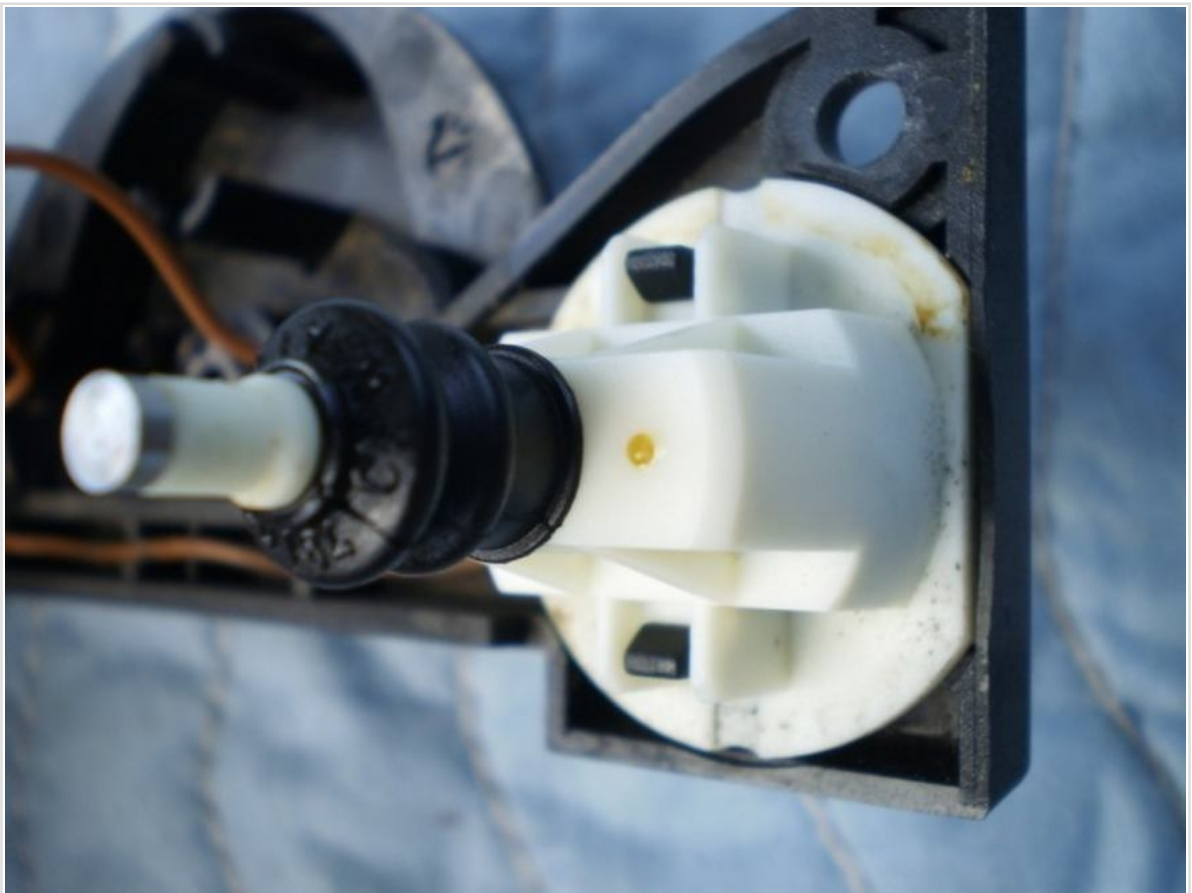
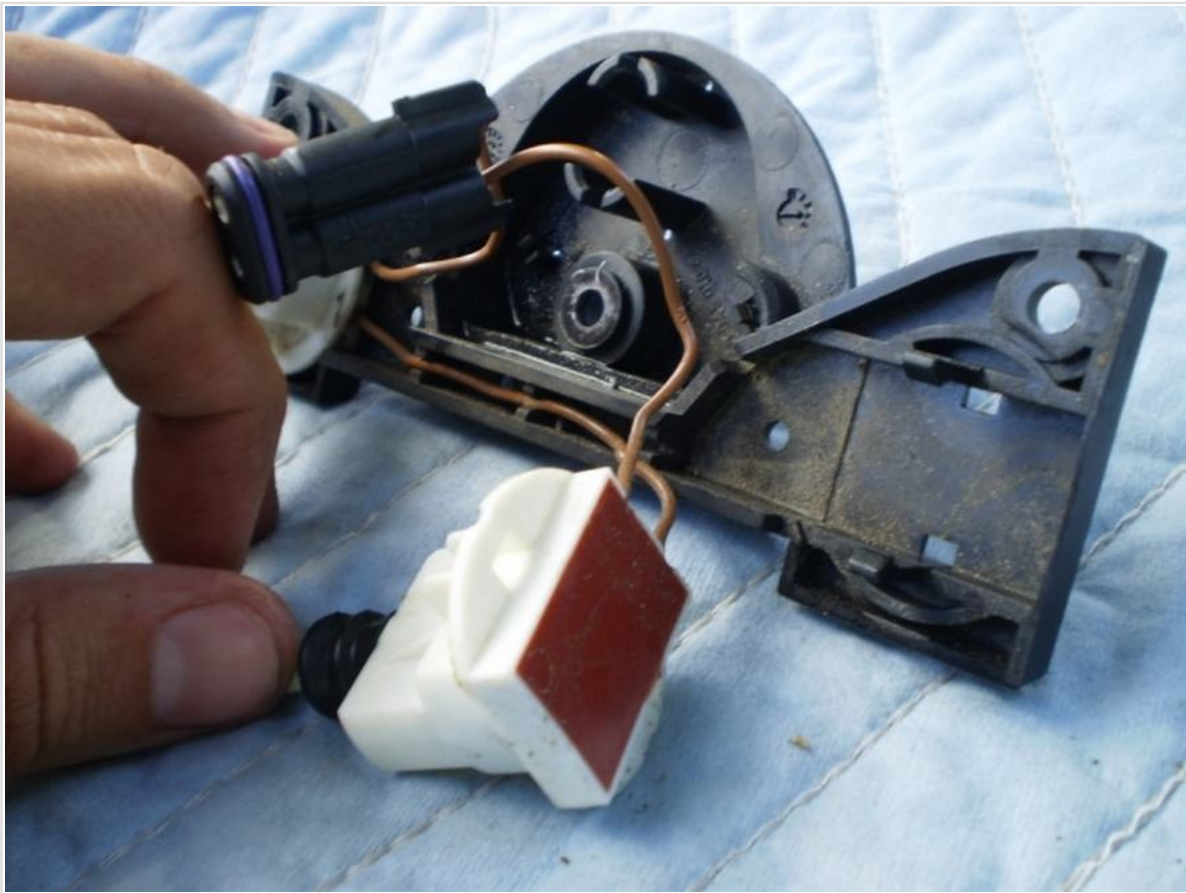
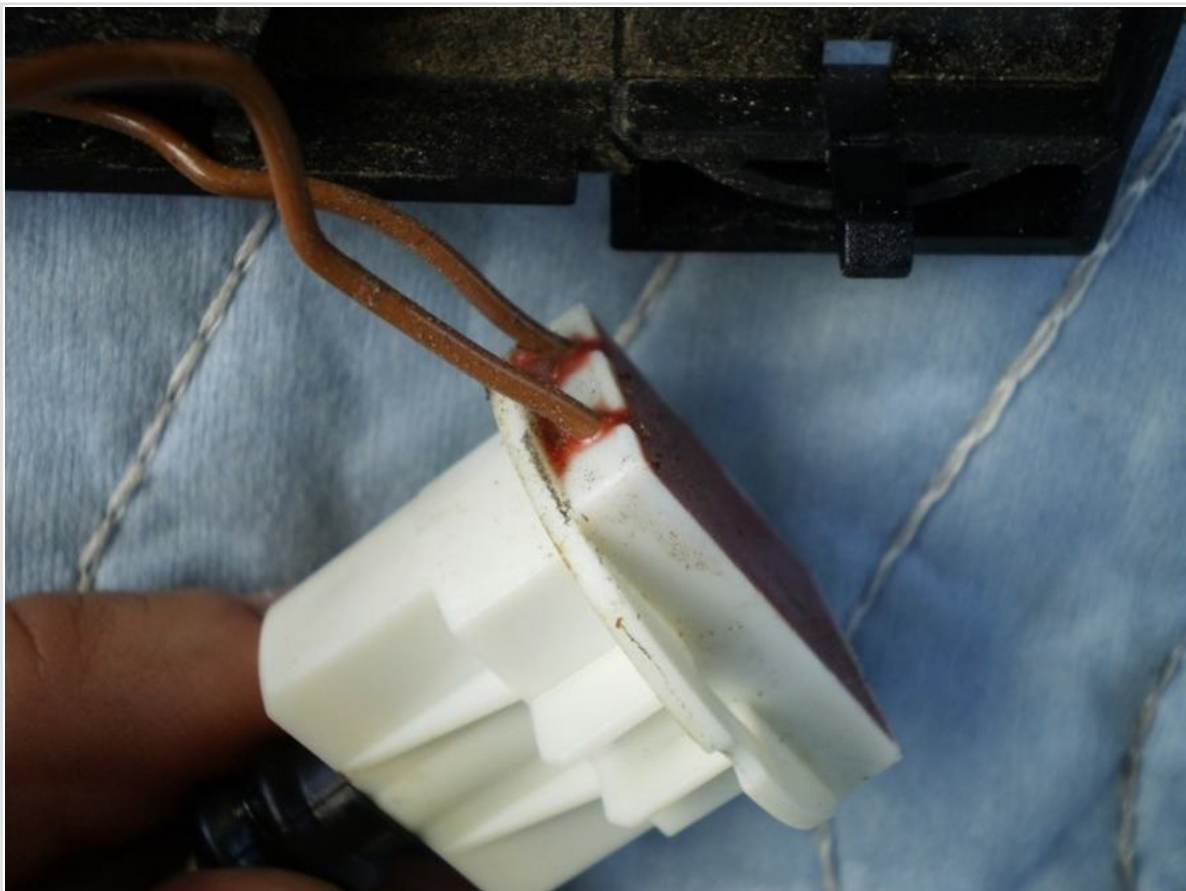
*The rubber boot is what prevents brake fluid from seeping out of the shuttle valves and getting inside fouling the switch. If the shuttle valves are leaking, they may be the cause of your THREE AMIGOS, you can replace the seals with this Shuttle Valve seal KIT from Falconworks in Arizona*

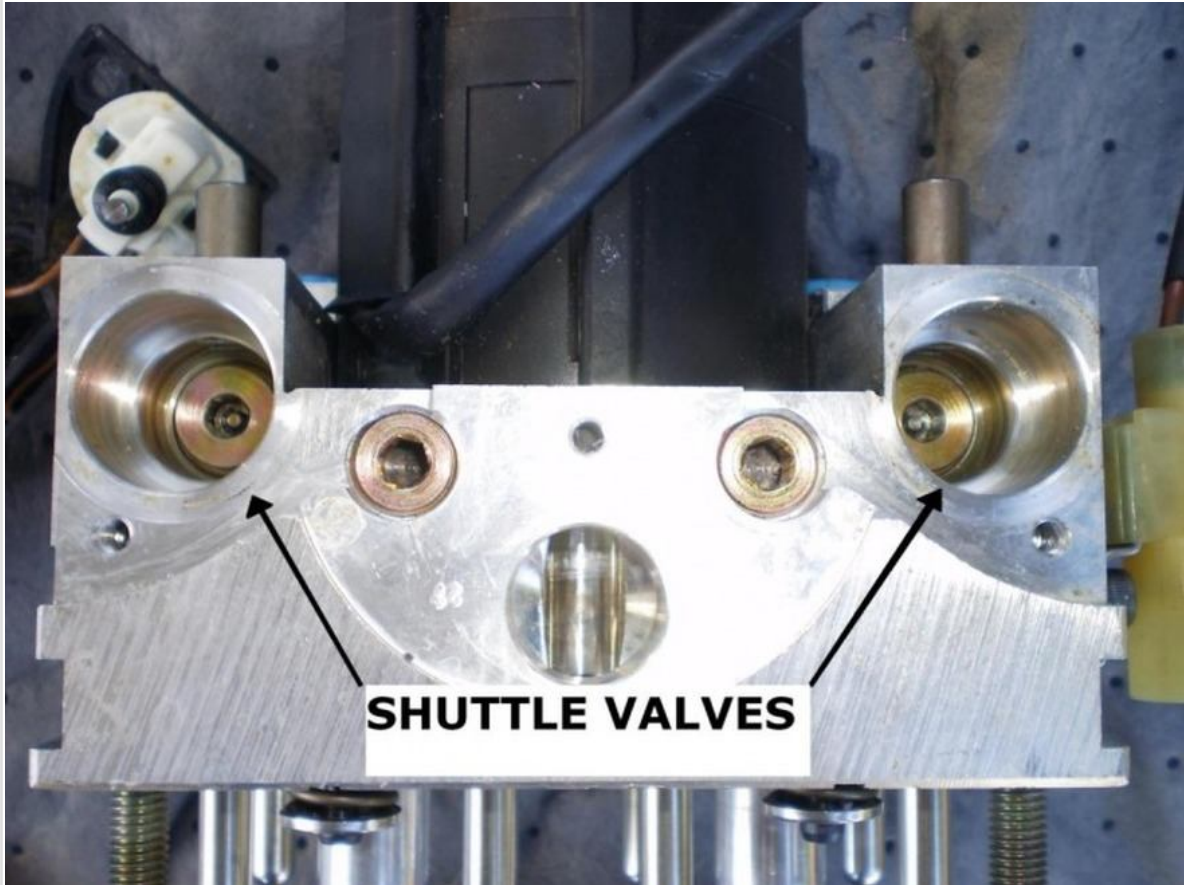
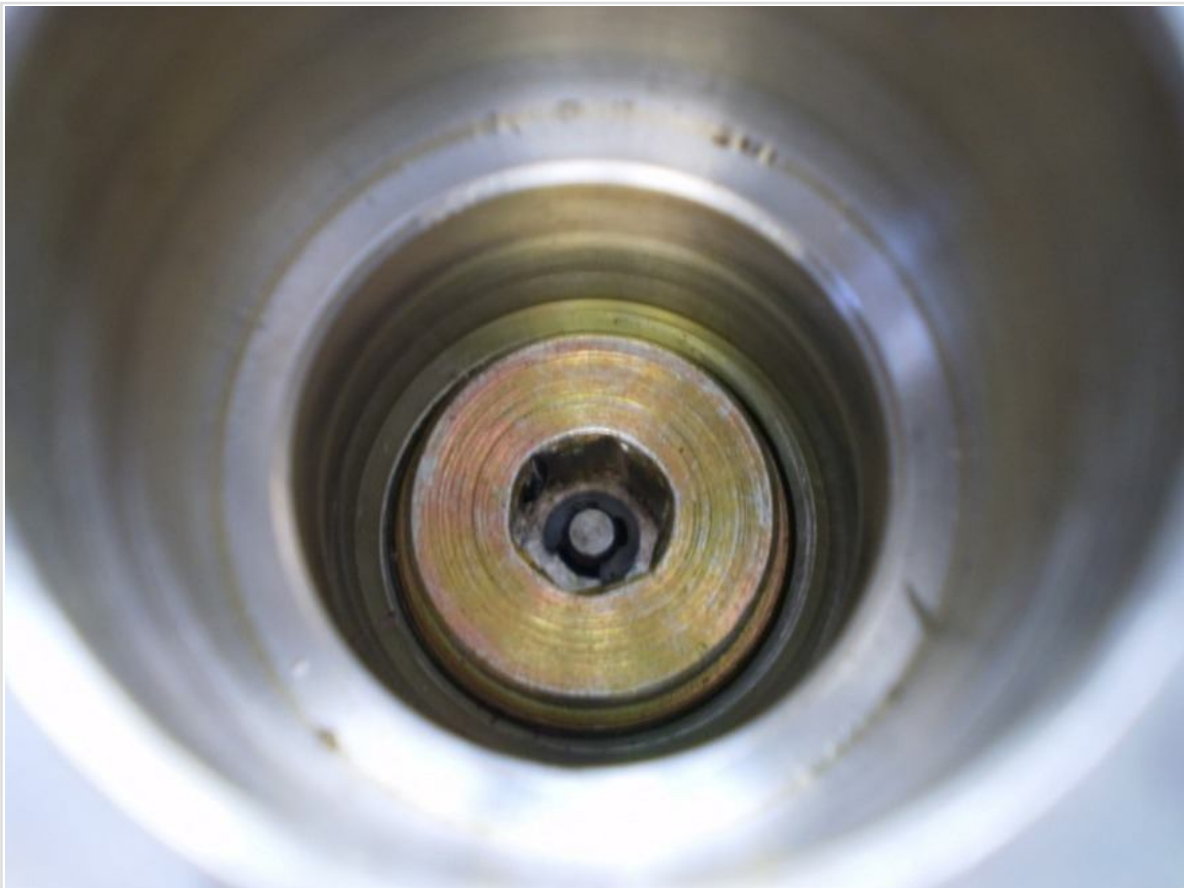
Shuttle Valve. You can see the SMALL circlip that comes in the kit mentioned above.

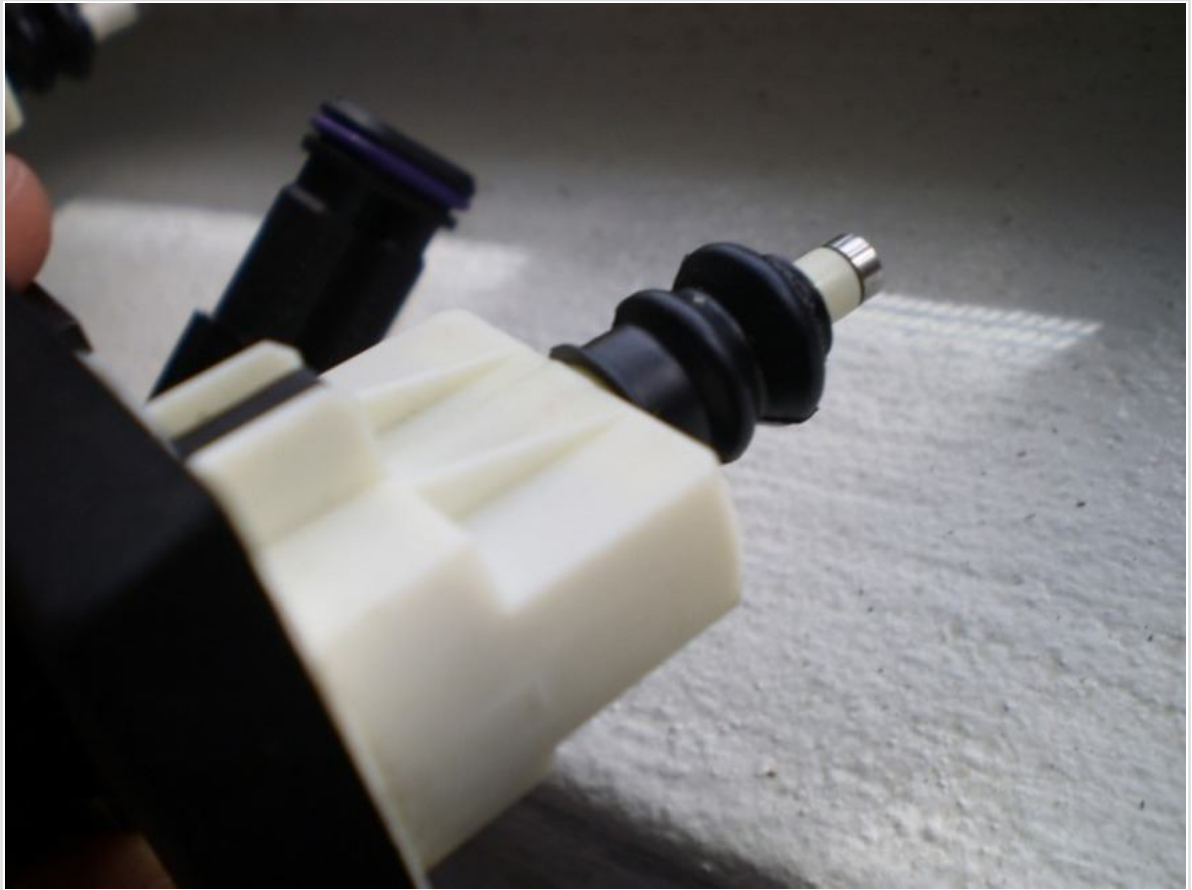
*Upon removing the boot I did find some fluid but not enough to cause any problems since they tested withing normal range.*

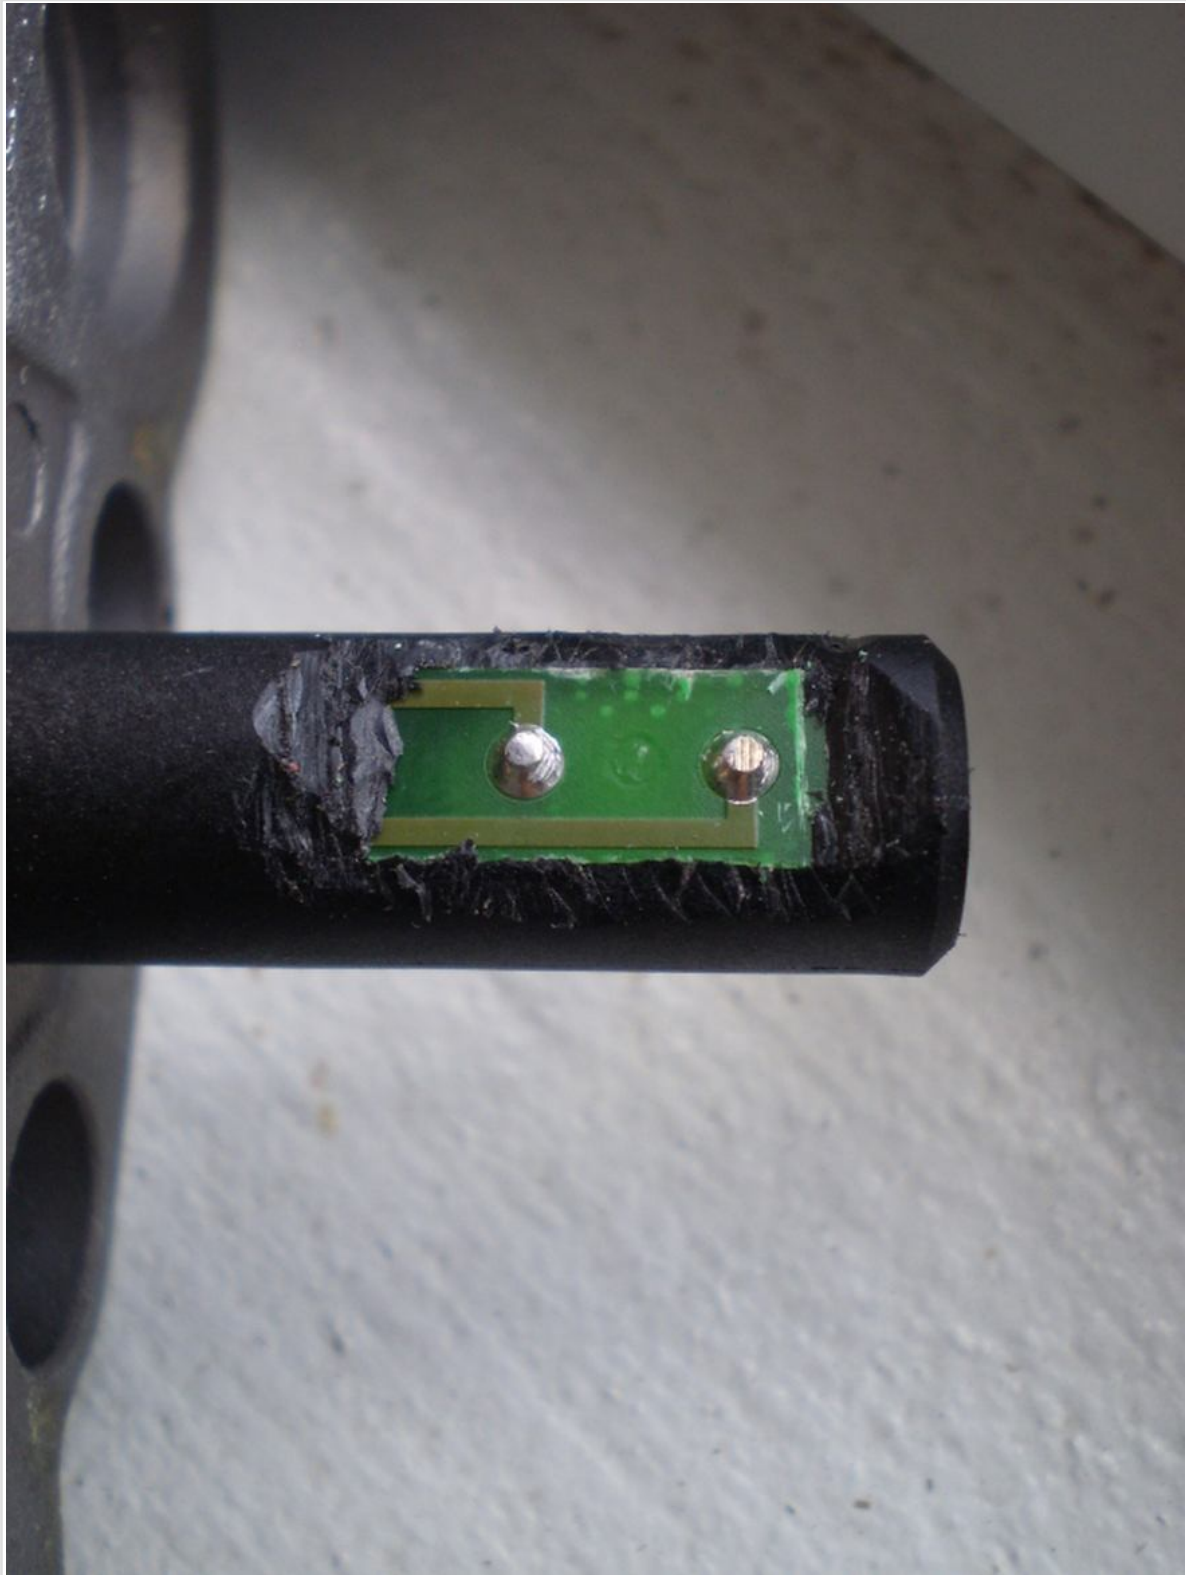
34. Luckily I had that spare modulator and I continued on with the repair. Except this time I used a very sharp serrated steak knife. **WHAT A DIFFERENCE!!!** I basically shaved it of little by little.

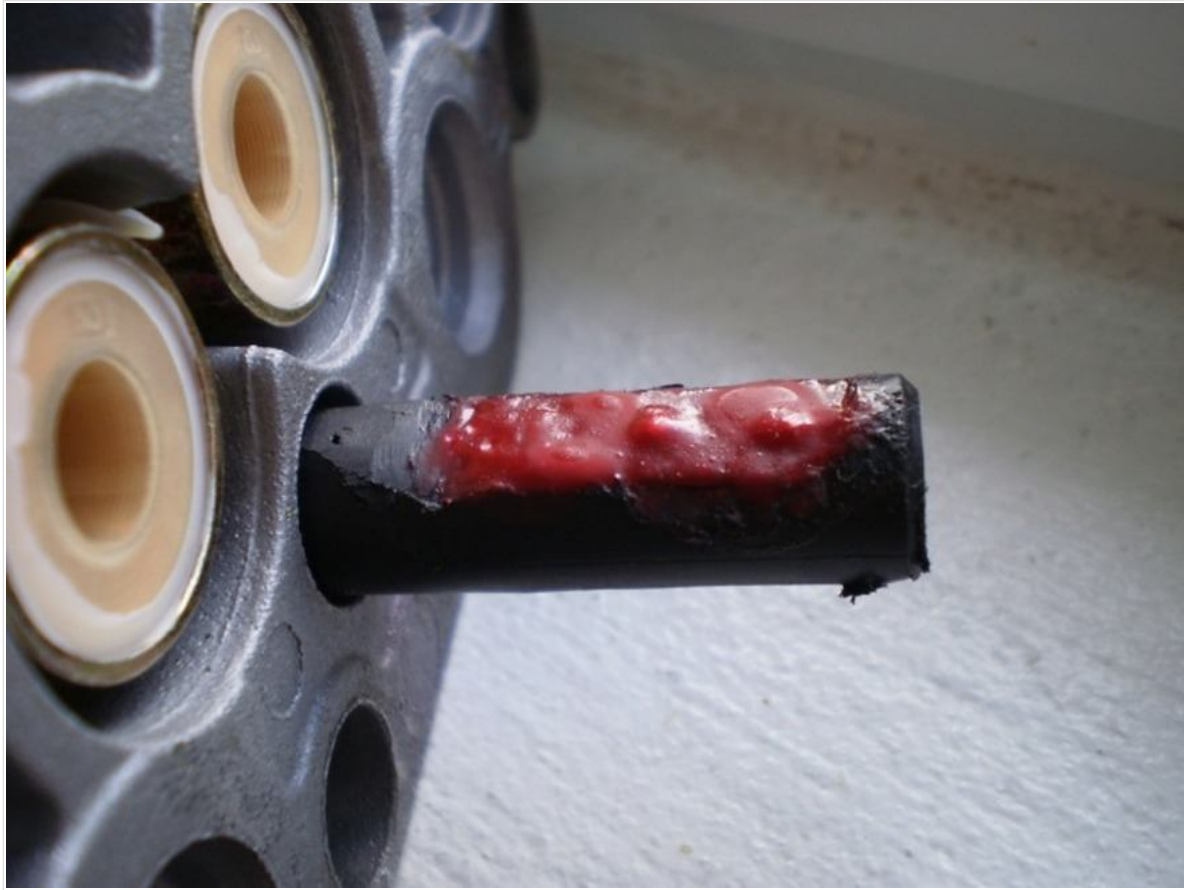
36. A few coats of liquid electric tape and done. The store only had red liquid electric tape.

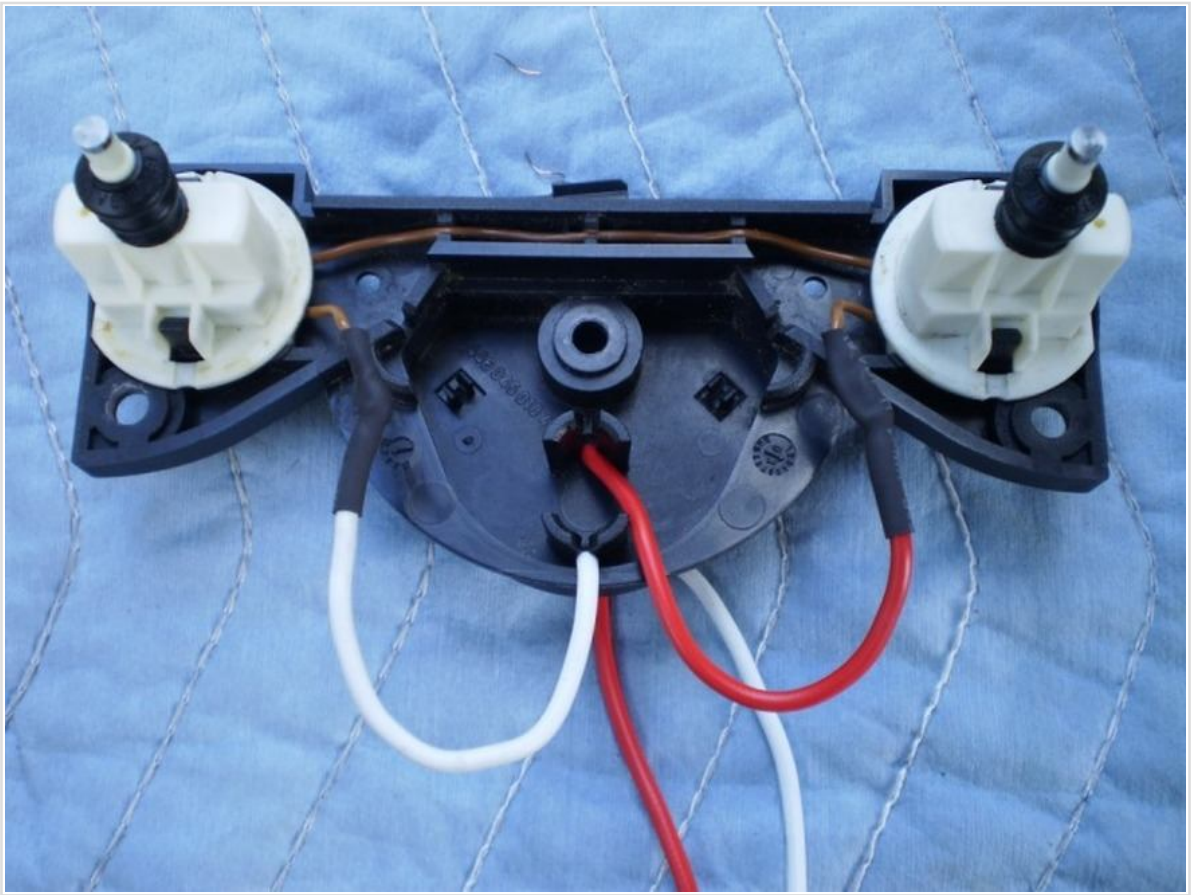
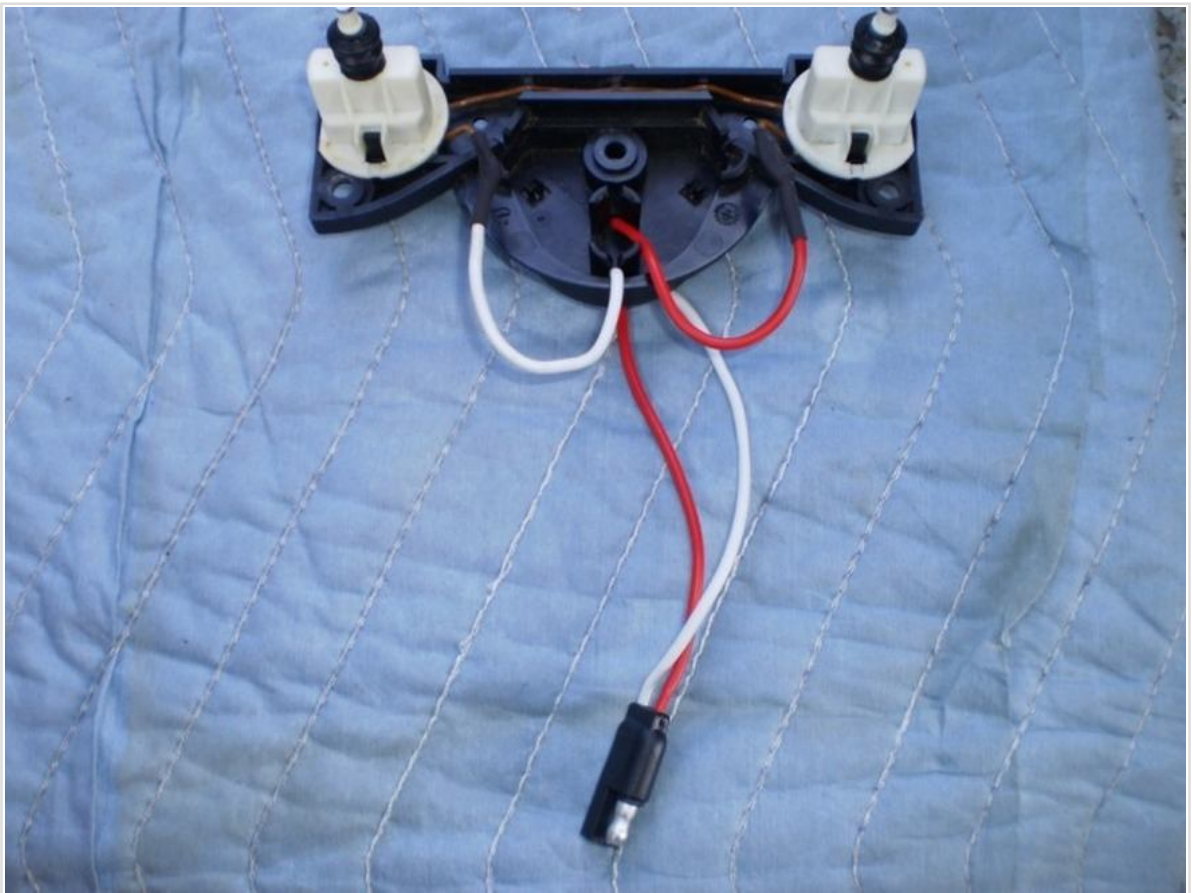
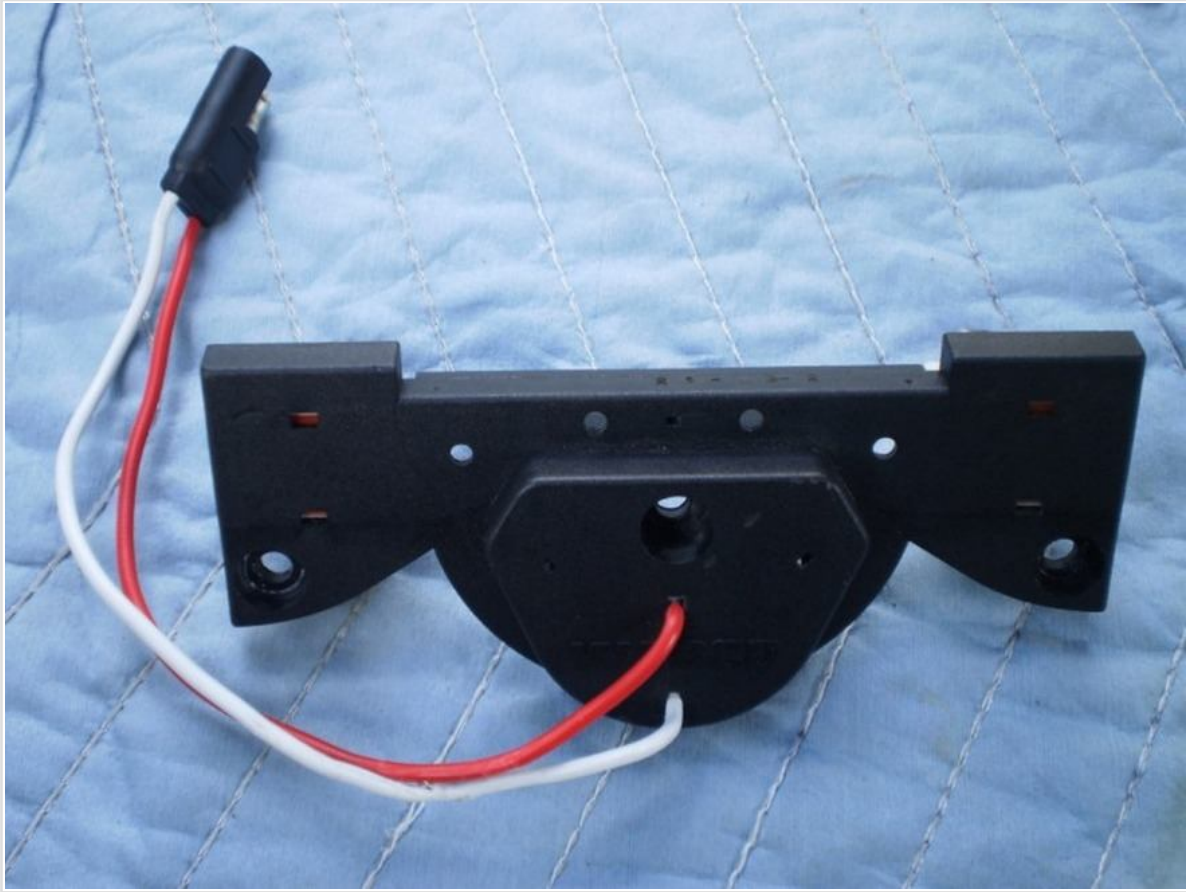
39. Splice, solder, and heat shrink the longer end of the trailer connector to the SVS wires and run them through the SVS cover plate.

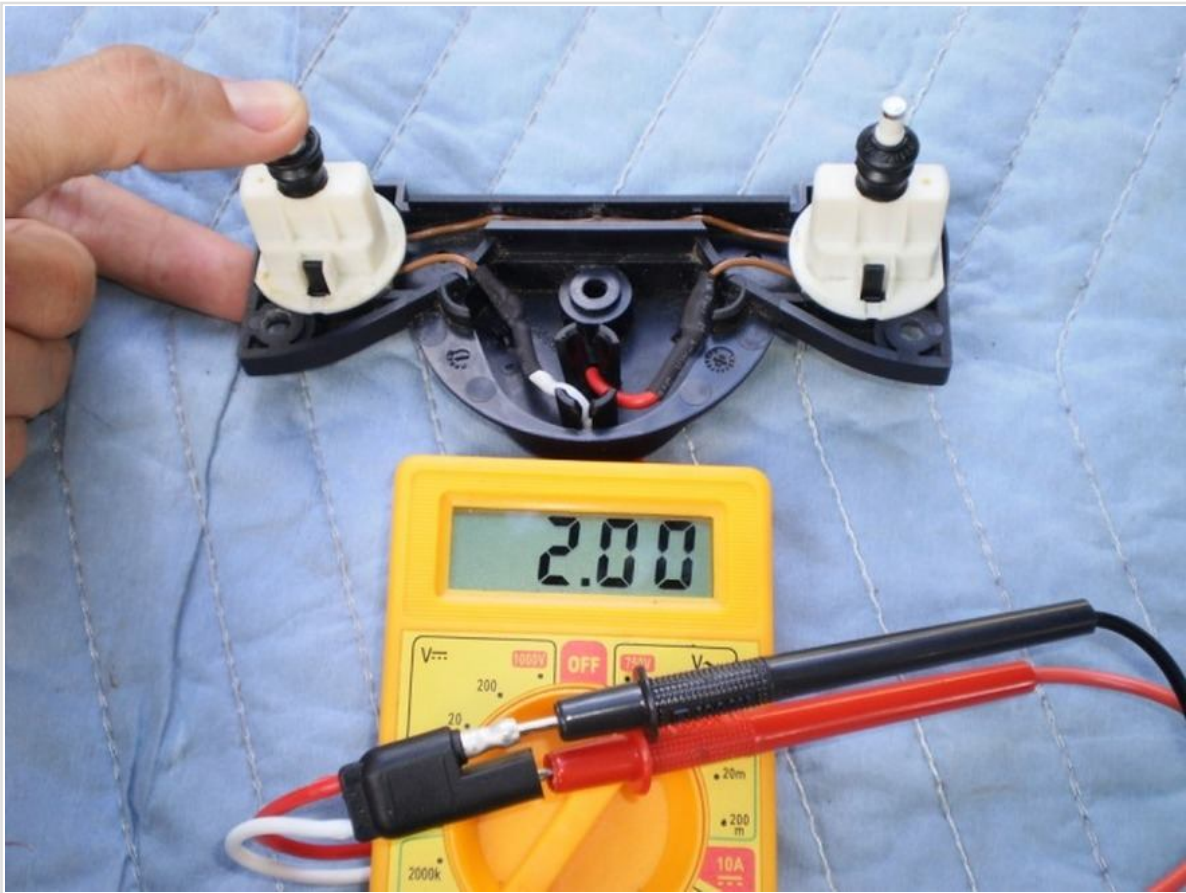
BOTH open, PASSED.

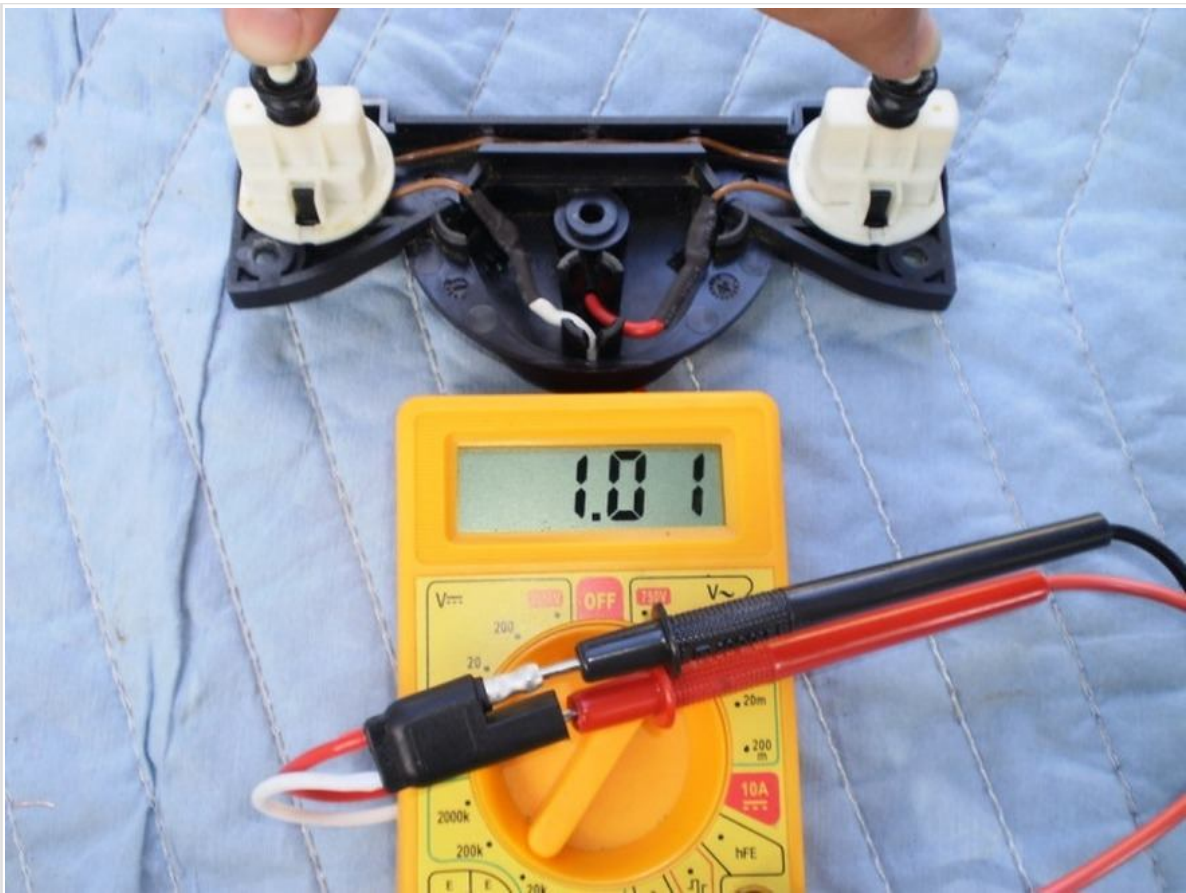
ONE Closed, PASSED.

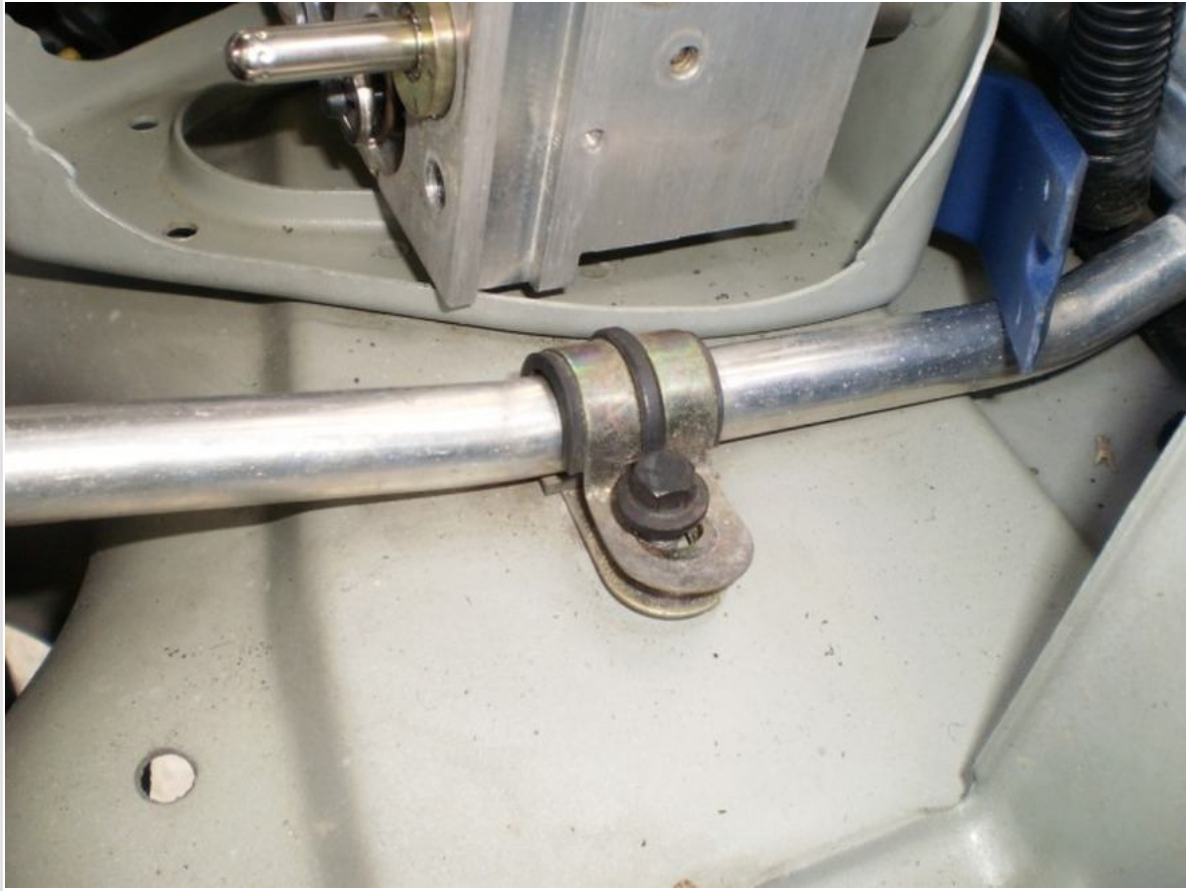
41. Now to find a close ground.... Since the YG wire we need to tap into runs along side the A/C line bracket retaining bolt.. Why not use it?

The Three Amigos returned in April 2010 as a result of this bolt coming loose. I may not have tightened it well when I did it the first time back in November 2009 so torque it good, and add loctite. I plan to check the bolt every oil change. In addition to using that bolt as a ground, ensure that it is free of dirt or rust or anything that would diminish a good electrical contact.

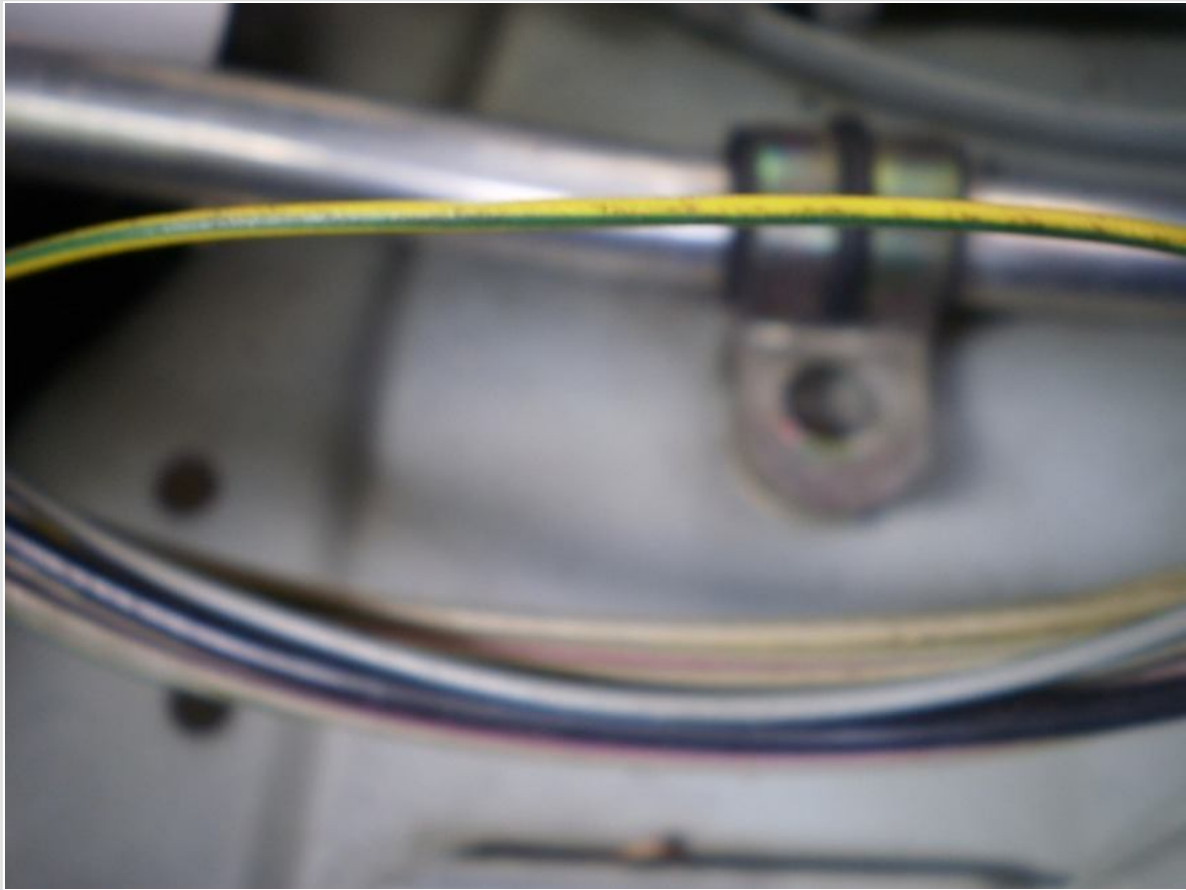
43. Peel off the wire loom shield off of the ABS Modulator wire harness. Locate the YG wire. Cut it in half but in such a way to leave enough length for your harness.
