# LAND ROVER CLUB V.I.

## ABS MODULATOR ELECTRICAL FAULT REPAIR

11/2009

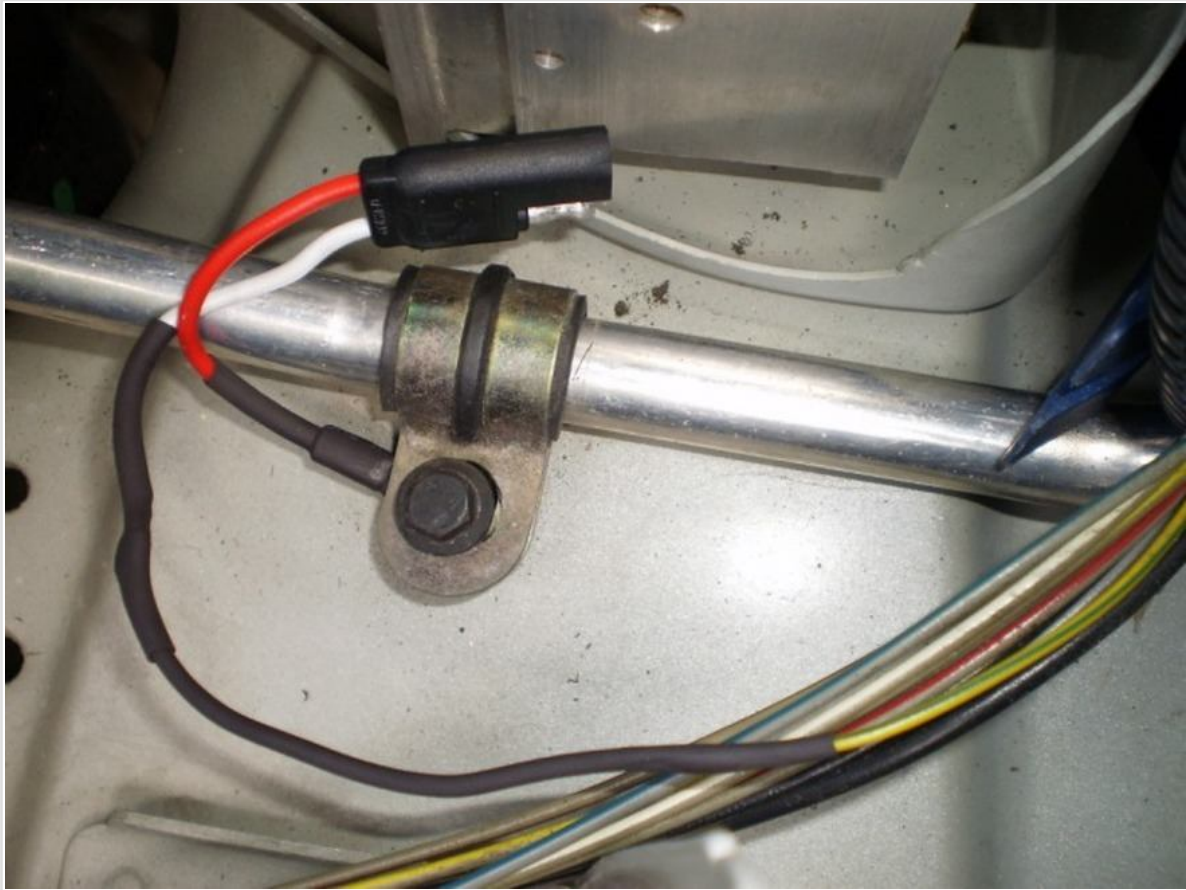
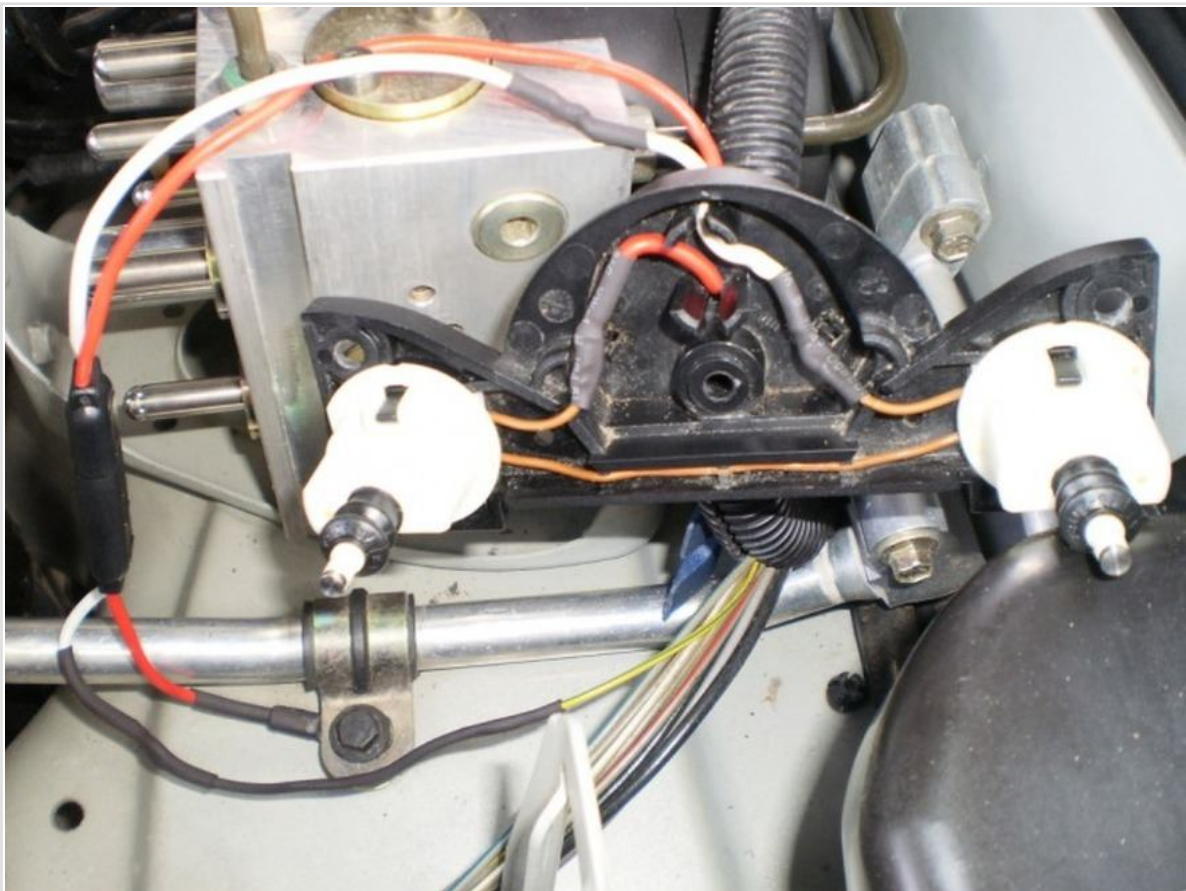
44. Take the second wire from your trailer harness and splice, solder, and heat shrink it into the YG wire coming from the main harness end NOT the end going back to the modulator plug.

*Note\*\* It does not matter which wire of the Trailer harness goes to ground or the YG wire. In other words, it doesn't matter which wire from the SVS goes to either GROUND or the YG wire as long as ONE goes YG wire, and the SECOND to GROUND. (So in my case I could have chosen either white or red wire)*

This is what it looks like plugged up.

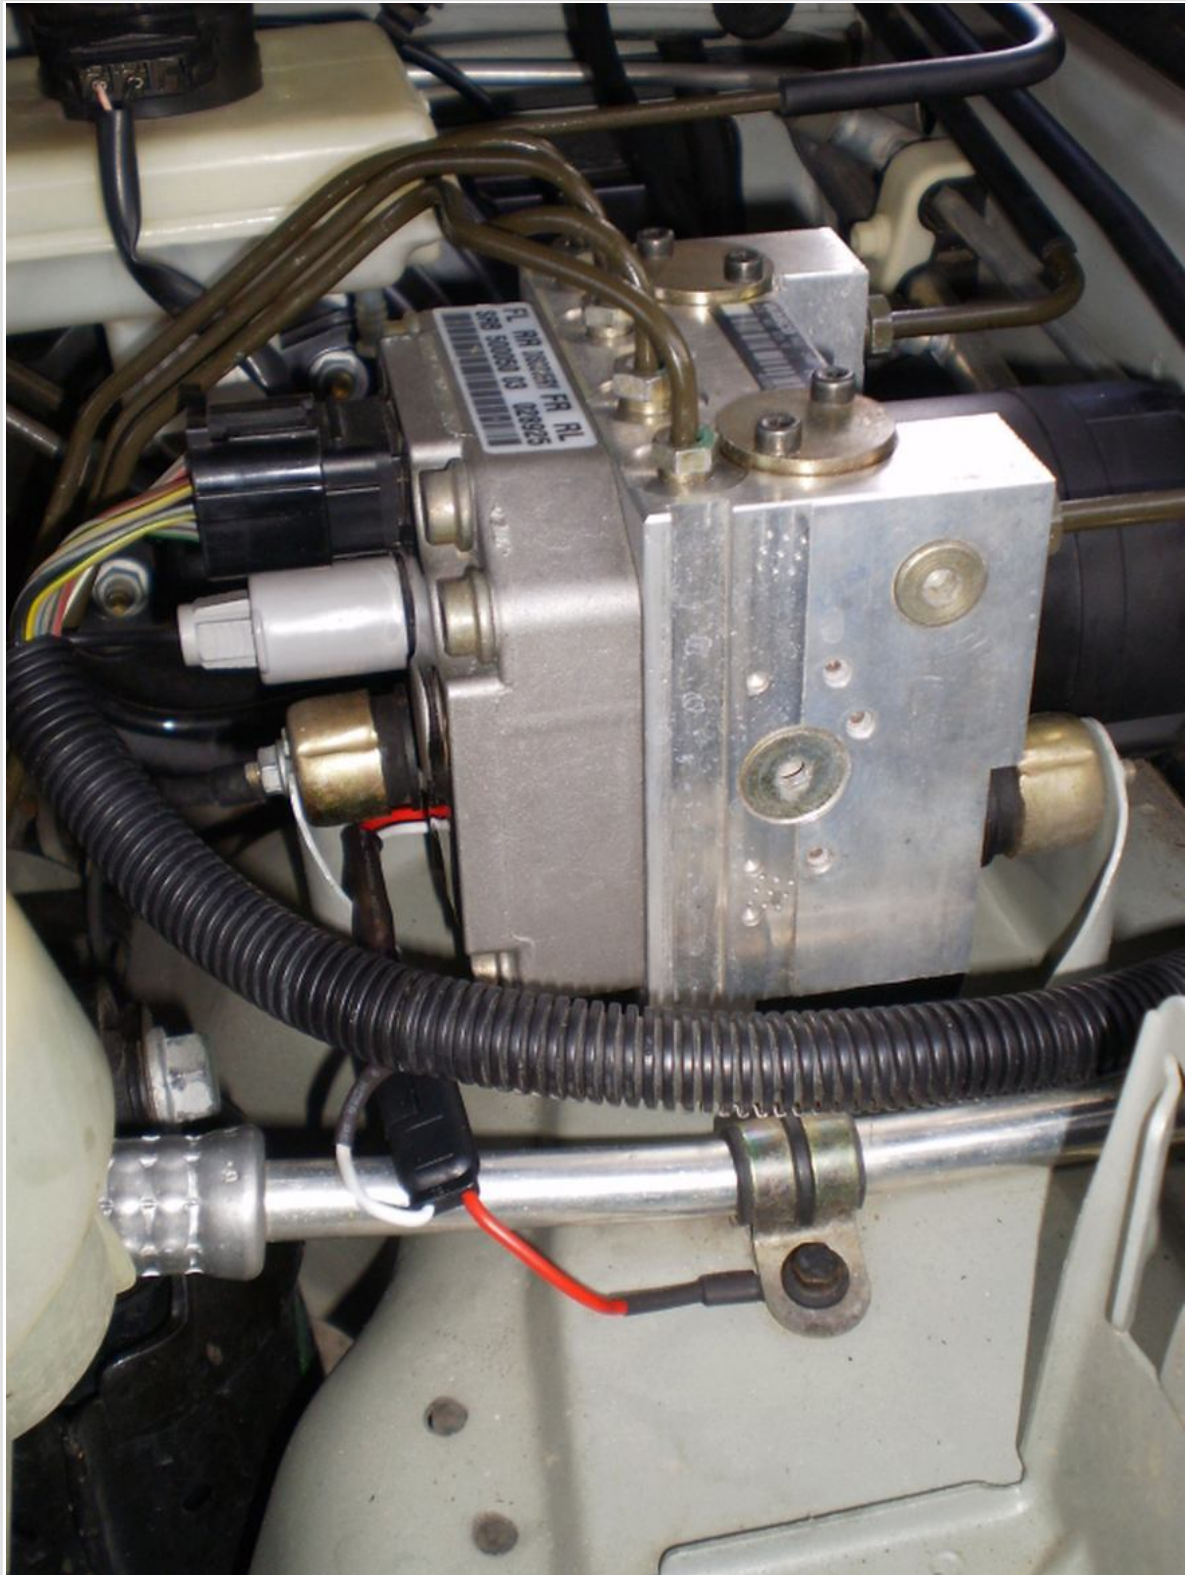
45. Everything installed, tested, no Amigos, no SLABS trouble codes. Installation is the reverse of removal for any method chosen to remove the SVS.
