JLRTB02058NAS1
TECHNICAL BULLETIN
19 AUG 2021

501-08

Tapping Noise From A-Pillar Area

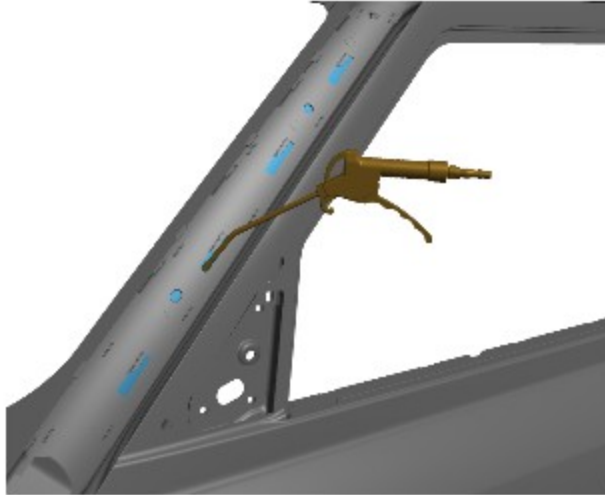
E271648

Using a suitable tool, blow compressed air into the holes shown highlighted in the illustration. This will remove any loose debris and contaminants.

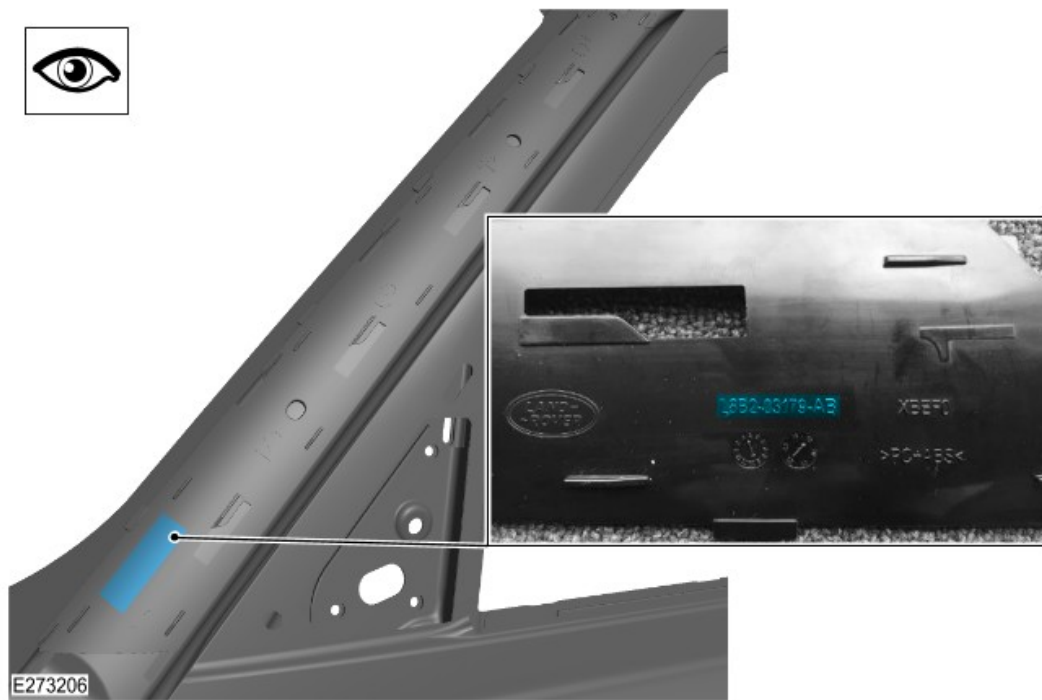
Locate the windshield molding carrier part number.

- If the part number is **L8B2-03178-AB**, **L8B2-03179-AB**, **L8B2-03178-AC** or **L8B2-03179-AC**, continue to **step 22**.
- If the part number is **L8B2-03178-AD** or **L8B2-03179-AD**, continue to **step 23**.

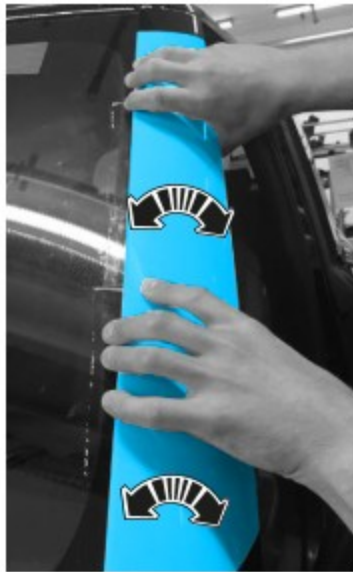
E273208

Make sure all of the windshield molding clips are correctly located by rotating the windshield molding in the directions shown in the illustration.

- If excessive movement and/or an excessive gap between the windshield molding and the windshield **is** evident, **remove the windshield molding and repeat step 25.**
- If excessive movement and/or an excessive gap between the windshield molding and the windshield **is not** evident, **continue to step 27.**
