1996-97 Discovery VSS Repair/Refurbish.

Version 1: 1/27/2013

Applies to:

Discovery series I, 1996 and 1997.

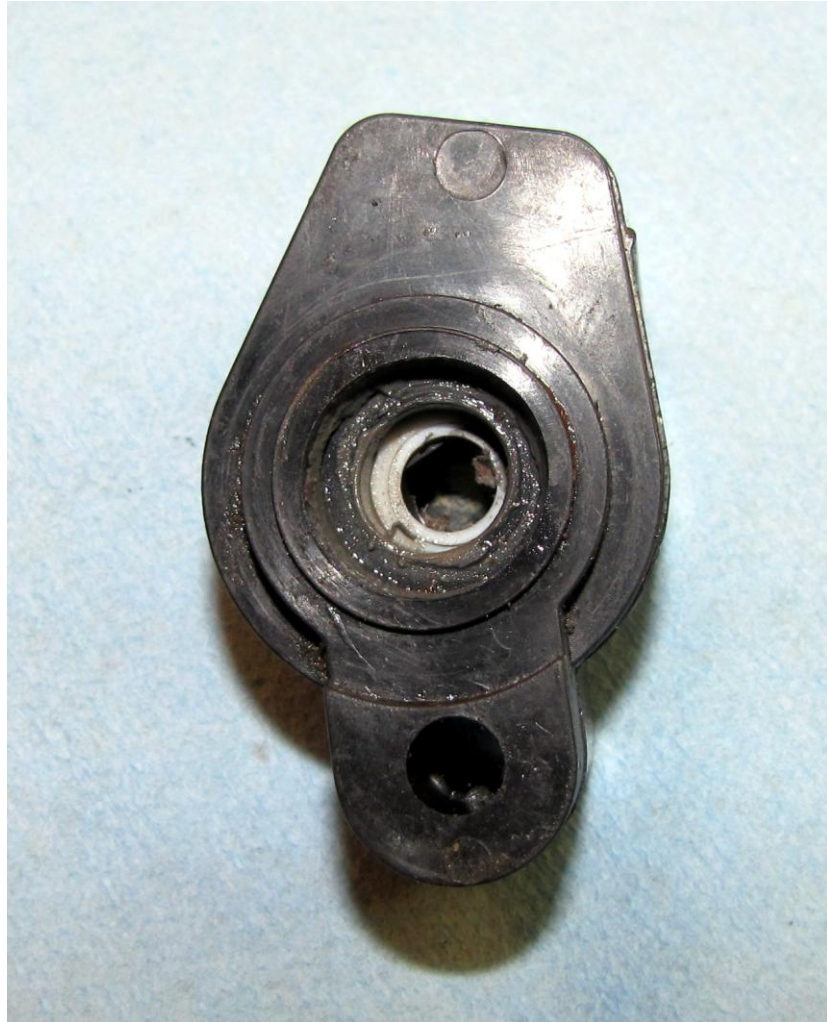
Figure 5: VSS body with shaft removed

After removing the shaft, we get to the part that probably would concern most people. We need to disassemble the case of the VSS. Since there are no screws, that would indicate that it's either glued or ultrasonically welded.

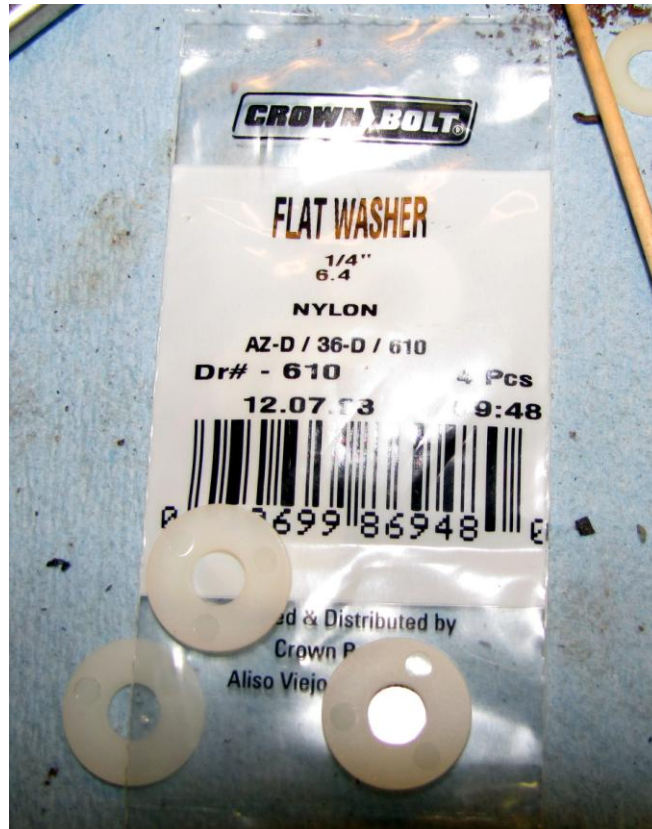
I started by finding the closest thing I could to what's needed. I got these washers at Home Depot. They've got the correct center dimension, but are too wide and a little bit less thick than the correct ones.

The thickness is not much of an issue, but the outside diameter is. The needed to be shaved down to 0.56" to fit in the spot needed. A little bit undersize is ok, as long as it doesn't allow too much wobble.
