TECHNICAL INFORMATION

SUBJECT	Inlet Manifold Valley Gasket- Leak	03/14/97 12/01/97/NAS
AFFECTED VEHICLES	LP up to 350645 LH up to 664120 LJ up to 709316 and 540078 LD up to 999463

**Revised Intake Manifold Gasket For
1989-97 Rover 4.0L Engines**

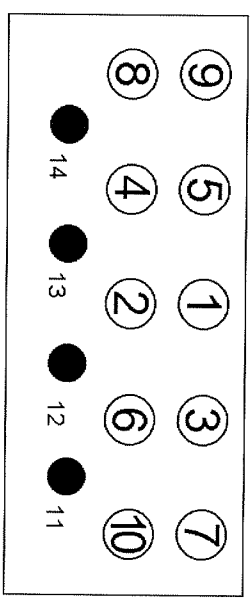
916.059

Anziehen/ Tightening/ Serrage/ Apriete 1989-1993 1994-

☼ 40-50 Nm
 60-70 Nm
 88-95 Nm
 POS. 11-14
 20-30 Nm
 30-40 Nm
 54-60 Nm

☼ 20 Nm
 > 90°
 > 90°
