Land Rover North America, Inc. Land Rover Canada

Bulletin:	STE05-04
Section:	<b>Tools &amp; Equipment</b>
Date:	26 January 2005
Model:	ALL

### Subject: New LR3 and Range Rover Navigation System Disc for "Bootloader" Fault

## HLDF CAN BOOTLOADER RECOVERY PROCEDURE

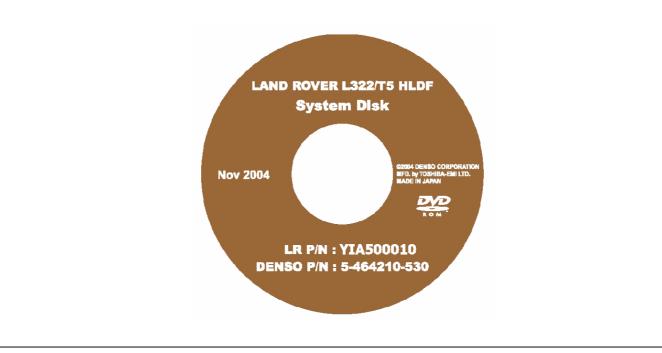
2 HLDF recovery is possible using the Multi-Media Module / MMM / Navigation Unit (when fitted) provided that the software update disc has been provided.

In order to recover the HLDF you must have a recovery disc -Land Rover Part Number: **YIA500010**

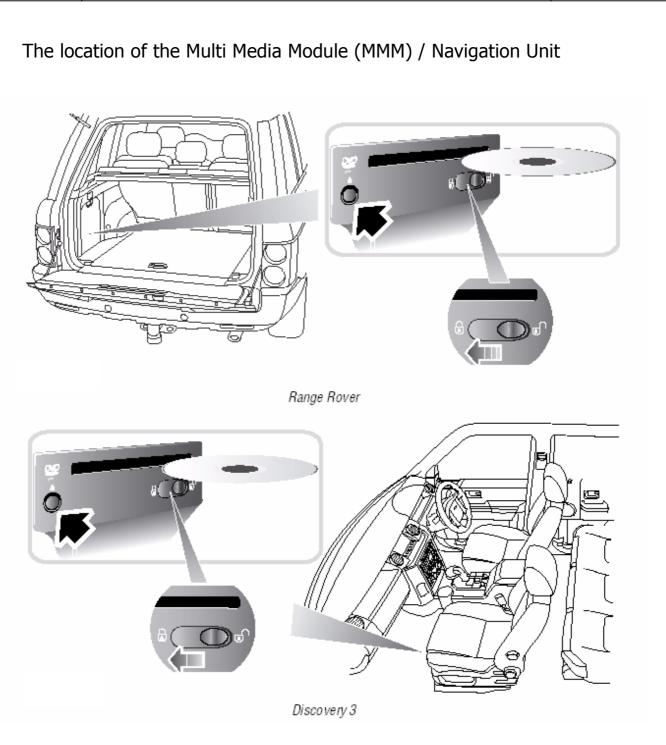
Note: On Discovery 3 vehicles fitted with electric seats, it is necessary to raise the left seat (left whilst sat in the vehicle) to its highest setting and then power the seat forward to its foremost position, before accessing the navigation DVD unit. This will also avoid any damge to the Map Disc and the System Disc.

3 Turn the ignition to position 'I' Move the lock / unlock button on the front of the Navigation Unit. Eject the Map DVD by pressing the Eject button **DENSO**
