ENGINE MANAGEMENT SYSTEM - V8

Crankshaft speed and Position (CKP) sensor (C0168)

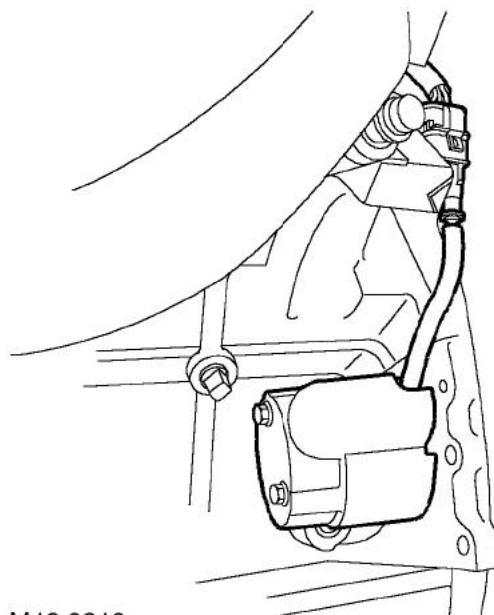
M18 0310

The CKP sensor is located towards the rear of the engine below cylinder number 7, with its tip adjacent to the outer circumference of the flywheel. The CKP sensor is the most important sensor on the vehicle and without its signal the engine will not run. The signal produced by the CKP sensor allows the ECM to determine crankshaft angle and speed of rotation. The ECM uses this information to calculate ignition timing and fuel injection timing.

The CKP sensor works as a variable reluctance sensor. It uses an electromagnet and a reluctor ring to generate a signal. As the reluctor ring passes the tip of the CKP sensor the magnetic field produced by the sensor is cut and then re-instated. The ECM measures the signal as an ac voltage.
