ENGINE MANAGEMENT SYSTEM - V8

Crankshaft speed and Position (CKP) sensor (C0168)

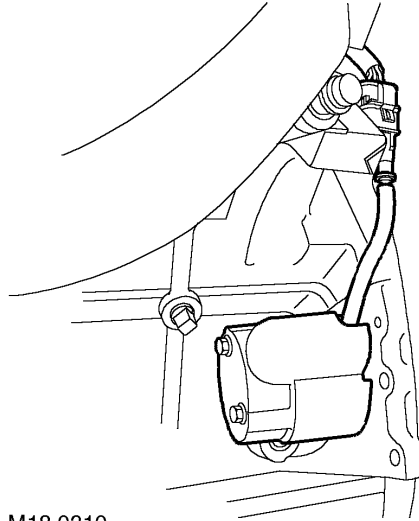
The CKP sensor is located towards the rear of the engine below cylinder number 7, with its tip adjacent to the outer circumference of the flywheel. The CKP sensor is the most important sensor on the vehicle and without its signal the engine will not run. The signal produced by the CKP sensor allows the ECM to determine crankshaft angle and speed of rotation. The ECM uses this information to calculate ignition timing and fuel injection timing.

The CKP sensor works as a variable reluctance sensor. It uses an electromagnet and a reluctor ring to generate a signal. As the reluctor ring passes the tip of the CKP sensor the magnetic field produced by the sensor is cut and then re-instated. The ECM measures the signal as an ac voltage.

The output voltage varies in proportion to engine speed. The reluctor ring has a set tooth pattern, 60 teeth are spaced at 6° intervals and are 3° wide, two teeth are removed to provide a reference mark at 60° BTDC for number 1 cylinder. There is no back up strategy or limp home facility if this sensor fails, the engine does not run.
